# National Transportation Safety Board

## **MATERIALS LABORATORY**

Factual Report 24-066

Location: Palm Springs, California  
Date: July 11, 2023  
Vehicle: Sling Aircraft LSA, N294JY  
Investigator: Elliott Simpson (AS-WPR)

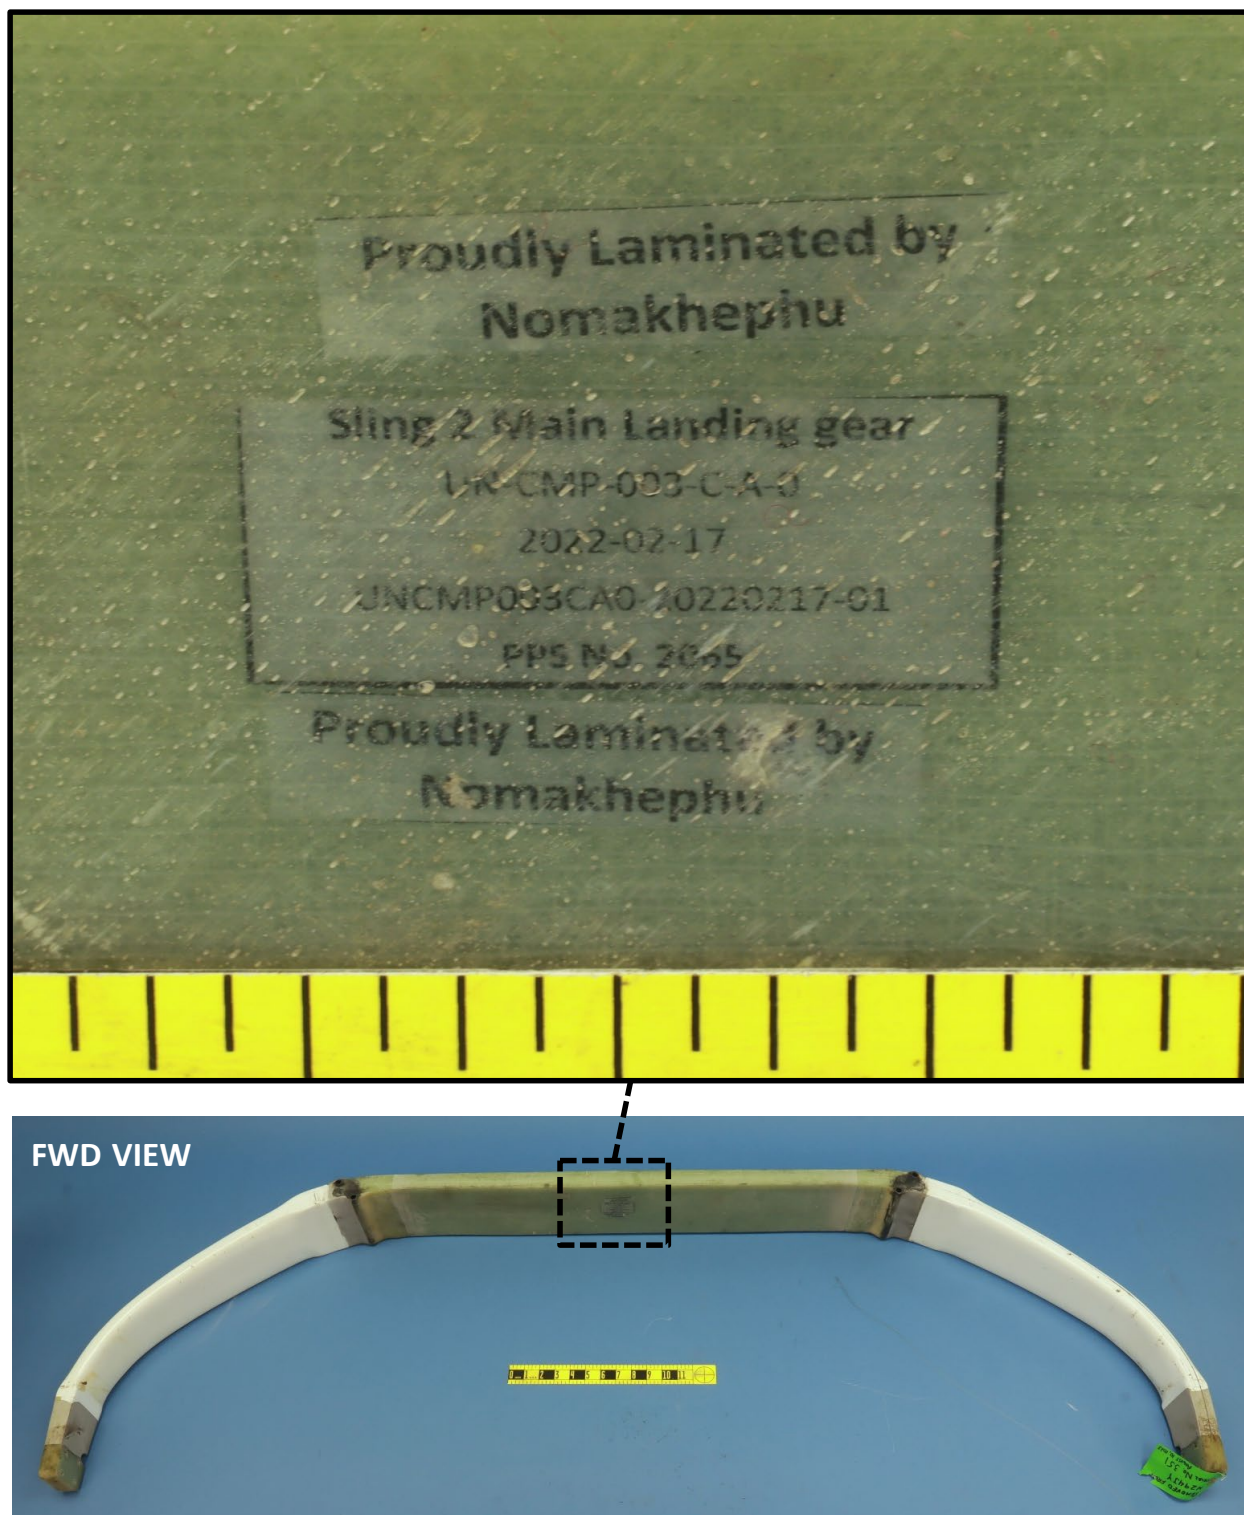
The subject landing gear strut was submitted after the left wheel experienced a failure during take-off roll out. The landing gear strut was subsequently disassembled from the aircraft and submitted to the NTSB Materials Laboratory for examination, as shown in the lower image of Figure 1.

The manufacturing identification information embedded in it is shown in the upper image of Figure 1. Per the identification information the strut was manufactured in February of 2022.

**Figure 1.** (Bottom) Overall photo showing the landing gear strut as viewed from the forward side. (Top) Close-up photo showing the embedded manufacturing information.

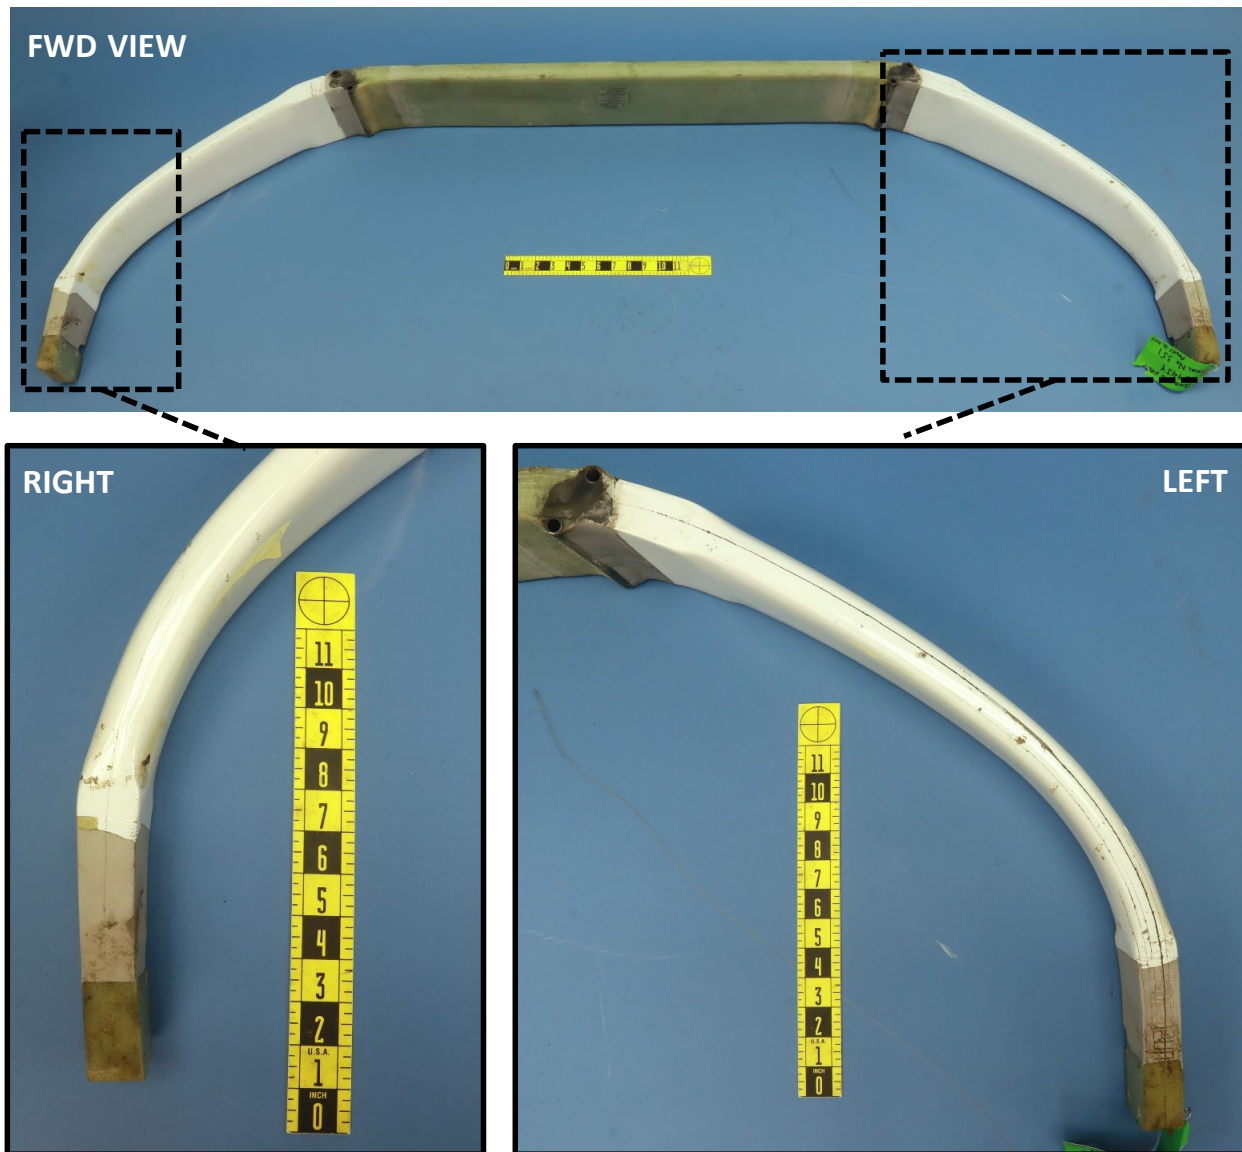
Cracking parallel to the lamina was visible on both sides of the strut, with more extensive cracking observed on the left side. Figures 2-6 show the left side had multiple cracks, with one crack that extended all the way through the strut upwards from the end and caused a gap between the lower and upper halves of the strut. The longest crack on the left side extended from the end, through the center of the forward face, through the brake line slot on the aft face, and past the bolt sleeve into the flat center portion of the strut. Additionally, one of the cracks extending up from the end on the left side branched onto the inner surface, as shown in Figure 7.

The right side of the strut is shown in Figures 2 and 4. There was one distinct crack extending through the center of the forward face near the end, though it did not appear to extend all the way to the end. On the aft face, the crack extended from the brake line slot towards the end, but again did not appear to extend all the way to the end.

**Figure 2.** (Top) Overall photo showing the landing gear strut as viewed from the forward side. (Bottom) Close-up photos showing cracks in the right and left sides of the strut.

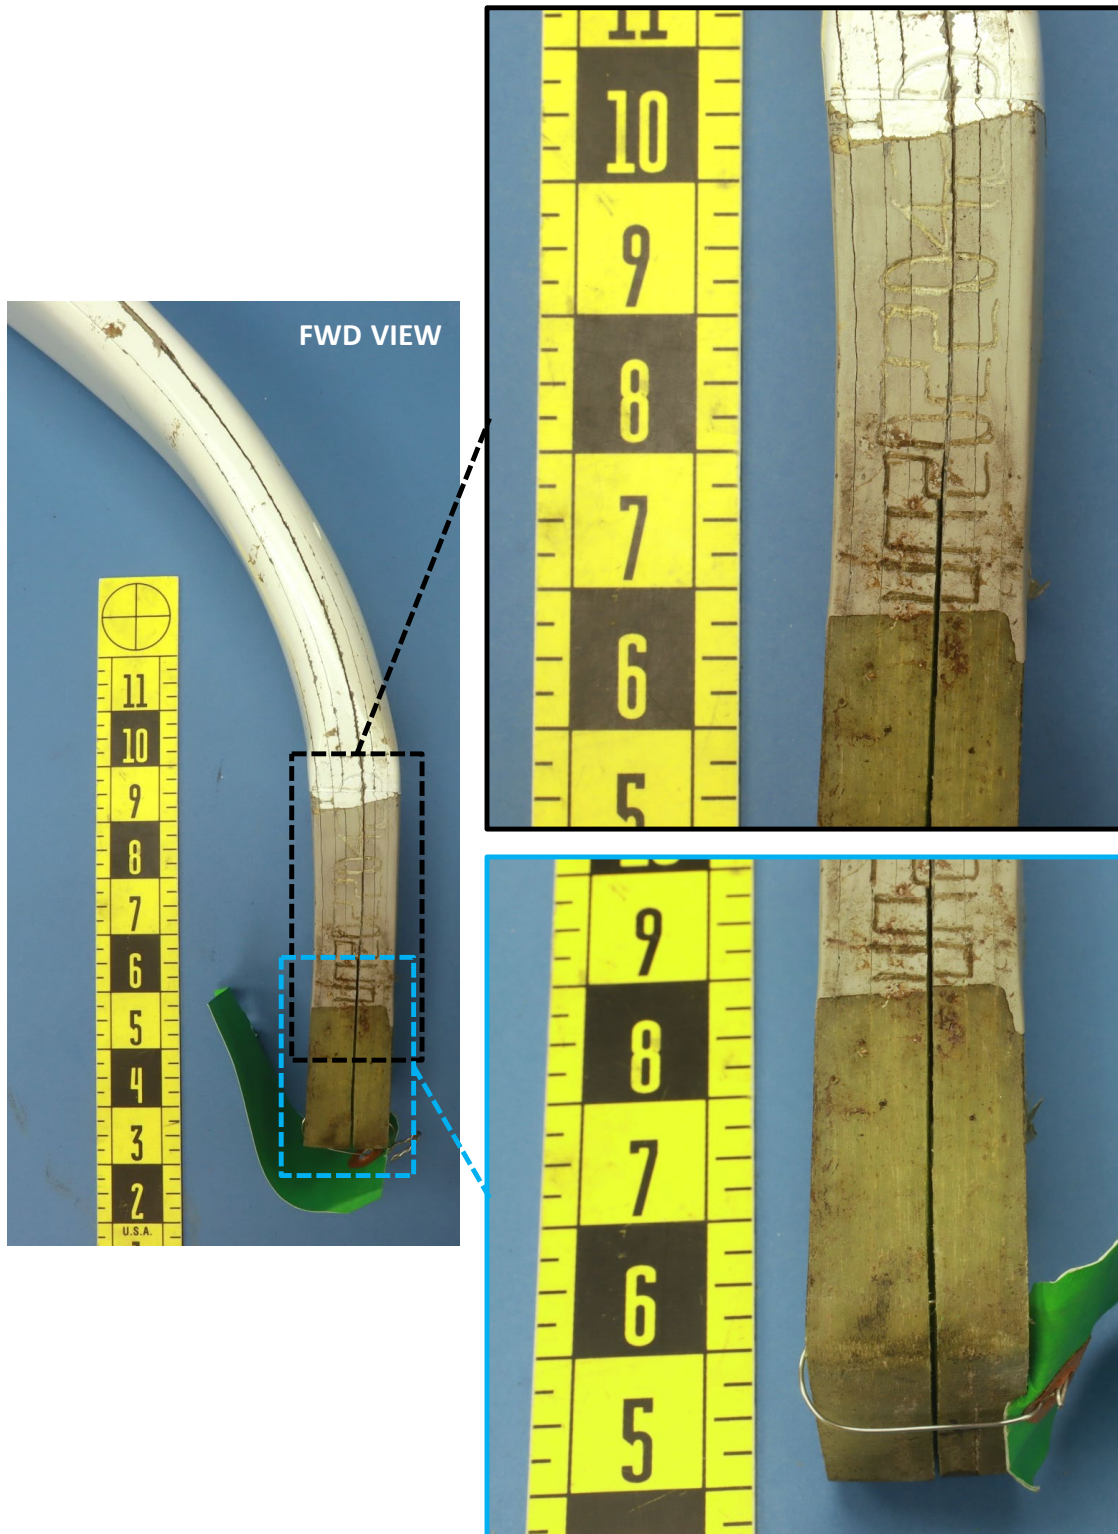
**Figure 3.** Close-up photos showing cracks in the left side end of the strut as viewed from the forward side.

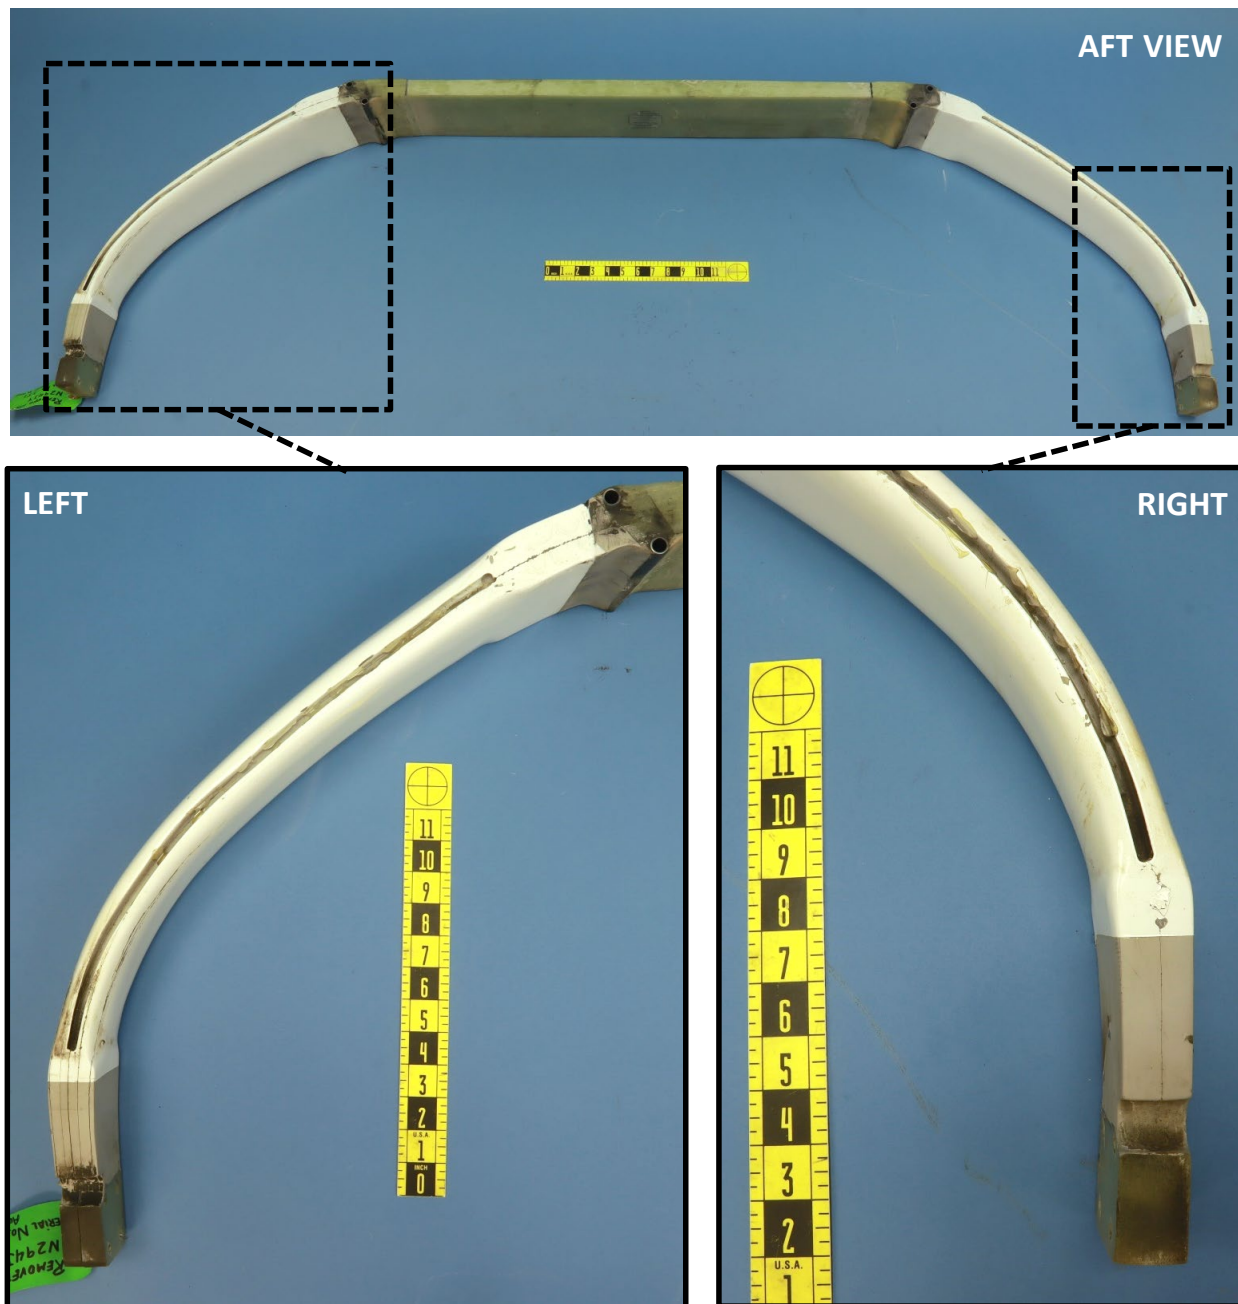
**Figure 4.** (Top) Overall photo showing the landing gear strut as viewed from the aft side. (Bottom) Close-up photos showing cracks in the left and right sides of the strut.

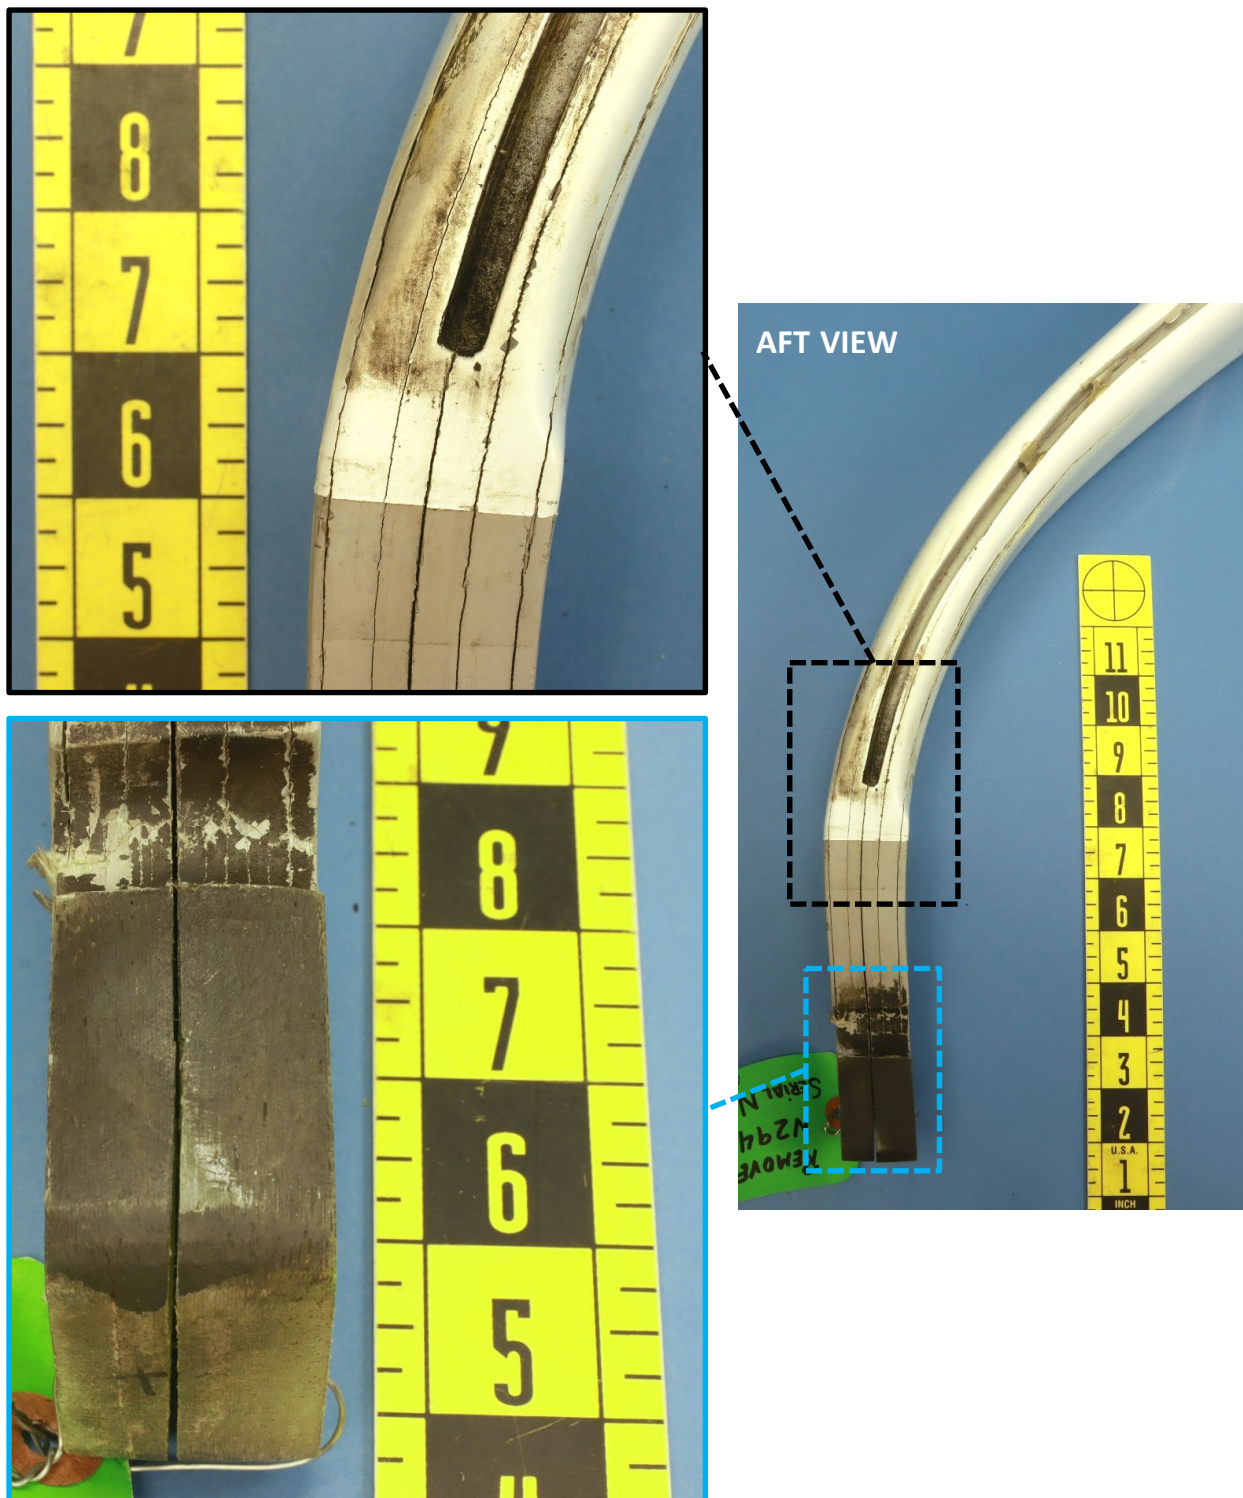
**Figure 5.** Close-up photos showing cracks in the left side strut end as viewed from the aft side.

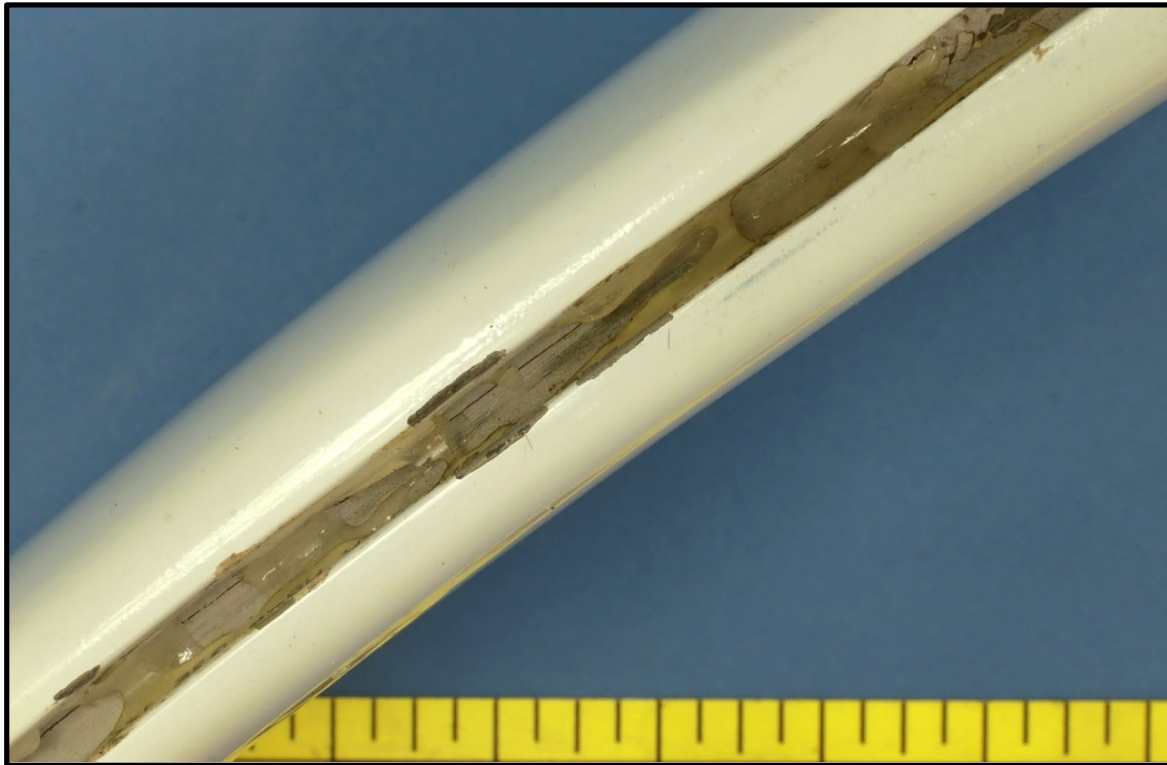
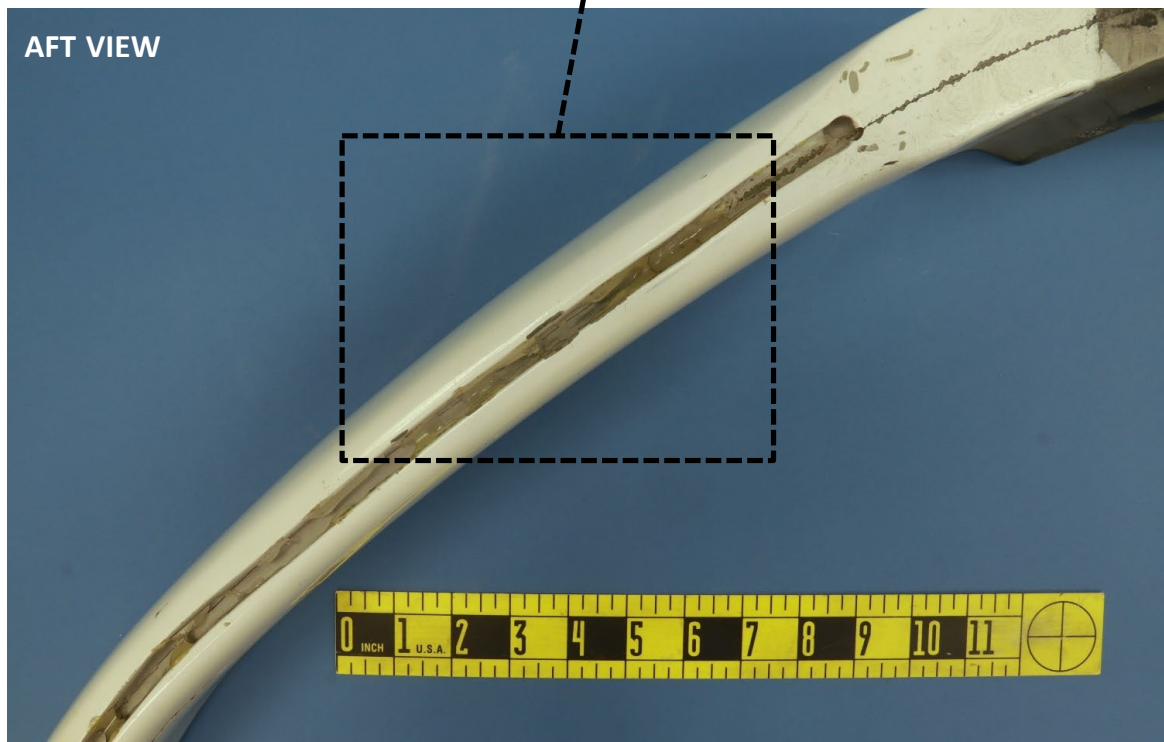
**Figure 6.** Close-up photos showing cracks within the aft brake line slot on the left side of the strut.

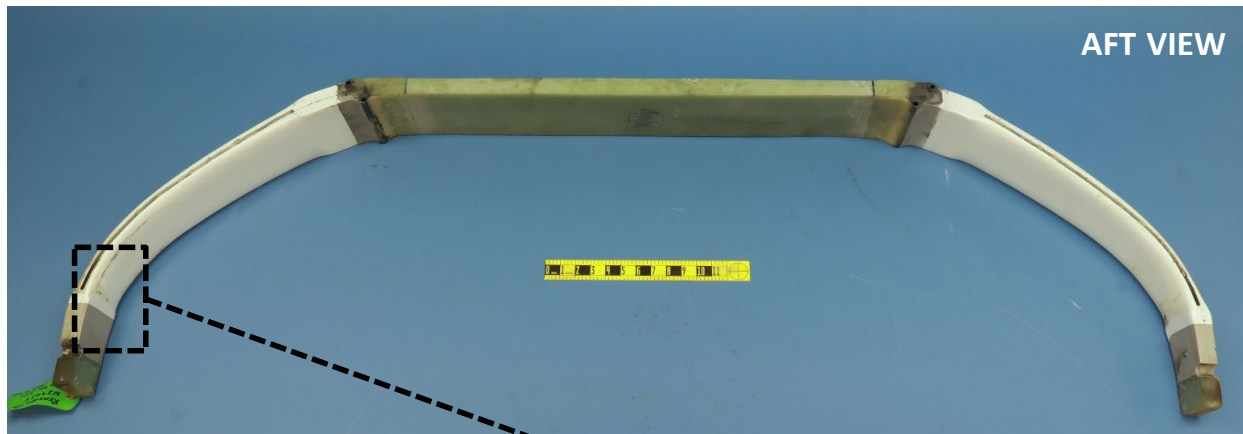
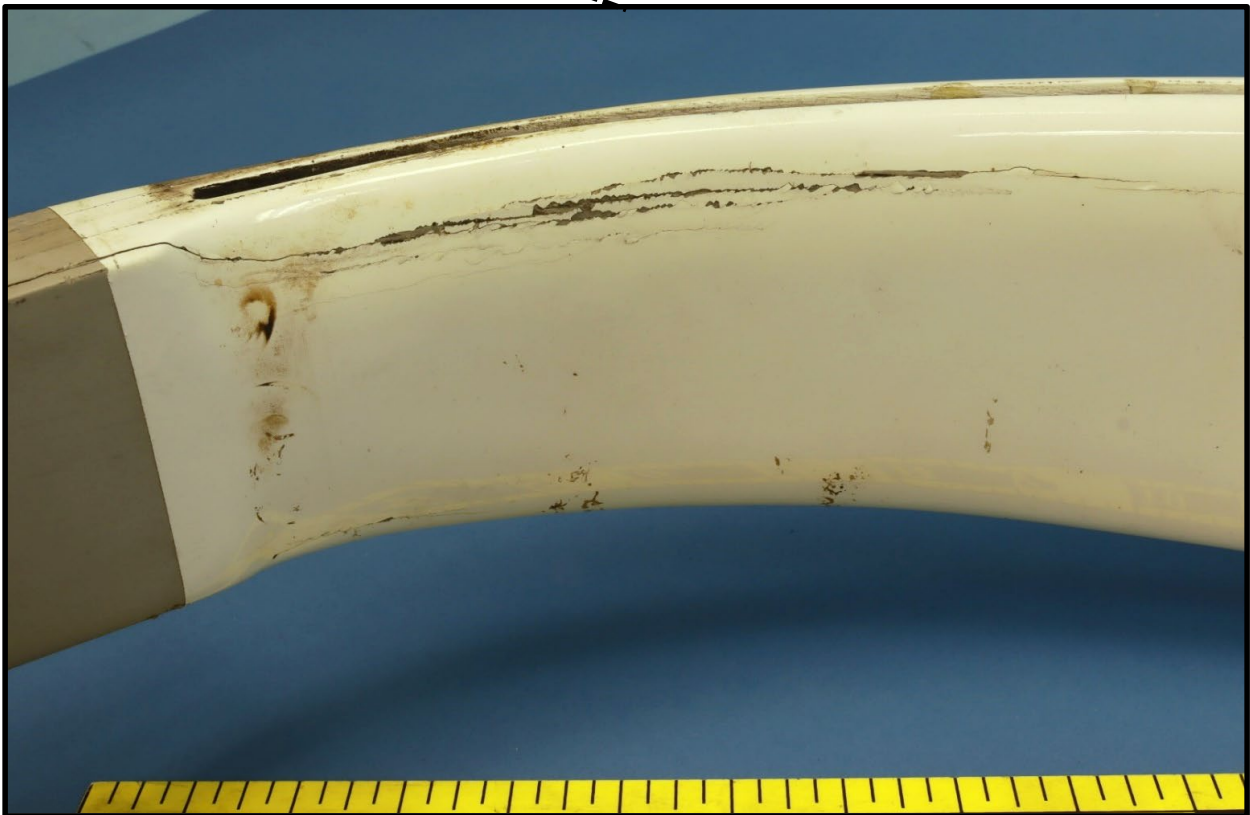
**Figure 7.** (Top) Overall photo showing the landing gear strut as viewed from the aft side. (Bottom) Close-up photo showing cracks branching onto the inner surface of the strut on the left side.

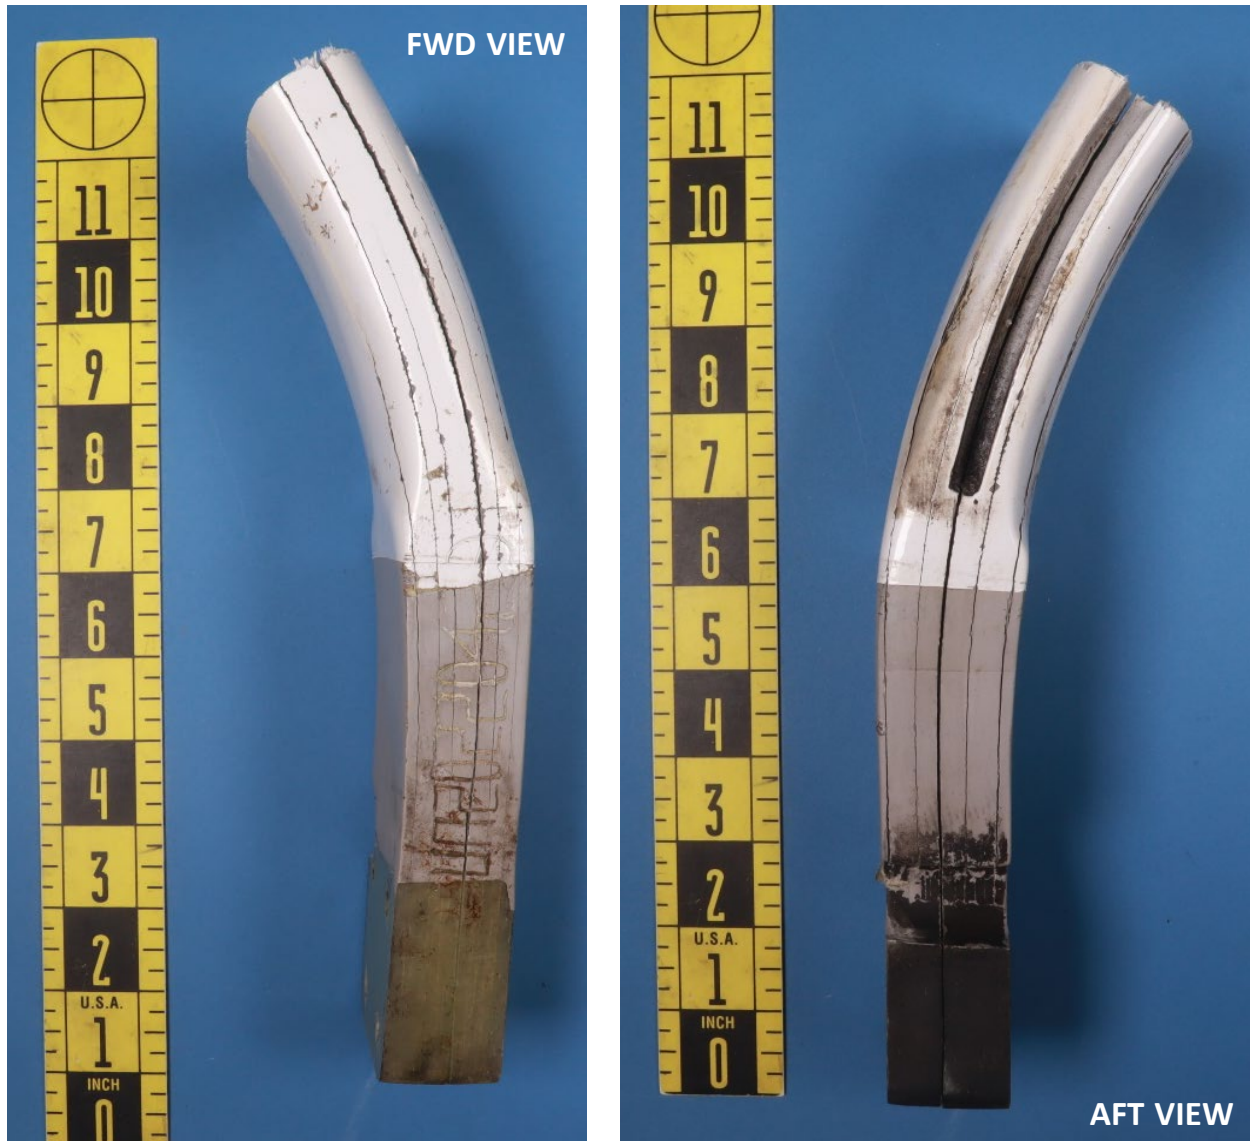
suction was applied to prevent contamination of the fracture surfaces by particles resulting from sectioning. The sectioned end piece is shown in Figure 8.

**Figure 8.** Overall photos of the left side end of the strut after sectioning, as viewed from the forward and aft sides (left and right, respectively).

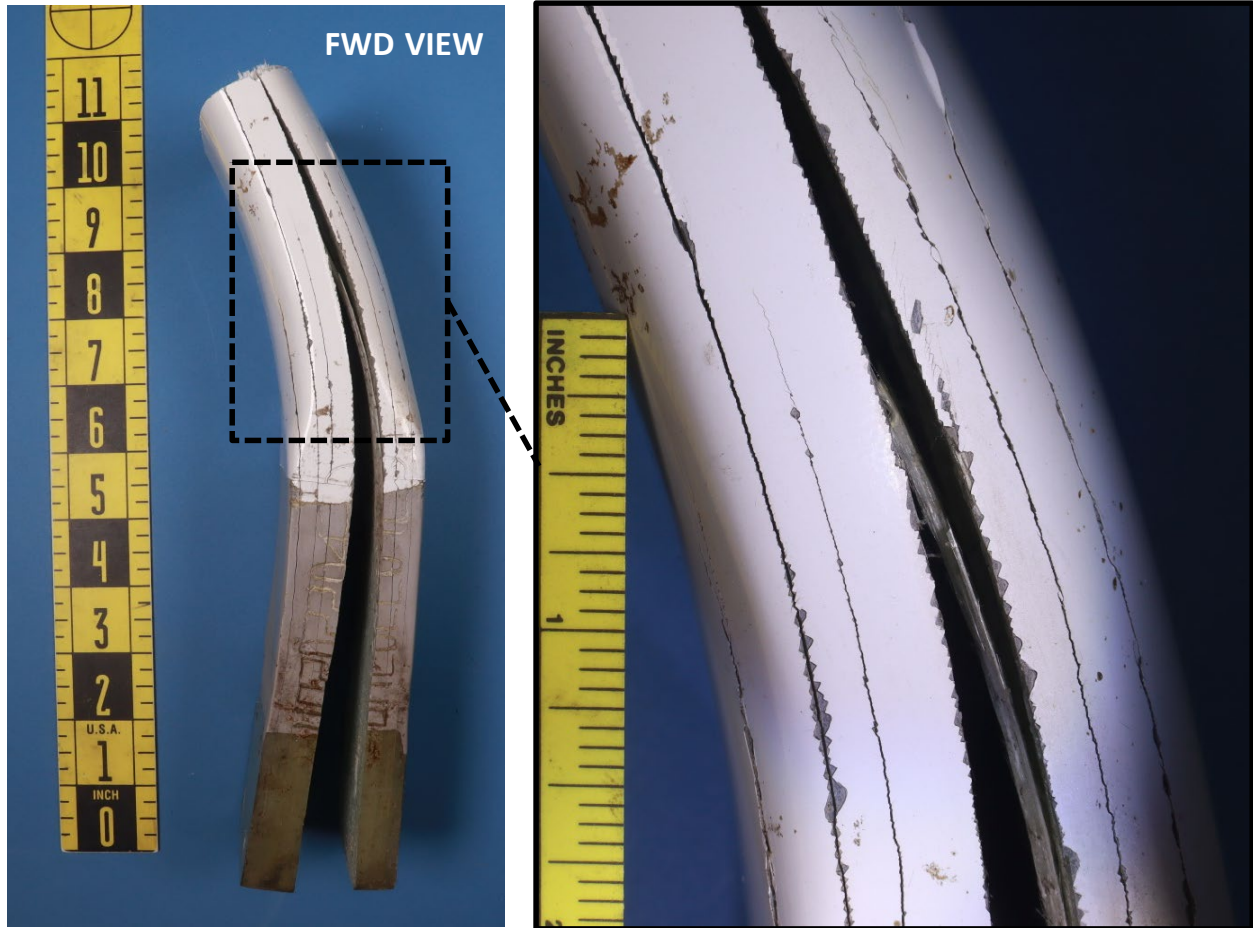
Following sectioning, the lower and upper halves of the piece were almost entirely separated, apart from a 0.5-inch-wide strip of laminate near the forward face containing several layers of fiber that bridged between the two halves. The bridging strip of material can be seen within the gap between separated halves shown in Figure 9. The strip was mechanically fractured in the laboratory and the exposed fracture surfaces of the two strut halves are shown in Figure 10.

**Figure 9.** Overall (left) and close-up (right) photos of the sectioned left side end of the strut, as viewed from the forward side. The only portion of material that remained adhered to both halves of the mating fracture surfaces on the strut is visible within the gap shown on the right.

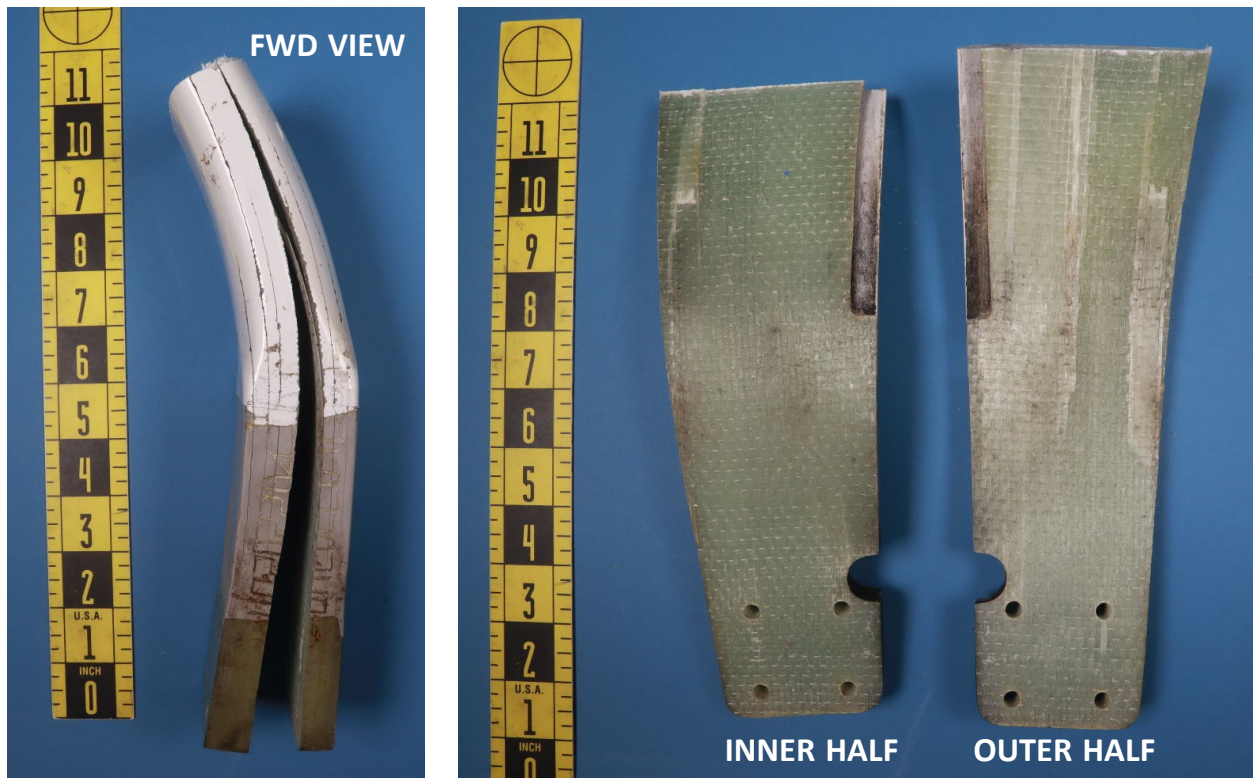
**Figure 10.** Overall photos of the sectioned left side end of the strut before and after (left and right, respectively) the portion of adhering material between the mating fracture surfaces was mechanically separated in the laboratory.

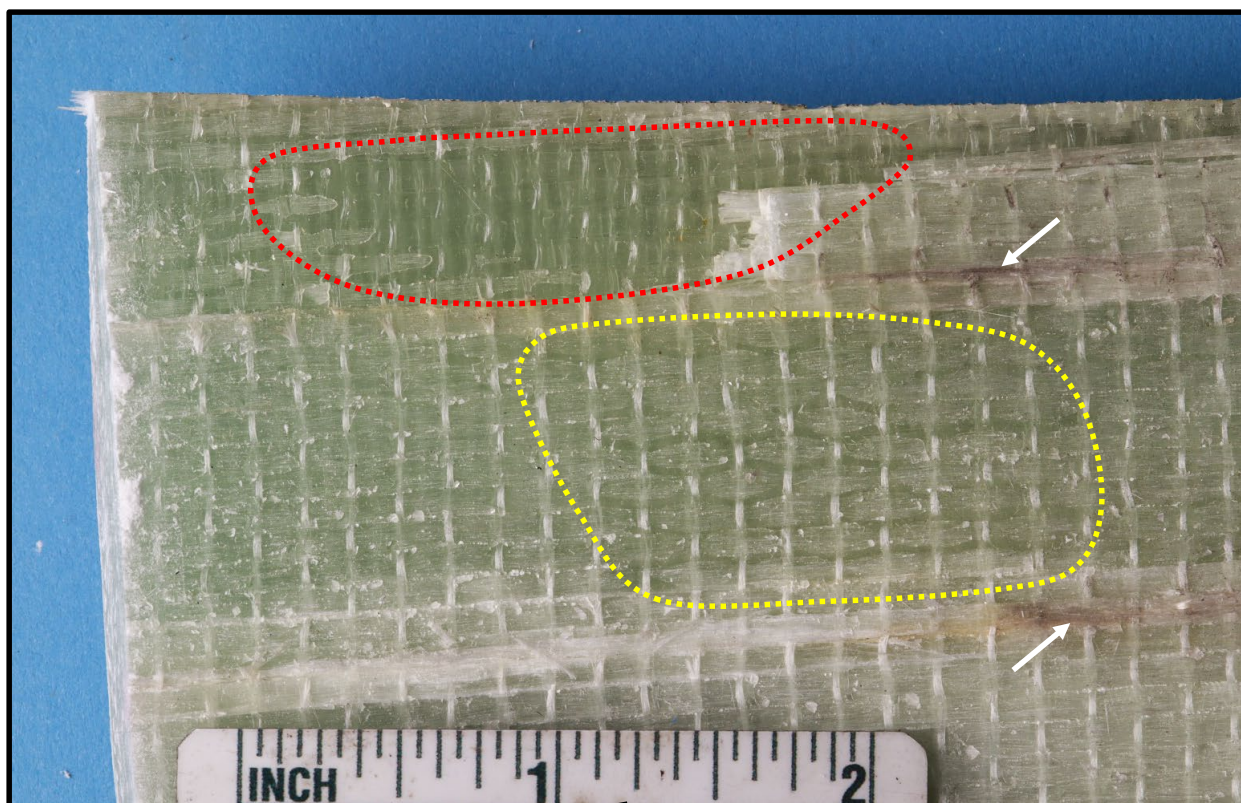
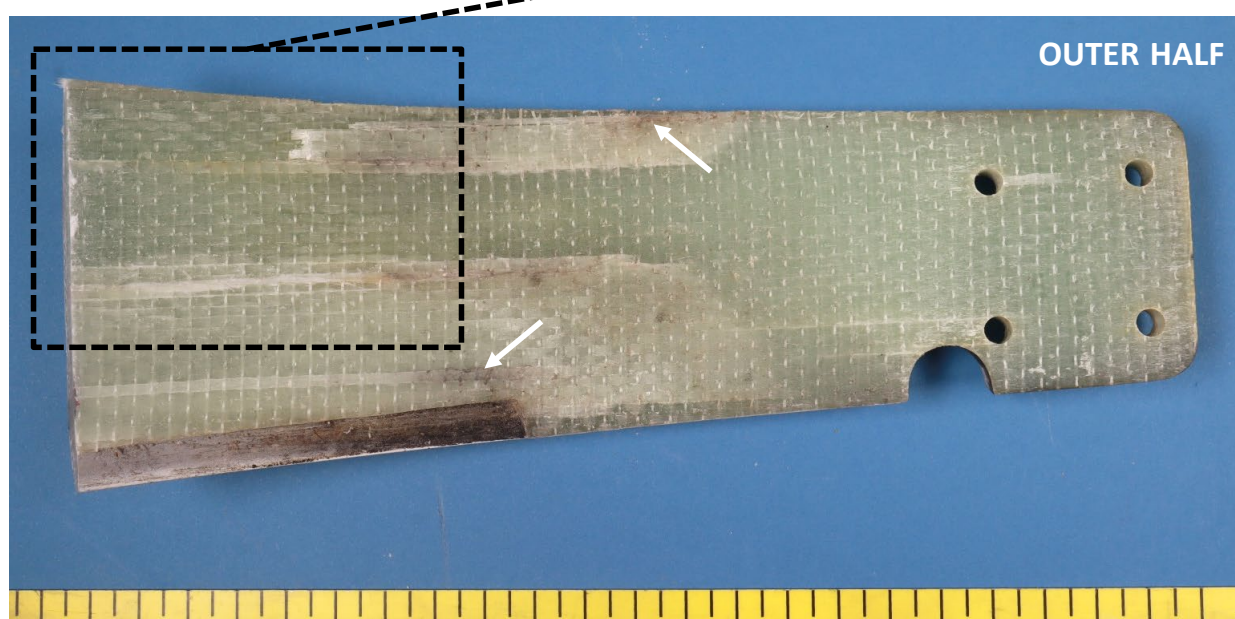
Flattened features were observed throughout the fracture surfaces. Embedded dirt/debris (indicated by the white arrows in Figures 11-13) was also visible on the fracture surfaces in several areas adjacent to flattened features. A large shiny area consistent with a void, outlined by a red dotted line in Figure 11, was observed adjacent to the forward face. Several other areas had interconnecting networks of shiny voids surrounding disbonded material. Some of these networks of voids are encircled by yellow dotted lines in Figures 11-13. Entrapped contaminants were also observed in several locations within the strut matrix, including a blue speck indicated by the red arrow in Figure 12 and a few pieces of red fiber indicated by the red arrows in Figure 13.

**Figure 11.** Overall (bottom) and close-up (top) photos of the fracture surface on the upper half of the sectioned left side strut end. The white arrows point to areas with embedded dirt/debris. The red and yellow dotted lines encircle a large shiny area and a network of shiny areas, respectively.

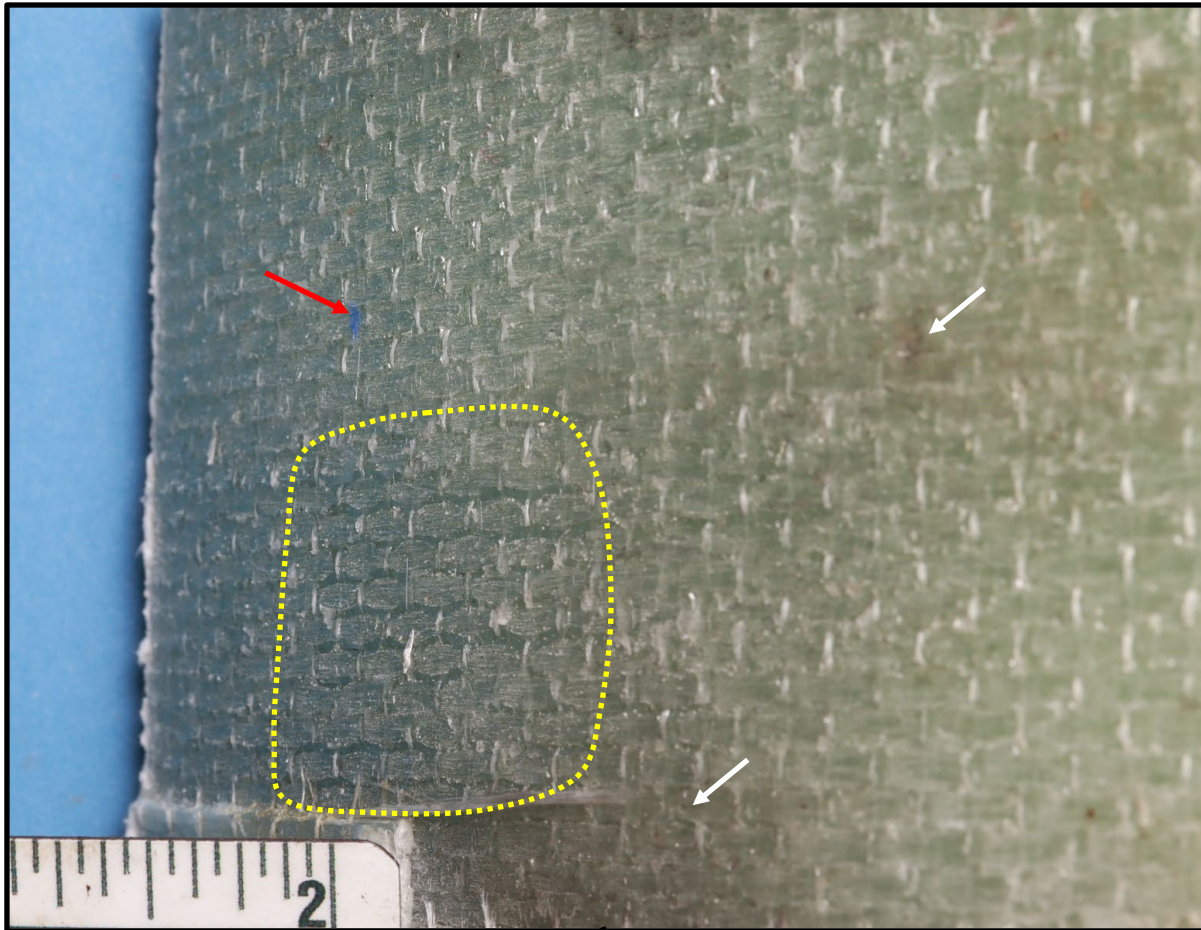
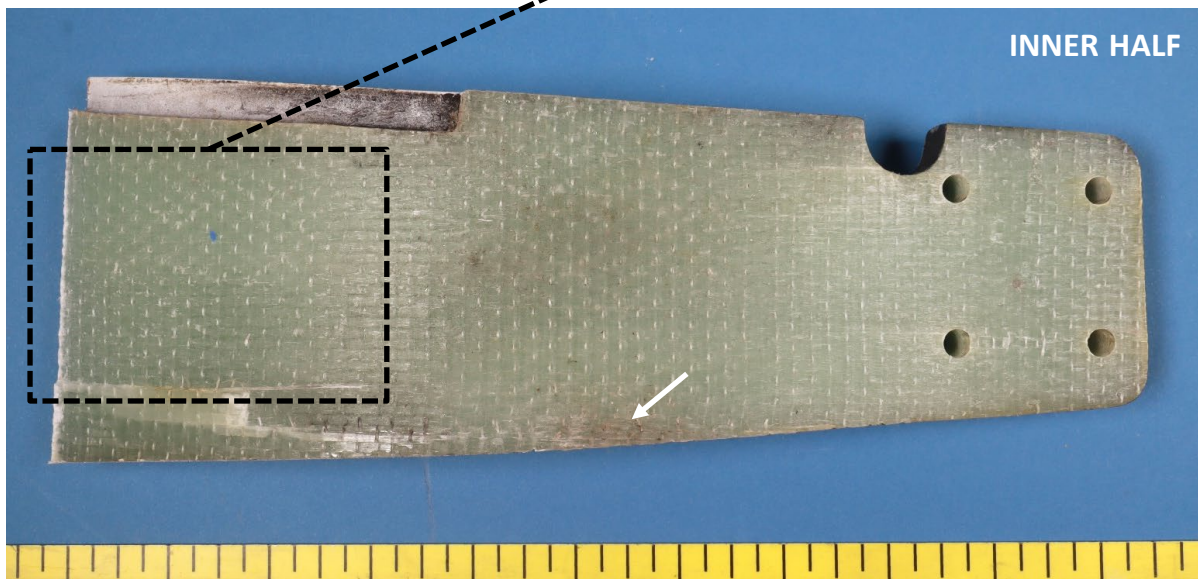
**Figure 12.** Overall (bottom) and close-up (top) photos of the fracture surface on the lower half of the sectioned left side strut end. The white arrows point to areas with embedded dirt/debris. The red arrow points to an entrapped blue speck of material. The yellow dotted line encircles a network of shiny areas.

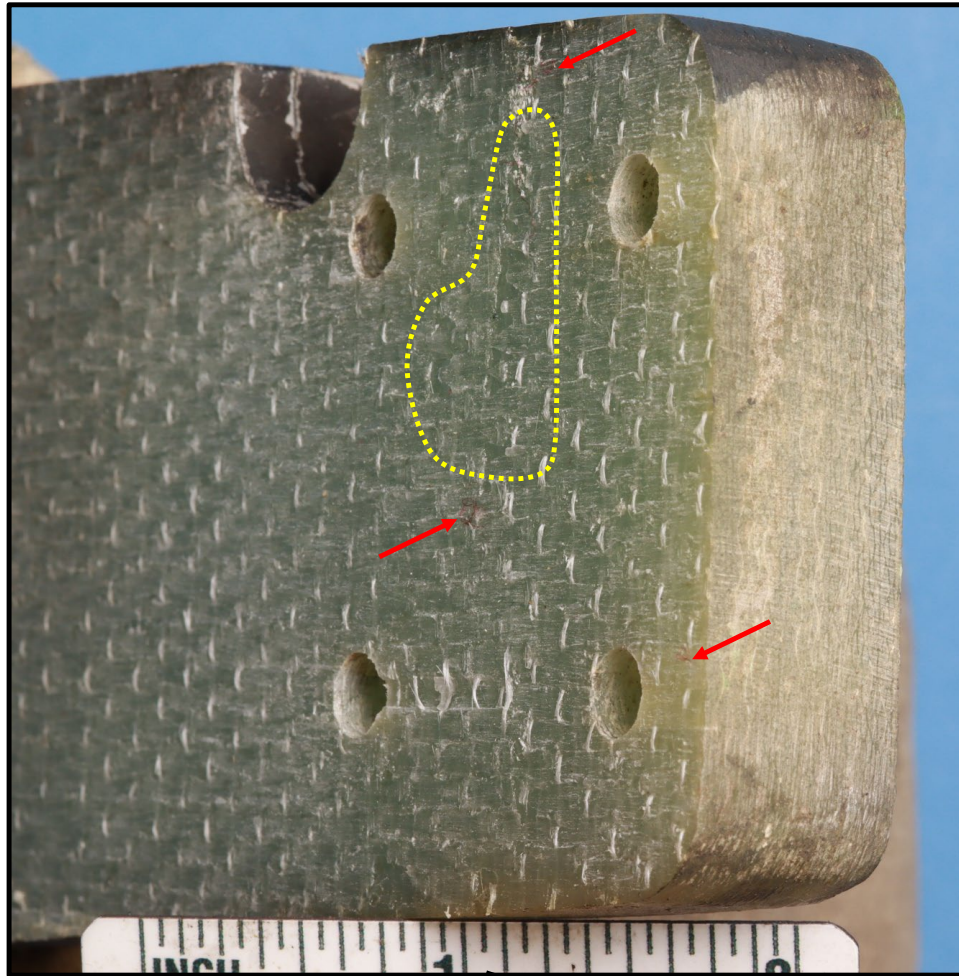
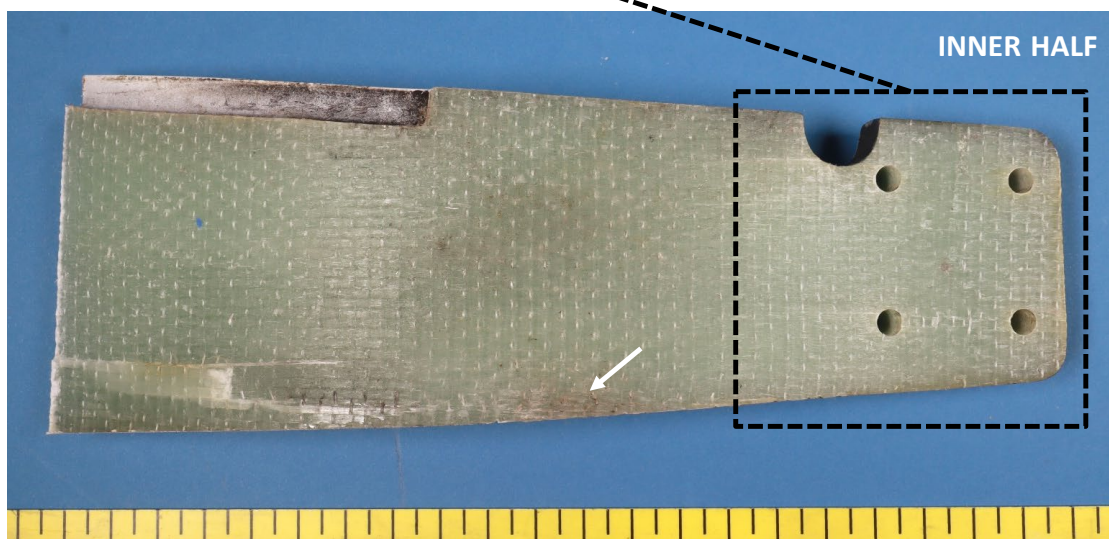
**Figure 13.** Overall (bottom) and close-up (top) photos of the fracture surface on the lower half of the sectioned left side strut end. The white arrows point to areas with embedded dirt/debris. The red arrows point to entrapped red fibers. The yellow dotted line encircles a network of shiny areas.
