Dan Baker  
Senior Air Safety Investigator  
AS-WPR

**Subject:** WPR23LA272, Fuel Fitting Examination

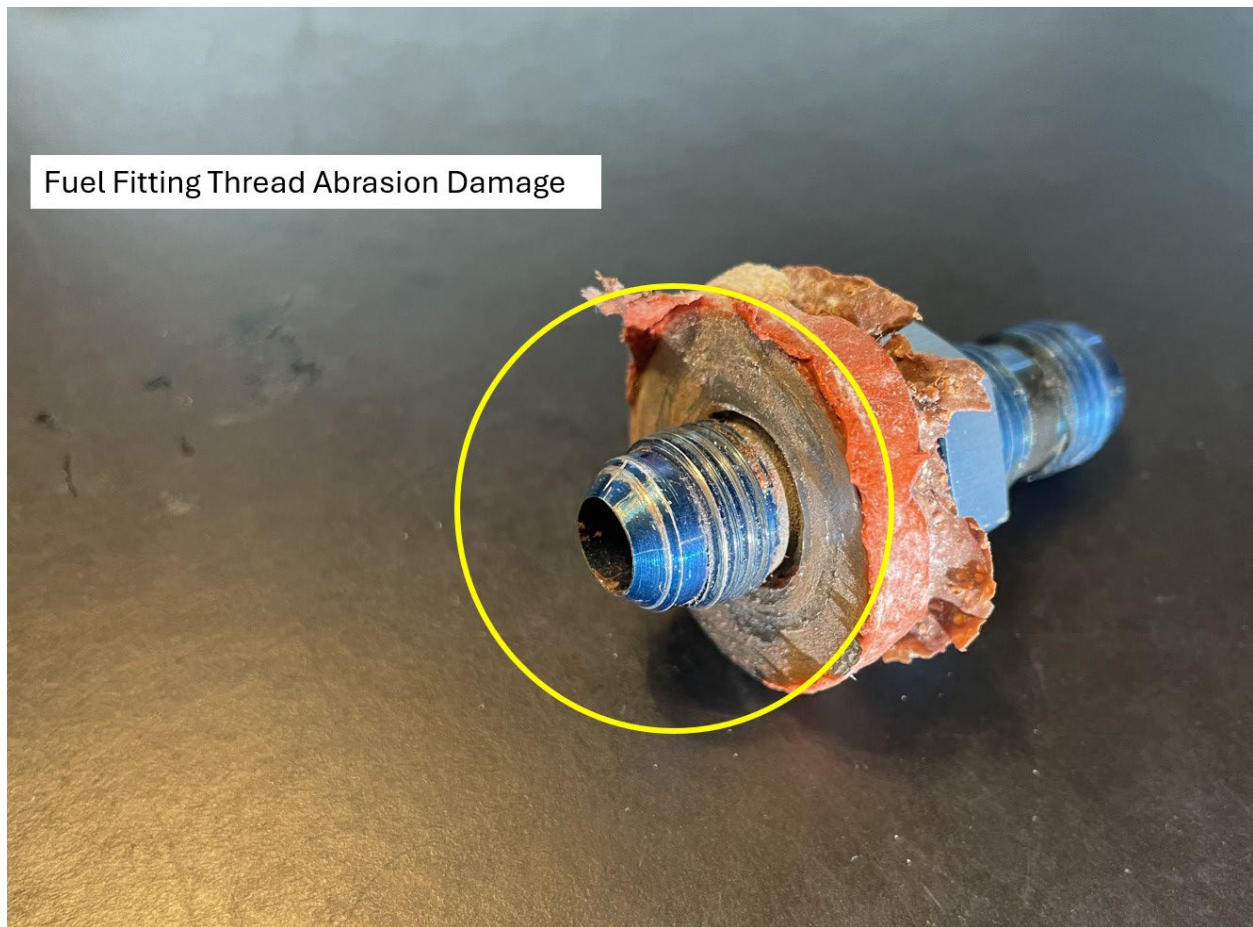
The fitting had male threads on both ends of the fitting. The threads that would have been on the engine side of the firewall exhibited abrasion damage and wear (figure 1). The threads that would have been on the cockpit side of the firewall were unremarkable and did not exhibit signs of wear or abrasion damage (figure 2).

Figure 1 - Fuel Fitting Thread Abrasion Damage

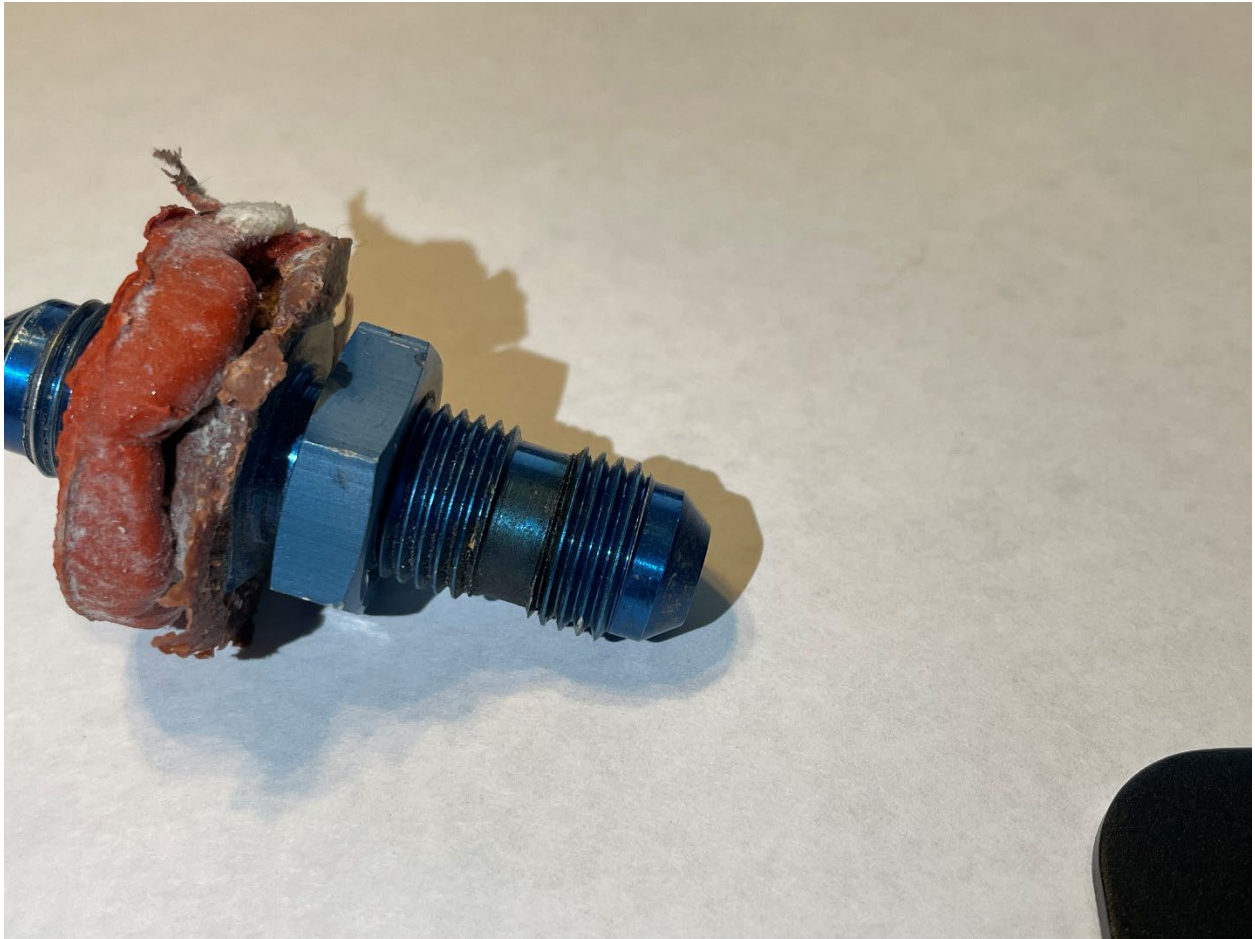
Figure 2 - Undamaged Fuel Fitting Threads
