# National Transportation Safety Board

## **MATERIALS LABORATORY**

Factual Report 24-078

Location: Farmington, Utah  
Date: July 19, 2023  
Vehicle: Aero AS-355E, N102UM  
Investigator: Elliott Simpson

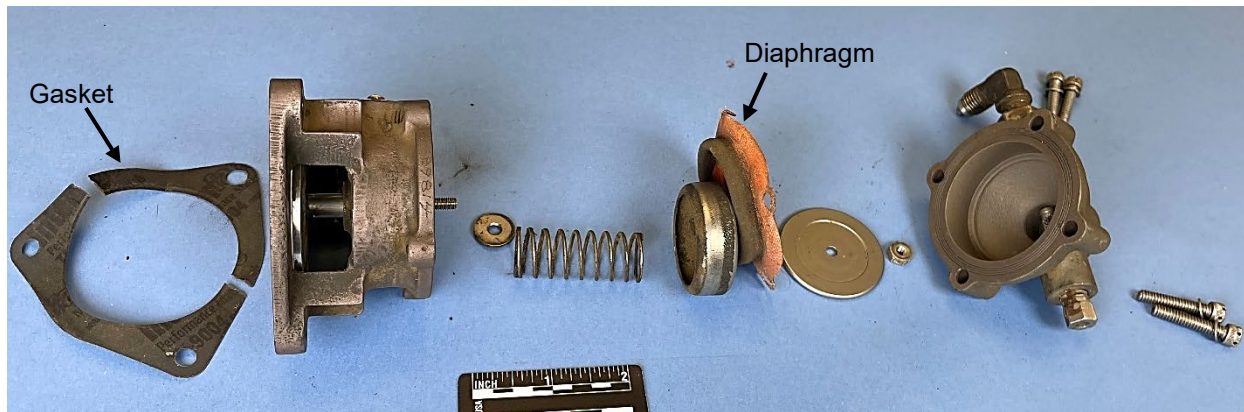
Figure 1 shows a photograph of the as-received parts from the engine compressor bleed valve assembly. The diaphragm contained a circumferential crack that penetrated the sidewall portion, as shown in figures 2 and 3. The diaphragm was specified by Allison as a composite material containing Nomex bidirectional fabric fibers in a matrix of fluorosilicone rubber elastomer. The crack penetrated the fabric fibers and elastomer portions. The length of the crack on the outer surface measured approximately 0.15 inch.

The gasket (see figure 1) appeared to be made from discontinuous random fibers in a sheet of cardboard-like matrix material that was fractured at two locations. Stereo microscope examination of the gasket revealed the fracture faces of the matrix material were on irregular slant (shear) planes typical of overstress separation.

**Figure 1.** As-received pieces of the engine compressor bleed valve assembly.

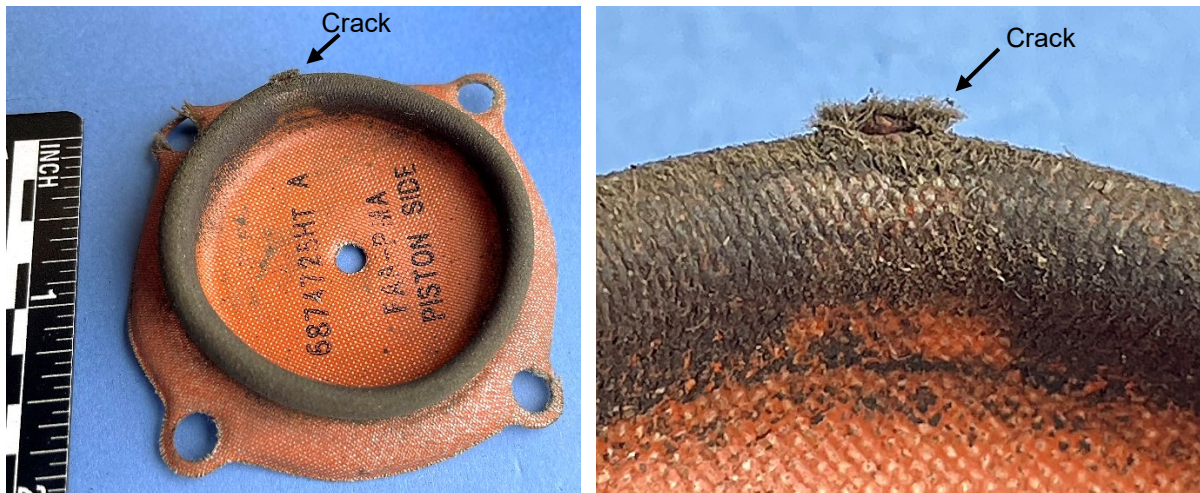
**Figure 2.** As-received diaphragm with a crack as seen on the outer surface of the sidewall.

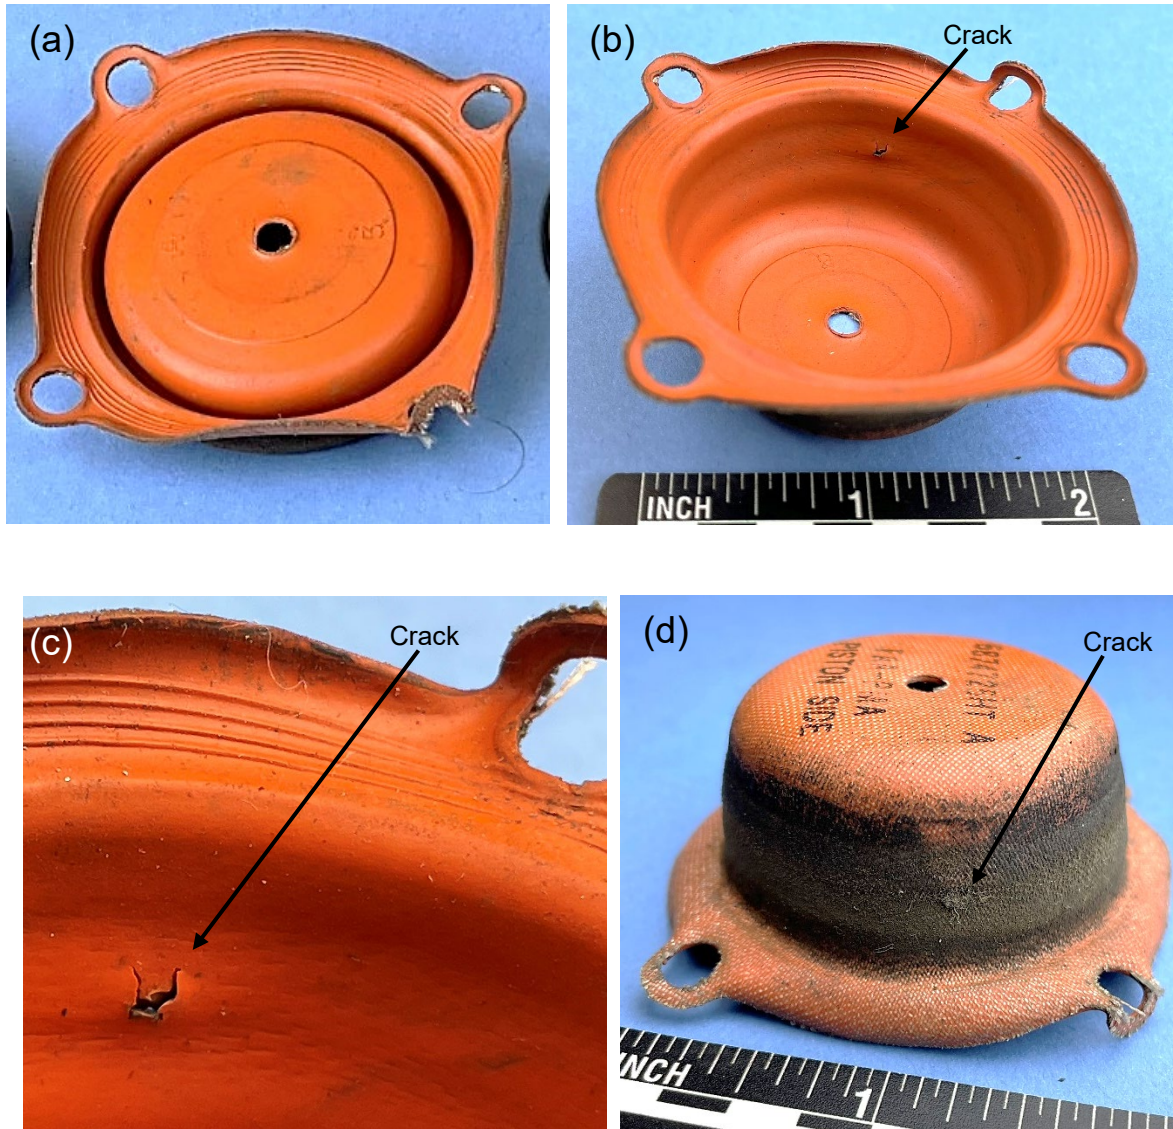
**Figure 3.** Diaphragm (a) in the as-received condition showing the inner surface of the sidewall ; (b) in the fully stretched condition showing the inner surface of the sidewall and crack; (c) in the fully stretched condition showing a close-up of the crack in the inner surface of the sidewall; (d) in the fully stretched condition showing the outer surface with crack.

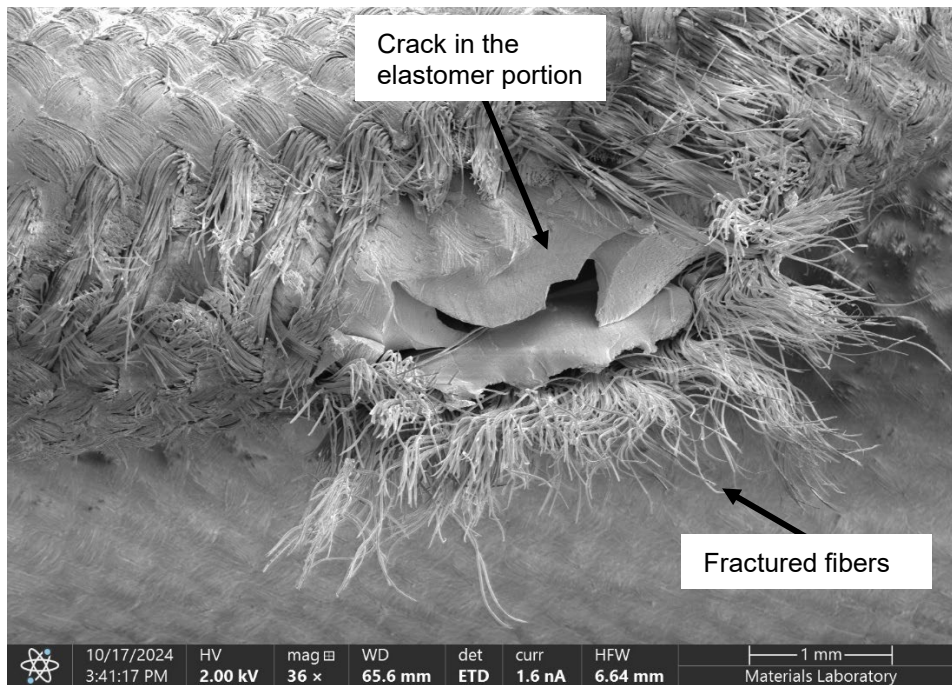
The diaphragm was ultrasonic cleaned with Alconox, a commercial detergent, followed by rinsing in methanol alcohol, and left to dry in air. Scanning electron microscope (SEM) examination of the diaphragm revealed the ends of many fibers were elongated. Several fibers in the area of separation were reduced to nearly a knife edge. Many of fibers exhibited evidence of severe mechanical damage (such as from fracture faces contacting each other). The non-damaged fracture faces of the fibers showed evidence of either a shear fracture, or cup and cone features typical of

overstress separation. Figures 3 through 5 show examples of fiber fractures. The elastomer portion showed no evidence of fatigue cracking.

**Figure 3.** SEM image of the diaphragm showing a crack on the outer surface of the sidewall; after cleaning and before fully stretching out the body of the diaphragm.

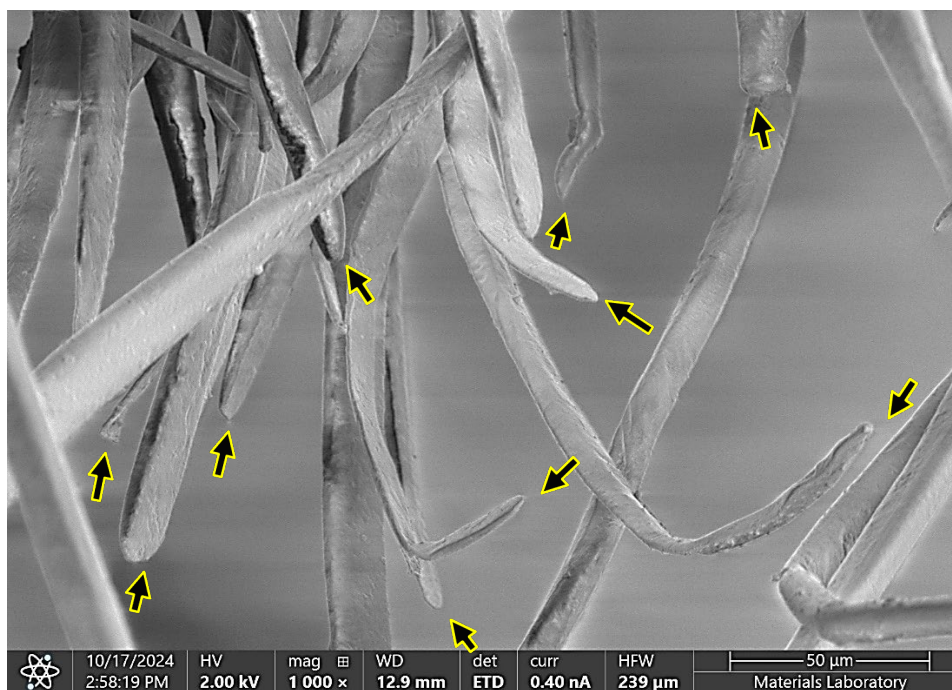
**Figure 4.** SEM image of the diaphragm in the area of the crack showing the fractured ends of several fibers, indicated by arrows. (1,000X)

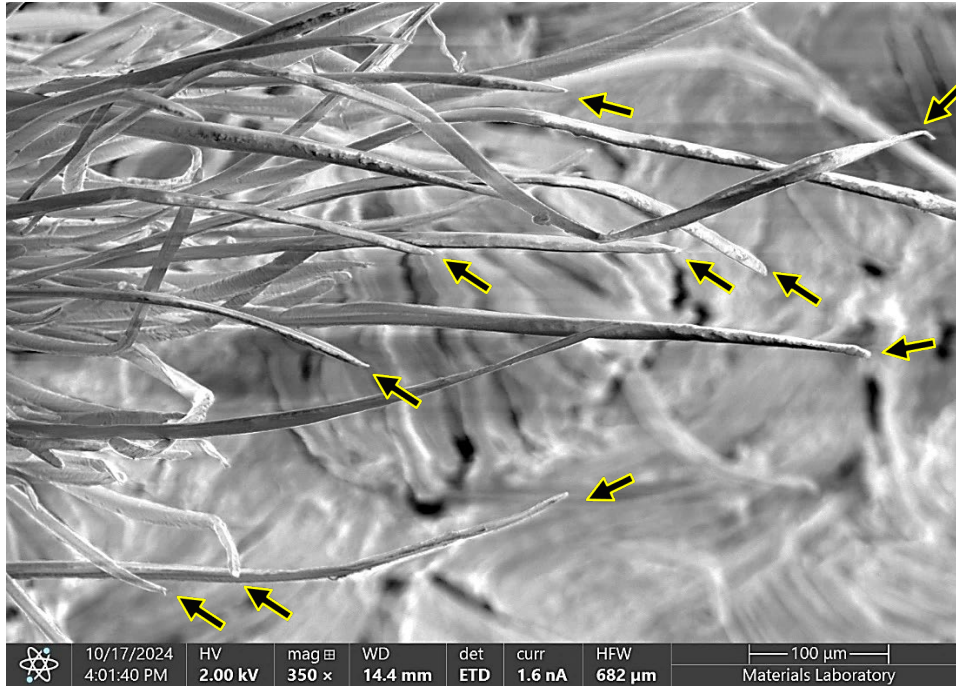
**Figure 5.** SEM image of the diaphragm in the area of the crack showing the fractured ends of several fibers, indicated by arrows. (350X)

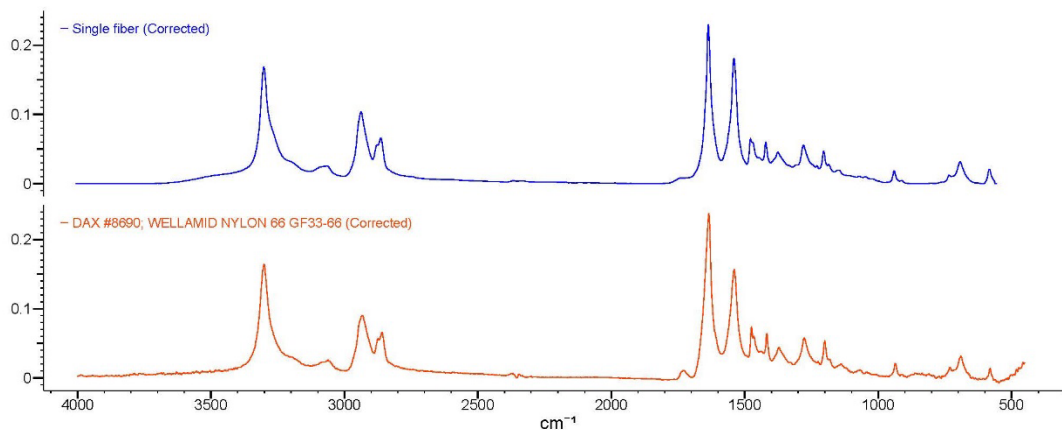
Attachment 1. FTIR spectrum of a fractured fiber portion (top) from the diaphragm involved in the accident compared to an FTIR spectrum of Nylon 66 (a polyamide material) from an FTIR reference library (bottom). Both appear similar.

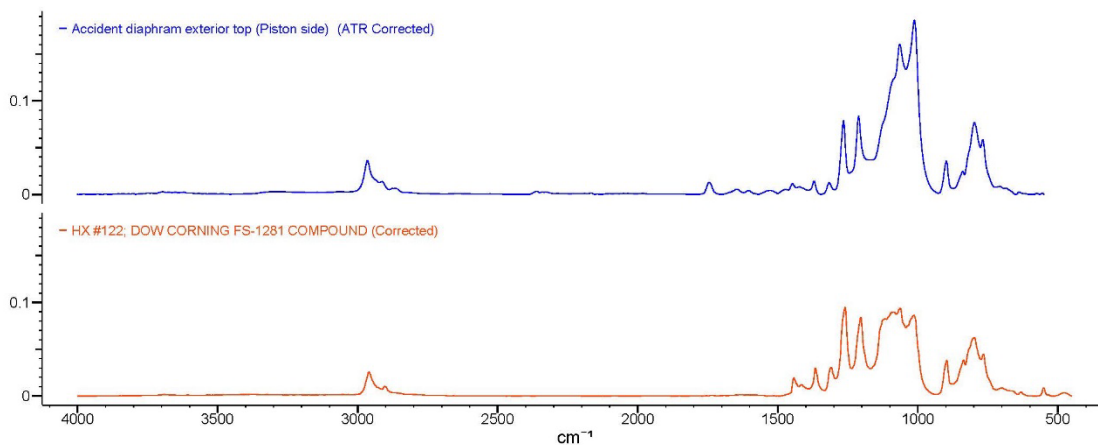
Attachment 2. FTIR spectrum of the flexible elastomer portion (top) from the diaphragm involved in the accident compared to an FTIR spectrum of Dow Corning FS-1281 compound (containing fluorosilicone) from a reference library (bottom). Both share similar peaks.
