# National Transportation Safety Board

WPR23LA278

## ENGINE EXAMINATION REPORT

Location: Farmington, Utah  
Date: July 19, 2023  
Time: 0830 mountain daylight time  
Helicopter: N102UM, Aerospatiale, AS-355E

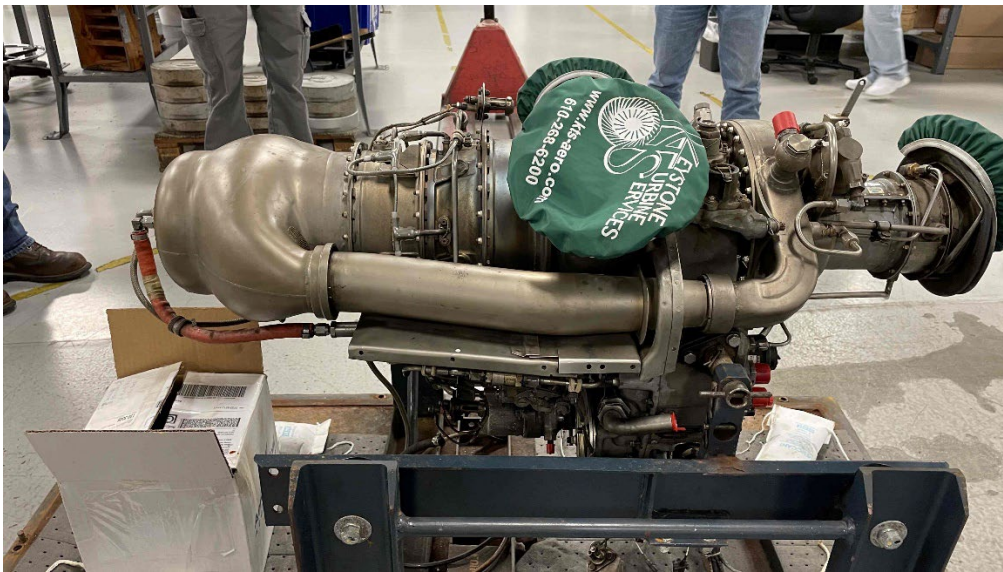
The engine was removed from its crate and appeared undamaged by shipping (Figure 1). A pneumatic system leak check was performed, with no leaks detected. Both the N1 and N2 rotors appeared to be locked, and fuzz/light FOD was present on

**Figure 1 - Engine #2 after removal from the shipping crate**

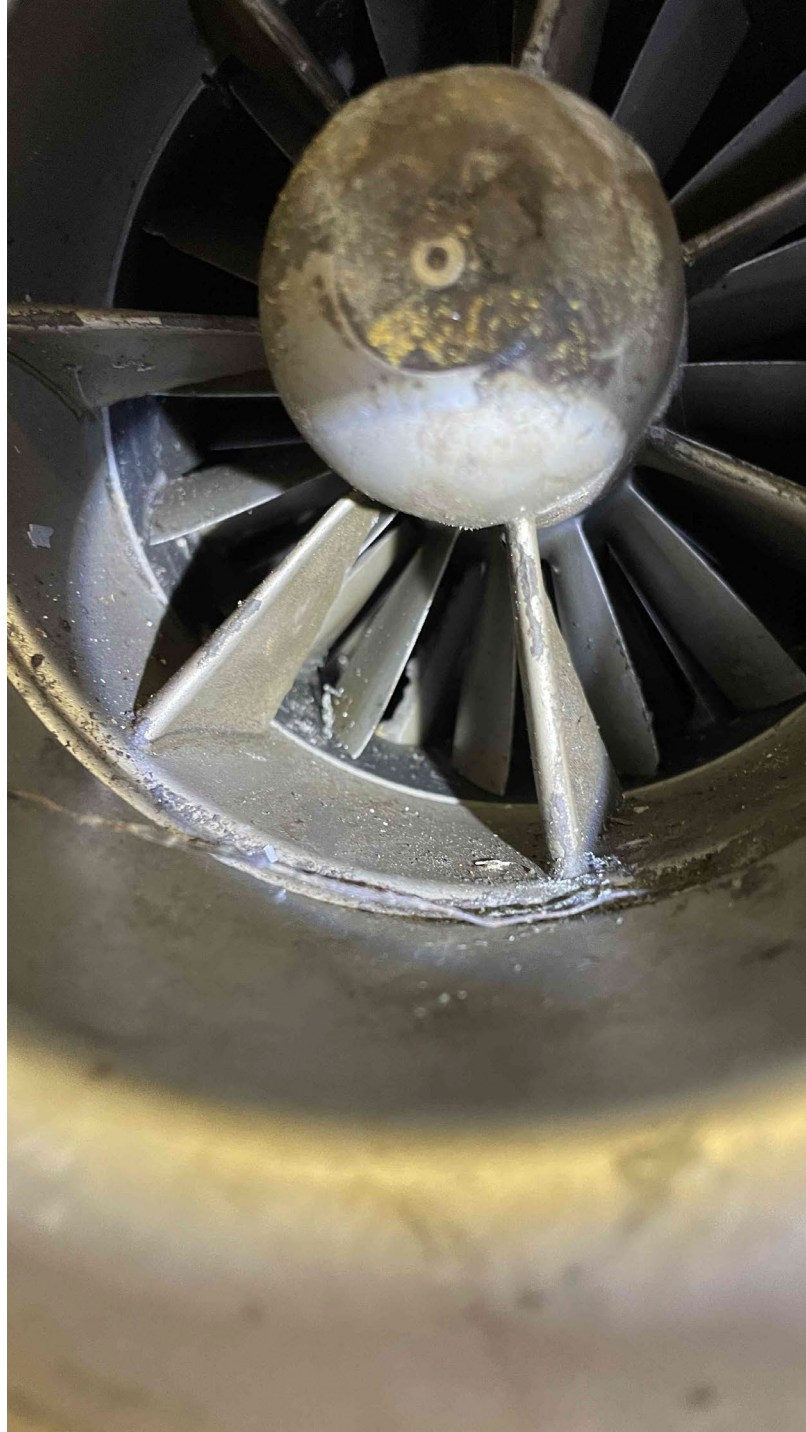
the first stage compressor blades, some of which sustained leading edge nicks and tip abrasions. (Figure 2).

**Figure 2 - First stage compressor blades - Engine #2.**

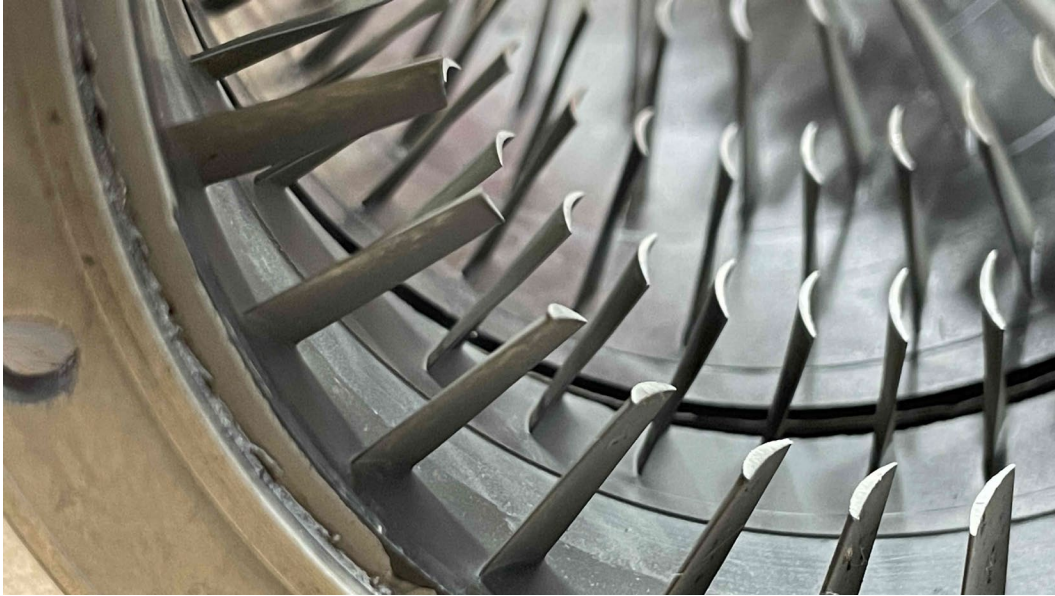
The compressor case was opened. There was no evidence of catastrophic failure to any of the blades or stators. A prominent groove of the inner liner was observed in the area of the number 5 and 6 blade tips of one case half (figure 3, 4). The other case

**Figure 3 - Rubbing indications from number 5 and 6 blade tips with groove in lining - Engine #2.**

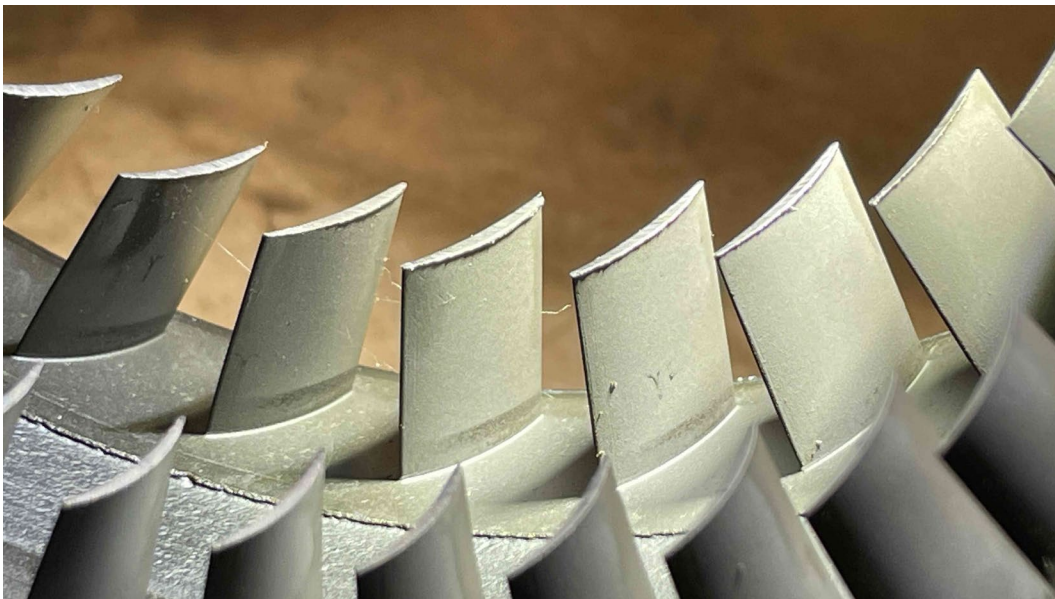
half had similar rub signatures but to about ½ the depth. The neighboring stator vanes on one case half exhibited blade tip smearing opposite the direction of rotation (figure 4), with corresponding rub marks on the adjacent area of the blade hub (figure 5).

**Figure 4 - Worn number 6 stator tips with groove in lining - Engine #2.**

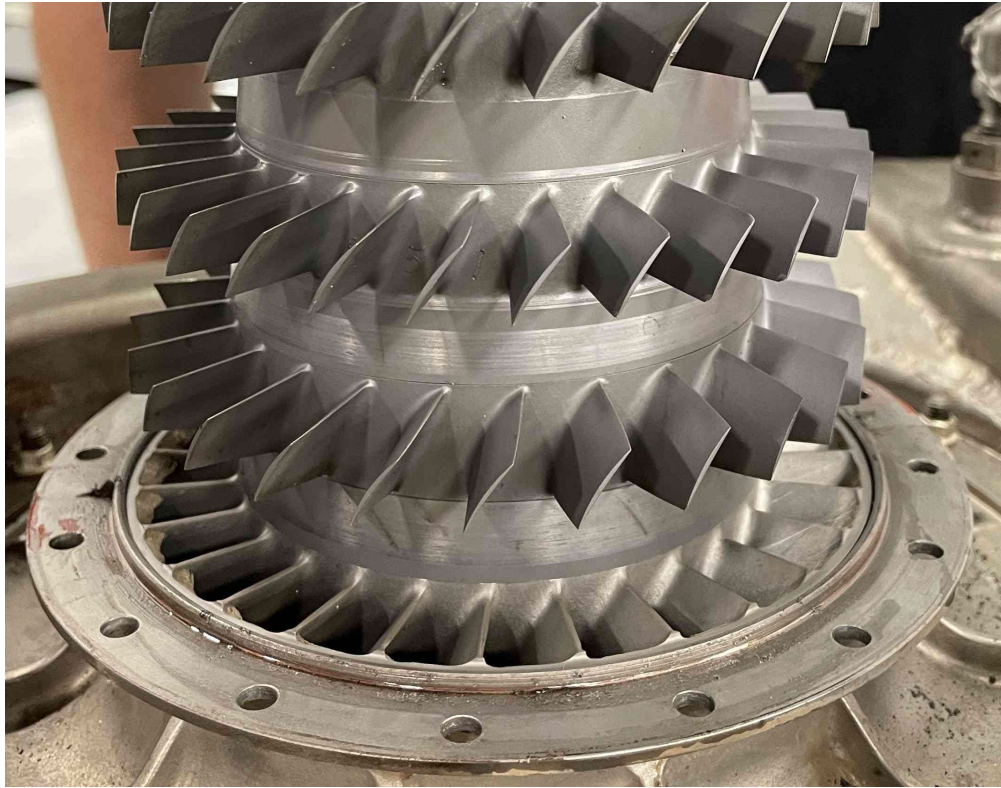
**Figure 5 - Compressor blade hub with rub marks - Engine #2.**

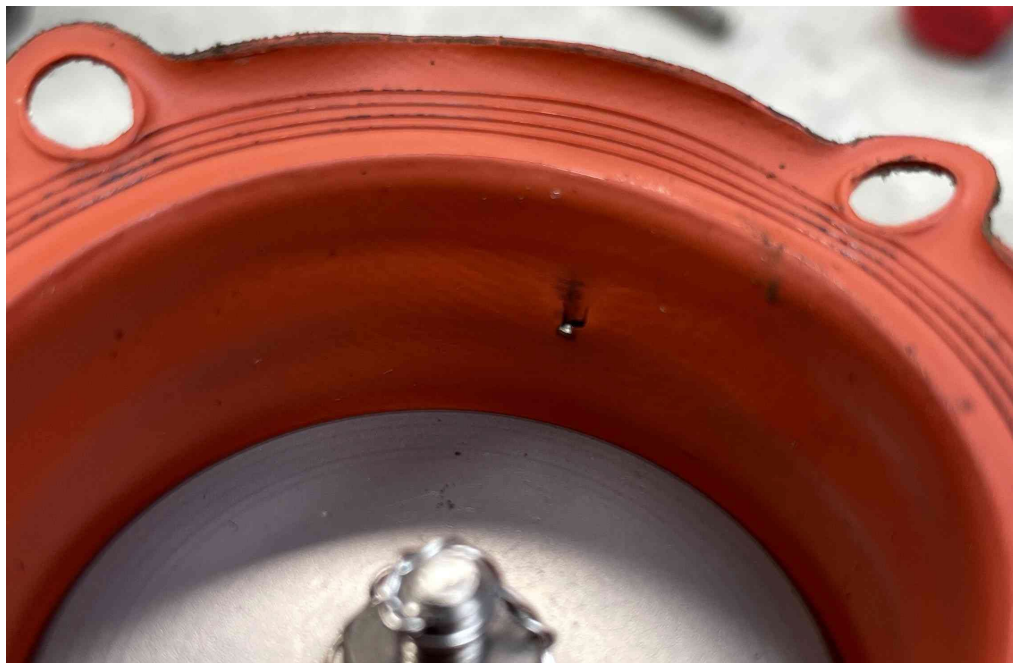
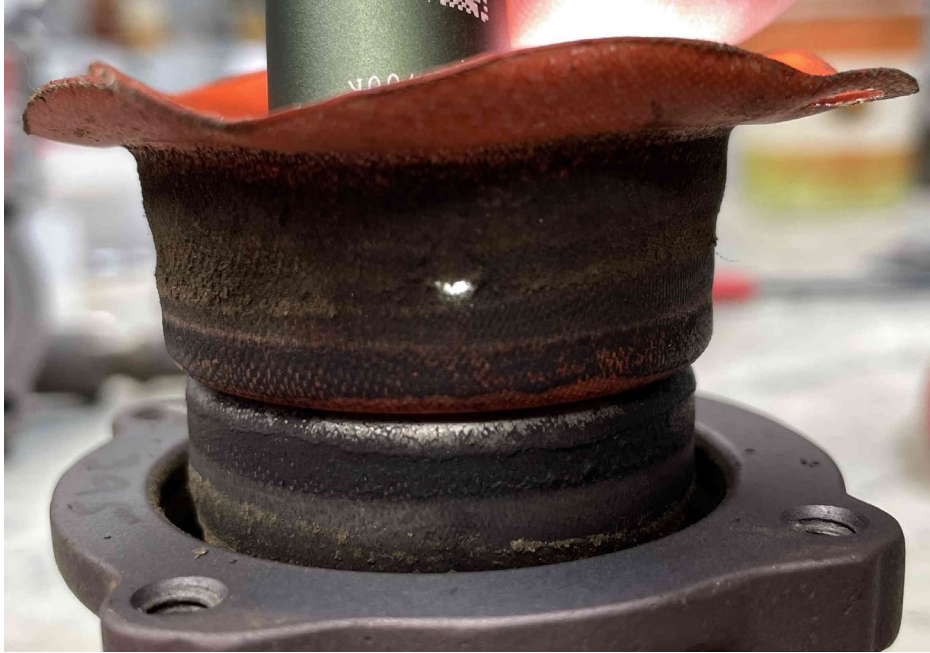
The unit was installed and tested in the bleed valve test stand. The valve appeared to intermittently hang up when transitioning from the open to closed position. The unit did not meet the specifications for the interstage pressure reduction required to close the valve. The diaphragm leakage test yielded nominal results.

The unit was disassembled, and an approximately 1/16<sup>th</sup> inch hole was observed in the rolling diaphragm (figure 6, 7). Although the unit passed the leakage test, the group determined that because that test was performed with the valve in the closed position, the hole would have been flat against the chamber wall of the valve cavity, thereby limiting leakage.

The bleed valve had a service life of 1,500 hrs., and according to maintenance records, it had 76.6 hrs. remaining.

**Figure 6 - Hole in diaphragm viewed from the inside - Engine #2.**

**Figure 7 - Hole in diaphragm viewed from the outside - Engine #2.**
