Subject: Results of the engineering examination of compressor assembly P/N 6890550, S/N CAC-36793 installed on M250-C20F engine CAE 840052 from aircraft N102UM.

The purpose of this memo is to provide a summary of the findings from the examination of the above referenced compressor assembly.

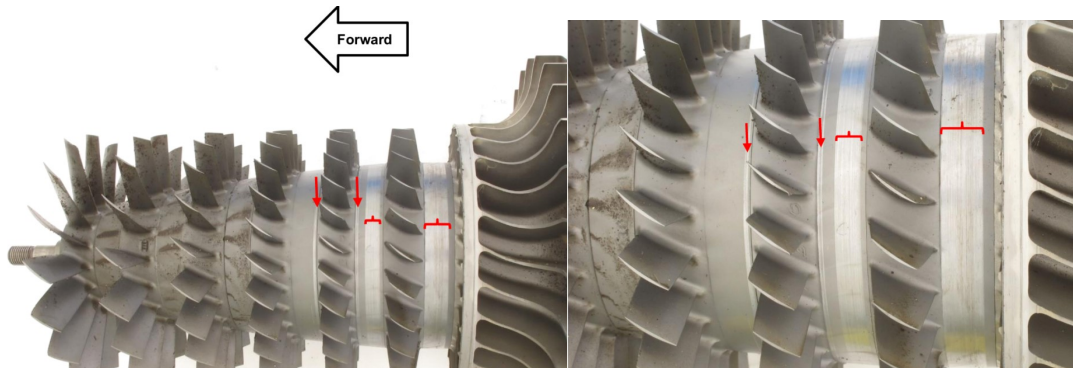
- The compressor rotor exhibited rub on the stage 4 through 6 wheels. The impeller blade tips exhibited tip rub around the full circumference of the impeller. (See Figures 1 through 4)

Figure 1. As-received condition of the compressor rotor assembly. Circumferential rub is indicated by the red arrows and braces.

The rub on the stage 4 through 6 compressor wheels was likely due to compressor rotor imbalance. The compressor rotor was check balanced as part of the investigation. The measured results were 71.5 mg-in at the forward end and 118 mg-in at the aft end, which are greater than 5 and 8 times the allowable limits respectively. This type of imbalance could lead to the rotor orbiting on its centerline, resulting in the observed metal to metal contact.

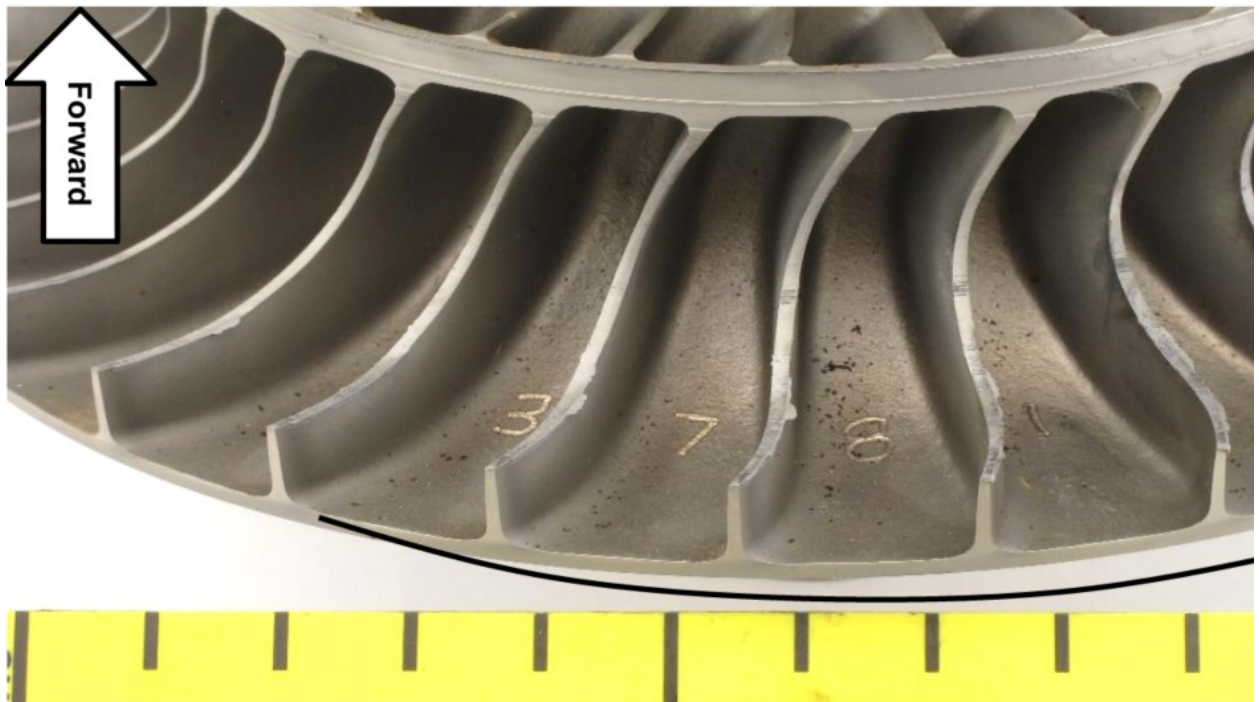
Figure 2. Detailed views of circumferential rub on the compressor impeller.

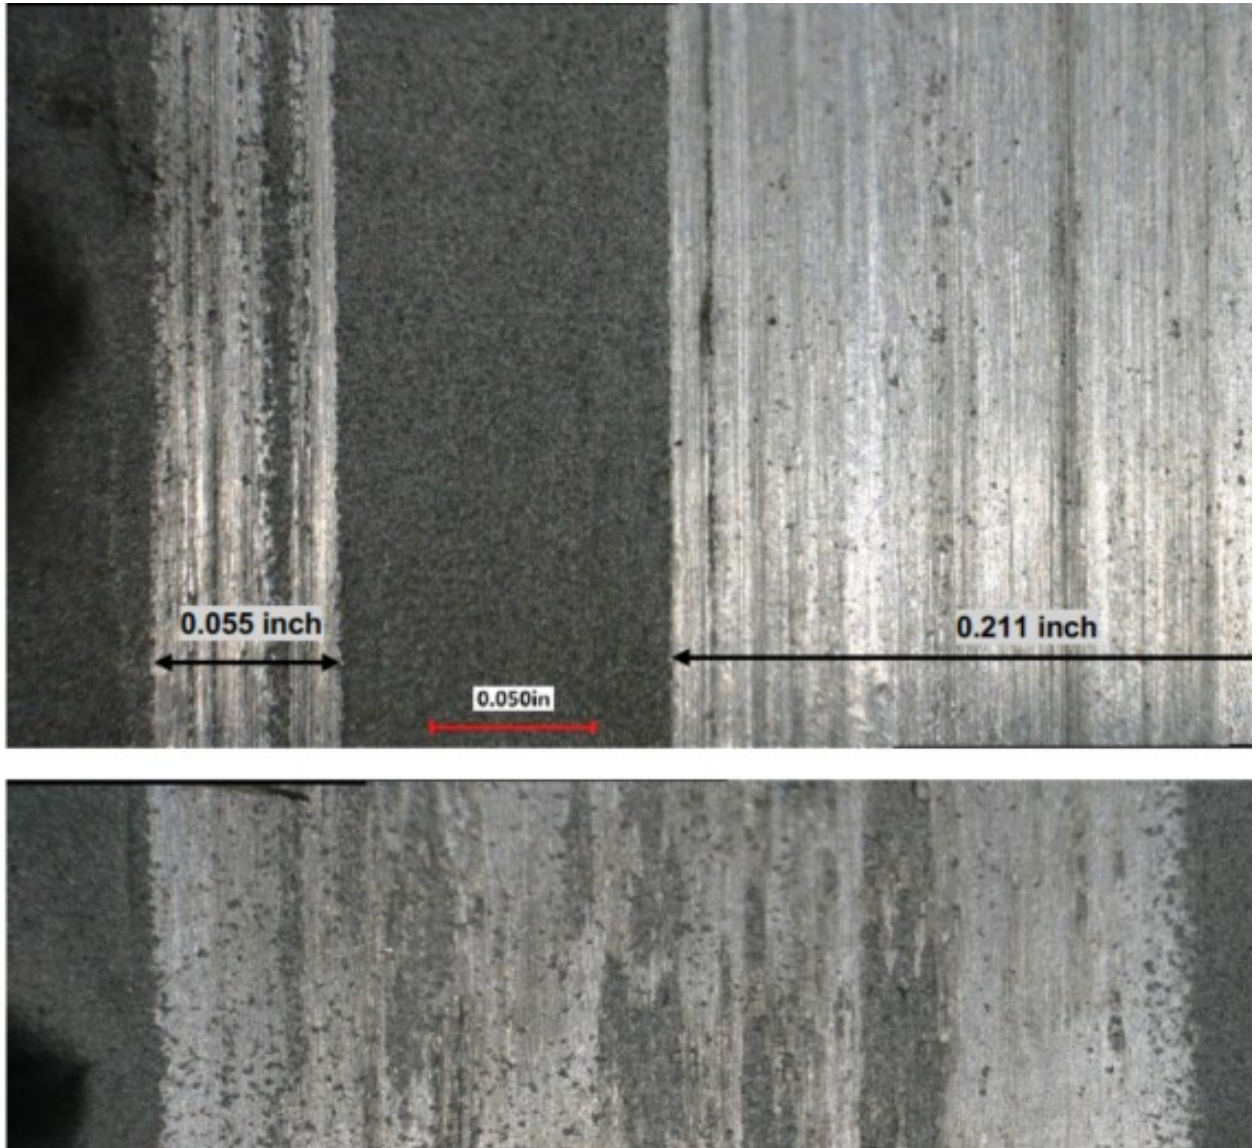
Figure 3. Detailed views of representative rub on the stage 5 compressor wheel (top) and stage 6 compressor wheel (bottom).

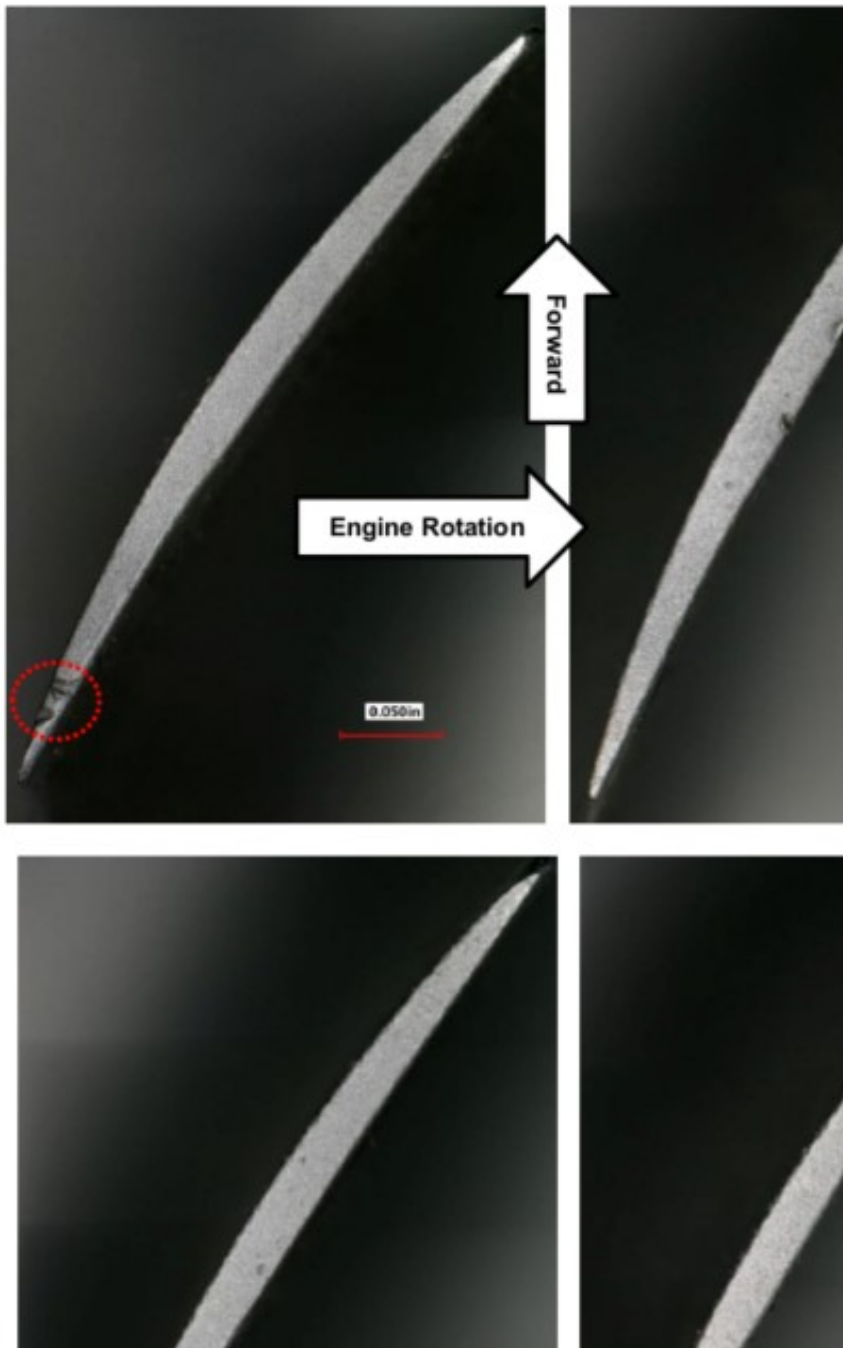
Figure 4. Detailed images of representative stage 5 blade tips. Each blade was approximately 90° from the previous in the direction of engine rotation. Trailing edge impact damage is indicated by the red ovals.

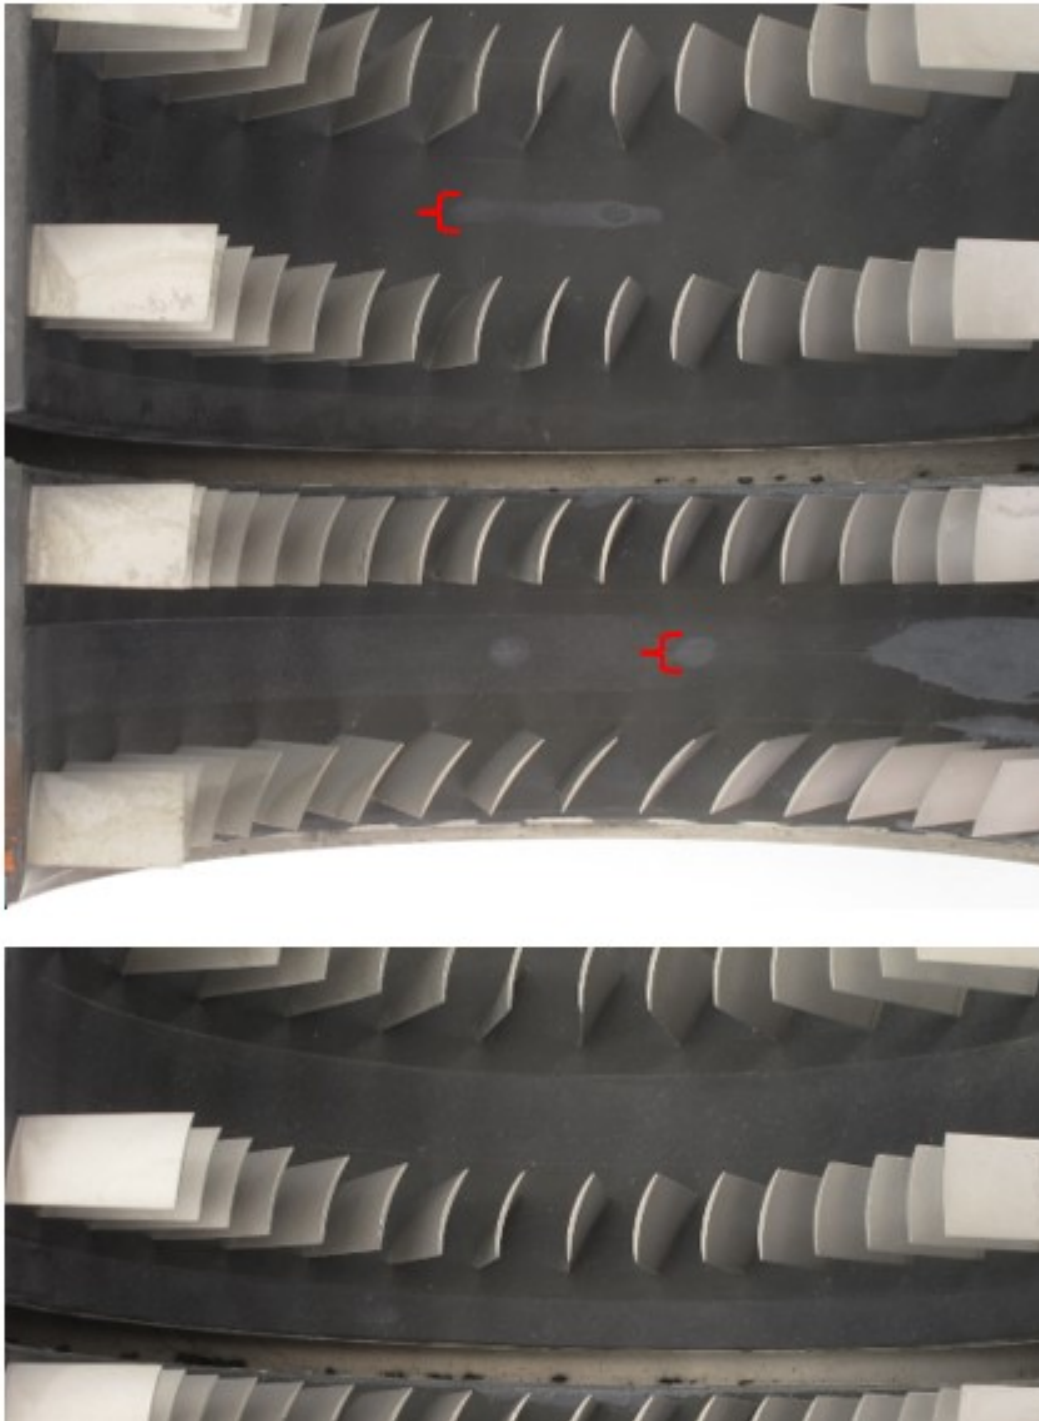
- The compressor case abradable coating exhibited uneven wear at the stage 5 and 6 blade tracks; the wear on the stage 6 blade track measured approximately 0.002 inch to 0.017 inch in depth on the top and bottom case halves, respectively. The stage 5 and 6 vane tips exhibited rub on the bottom case half, which exhibited the greater extent of abradable coating wear. (See Figures 5 through 7)

Figure 5. Detailed inboard looking outboard views of stages 3 through 6 of the top case half (top) and bottom case half (bottom) after cleaning. Rub is indicated by the red braces.

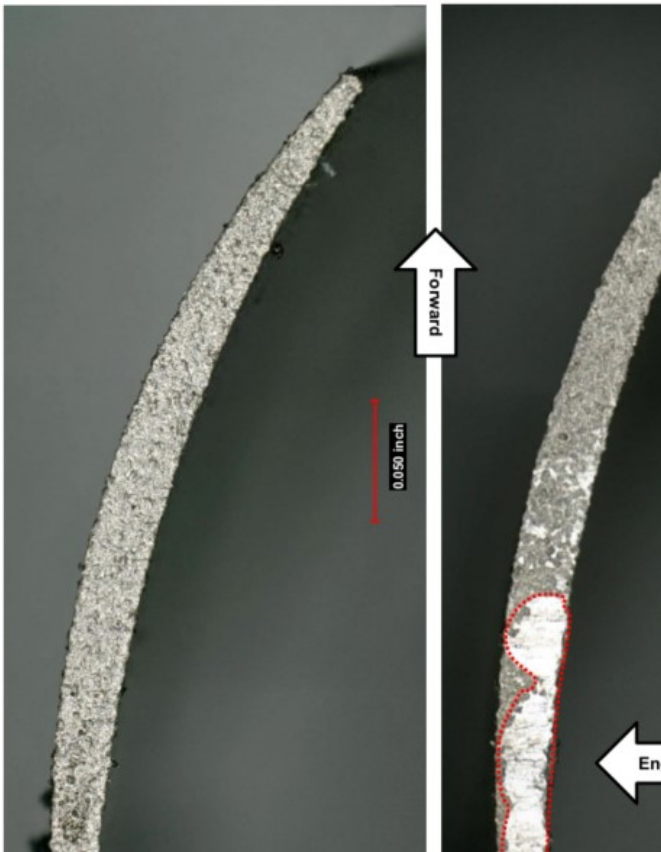
Figure 6. Detailed images of representative stage 5 vane tips from the top case half (left) and bottom case half (right). The vanes were approximately 180° apart in the compressor assembly. Rub is indicated by the red borders.

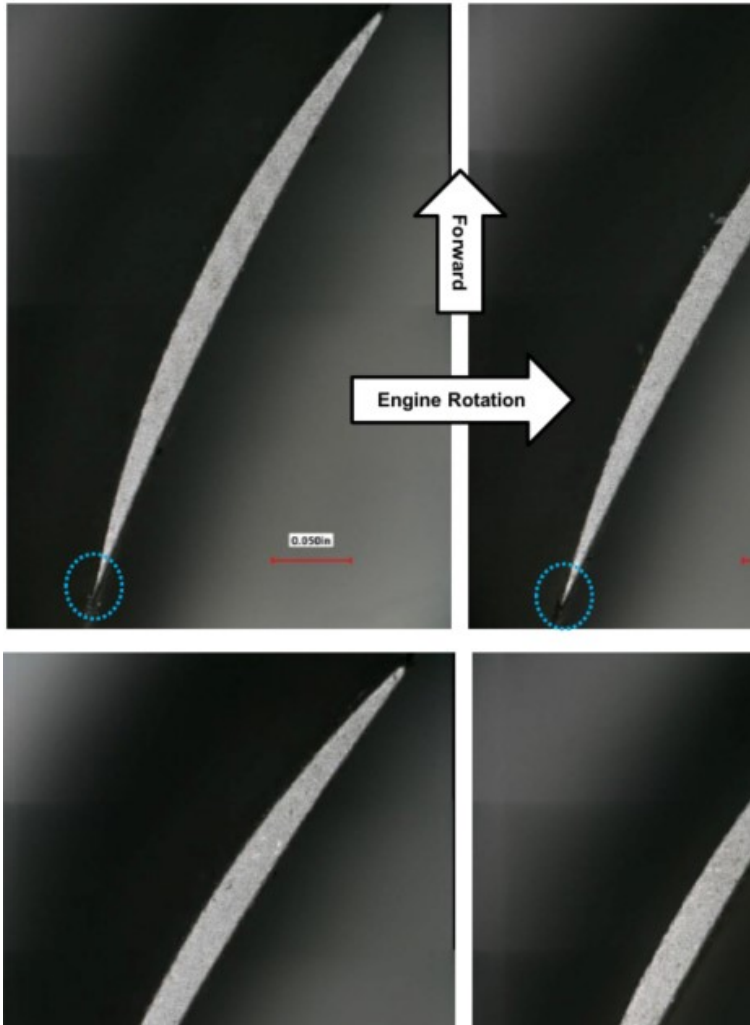
Figure 7. Detailed images of representative stage 6 blade tips. Each blade was approximately 90° from the previous in the direction of engine rotation. The trailing edges indicated by the blue ovals exhibited thinning consistent with erosion. The trailing edge indicated by the red oval also exhibited impact damage.

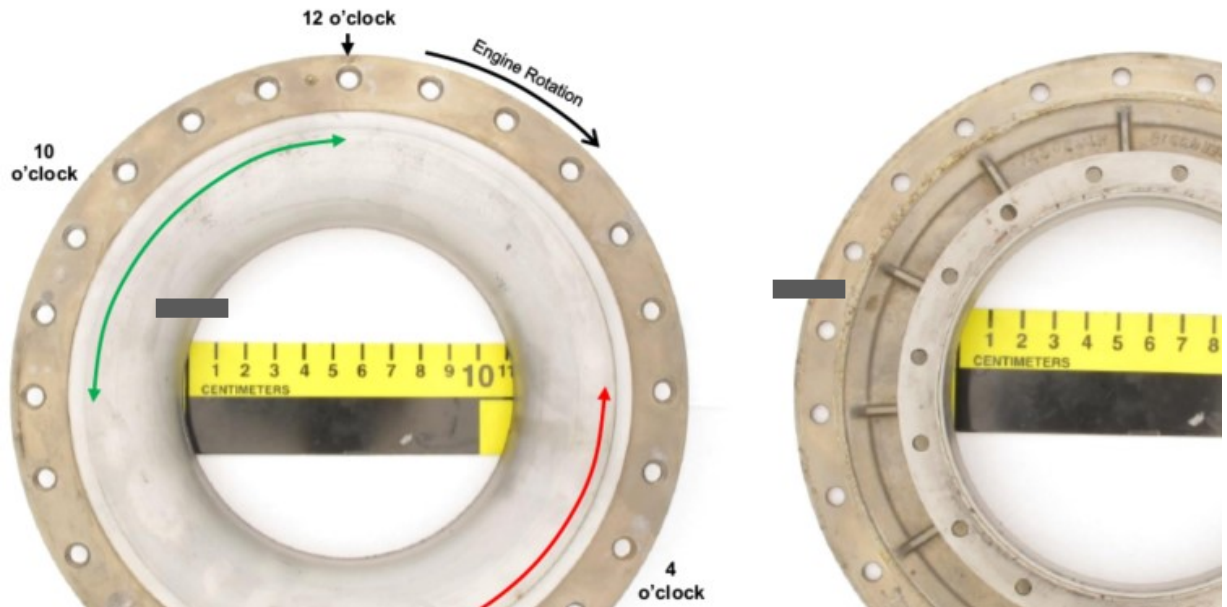
- The compressor shroud abradable coating exhibited rub that varied from approximately 0.0008 inch to 0.0162 inch in depth at locations 180° apart. The greater extent of wear was observed on the bottom half of the shroud consistent with the location of more significant abradable coating wear on the case halves. (See Figure 8)

Figure 8. Aft looking forward (left) and forward looking aft (right) views of the compressor front diffuser assembly (shroud) in the as-received condition. The green and red double arrows indicate areas of least and most severe wear, respectively.

The compressor build records detail the measurements taken and the final clearance between the impeller and compressor shroud. This clearance is related to compressor performance and efficiency. The larger the clearance between the impeller and shroud, the less efficient the compressor. According to build measurements, to achieve the documented bump clearance, a 0.034 inch shim stack would have been required. However, the shim stack measured by the Rolls-Royce laboratory removed from the rotor assembly was 0.0254 inches resulting in a difference of 0.0086 inches. The discrepancy in shim thickness would result in an actual clearance of 0.0186 which is >50% larger than the max build standard. An increased bump clearance would likely result in decreased compressor efficiency.
