# National Transportation Safety Board

WPR23LA294

## **AIRFRAME AND ENGINE EXAMINATION REPORT**

Location: Ravensdale, Washington  
Date: July 30, 2023  
Time: 1301 Pacific daylight time  
Airplane: Cessna 195

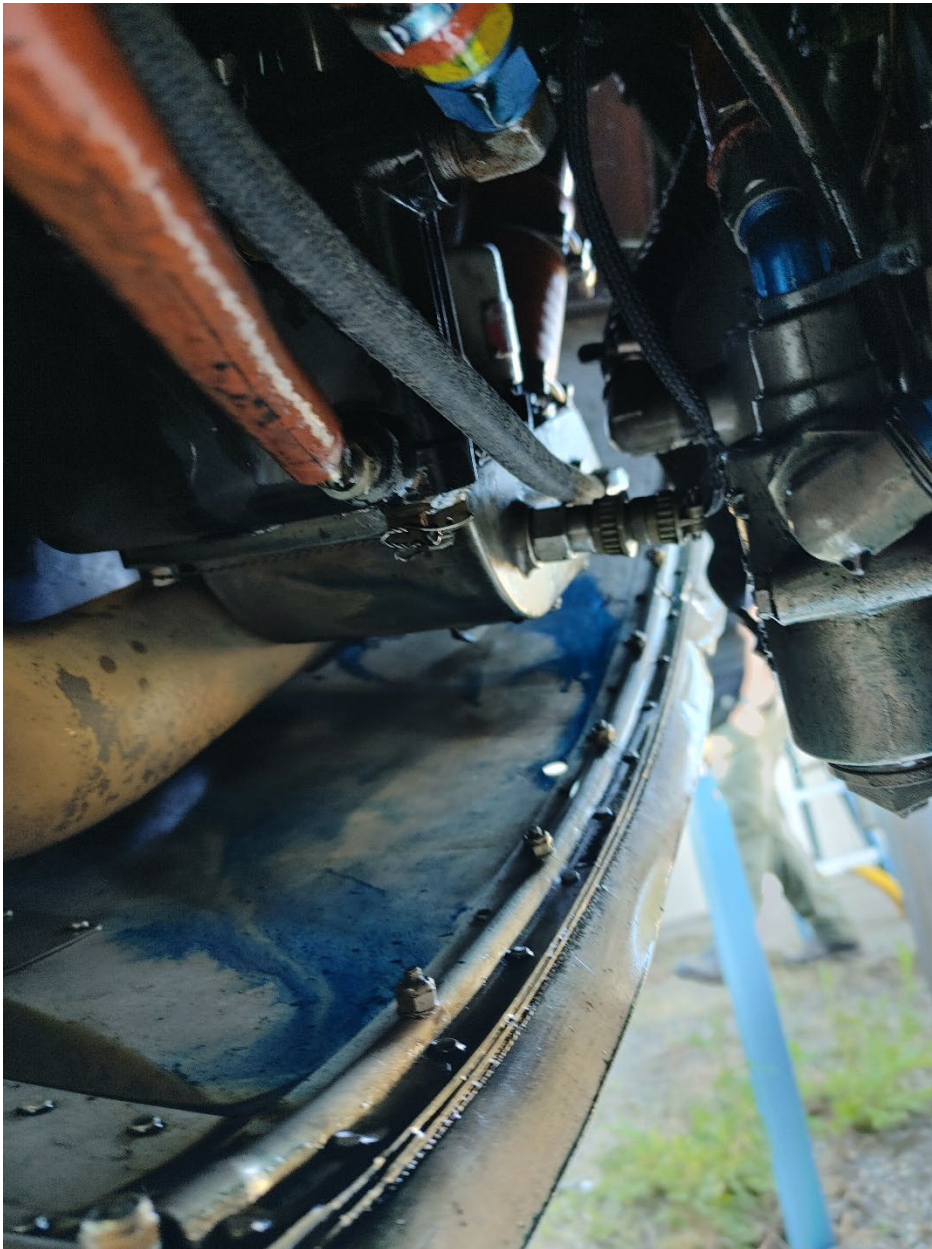
engine cowling, directly under the carburetor and captured an image of blue fuel staining, as shown in figure 1 and 2.

**Figure 1. Image of blue staining underneath the carburetor. Image courtesy of the owner.**

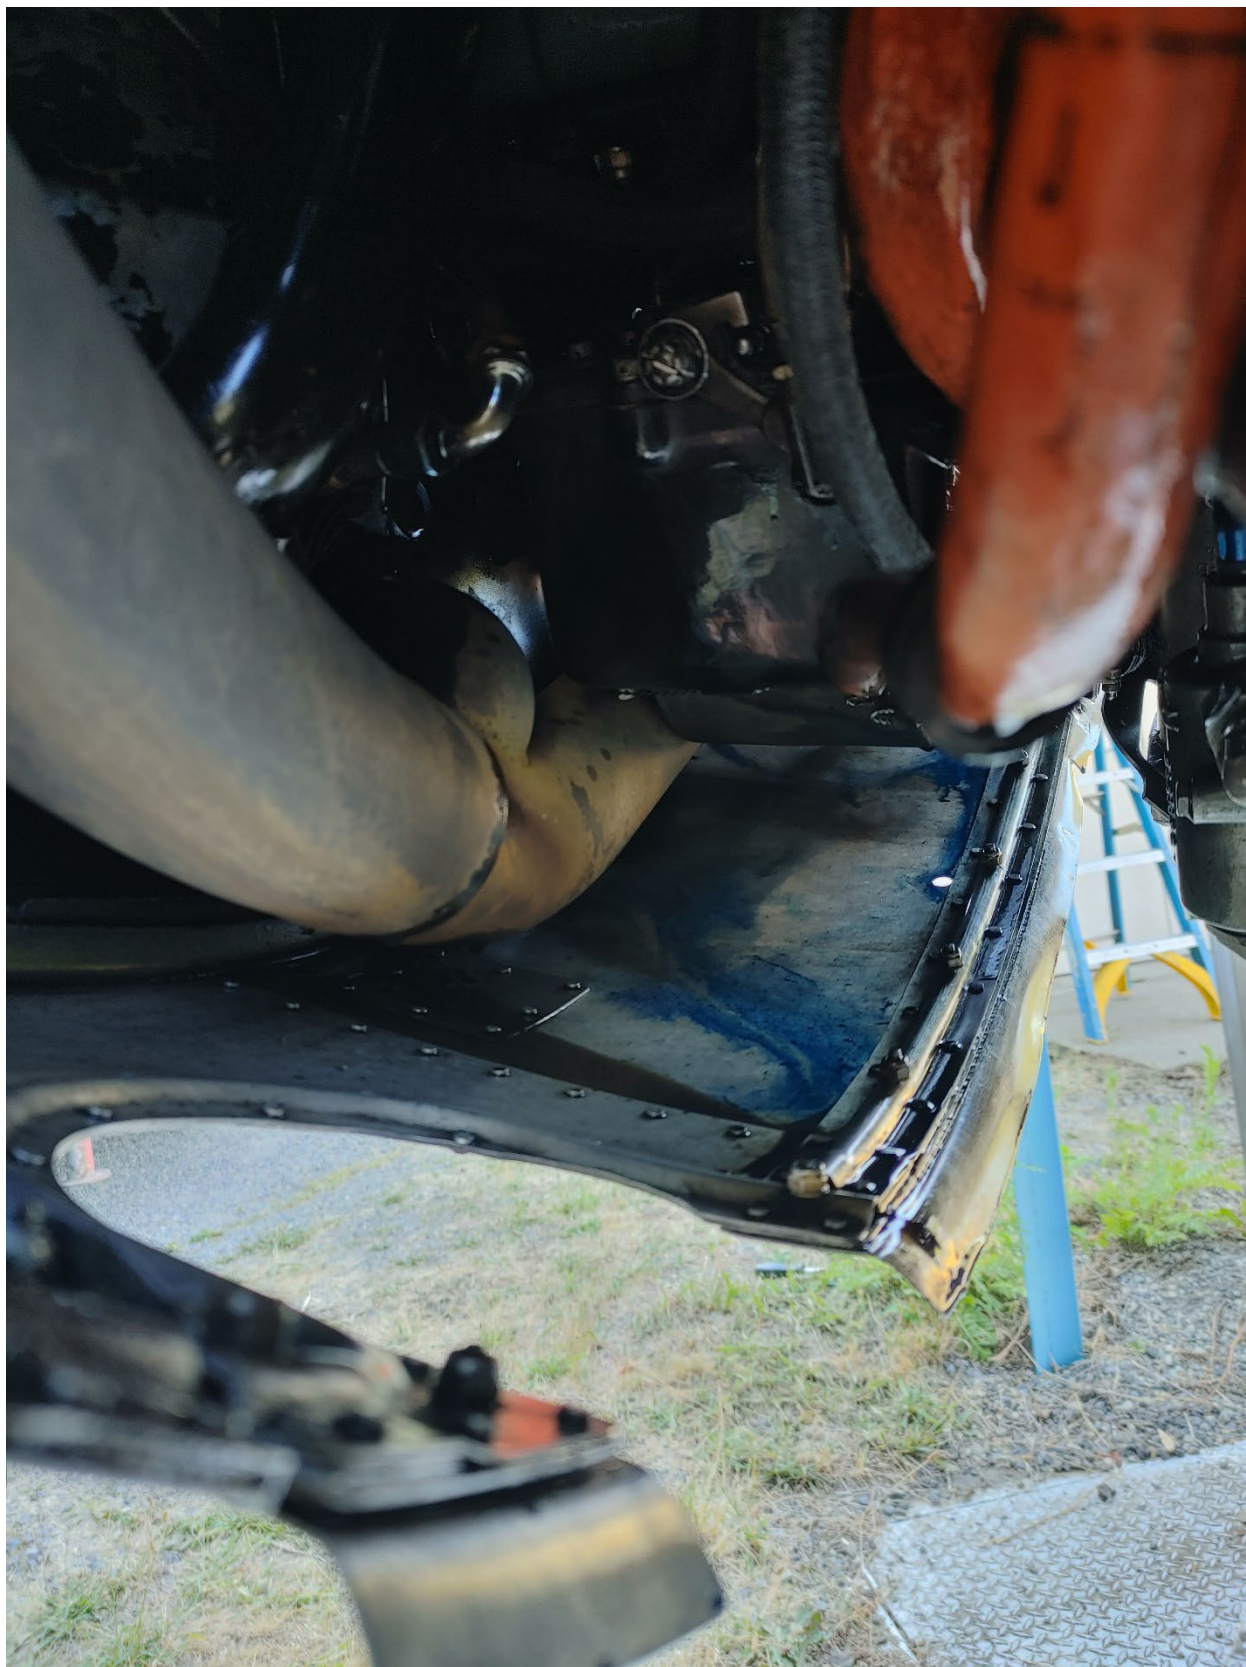
**Figure 2. Additional blue staining on cowl. Photo courtesy of the pilot.**

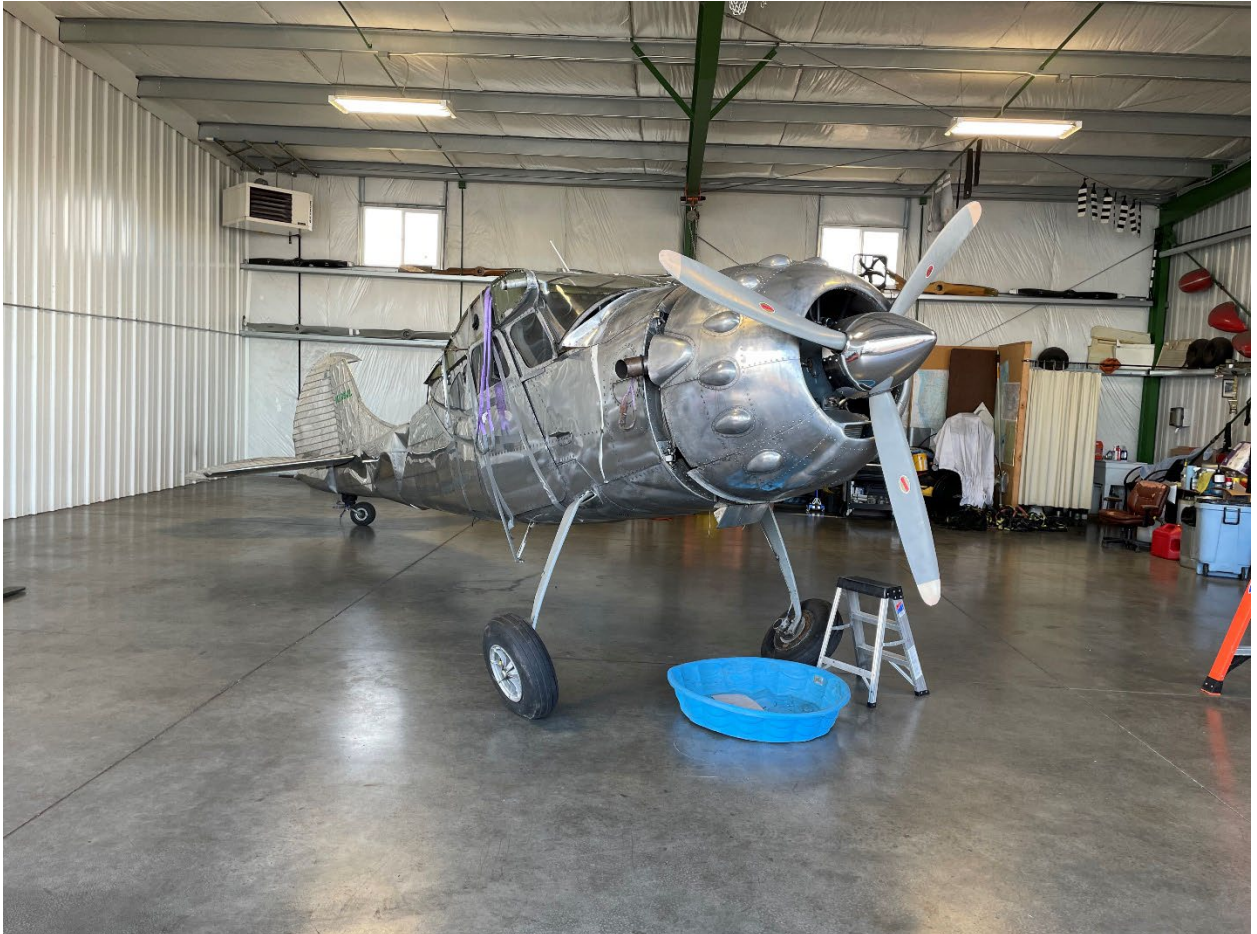
**Figure 3. Airplane right-side view.**

The fuselage was substantially damaged. The mid-section exhibited deep wrinkles and bent sheet metal. The entire aft section of the fuselage was bent to the right about 5° to 10°. The left-side fuselage above the left main landing gear exhibited breaches and wrinkles in the sheet metal.

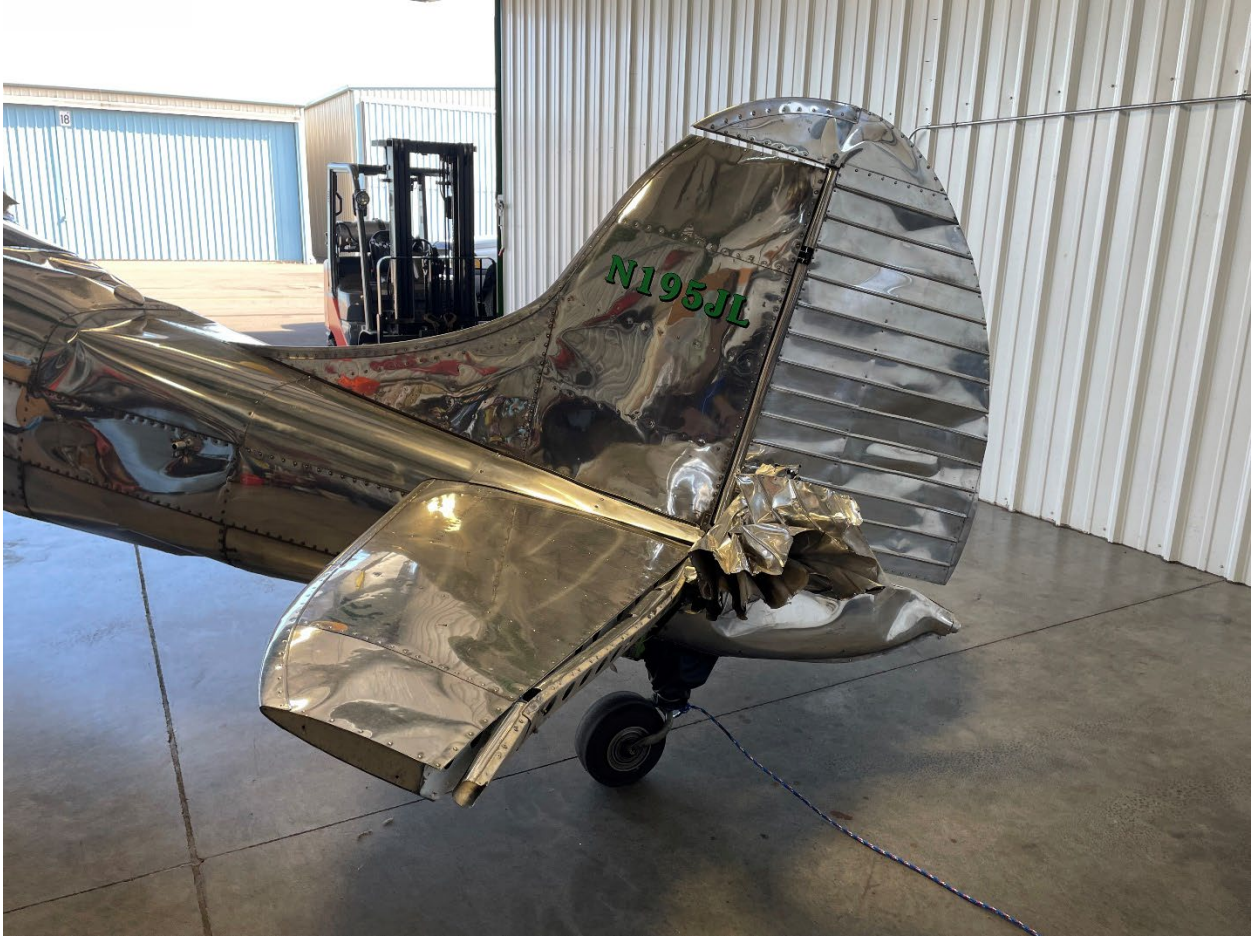
**Figure 5. Left-side view of empennage.**

The empennage remained secured to the end of the fuselage. The left elevator was crumpled to the root. The vertical stabilizer exhibited wrinkles and bends to the sheet metal. The rudder exhibited dents and wrinkles. The right-side horizontal stabilizer and elevator exhibited minor damage.

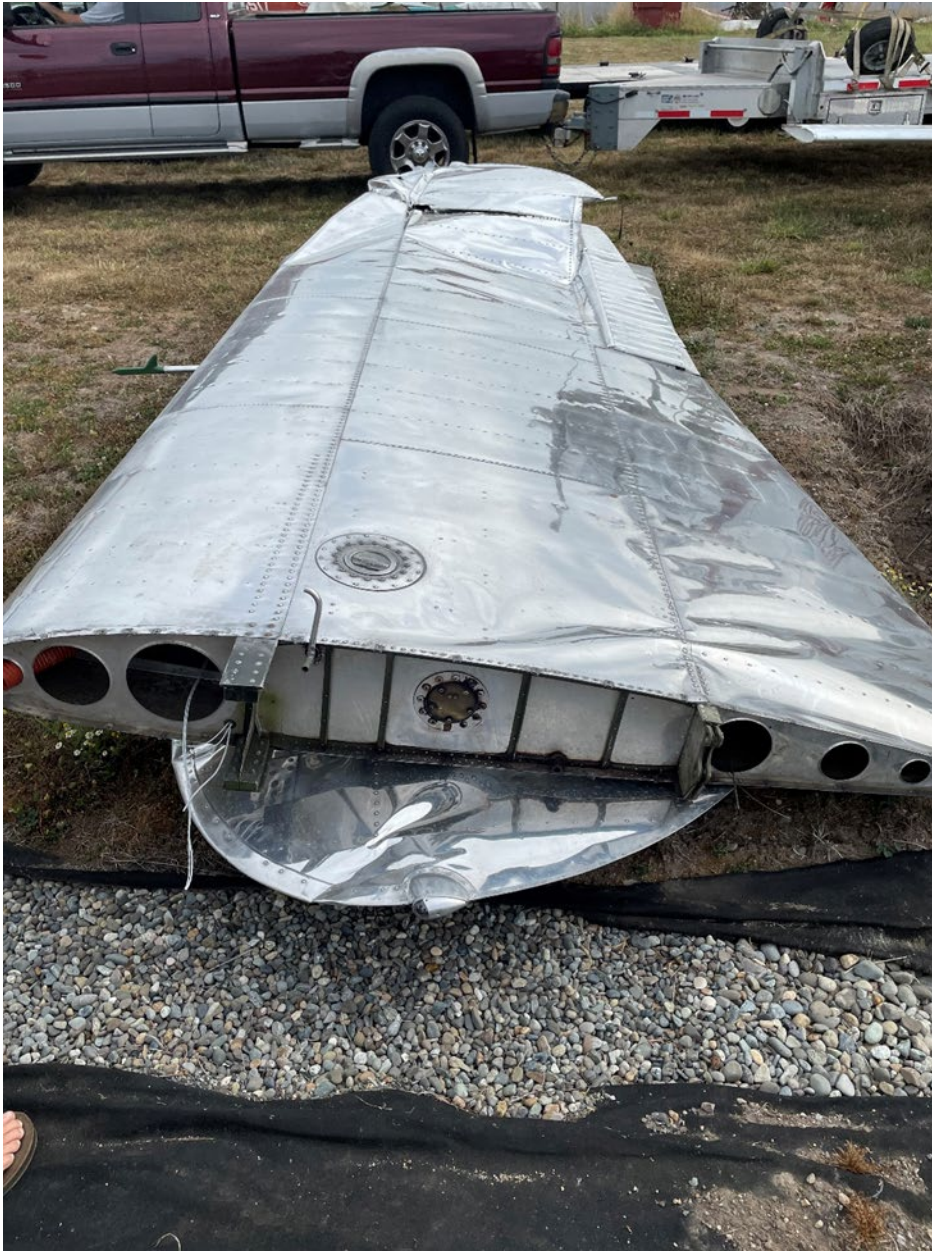
**Figure 7. Right wing, topside**

The right-side wing was removed from the airframe during the recovery. About 3 to 5 gallons of fuel had been reported to have been removed from the right-side wing tank. The fuel cap was found to be secured and the rubber seal was soft and pliable. The right-side wing tip and about 36 inches inboard was bent upwards. The wing root exhibited dents and bends.

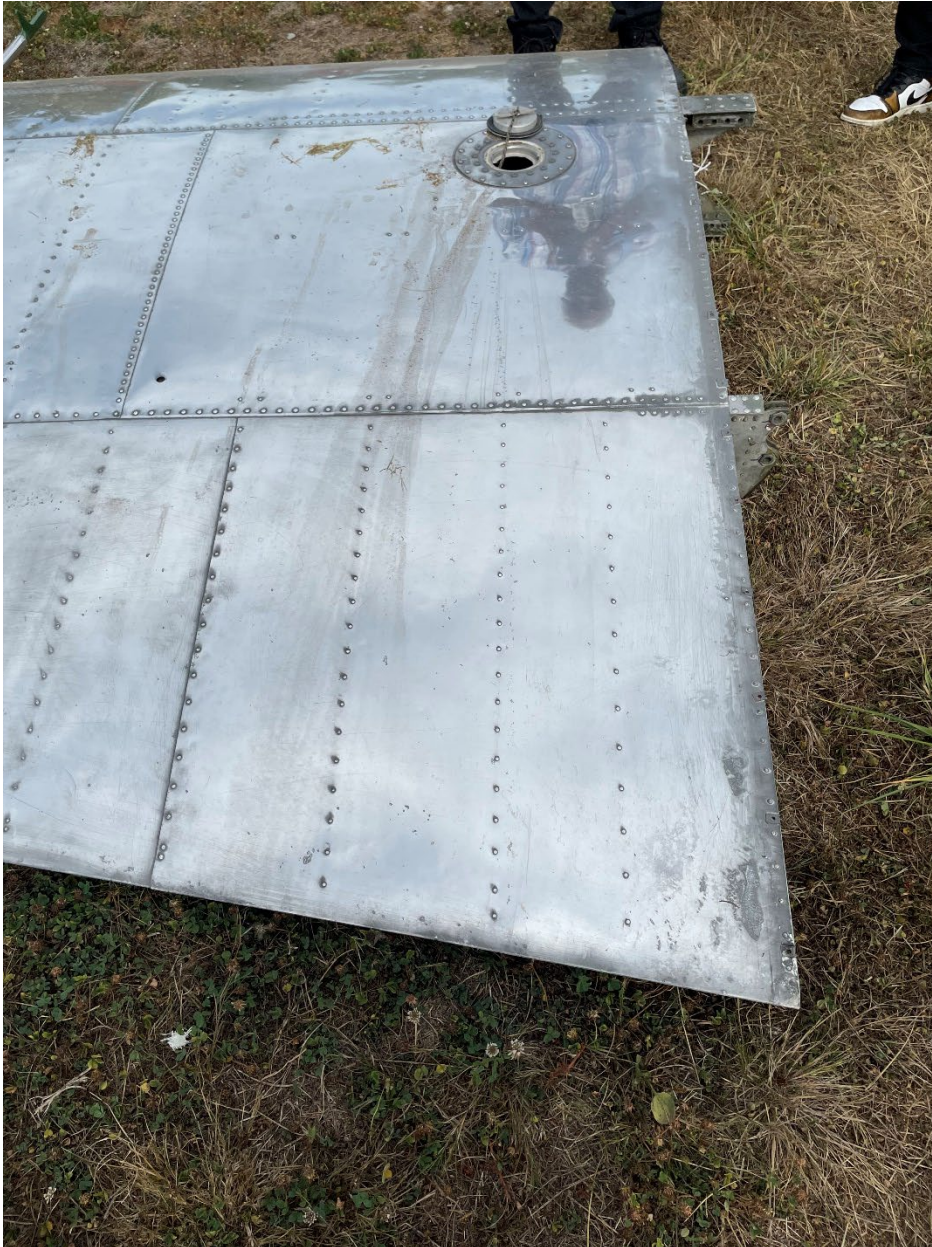
The left-side wing was removed from the fuselage during the recovery. About 3 gallons of fuel was reported to have been removed during the recovery. Postaccident examination revealed a significant amount of fuel staining on the top surface of the wing, that ran aft of the fuel fill port to the trailing edge of the wing. There was enough fuel/dirt staining that the area exhibited a flat hue when compared to the shiny, clean remainder of the wing and the right wing. The fuel cap was found to be secured and the rubber seal was soft and pliable. Disassembly of the filler port revealed wearing in the area of the cap locking section of the port. The left-wing tip, inboard to about 24 inches exhibited upward bending. The left aileron exhibited damage.

**Figure 8. Left-side wing, top view showing the staining that ran aft from the fuel fill port to the end of the wing.**

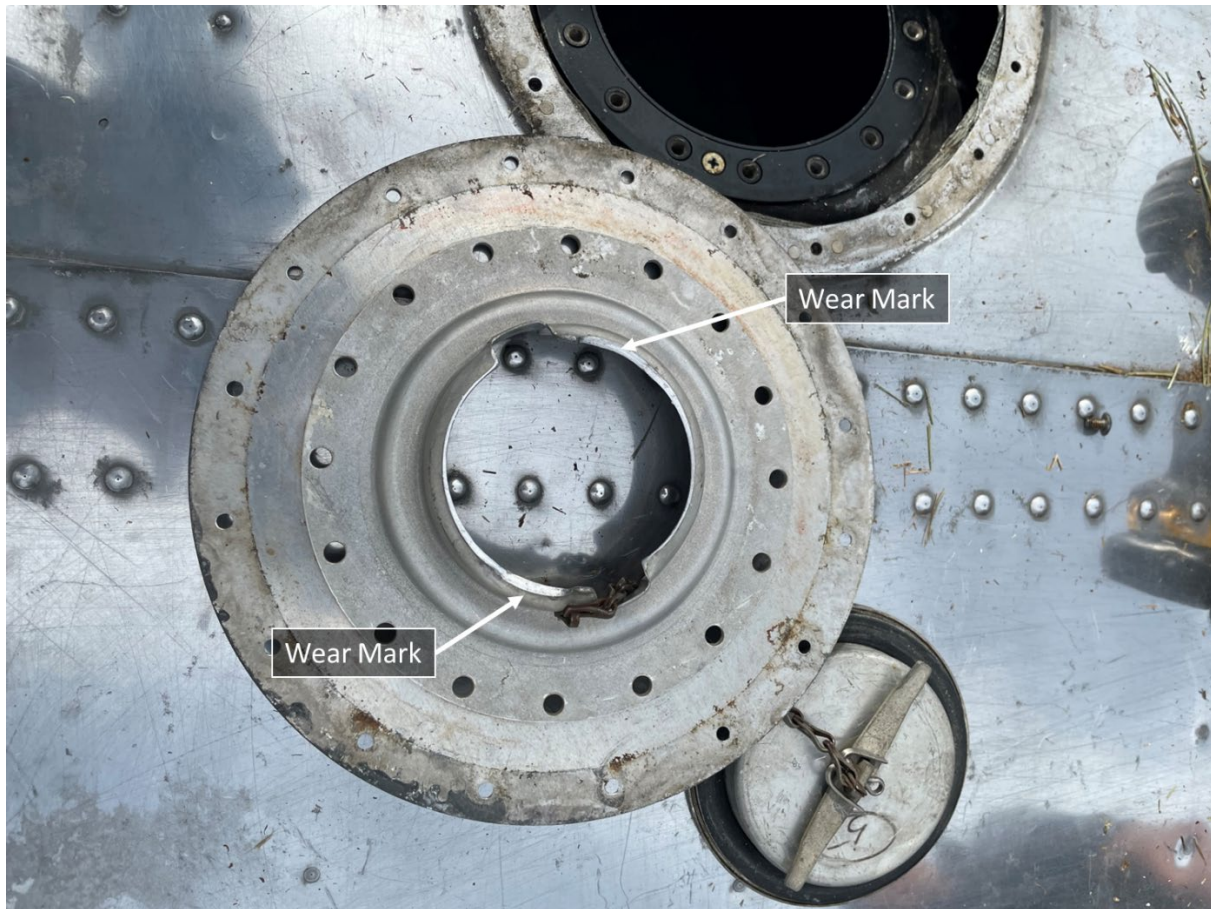
**Figure 9. Left wing fuel filler port, showing wear marks near the cap locking section of the port.**

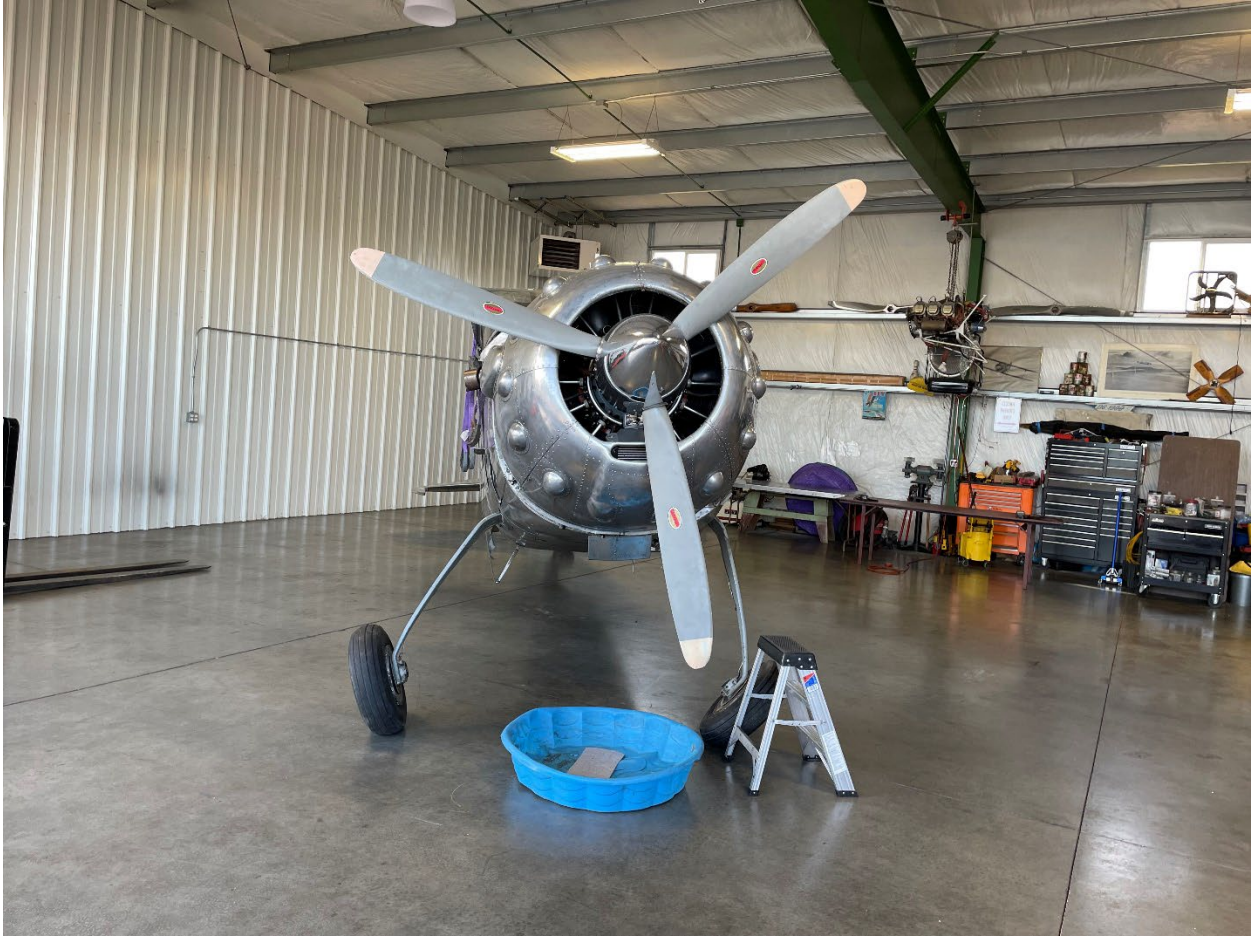
**Figure 10. Main landing gear**

The main landing gear remained attached to the lower fuselage. The left main landing gear exhibited inward bending of the strut so that the outer surface of the wheel contacted the ground. The right-side main landing gear exhibited little to no bending of the strut. The brakes remained attached to the main landing gear wheels. The tail wheel remained attached to the aft fuselage and exhibited minor damage.

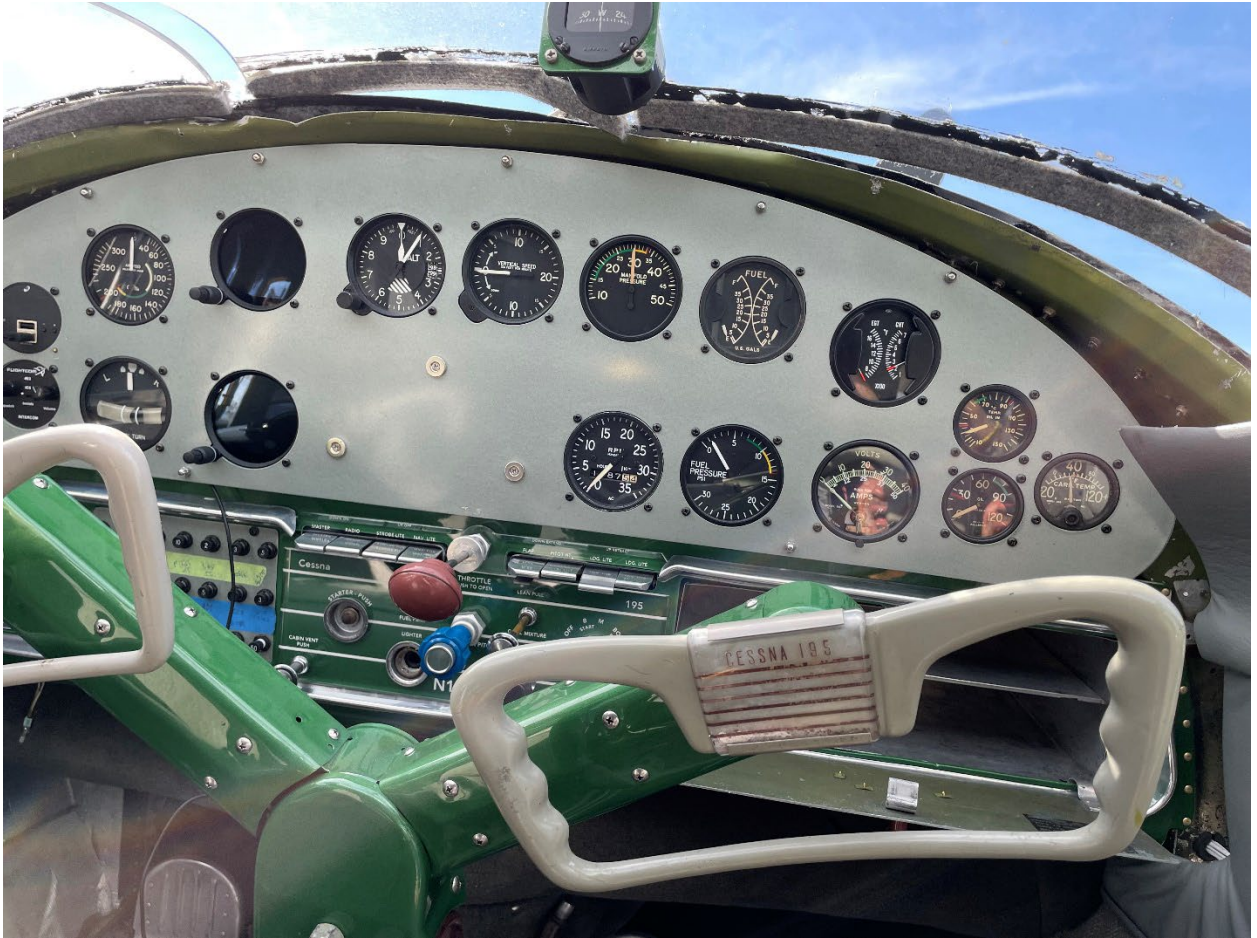
**Figure 11. Instrument panel and control yoke**

The cockpit remained secure and exhibited no structural damage. The instrument panel remained secured. When power was applied, and the engine was operating, both fuel quantity gauges displayed  $\frac{1}{4}$  tank full.

A maintenance records review revealed the engine was re-installed, in addition to an annual inspection on January 14, 2023, at a tachometer time of 1160.5 hours. The tachometer time recorded after the accident was 1187.54 hours, as shown in figure 11.

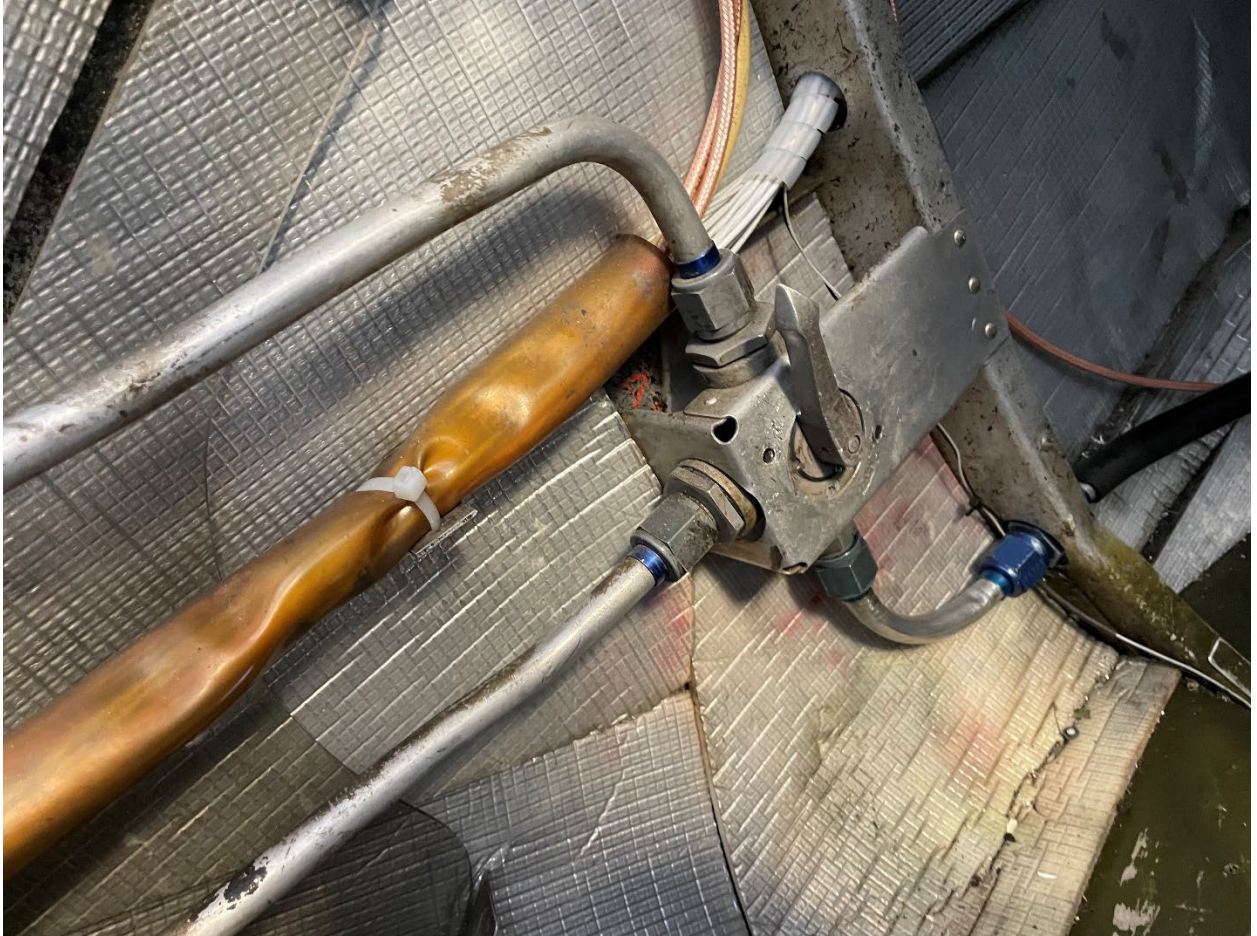
**Figure 12. Fuel tank selector switch**

The two wing fuel screens were clean and free of obstruction. The fuel tubing for the right wing was secure and ran across the overhead cabin roof to the left side. The tubing ran to the fuel selector switch and was secure and exhibited no signs of fuel leaks. The fuel selector switch remained secured to the fuselage and exhibited no signs of fuel leakage. The fuel tube ran out of the switch and turned 90°. There was an indication of staining under the fuel selector switch. The fuel line ran to the fire wall and exited to the gascolator.

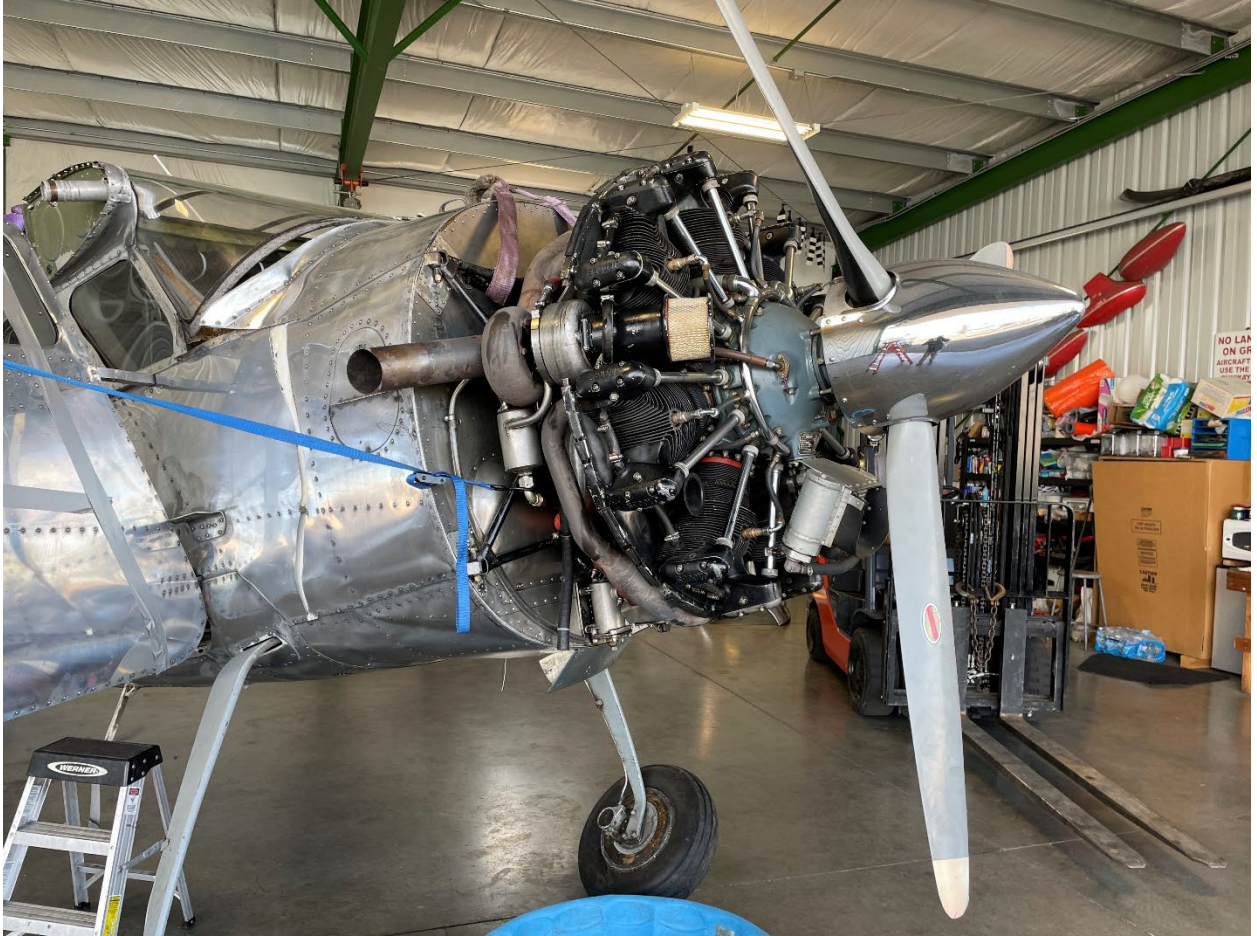
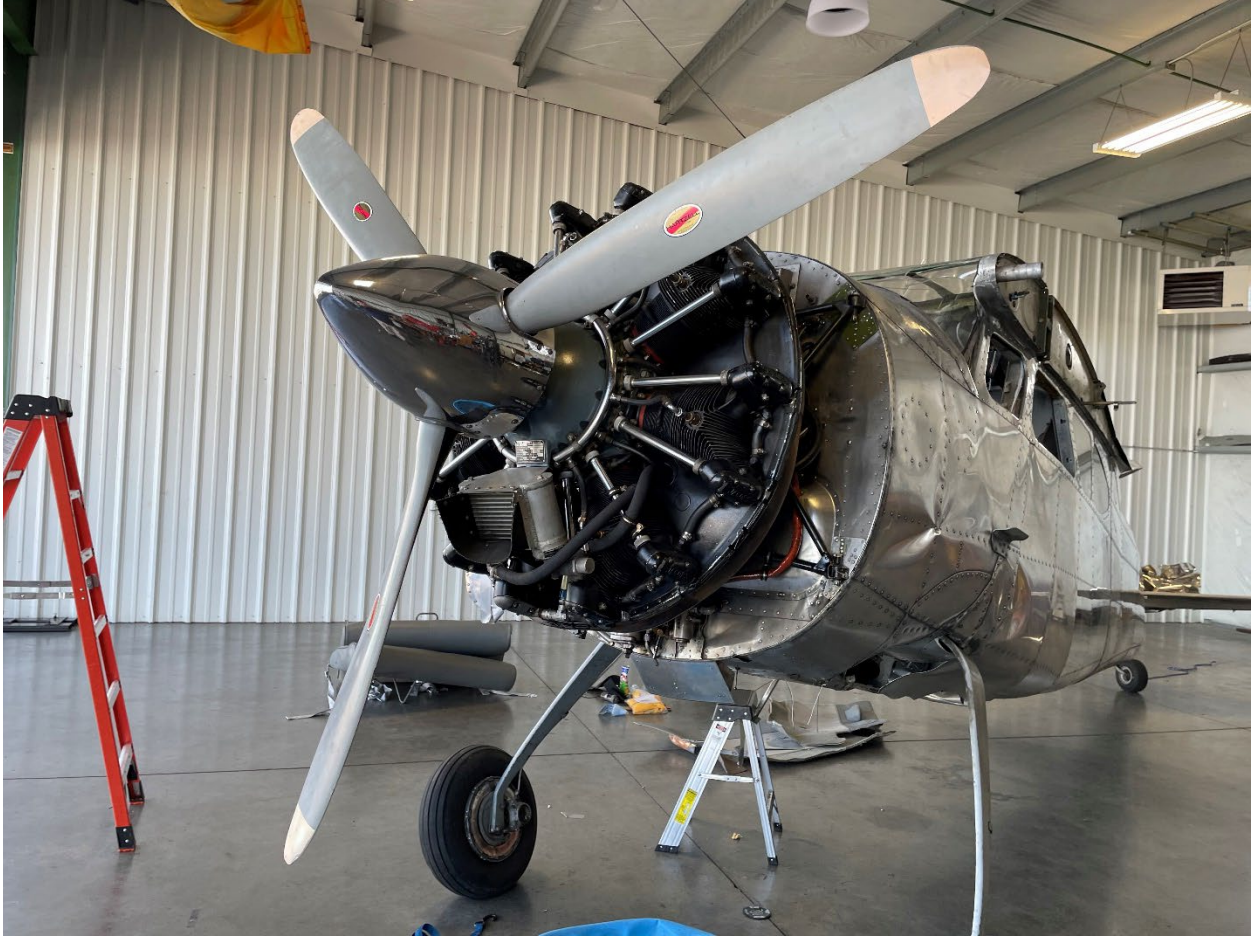
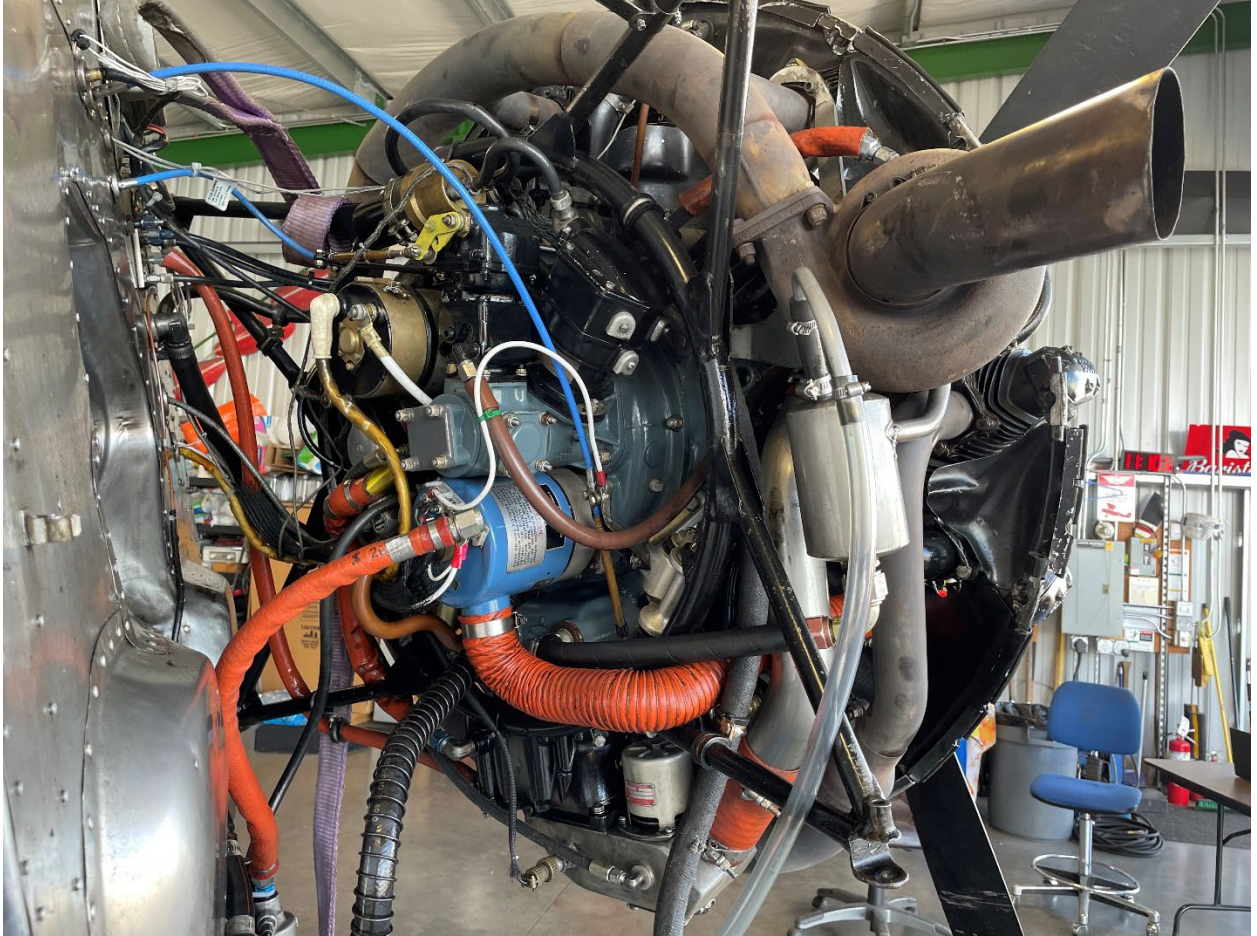
The radial engine was identified as a Jacobs, model R755-S, serial number: 35063, 7-cylinder radial engine. It remained attached to the engine mounts that remained attached to the firewall. The engine exhibited no external damage. There was no sign of fuel leaks or blue staining around the engine, nor the three-piece engine cowling (same area as shown in figure 1). Several small strips, aft of the engine cowling, were removed and exhibited no signs of fuel stains.

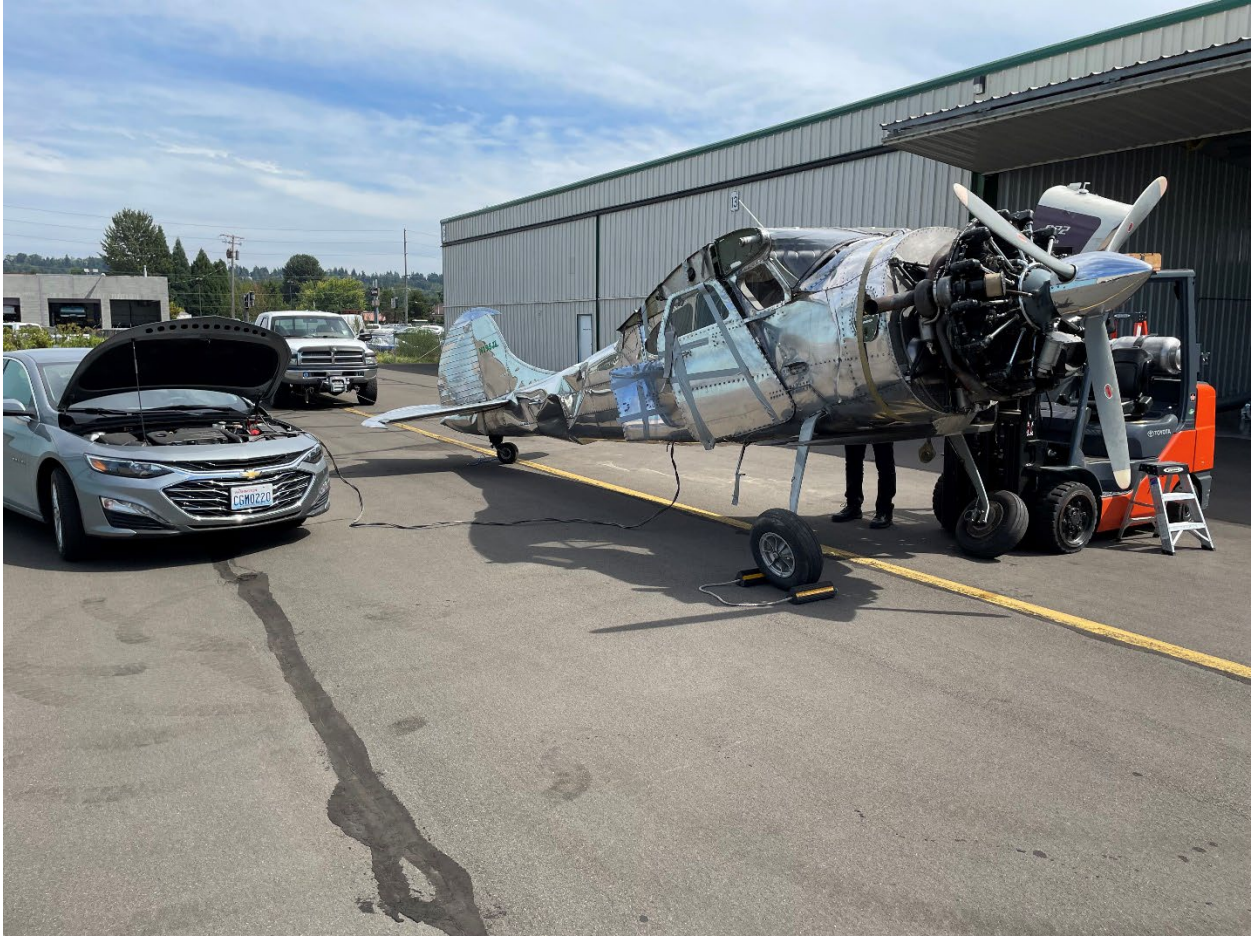
**Figure 17. Airplane configured for a test run of the engine.**

After the engine examination was completed, a test run of the engine was conducted. An external fuel tank was secured to a forklift, and the forklift secured the fuselage. The electrical system was charged via a jump start cables and power was supplied from an external source. The engine was cleared by rotating the propeller through several cycles. The engine started and ran at near full RPM (2,200 RPM and 22 inches of manifold pressure). The engine ran smoothly and exhibited no anomalies. There were no indications of fuel leaking from the carburetor before, during, and after the test run.

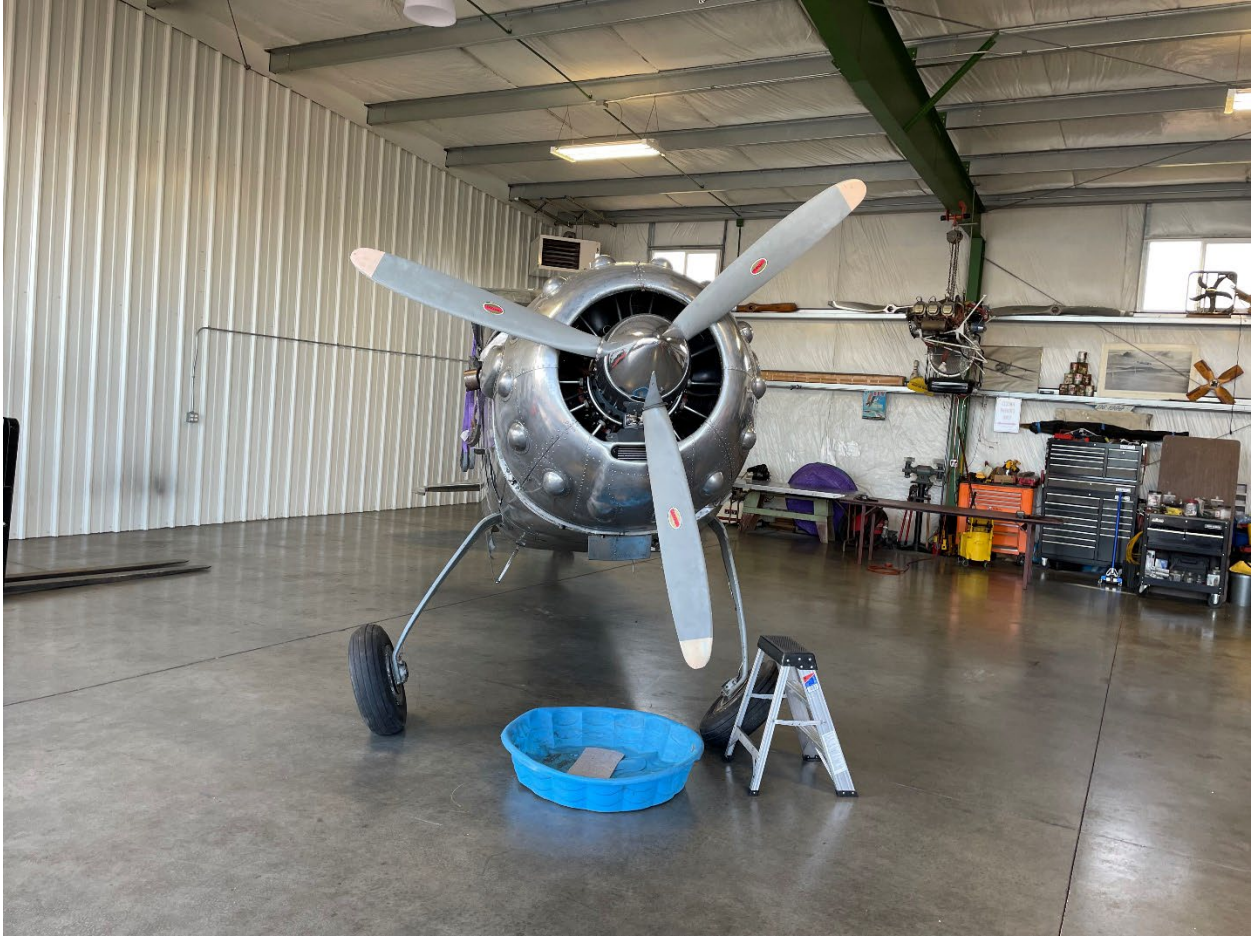
**Figure 18. Image of the propeller.**

The three-bladed, propeller remained attached to the propeller flange and exhibited a slight bend on one of the propeller blades.
