# National Transportation Safety Board

WPR23LA295

## **MATERIALS LABORATORY**

Factual Report 24-017

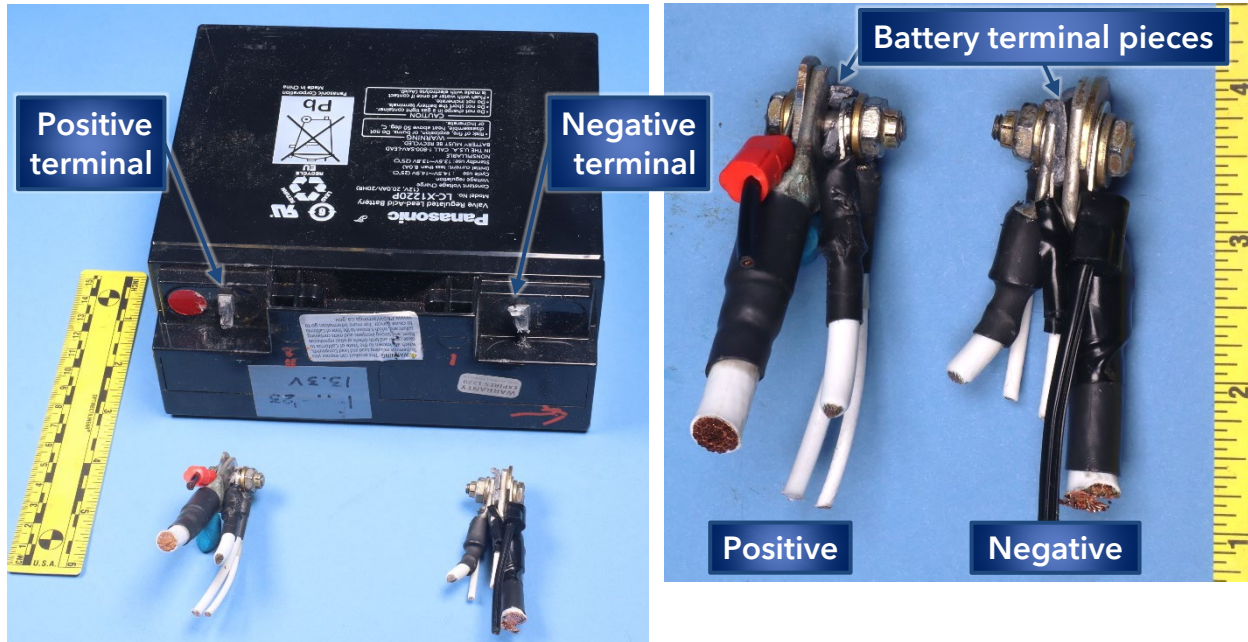
Overall views of the battery and fractured terminals are shown in figure 1. Both the positive and negative battery terminals were fractured, and wire terminal connectors remained attached to the separated pieces of the battery terminals as shown in the right image in figure 1.

**Figure 1.** Overall view of the submitted battery and fractured battery terminal pieces with attached wire terminal connectors (left image) with a closer view of the terminal pieces and attached connectors (right image).

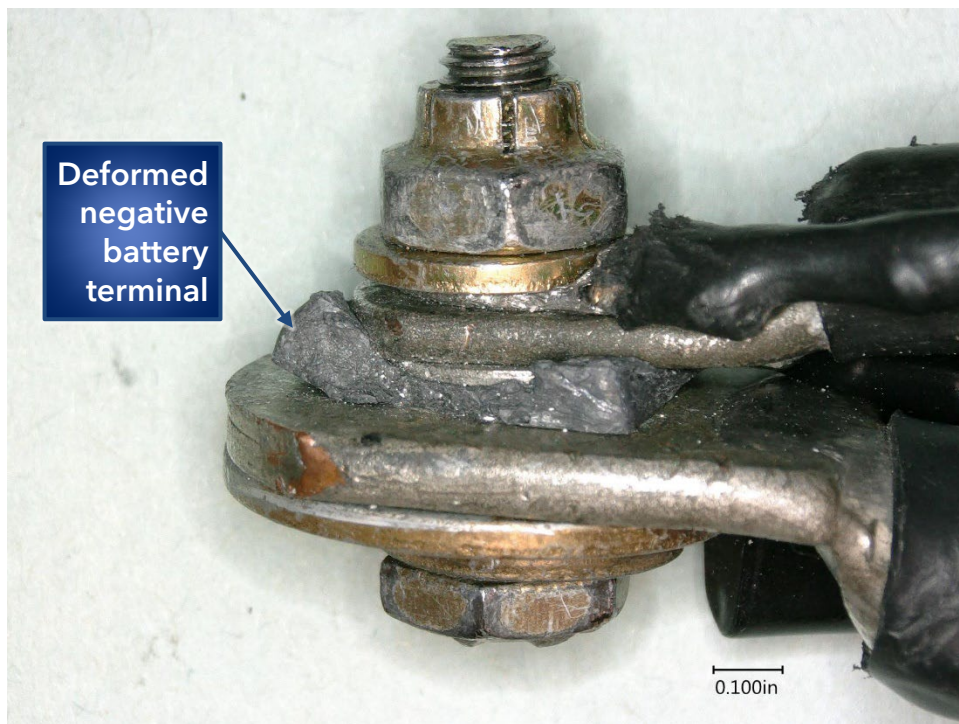
The battery terminals were made of nearly pure lead, which is a relatively soft and easily deformed metal. The battery terminals were deformed, and the terminals appeared to be thinned and pressed into the connections at the clamped faces. A view of the negative battery terminal showing deformation at the clamping surfaces relative to the outer edges is shown in figure 2.

**Figure 2.** Close view of the negative terminal connection showing the outer surface of the battery terminal (the side opposite the fracture).

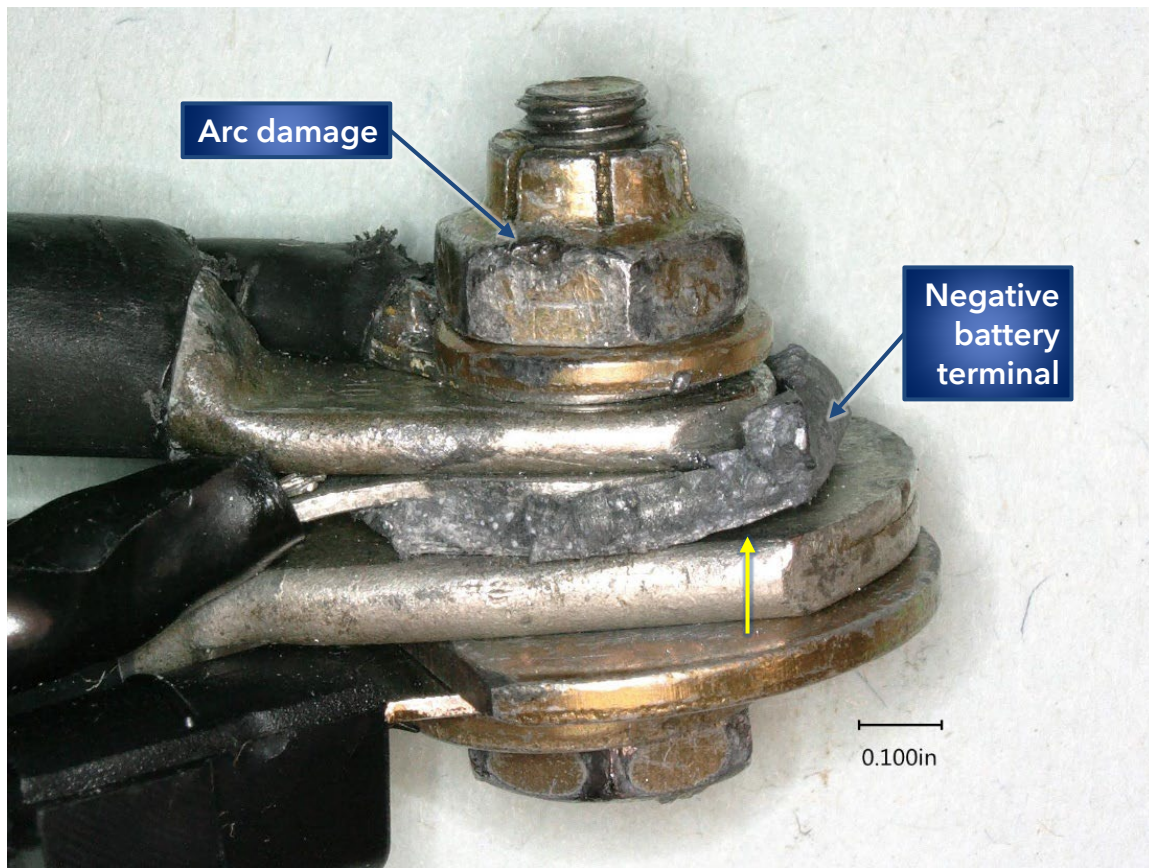
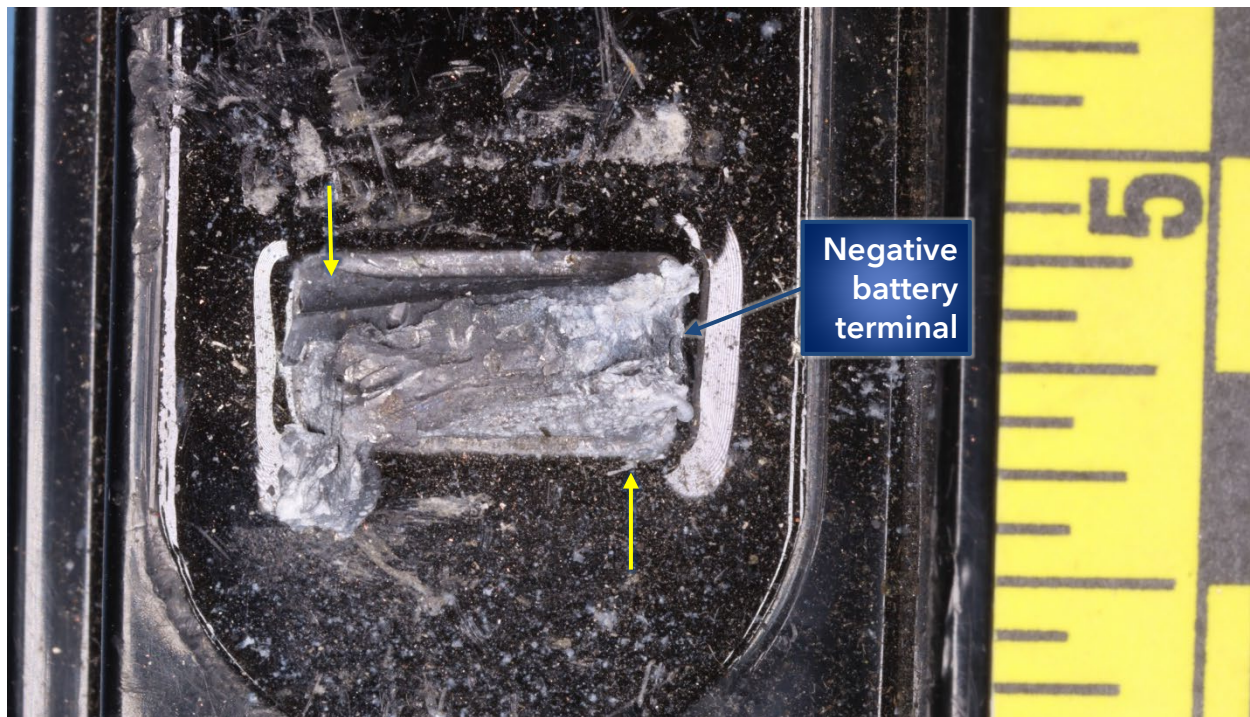
The mating fracture surfaces of the negative battery terminal are shown in figure 3. The mating fracture surfaces showed deformation consistent ductile overstress fracture under torsion loading with relative motion from the mating side as indicated by arrows in figure 3. The fracture surfaces appeared smeared, and spheres of remelted lead balls were observed deposited on adjacent surfaces. Additionally, the nut for the negative terminal connections had an area where surface appeared cratered at the edge of a wrench flat with smooth rounded features at the edges. The overall appearance of the cratered area was consistent with damage from electrical arcing as indicated in figure 3.

**Figure 3.** Mating sides of the fractured negative battery terminal showing the connection side (upper image) and the battery side (lower image). Arrows point to the direction of deformation from relative motion of the mating side of the fracture.

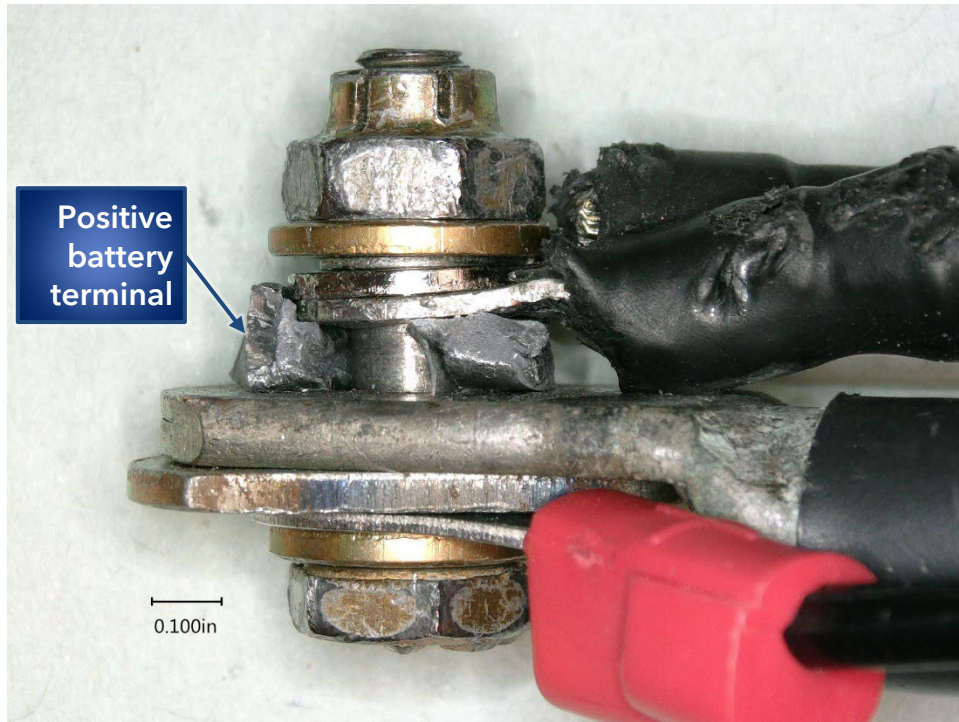
A close view of the positive battery terminal piece fracture surfaces with attached wire terminal connectors is shown in figure 4. Most of the fracture surface had matte gray features consistent with ductile overstress fracture. The overall

deformation pattern at the fracture location appeared consistent with overstress fracture from torsion loads.

**Figure 4.** Fracture surfaces on the connection side of the positive battery terminal.

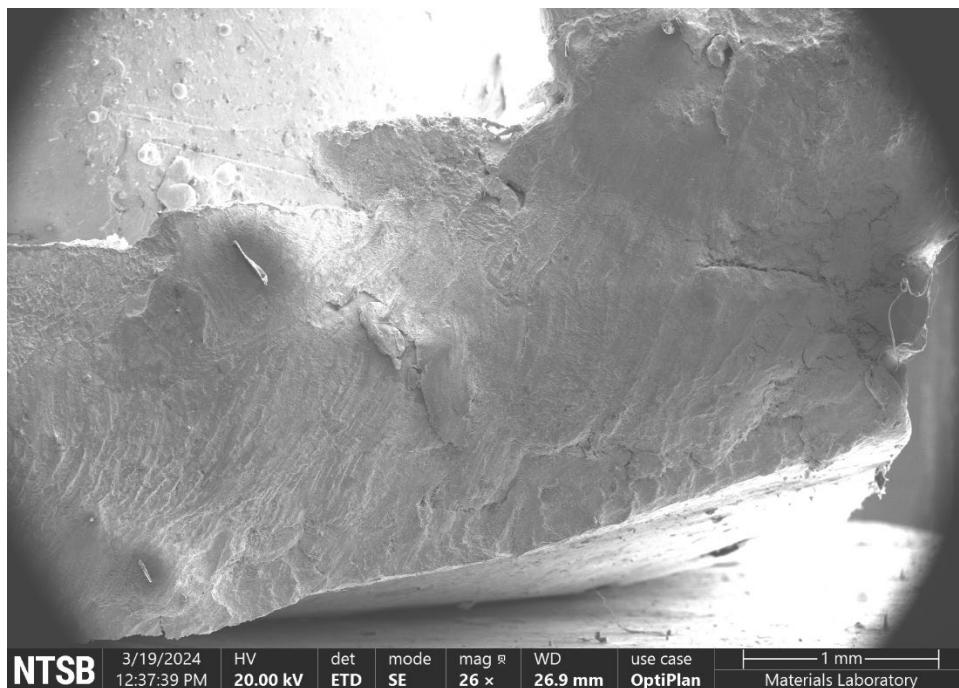
The fracture surfaces were examined using a scanning electron microscope (SEM), and images of portions of the fracture surfaces on the negative and positive battery terminals are shown in figures 5 and 6, respectively. The fracture surfaces of the negative battery terminal were mostly smeared consistent with sliding contact between the mating fracture faces under mostly shear loading with limited tensile stresses in the fracture plane. On the positive terminal the fracture surfaces mostly showed elongated dimples, consistent with a combination of tension and shear stresses on the fracture plane.

**Figure 5.** SEM image of fracture features on a portion of the negative terminal.

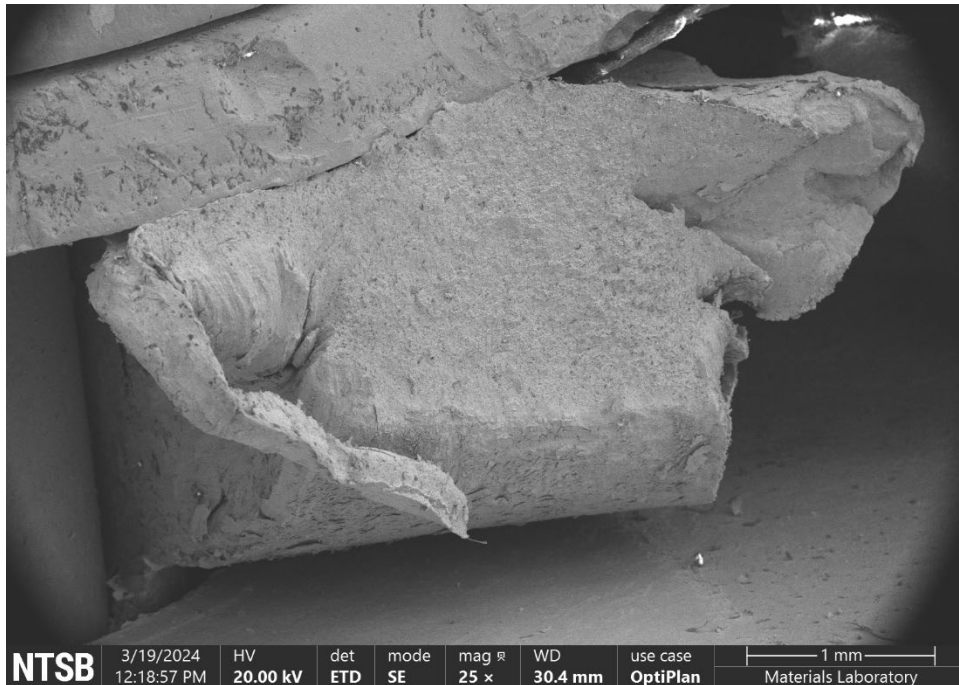
**Figure 6.** SEM image of fracture features on a portion of the positive terminal.

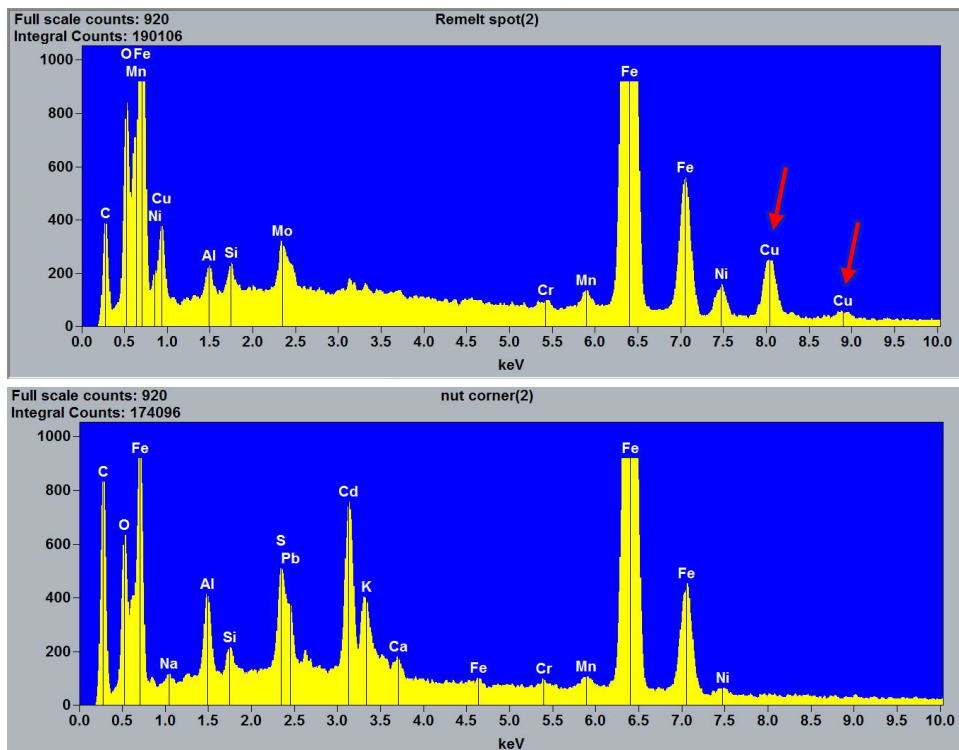
The arc damaged area of the nut on the negative terminal was analyzed in the SEM using energy dispersive x-ray spectroscopy (EDS). The spectra obtained in the cratered area were compared to a corner of the nut wrenching flat where the cadmium coating appeared to be mostly disturbed by mechanical means. The baseline spectrum obtained in the area where the cadmium coating appeared to be mechanically disturbed is shown in the lower image in figure 7, where expected peaks associated with the steel nut and cadmium coating along with other light elements were observed. In the cratered area, peaks associated with copper were detected in addition to others shown in the baseline spectrum.

**Figure 7.** EDS spectra obtained within the arc damage area on the nut (upper spectrum) and on an area of the nut where most of the cadmium coating appeared to be mechanically removed (lower spectrum). Red arrows in the upper spectrum point to copper peaks that are not observed in the lower spectrum.
