# National Transportation Safety Board

WPR23LA295

## **NTSB WRECKAGE EXAMINATION REPORT**

Location: Renton, Washington  
Date: July 31, 2023  
Time: 0920 Pacific daylight time  
1720 UTC  
Airplane: Experimental Lancair 320

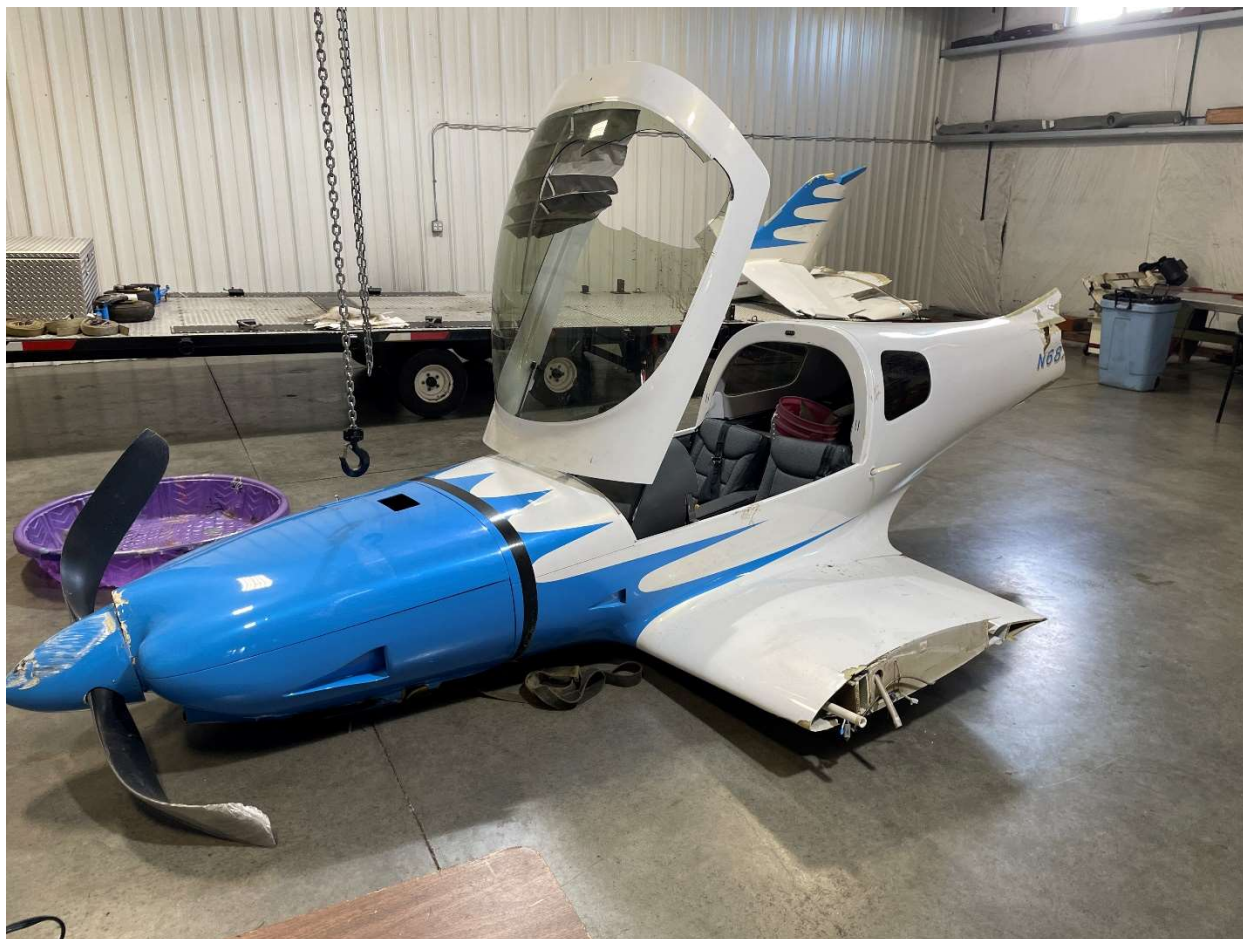
The airplane was a fully composite monocoque design. Both wings were separated inboard by recovery personnel. The cockpit and engine compartment remained intact and mostly undamaged with exception of exhaust tubes below the engine case that were crushed and the fuel servo was partially fractured at the mounting pad.

**Photograph 1: Airplane prior to examination**

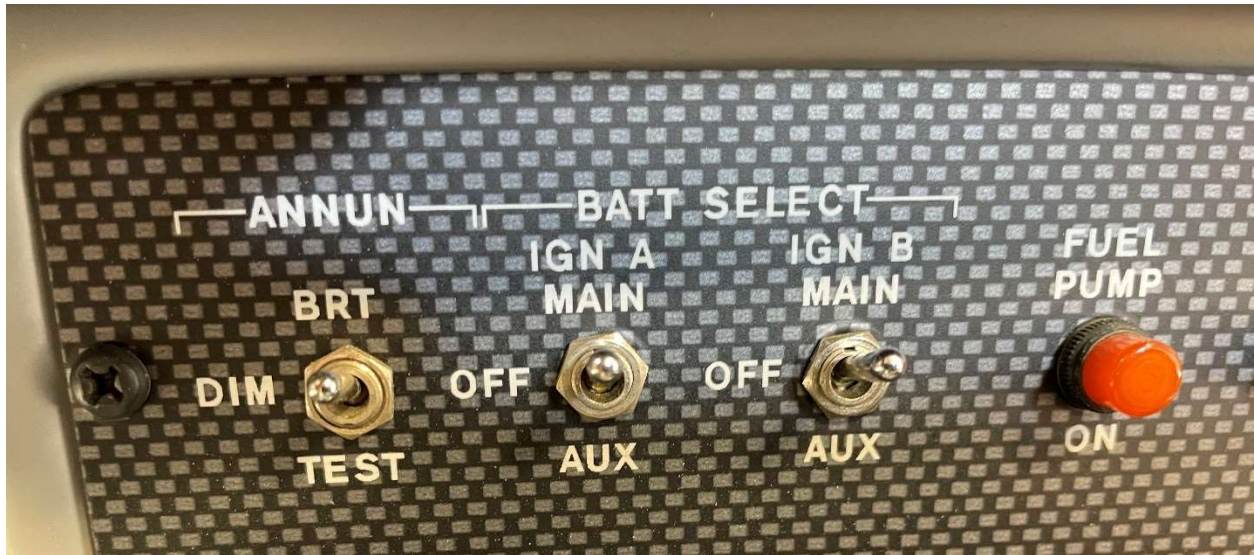
The avionics system was powered by a 12 volt main battery and was also equipped with a 12 volt auxiliary battery. Two solenoids drew power from the main and auxiliary batteries, respectively. Together, the solenoids delivered power to the starter motor. The operator could toggle between the main and auxiliary batteries through two switches on the instrument panel labeled "IGN A" and "IGN B." The switches were used to select either the main or auxiliary battery to run the electronic ignition system ("IGN A" runs 4 spark plugs and "IGN B" runs 4 spark plugs).

**Photograph 2: Battery Switches on Instrument Panel**

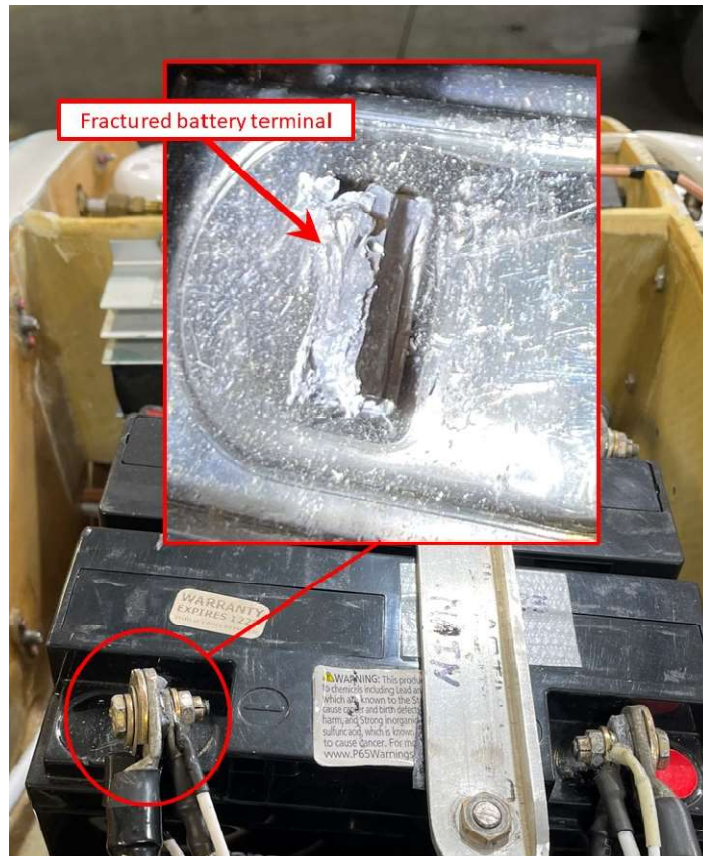
The negative terminal of the main battery was fractured and exhibited evidence of arcing. The positive leads were secured to the positive terminal of the battery. The terminals on the auxiliary battery were unremarkable. The main battery voltage measured 3.67v and the auxiliary battery voltage was 12v when tested with a multimeter.

**Figure 1: Main battery and fractured negative terminal**
