# National Transportation Safety Board

WPR23LA303

## **AIRFRAME & ENGINE EXAMINATION**

Location: McDermitt, Oregon  
Date: August 3, 2023  
Time: 1145 Pacific daylight time  
Airplane: Experimental amateur-built Cozy, N964AL

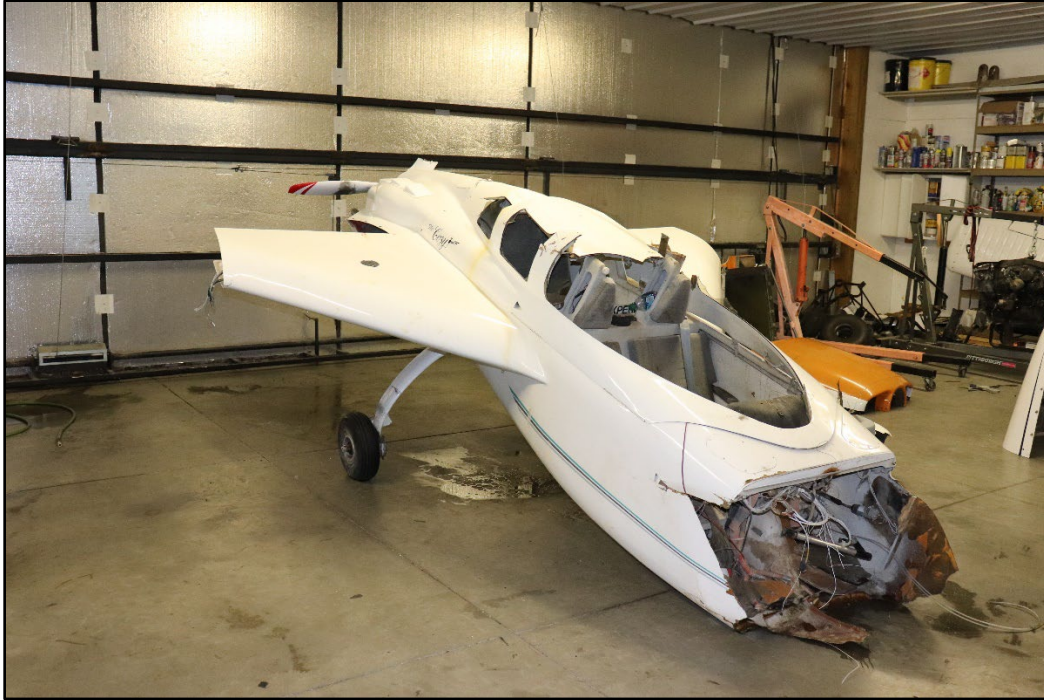
Examination of the recovered wreckage revealed that the nose landing gear and canard were fracture separated from the airplane. Both outboard wings, vertical stabilizers, and rudders were removed by recovery personnel. Additionally, the recovery personnel reported that no fuel signatures had been observed at the accident site location and no fuel was drained from the wreckage.

**Figure 1: View of accident airplane during examination.**

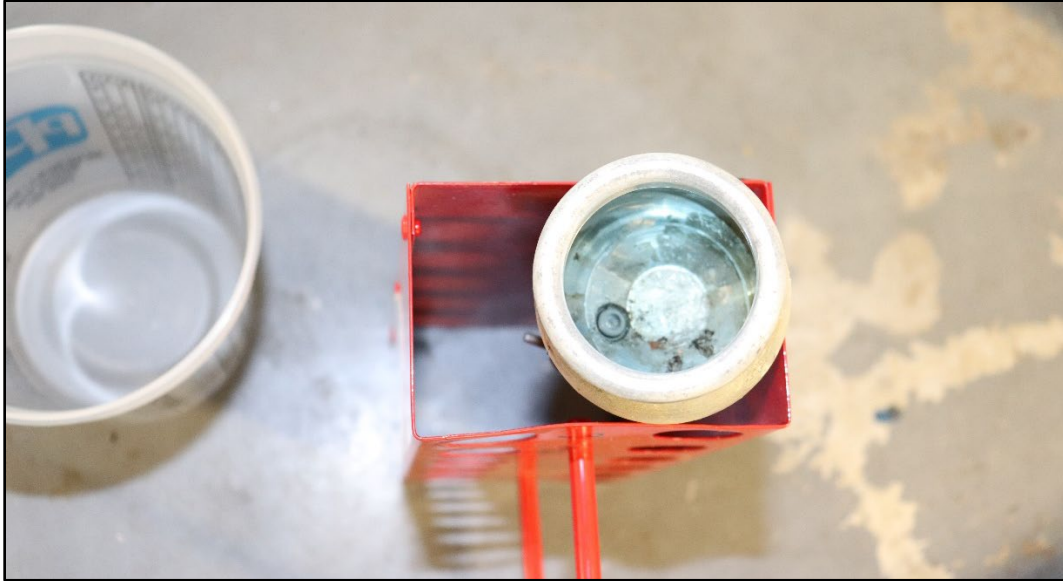
A visual inspection of the fuel system was conducted. Continuity was established from the main fuel tanks throughout the system to the carburetor. Visual inspection of the airframe fuel strainer revealed a small amount of blue in color liquid, consistent with 100LL and minor debris consistent with normal operation. The fuel was tested for water using SAR-GEL water finding paste, with negative results. Fuel was added to the fuel tanks, and the carburetor float bowl drain plug was removed. When the airframe electric fuel pump was turned on, fuel expelled from carburetor float bowl drain.

**Figure 2: View of fuel in airframe fuel strainer.**

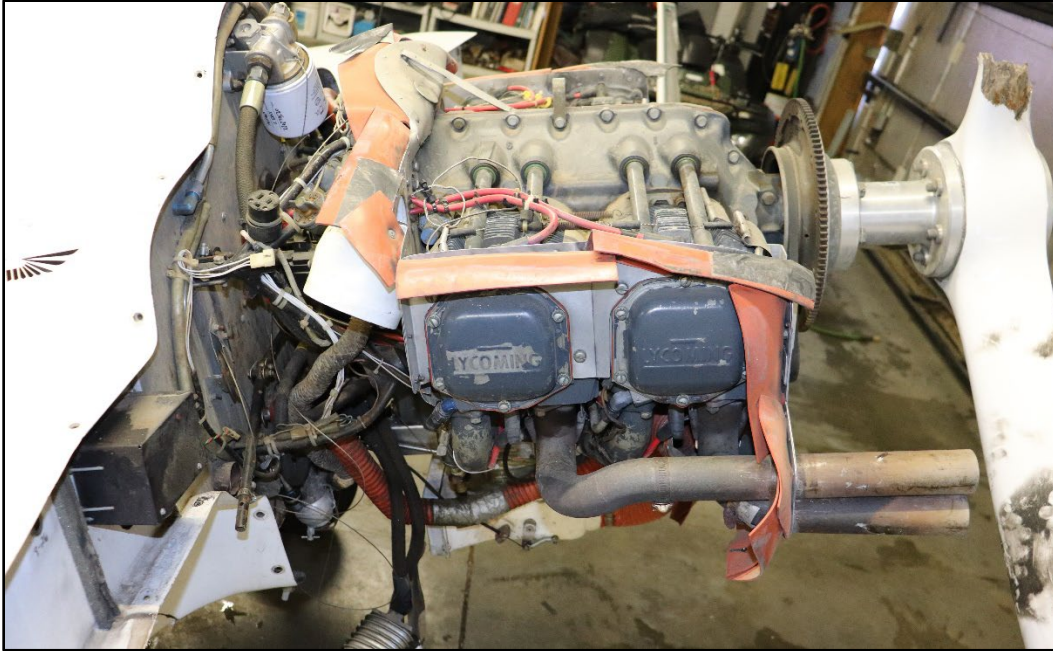
Examination of the recovered engine revealed that it remained attached to the engine mounts. All four cylinders and all engine accessories remained attached. All fuel and oil lines appeared attached to their respective fittings and were tight. No evidence of any mechanical damage was observed to the engine crankcase.

**Figure 3: View of left side of engine during exam.**

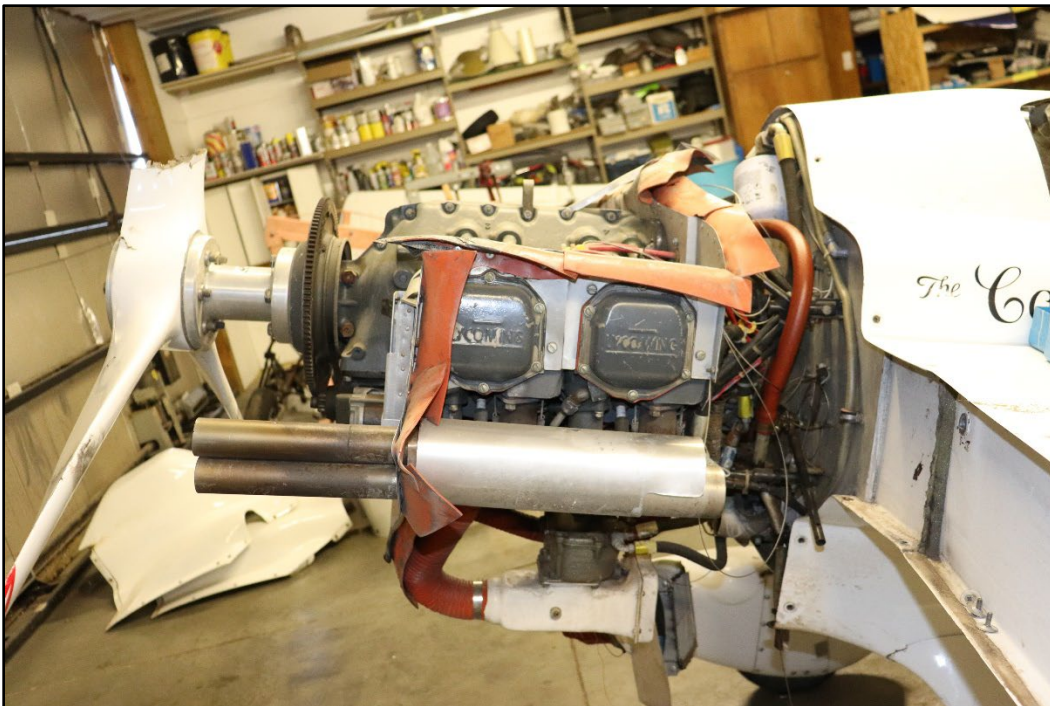
**Figure 4: View of right side of engine during exam.**
