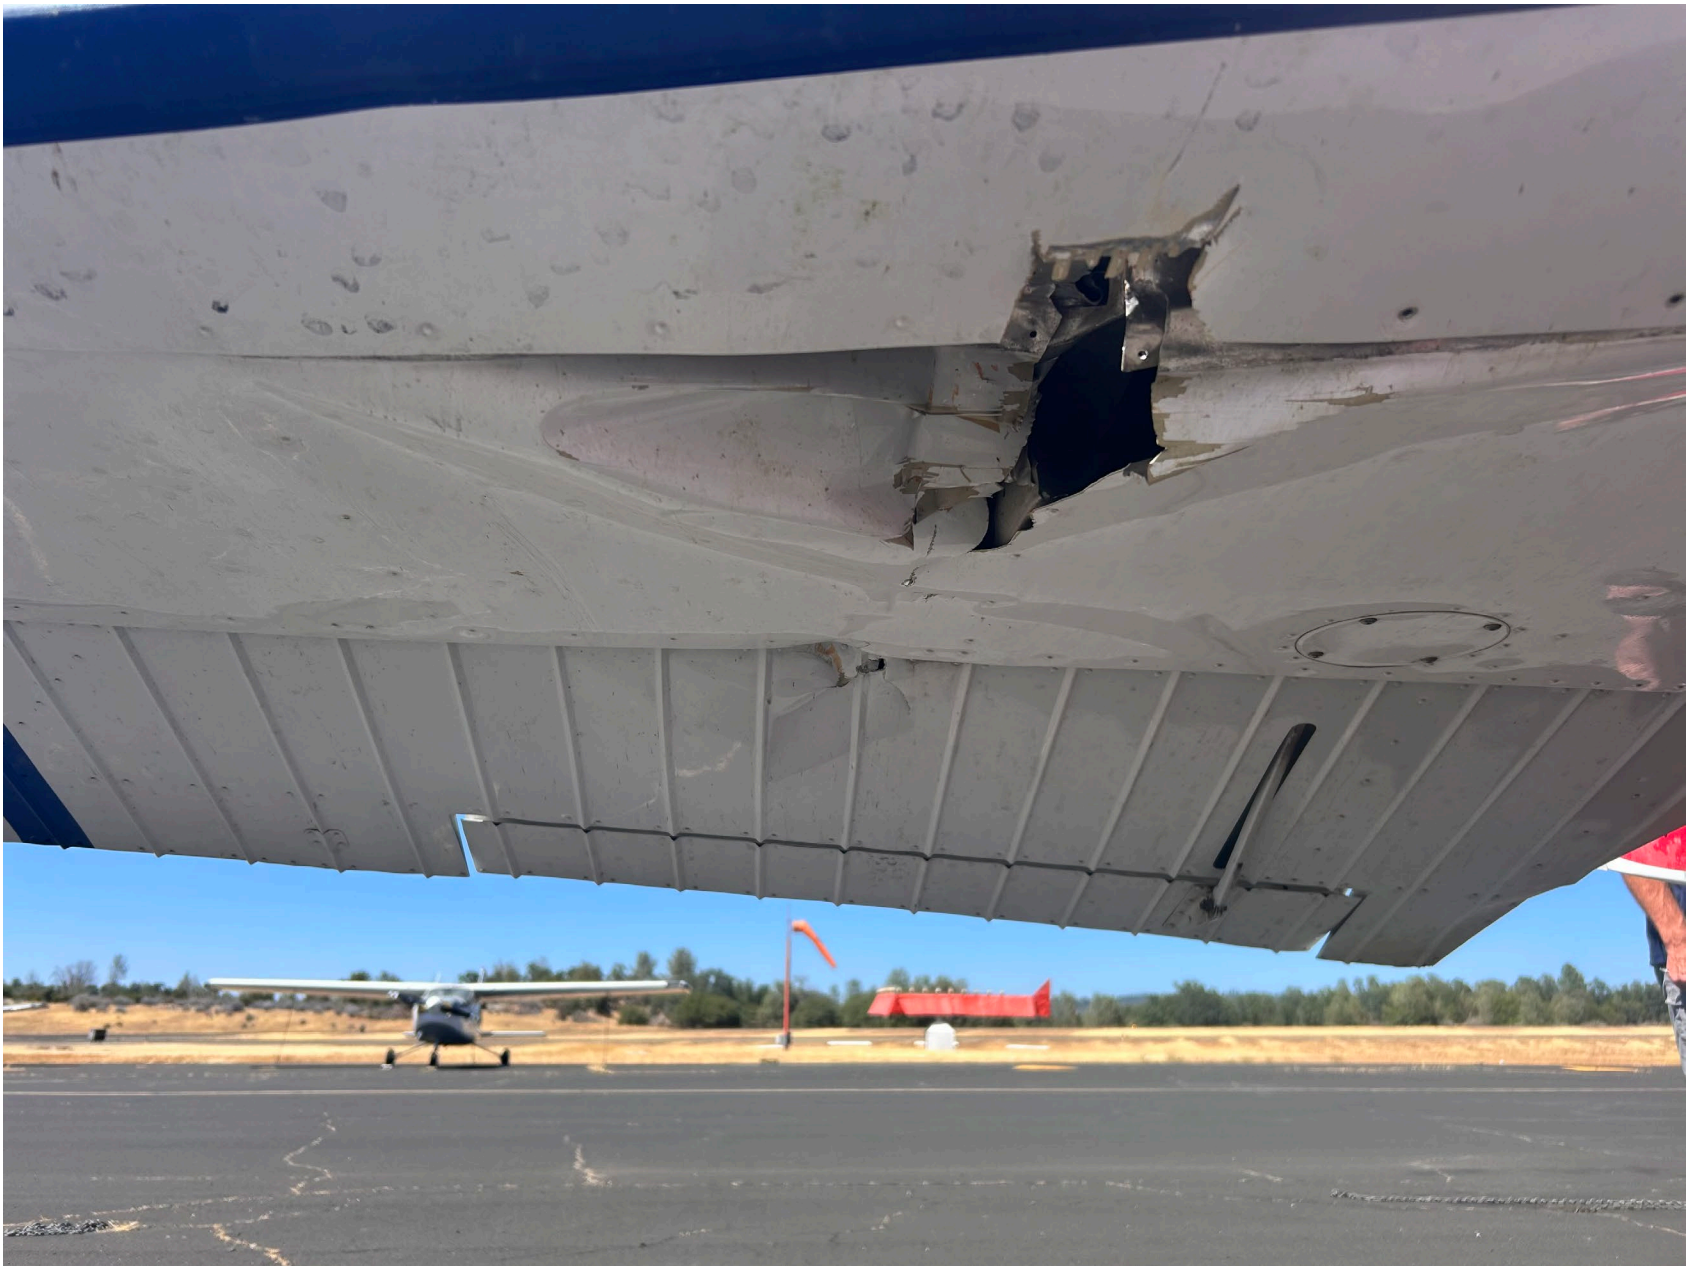
**Photo 1 – View of substantial damage to right horizontal stabilizer and elevator (owner)**
