**Incident Time: 2:05 PM, 8/10/2023**

**Aircraft: N20268 / Cessna 172M**

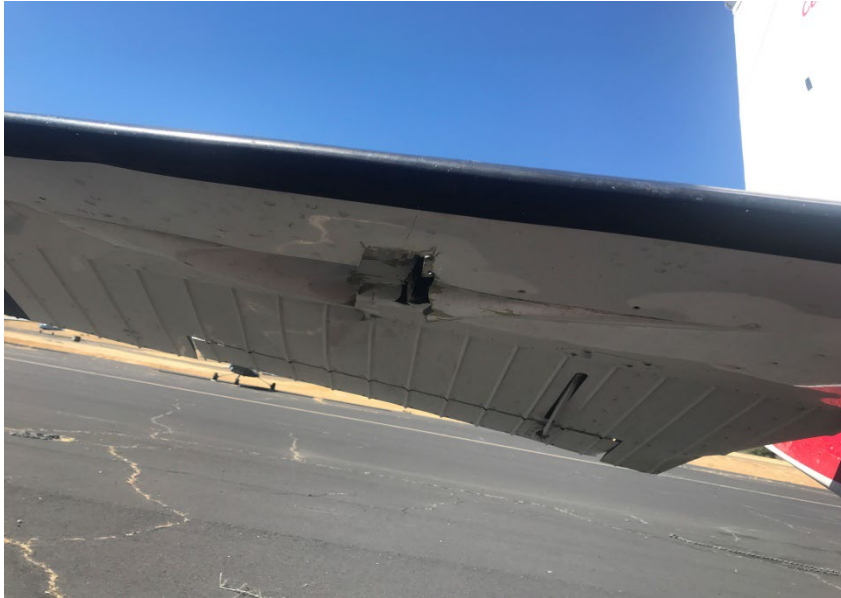
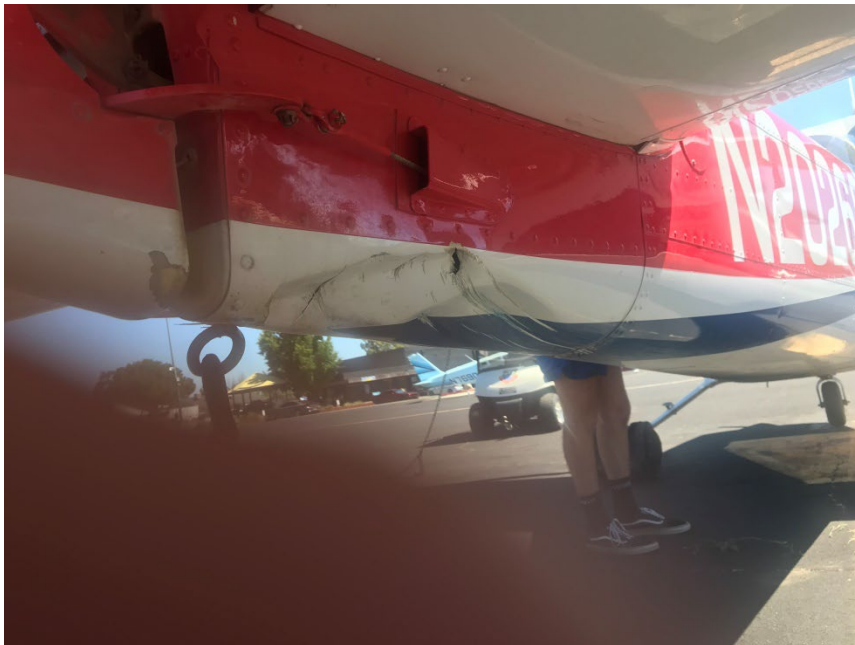
**Photos of Damage**

We ran off the runway and into the gravel, and I attempted to keep the nose up to get off the ground to both avoid nose damage and get the plane into the air.

Later, upon further inspection, we observed damage to the empennage and the right horizontal stabilizer of the aircraft.

1. I needed to more closely monitor my students ground speed and throttle settings during the high speed taxi.
  2. I should have also added extra 1000 feet to the allowable stopping distance for even more safety.
  3. I also now know that a Cessna 172M can easily be taxied at 85 MPH if the throttle is set to high.
- Looking outside is not sufficient to accurately determine ground speed.
