# National Transportation Safety Board

WPR23LA317

## EXAMINATION REPORT

Location: Fullerton, California  
Date: August 8, 2023  
Time: 1500 LCL  
Airplane: Piper PA-24-260, N503JA

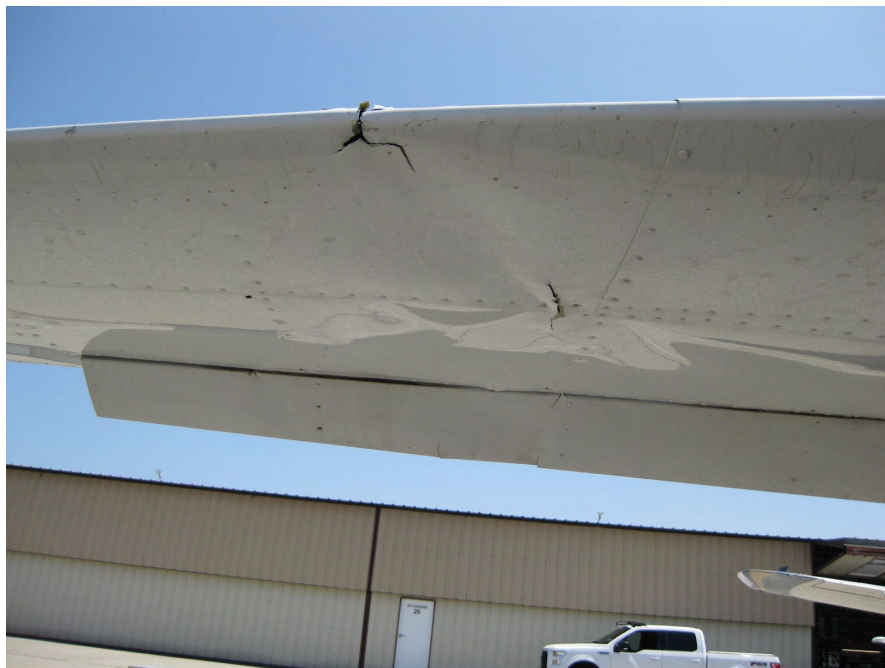
Examination of the airframe revealed a crack in the spar web and lower cap of the right stabilator, about midspan (figure 1). The stabilator had creased and preformatted at its leading edge in the midspan area. There was no evidence of corrosion or preexisting damage to any of the failed structure.

**Figure 1 - Damage to right stabilator**

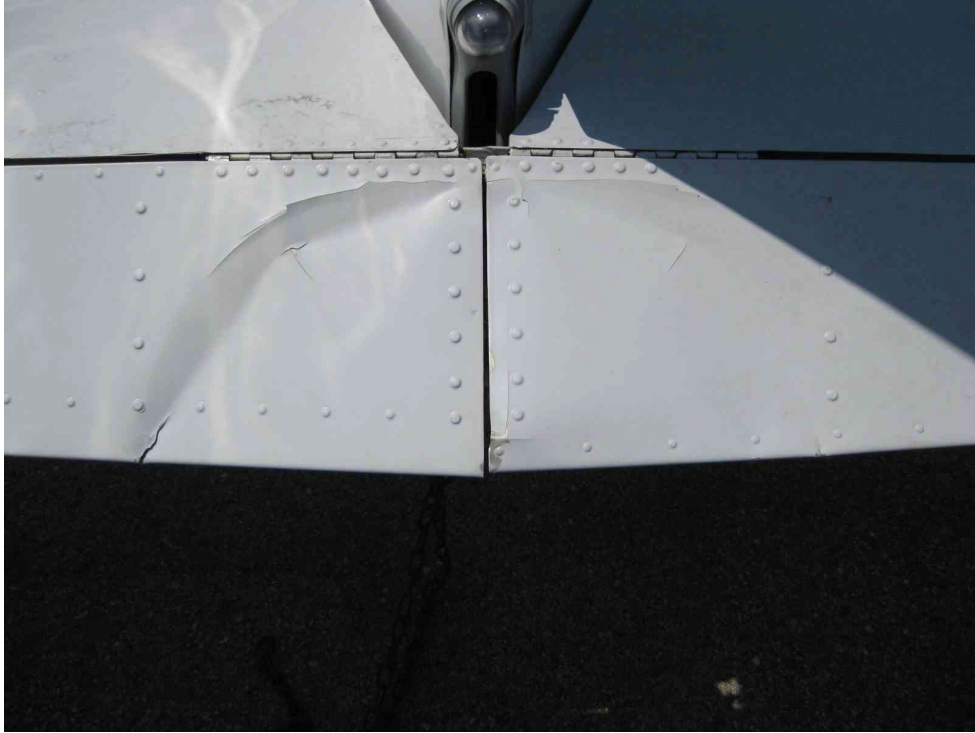
Examination of the stabilator tabs revealed that both were in place at their respective hinges, and both sustained perforations to their trailing edges and a diagonal crease on their inboard sides next to the control tabs (figure 2).

**Figure 2 - Stabilator control tab damage.**

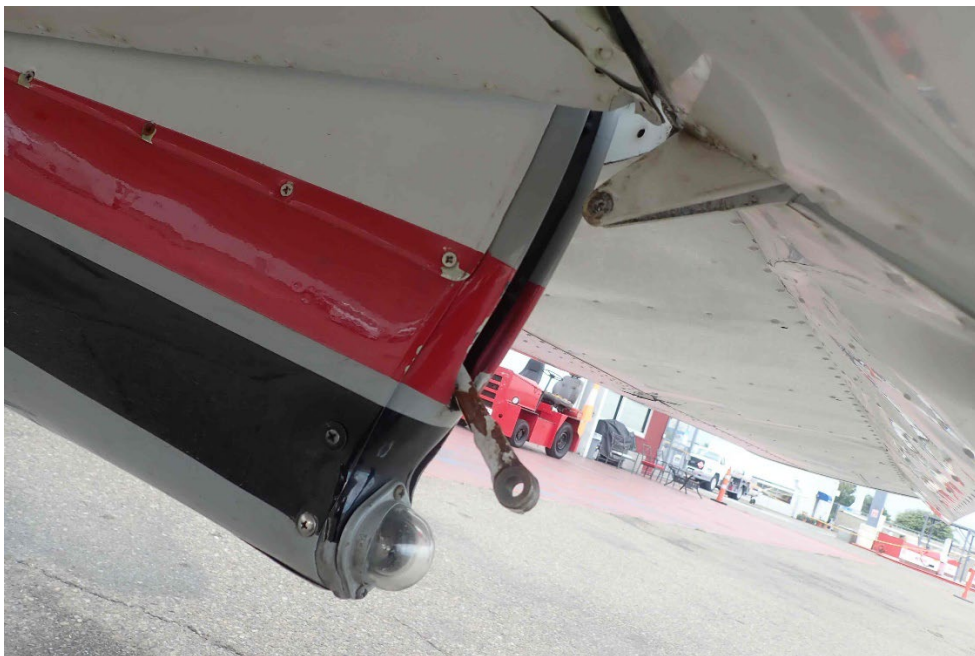
The bolt, nut and washer that connected the stabilator tab actuator to the control tab were missing. Circumferential scoring to the tab surface adjacent to the connecting bolt indicated that the bolt was loose for a period before it either failed or the nut came completely loose. No other flight control anomalies were noted, and the damage sustained to the stabilator was consistent with aerodynamic flutter.

However, the stabilator tab actuator was disconnected from the control tab, and the bolt, nut and washer that connected them were missing (figure 3).

According to the airplanes illustrated parts catalog, the actuator retaining nut was supposed to be a self-locking type, with no provisions for a cotter pin. According to the mechanic who had just serviced the airplane, he did not remove or replace either the bolt or the nut during the annual inspection and performed a functional check of the pitch trim system rather than a disassembly, with no anomalies noted. Examination of the maintenance logbooks did not reveal any evidence that the nut had ever been replaced.

**Figure 3 - Stabilator tab actuator disconnected.**

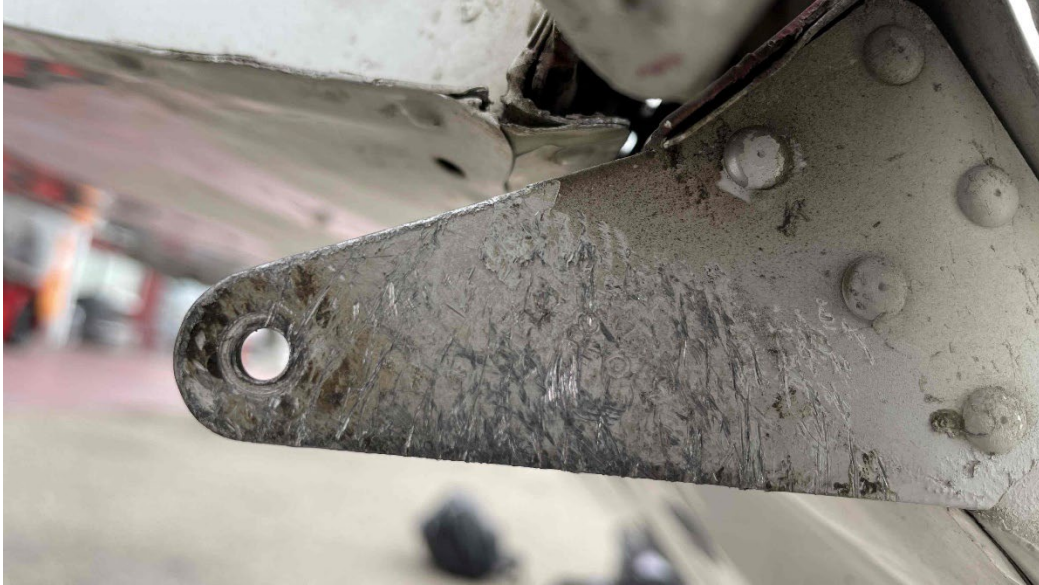
**Figure 4 - Right stabilator tab.**

The tabs sustained extensive scrape and peening damage to both their inner and forward surfaces consistent with high frequency oscillatory contact with the actuator arm fitting (figures 4, 5). The paint around the end of the tab actuator arm had chipped away revealing similar peening damage to its steel surface (figures 6).

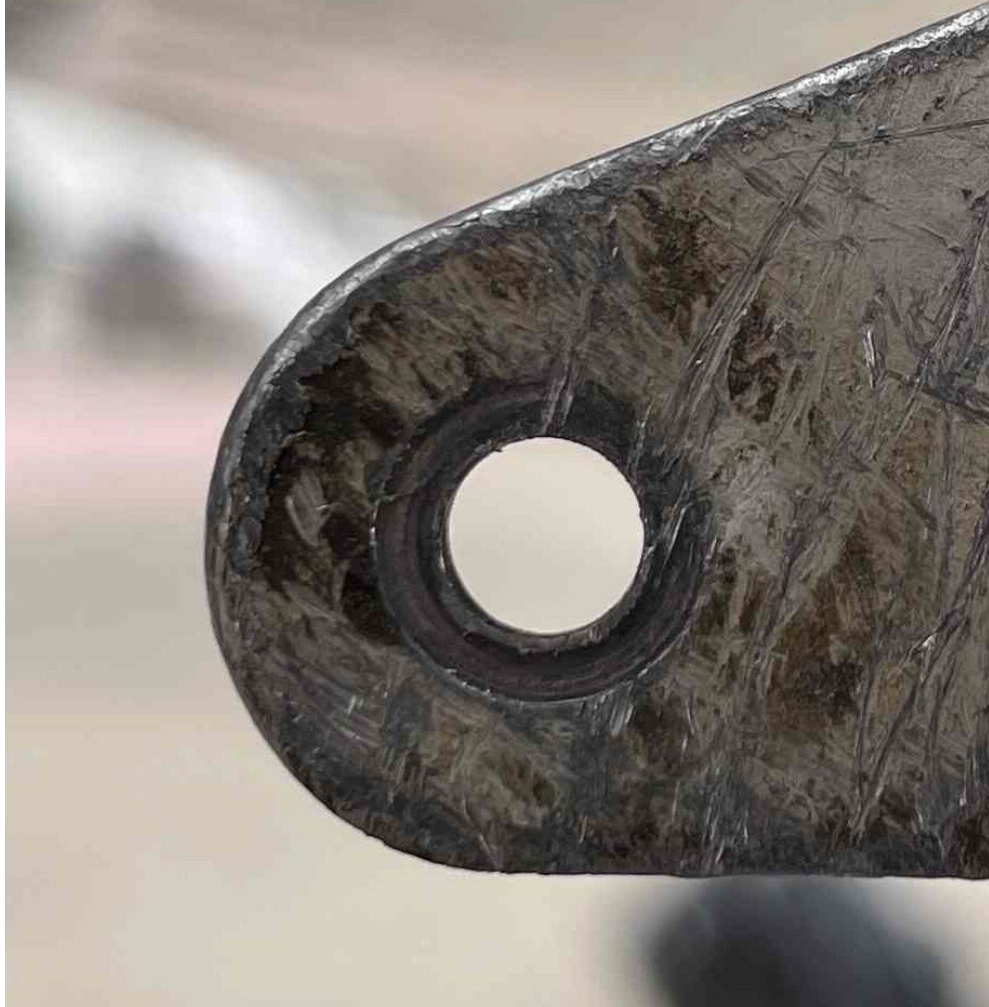
Neither the bolt nor the nut that connected the tabs to the actuator were located, and although there was circumferential scoring to the tabs in the vicinity of the bolt hole (figure 7), neither bolt hole appeared to be unduly elongated. Likewise, the bushing within the actuator did not appear to be out of round.

**Figure 7 - Circumferential scoring around tab bolt hole.**
