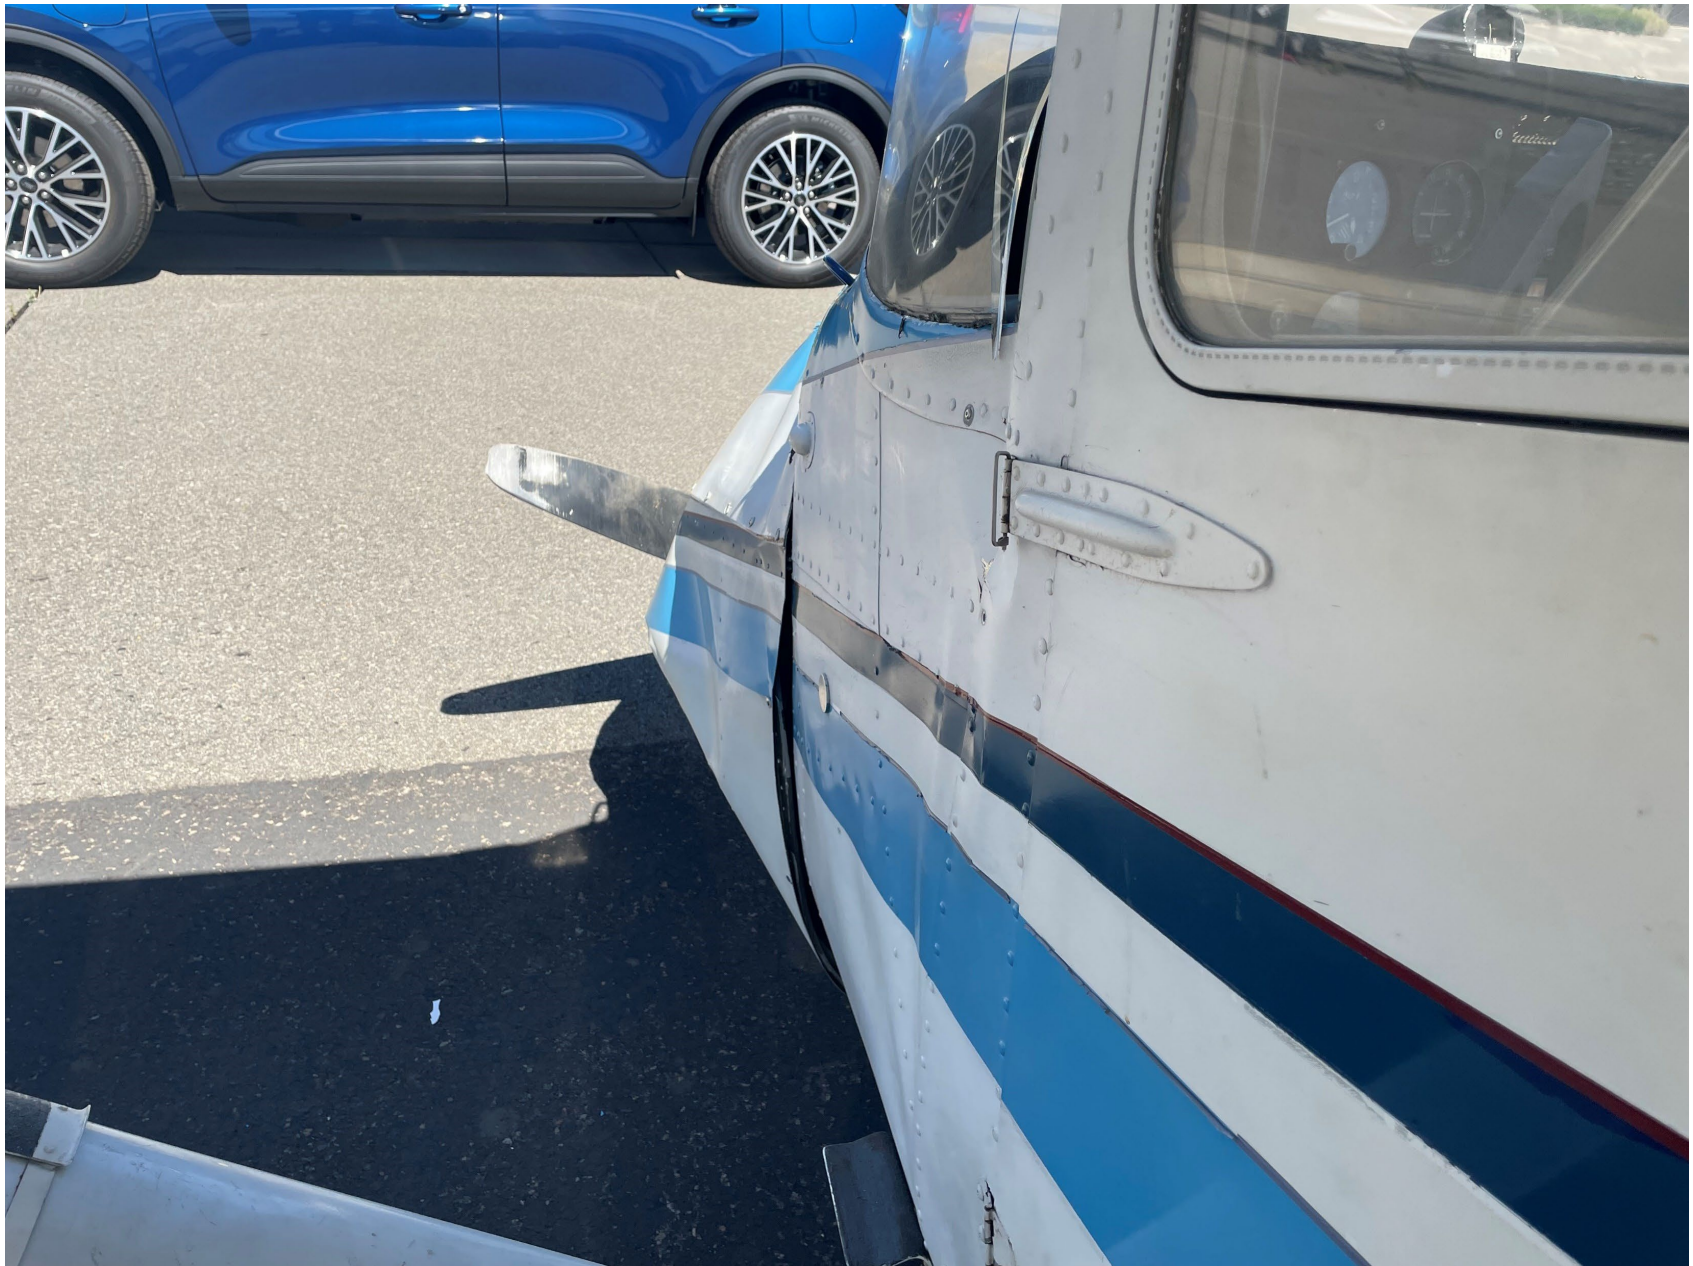
**Photo 1 – forward fuselage damage (courtesy of FAA)**

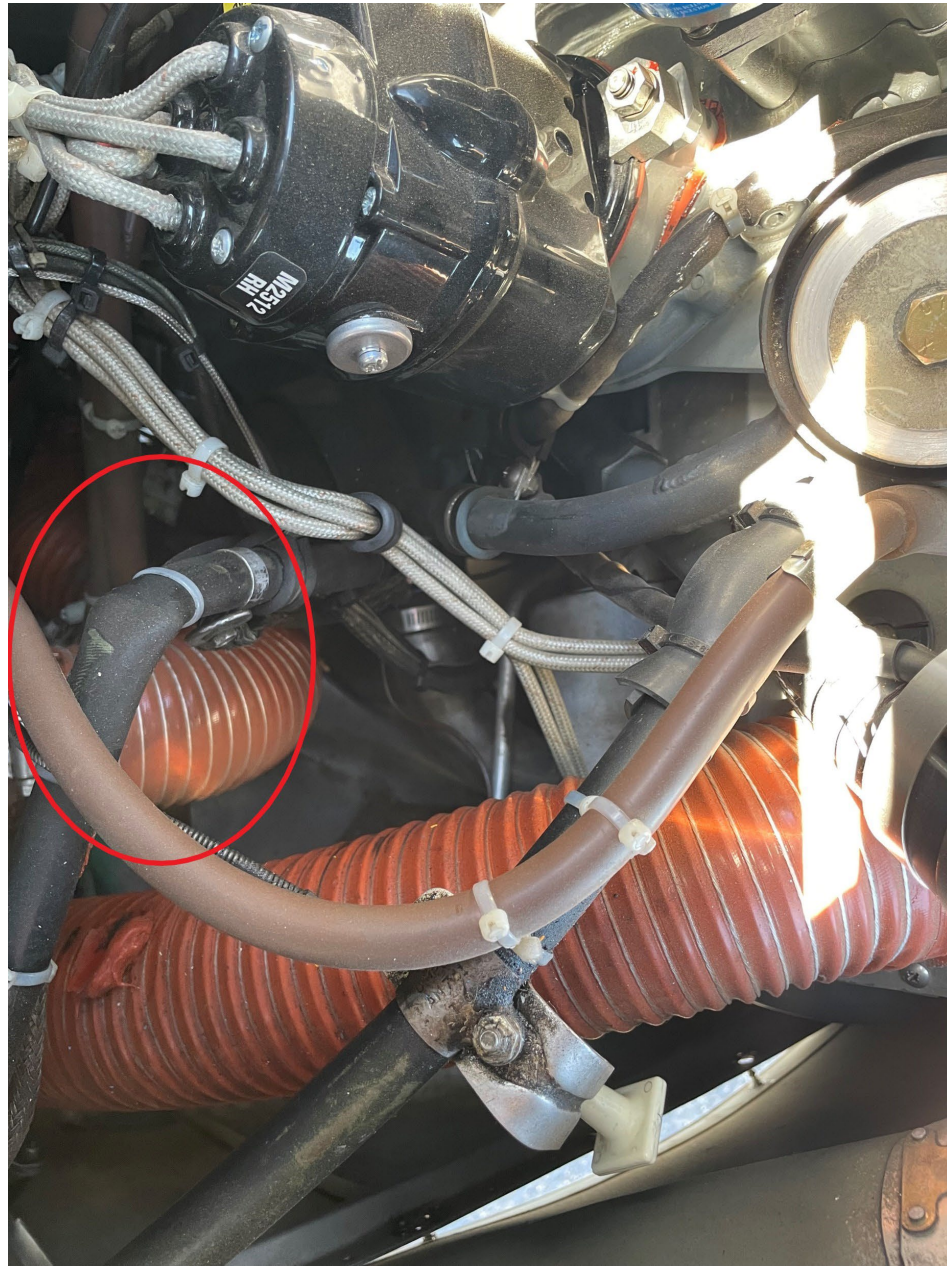
**Photo 2 – engine mount damage (courtesy of FAA)**
