# National Transportation Safety Board

WPR23LA329

## **ENGINE TEST RUN REPORT**

Location: Kanab, Utah  
Date: August 30, 2023  
Time: 0942 MDT  
Airplane: Piper PA-28-180

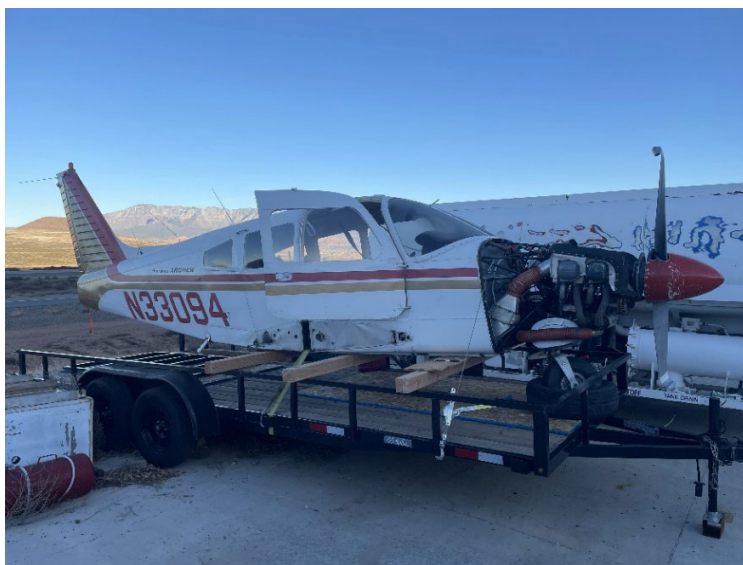
**Figure 1-Engine test run rig.**

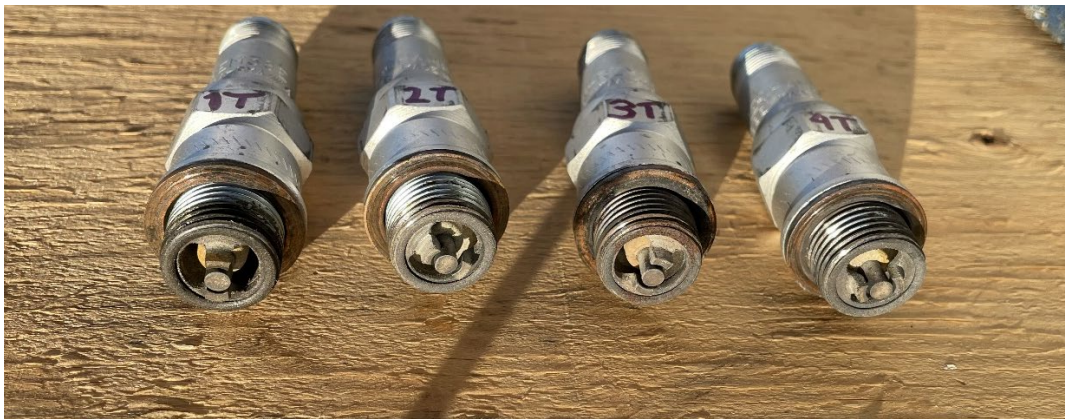
The wings and horizontal stabilizers were removed from the airplane during the recovery process. The engine remained attached to the fuselage and was secured to a trailer in preparation for a test run. The nose landing gear support structure and engine mount had impact damage. The upper and lower cowling were removed, and a header tank was attached to the fuel lines in the cabin area. The oil dip stick indicated about 6 quarts of dark oil. The upper spark plugs were removed, and the electrodes had normal wear conditions. The electrode areas had a light amount of combustion deposits.

**Figure 2-Upper sparkplugs.**

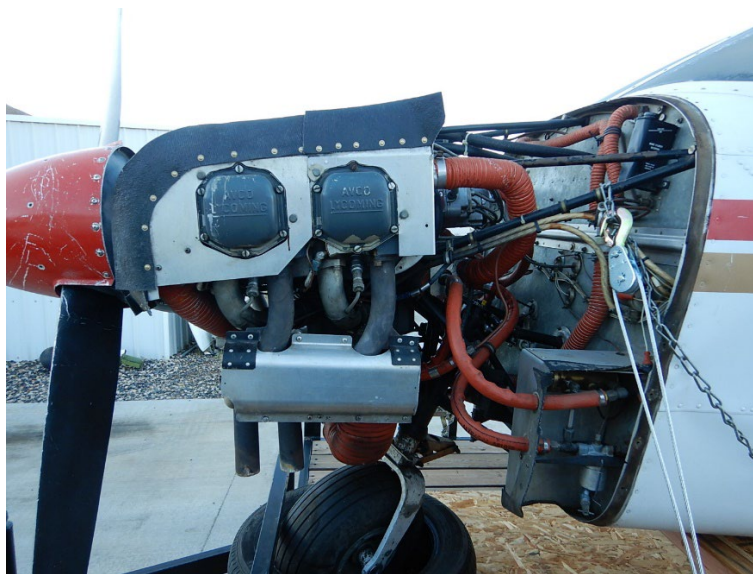
**Figure 3-Engine test run setup.**

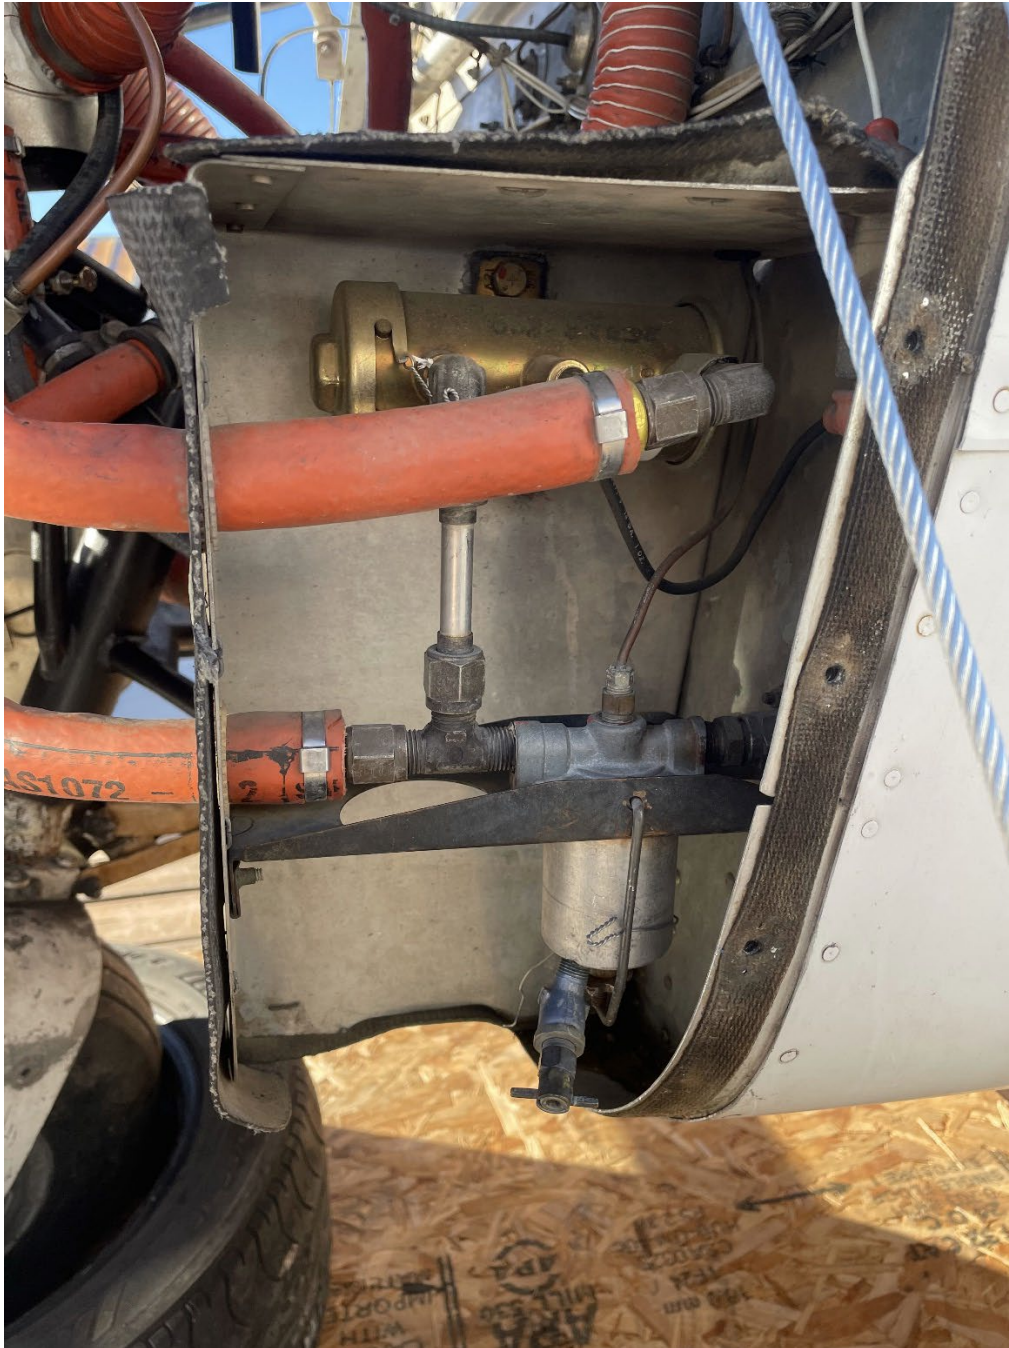
The fuel strainer was drained and had about 2 ounces of blue fuel. No contaminants were noted. The fuel strainer was disassembled, and the screen was undamaged and clear of debris. The carburetor inlet filter screen was removed and was clear of debris. Fuel was present in the fuel supply lines to the carburetor.

**Figure 4-Fuel strainer and fuel boost pump.**

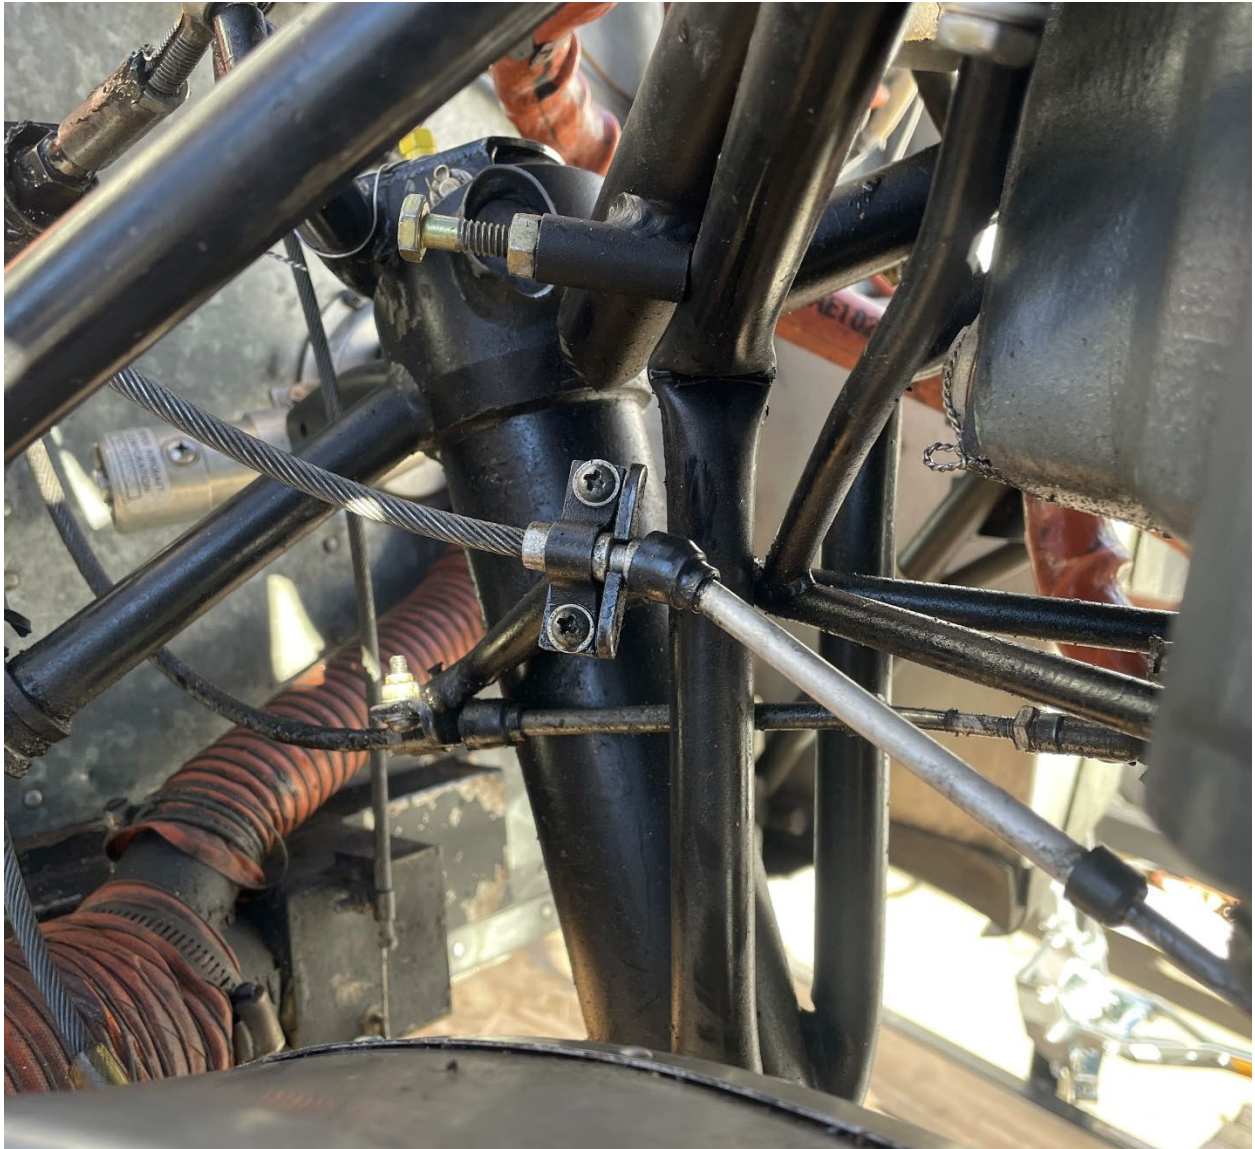
The throttle cable and mixture cable control continuity was established. The throttle cable had excessive resistance and full throttle position could not be established. The throttle cable attachment on the damaged engine support structure was not in its original position. The throttle cable near the attachment was bent consistent with impact damage. The full mixture position could not be established. The mixture cable was bent near the damaged engine support structure consistent with impact damage.

**Figure 5-Throttle and mixture cable attachments and damaged engine support structure.**

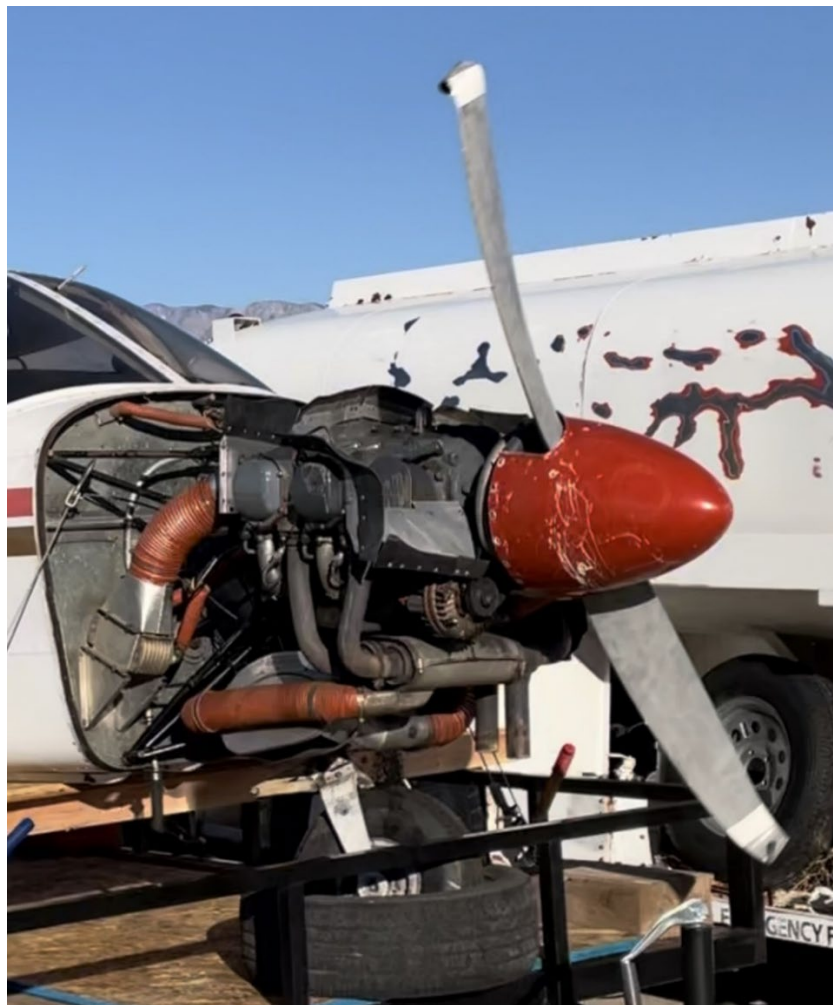
The engine started with little hesitation and the fuel boost pump was shut off after engine start. The engine continued to idle smoothly at about 1,000 RPM for about 5 minutes. During this time, oil temperature increased slightly, and oil pressure continued to rise to about 60 psi. The fuel selector valve was moved from the left position to the right position during the engine run and functioned normally. Engine RPM was then increased to about 1,500 and a magneto check was conducted. The magneto check revealed no more than a 25 RPM drop on each magneto. The mixture lever was brought to idle cutoff position and the engine shut down normally.

A full power engine run could not be accomplished due to throttle and mixture control damage consistent with the accident sequence.

**Figure 6-Engine operating during test run.**
