**Photo 1 – Aircraft logbook front cover**

Sierra Hotel Aero, Inc. 1690 Aeronca Ln, So St Paul, MN 55075 (651)306-1456  
N6834W Lycoming O-320-E2A S/N L-15193-27A TSMO 1164.79 TACH 3252.79 May 31, 2023

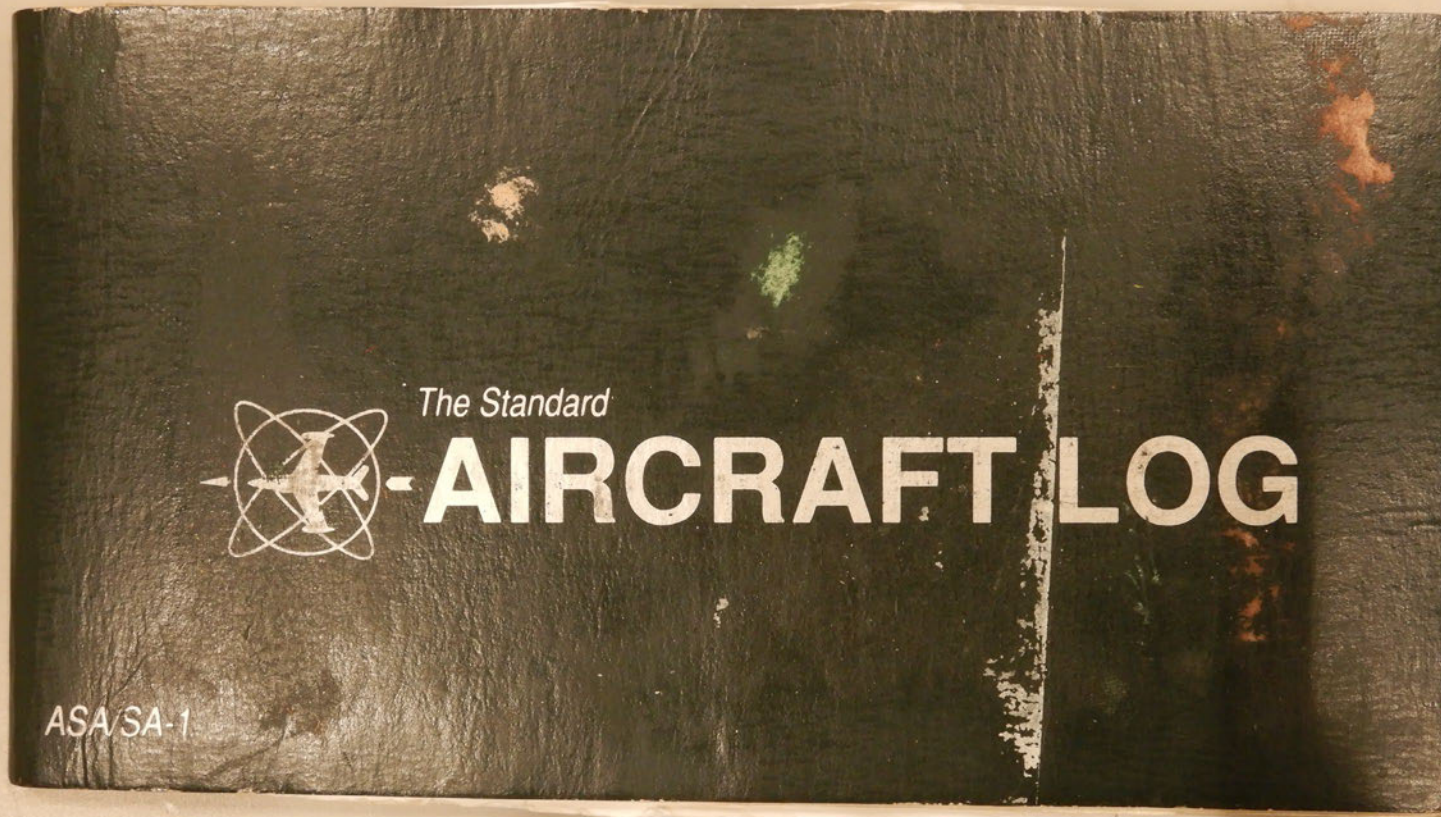
**Photo 2 – Aircraft log Page 1**

Performed compression checks result cylinder (1) 78, (2) 80, (3) 80, (4) 78. Cleaned, inspected and gapped spark plugs. Inspected oil cooler hoses this date, no defects noted, next inspection due in 100hr/TACH 3452.79 (AD 17-14-04). Next oil cooler hoses replacement due by 04/2025 or TACH 4190.81, whichever occurs first. Drained engine oil and replaced oil filter with P/N AA48110-2. Cut and inspected old oil filter element, found to be satisfactory. Serviced engine with 7 quarts Phillips 20w50 and pint Cam Guard. Checked Timing both magnetos. Performed engine run up checks, found to be satisfactory.

I certify this engine has been inspected in accordance with a 100hr inspection and was determined to be in an airworthy condition.  
Reference AD report this date

| Compression Test 1) | | 78/80 | 2) 77/80 | 3) 78/80 | 4) 75/80 (cold) |

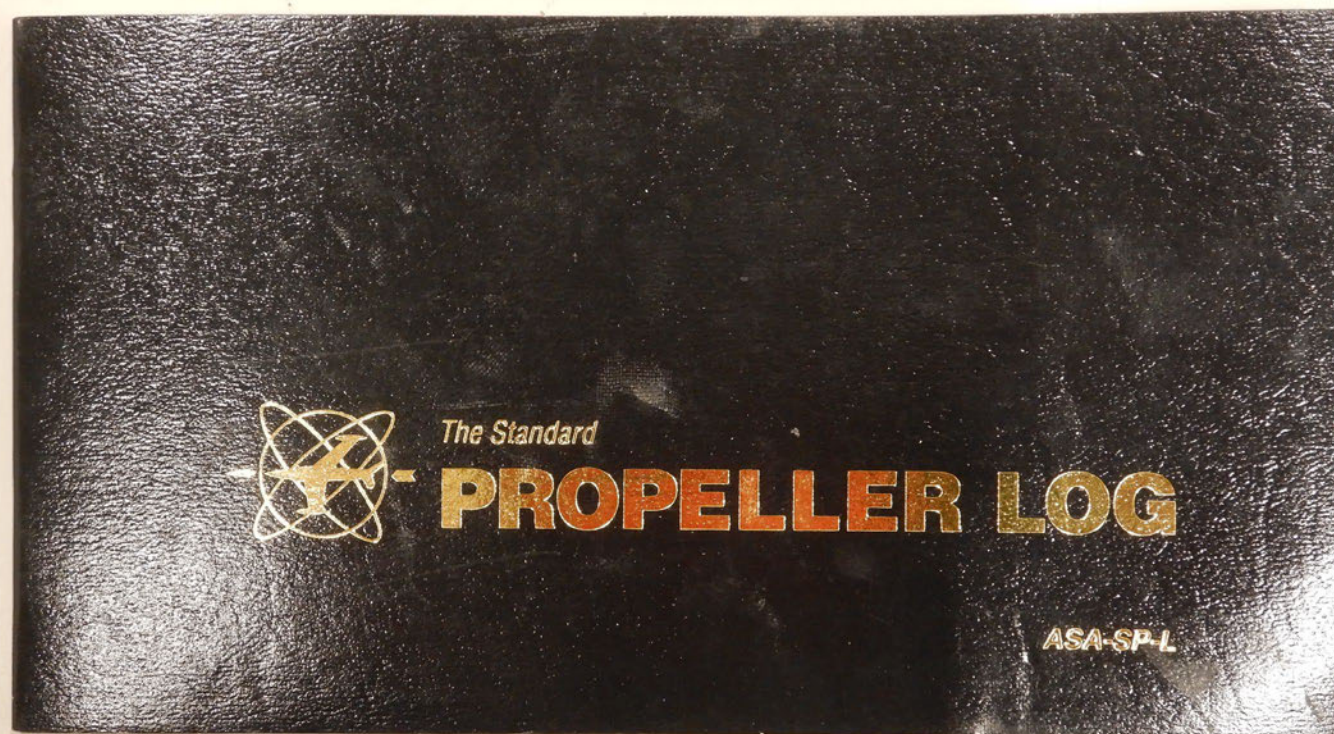
Photo 6 – Propeller page 1

Removed Propeller for access to change alternator. Installed propeller per Sensenich General Document 08/10/05

I certify this propeller has been inspected in accordance with a 100hr inspection and was determined to be in an airworthy condition.  
Reference AD report this date.
