# National Transportation Safety Board

WPR23LA334

## **AIRFRAME AND ENGINE EXAMINATION**

Location: Prescott, Arizona  
Date: September 02, 2023  
Time: 0802 Pacific standard time  
1502 UTC  
Airplane: Piper PA-28-140 Cherokee

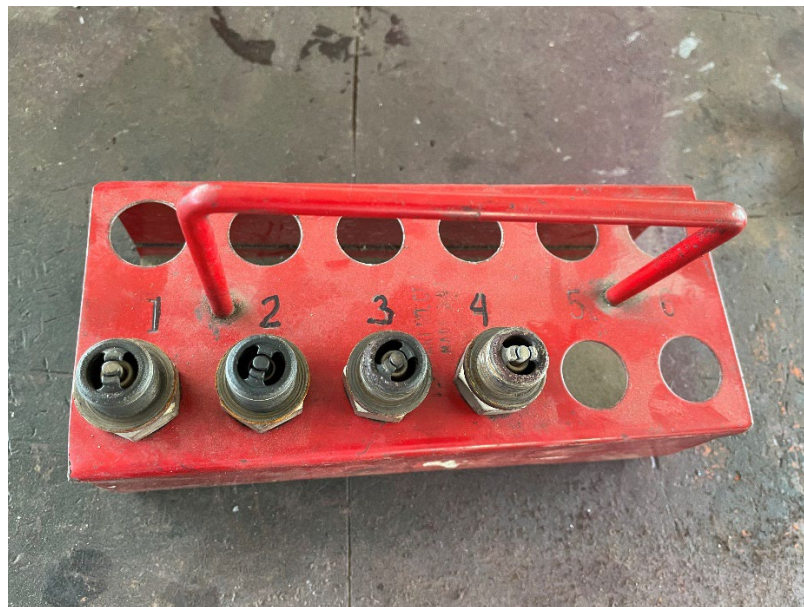
The top engine spark plugs were removed from the engine, and they were the massive electrode type. All the spark plugs exhibited black and gray deposits within the electrode area. The spark plugs exhibited signatures consistent with WORN NORMAL when compared to the Champion Check-A-Plug comparison chart.

**Figure 1- Removed engine top spark plugs**

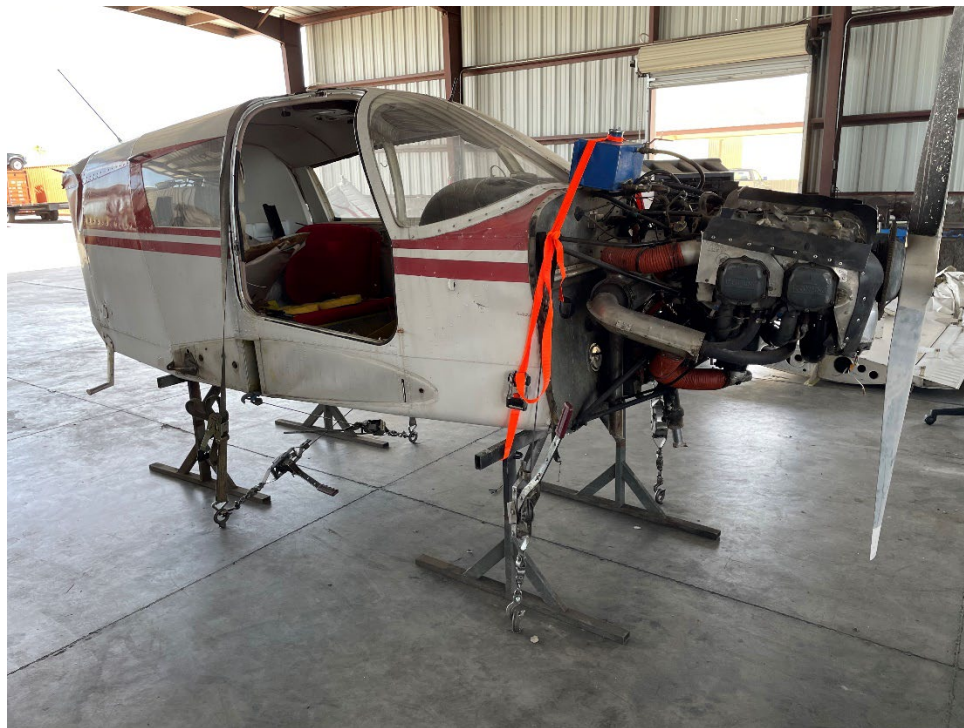
The airplane was strapped down to stationary I-bolts. The engine started during the first attempt to start. The engine throttle was advanced to about 1700 RPM. The engine ran throughout various power settings uneventfully for about 5 minutes. A functional check was conducted of the magnetos. A change of about 75 RPM was noted during the left and right magneto checks. The throttle was advanced to the full forward position and a static RPM of about 2700 RPM was observed. The engine ran smoothly during the operational check and exhibited no unusual indications.

**Figure 2- Floor mount for engine run**
