# National Transportation Safety Board

WPR23LA338

Group Chair's Factual Report

Location: Balch Camp, California  
Date: September 9, 2023  
Time: 1345 Pacific daylight time  
Helicopter: Bell 212, registration N873HL

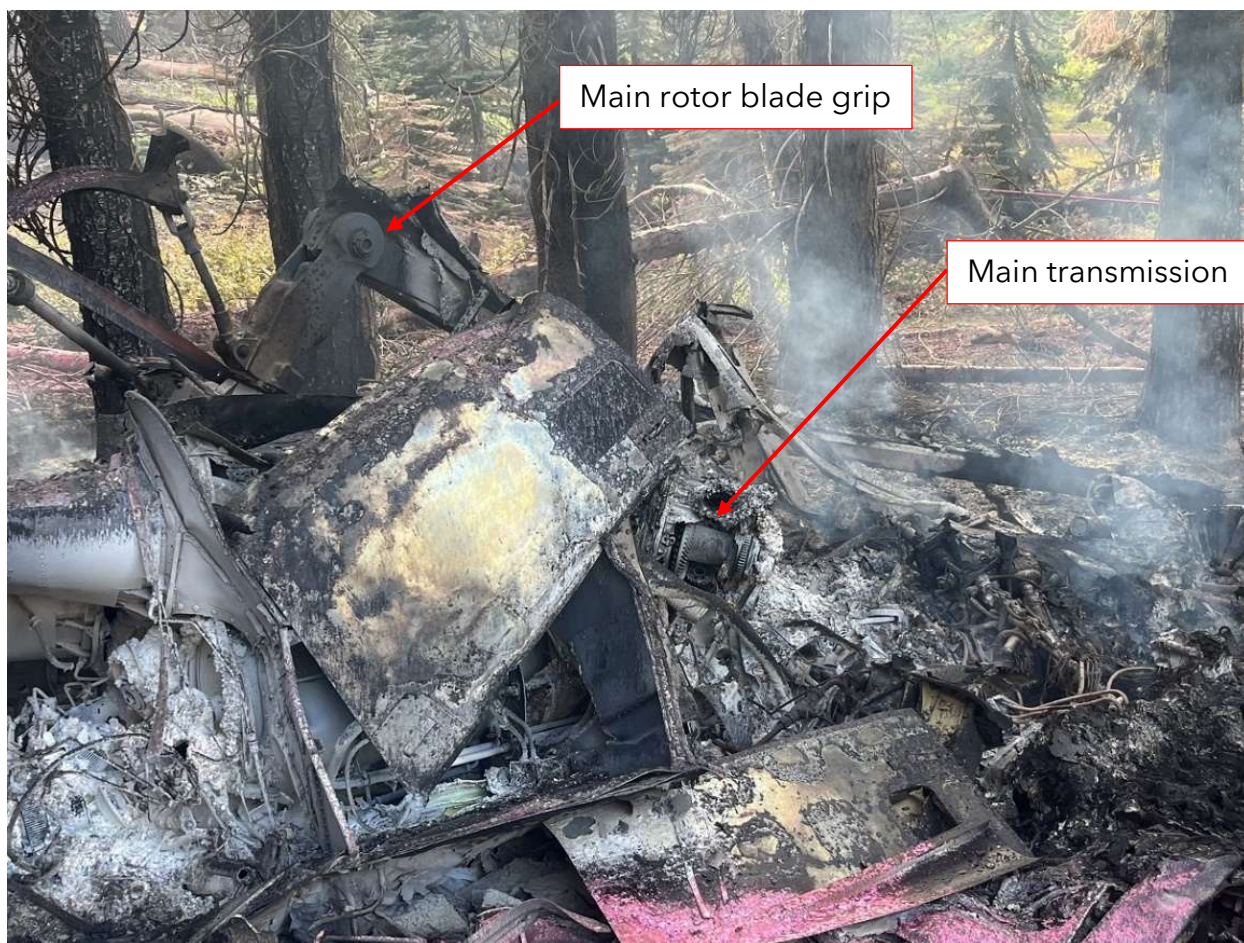
The NTSB did not travel to the accident site. Based on a ground witness video provided to the NTSB by the USFS, the accident helicopter did not experience an inflight breakup prior to contacting trees.<sup>3</sup> Photographs of the accident site provided by the USFS showed the helicopter experienced a postcrash fire that consumed large portions of the wreckage (**Figure 2**). Red-colored fire retardant was visible on portions of the wreckage, which was applied on the wreckage due to the postcrash fire. According to the USFS, the left (No. 1) engine twist grip was found out of its fly/governing position (**Figure 3**). The left engine twist grip was estimated to be about a 90° turn toward the throttle close position. The right (No. 2) engine twist grip was found at its fly/governing position. The wreckage was recovered and transported to Plain Parts facilities in Pleasant Grove, CA.

**Figure 2.** The wreckage after the postcrash fire. (Image courtesy of the USFS)

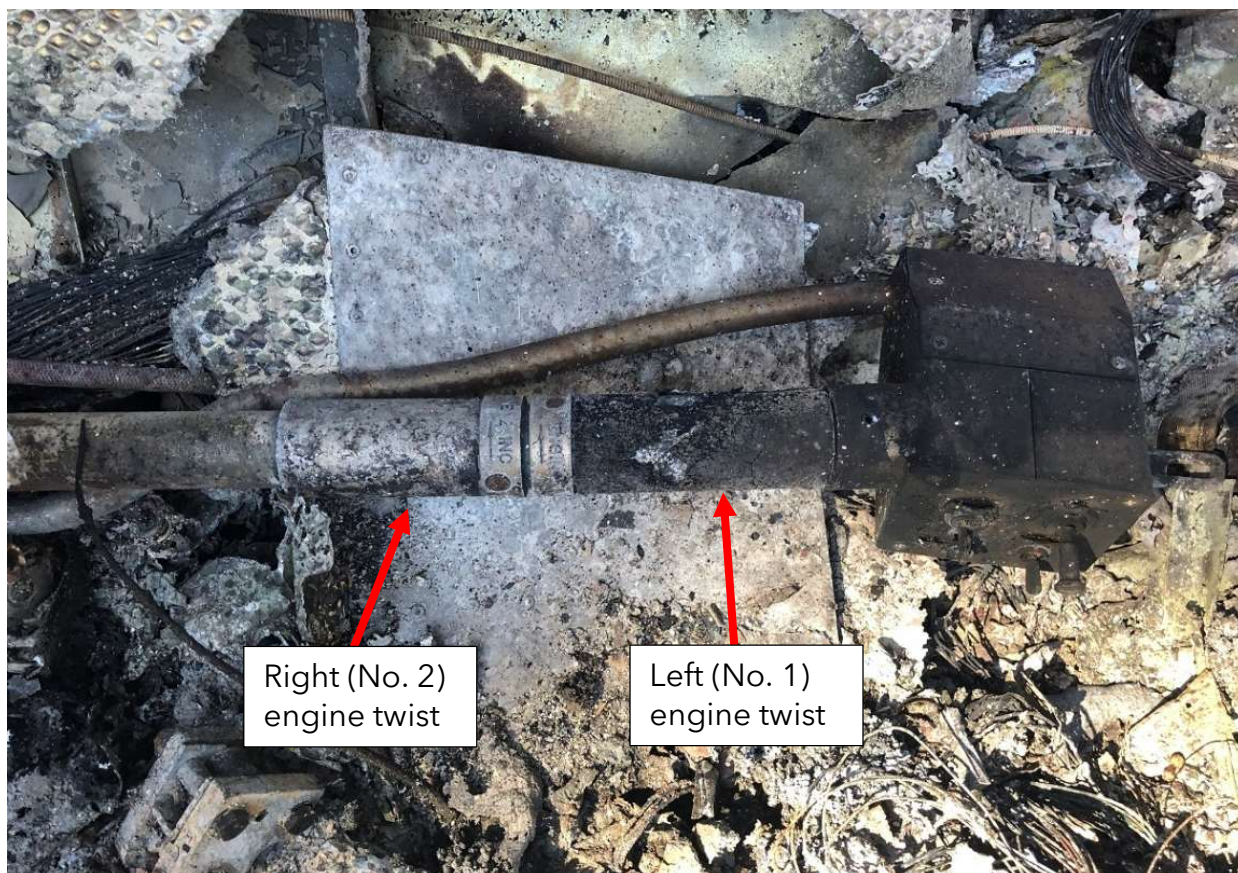
**Figure 3.** The collective-mounted twist grips. (Image courtesy of the USFS)

The left-seat collective control was found separated from the wreckage and was thermally damaged. The twist grips for the left and right engines remained installed on the collective control and could be manipulated by hand.

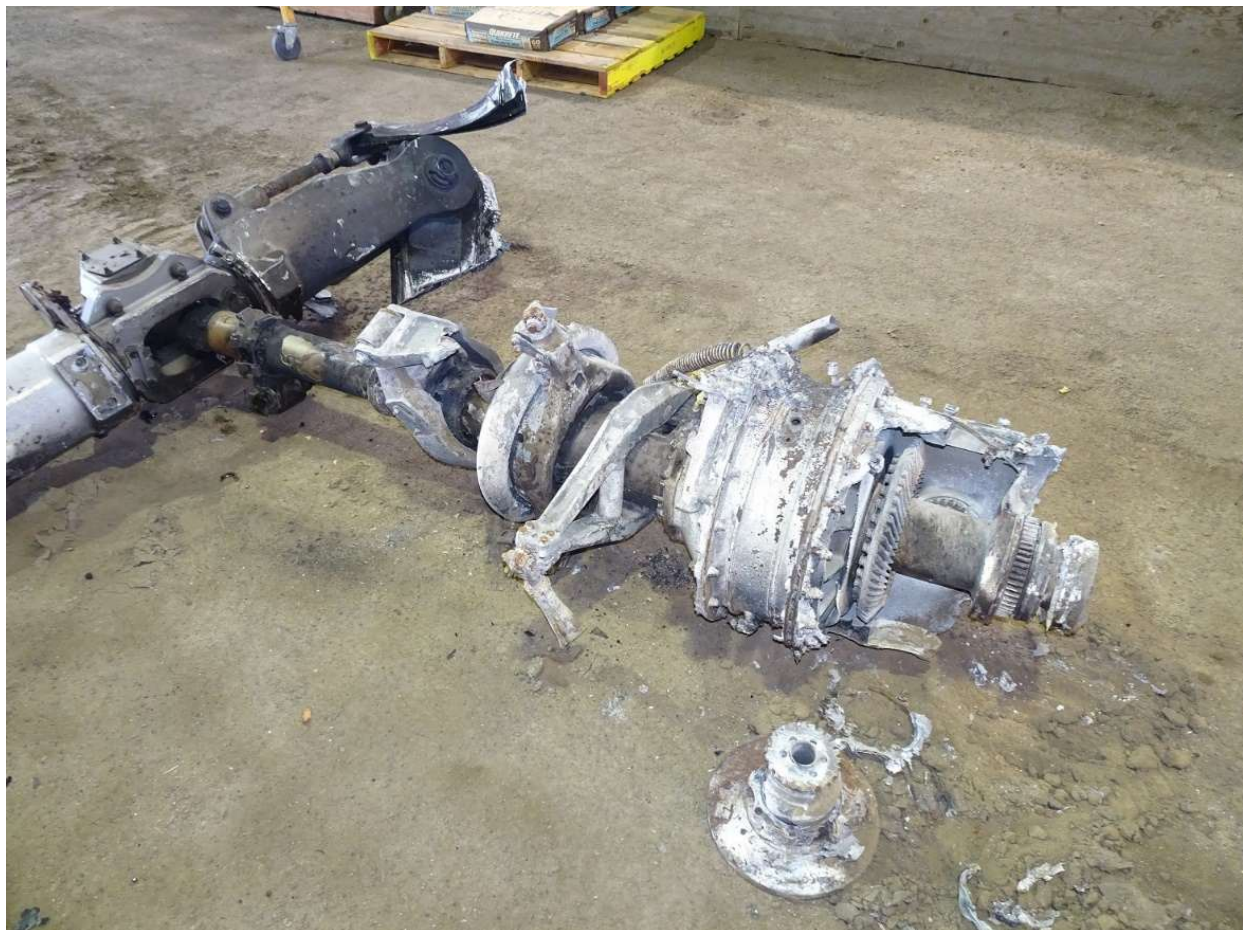
The main transmission was separated from the airframe and was partially consumed by the postcrash fire (**Figure 4**). The main [input] drive shaft to the input quill (between the combining gearbox and the main transmission) was found in the recovered wreckage. The input drive shaft spline teeth, on both ends, did not exhibit missing teeth or anomalous and excessive wear. Circumferential scoring was observed through the input drive shaft tube adjacent to both splined ends. The tail takeoff pinion gear was found separated in the recovered wreckage; it was thermally damaged. The lower portion of the main transmission, containing the oil sump and pumps, had fractured and separated. The swashplate and collective lever assemblies remained attached to the main rotor mast and exhibited impact and thermal damage. The main rotor hub remained attached to the main rotor mast. The stabilizer bar was recovered as a single assembly but had fractured and separated from the main rotor head.

**Figure 4.** The main transmission was partially consumed by the postcrash fire. The swashplate assembly also exhibited thermal damage.

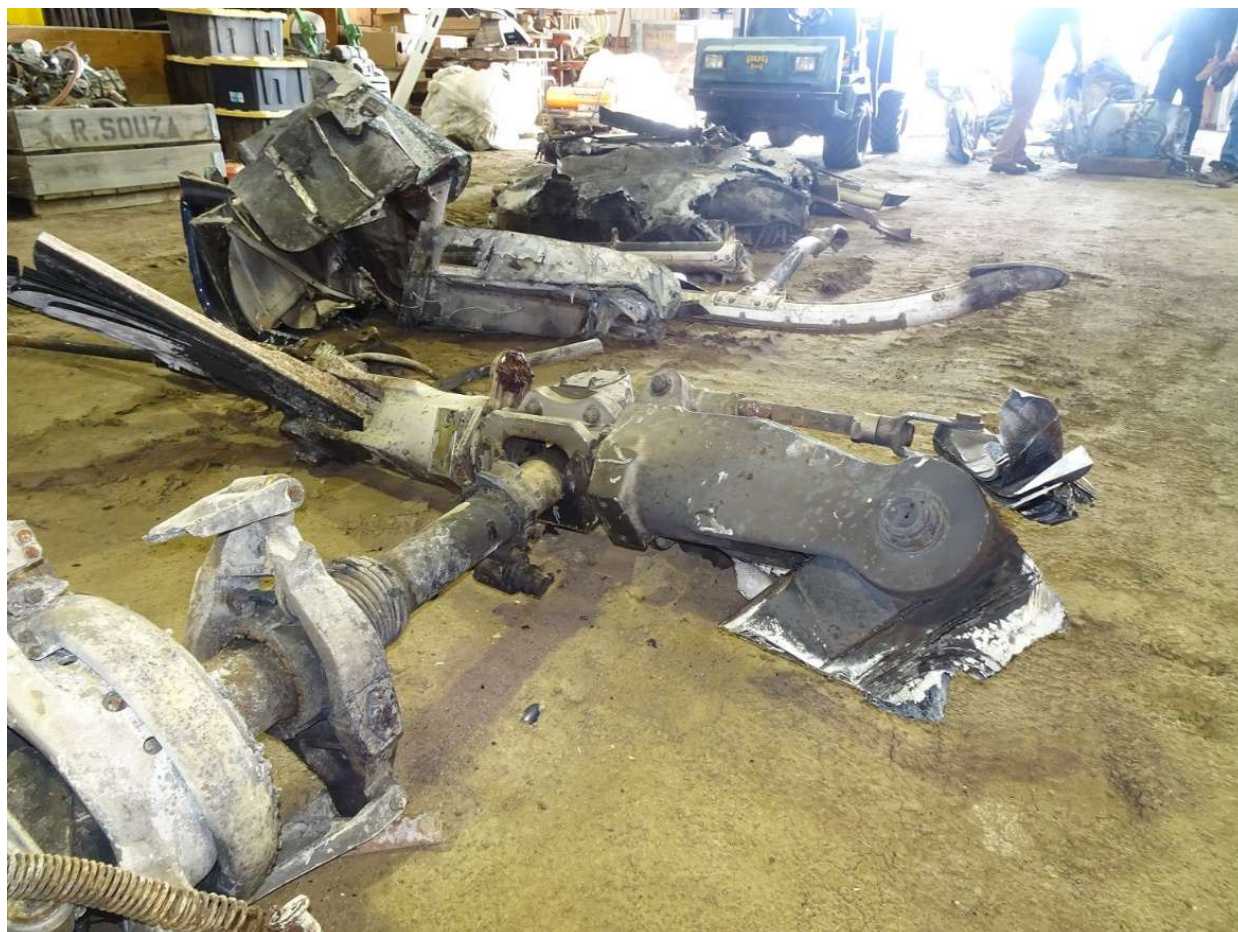
The main rotor blades had been cut into multiple sections for the purpose of recovery. Portions of the main rotor blades remained attached to the hub at their inboard ends (**Figure 5**). Both main rotor blades exhibited impact damage, but did not exhibit evidence of preimpact failure. The pitch horns of both main rotor blades had separated from their respective blades, but portions of the pitch change links remained attached to the horns.

**Figure 5.** The inboard ends of the main rotor blades, the main rotor hub, and main rotor mast remained as an assembly.

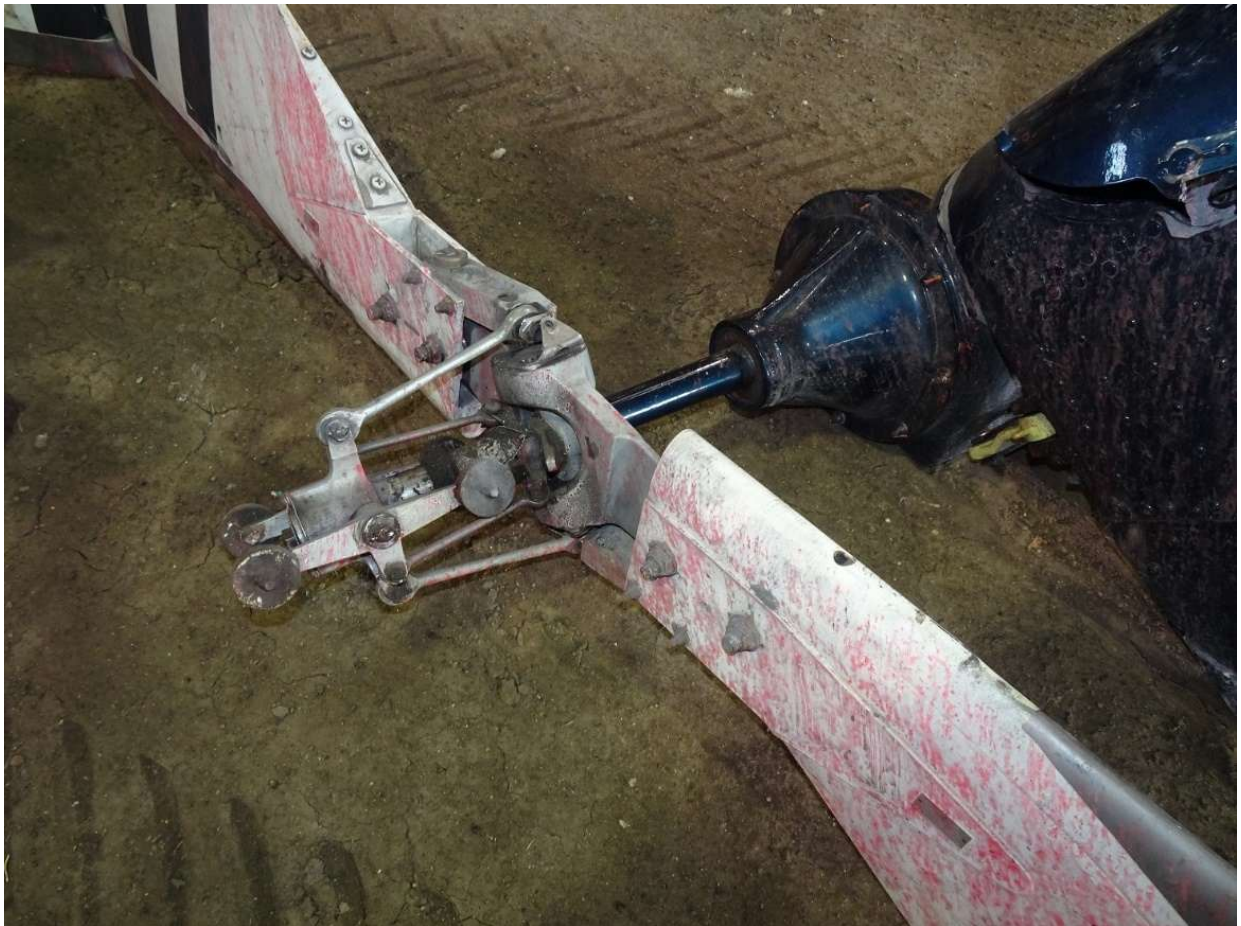
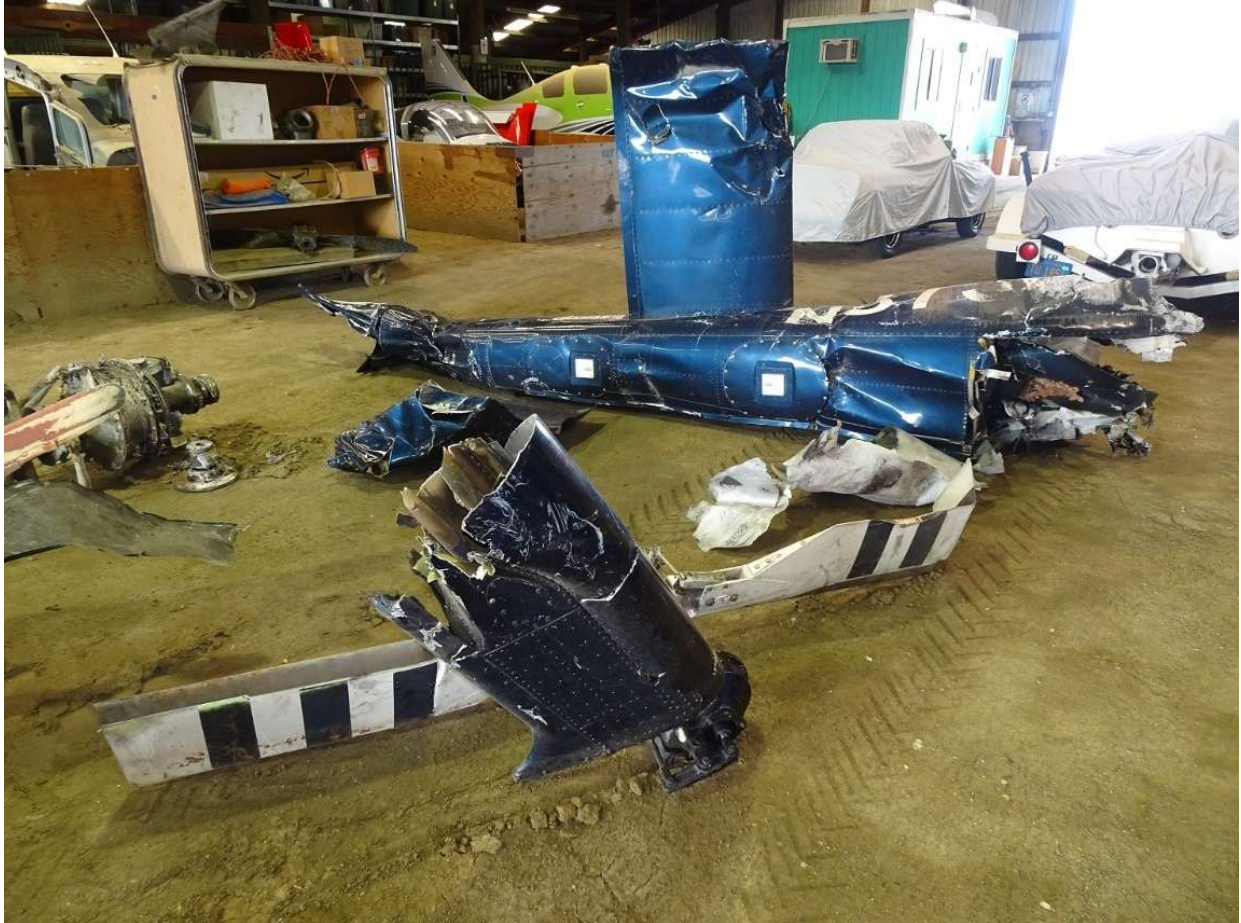
The two tail rotor blades remained installed on the tail rotor hub and did not exhibit fragmentation (**Figures 6 and 7**). One of the tail rotor blades was bent chordwise about 1/4-span inboard of its tip end. The second tail rotor blade did not exhibit significant deformation. The tail rotor pitch links remained installed and intact. Both blades exhibited continuity of control through the gearbox-mounted tail rotor actuator to the tail rotor blades.

**Figure 6.** The inboard ends of the two tail rotor blades, the tail rotor head, and the tail rotor gearbox. The red-colored material on the surfaces of the tail rotor is fire retardant that was applied on the wreckage after the accident occurred.

**Figure 7.** A view of the separated tail boom, with the right horizontal stabilizer attached, and the separated upper portion of the vertical fin with the tail rotor blade spans visible behind it.

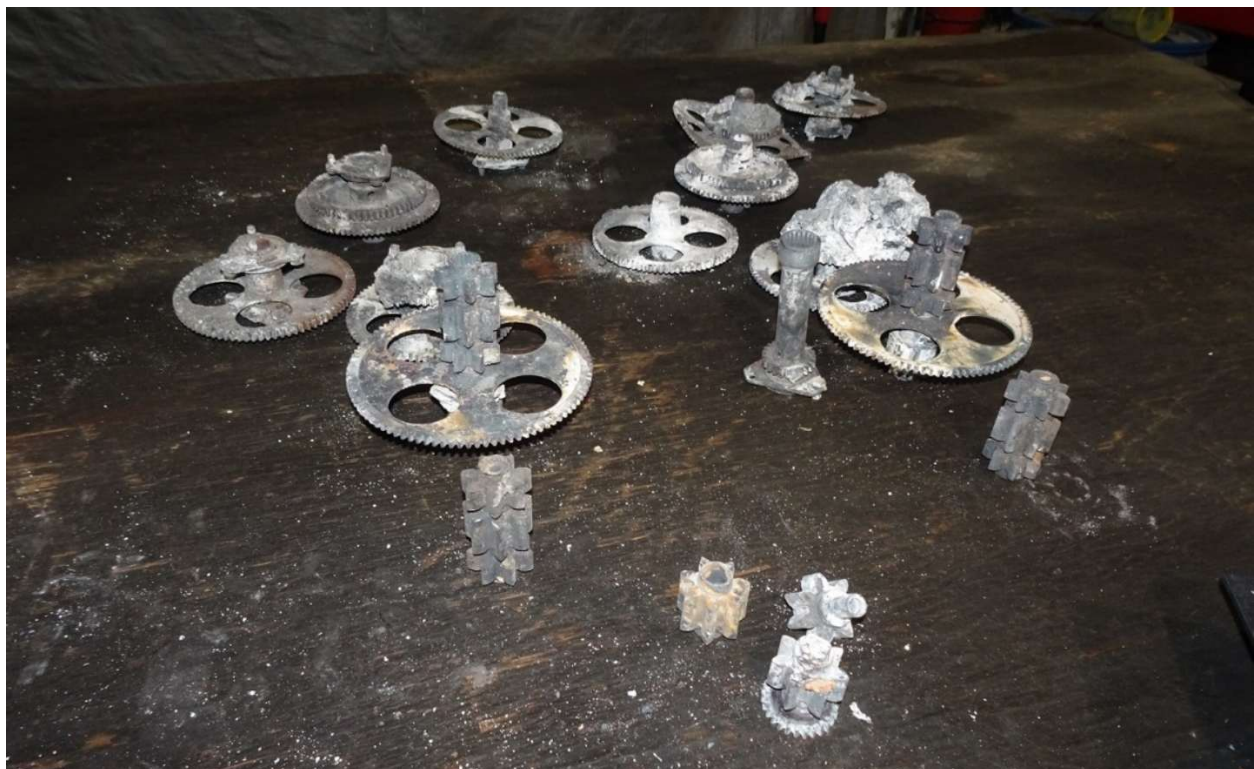
The accessory gearbox housings for the Nos. 1 and 2 engines were consumed by the postcrash fire. Thermally damaged parts of the engine accessories gearbox, such as the starter/generator, oil pump gears, fuel pump drive gear, and a fuel control unit governor flyweight, were found in the recovered wreckage (**Figure 8**). One partially consumed fuel control was recovered in the wreckage. Most of the gearsets of the accessory gearboxes were found in the recovered wreckage. One fuel pump, a fuel control unit gear, and one coupling shaft were not found in the recovered wreckage. None of the recovered accessory gearsets exhibited missing gear teeth or excessive and anomalous wear.

**Figure 8.** Separated gears found in the recovered wreckage. (The fuel control unit governor flyweight is not shown in this image.)

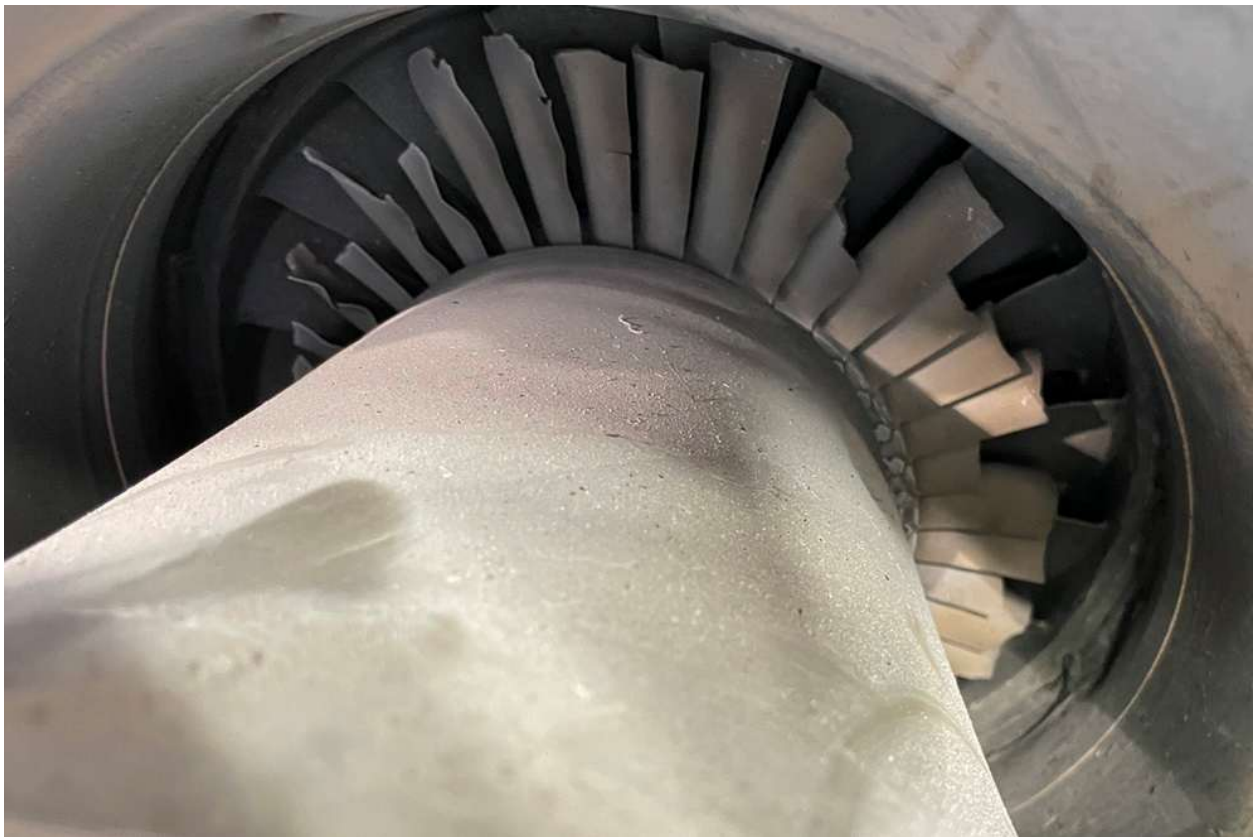
The first stage compressor blades were all present and did not exhibit impact deformation or missing material from their leading edges. The stators behind the first stage compressor remained intact with all stators [of that stage] present. The tail pipe was removed and the power turbine was visible through the exhaust. All power turbine blades were damaged and missing airfoil material at varying lengths (**Figure 9**). The trailing edges of most of the blades exhibited a wavy deformation. The power turbine shroud was rubbed through portions of the shroud around the shroud inner circumference. The combustor injectors remained installed on the combustor case and the fuel lines between the injectors were present.

**Figure 9.** Damage observed on the No. 1 engine power turbine blades viewed through the exhaust.

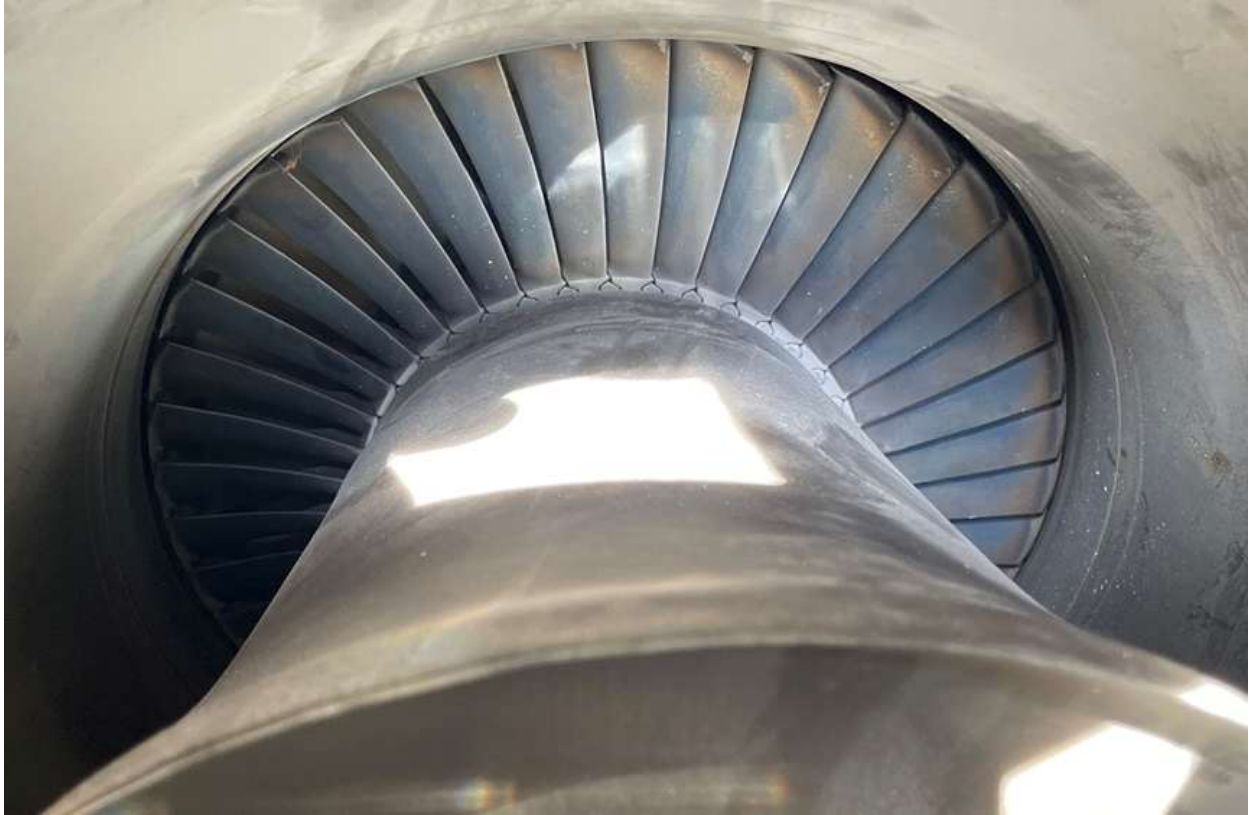
The first stage compressor blades were all present and did not exhibit impact deformation or missing material on their leading edges. The stators behind the first stage compressor remained intact and all stators were present. The exhaust ejector was removed and the power turbine was visible. All blades from the power turbine were present and were mostly intact with the exception of the tip ends of about 1/3 of the blades in an arc, which exhibited tip rub damage consistent with the tips contacting the turbine shroud (**Figure 10**). Rotational scoring was also visible on the turbine shroud. The power turbine coupling (output) shaft was present. Manual rotation of the coupling shaft resulted in movement of the power turbine, but manual movement was extremely difficult. When the coupling shaft was moved axially, the power turbine exhibited significant axial movement as well. The combustor injectors remained installed on the combustor case, but several portions of the fuel lines between the injectors were thermally damaged and consumed by the postcrash fire.

**Figure 10.** The No. 2 engine power turbine blades viewed through the exhaust.
