# National Transportation Safety Board

WPR23LA338

## **POWERPLANTS**

Group Chair's Factual Report

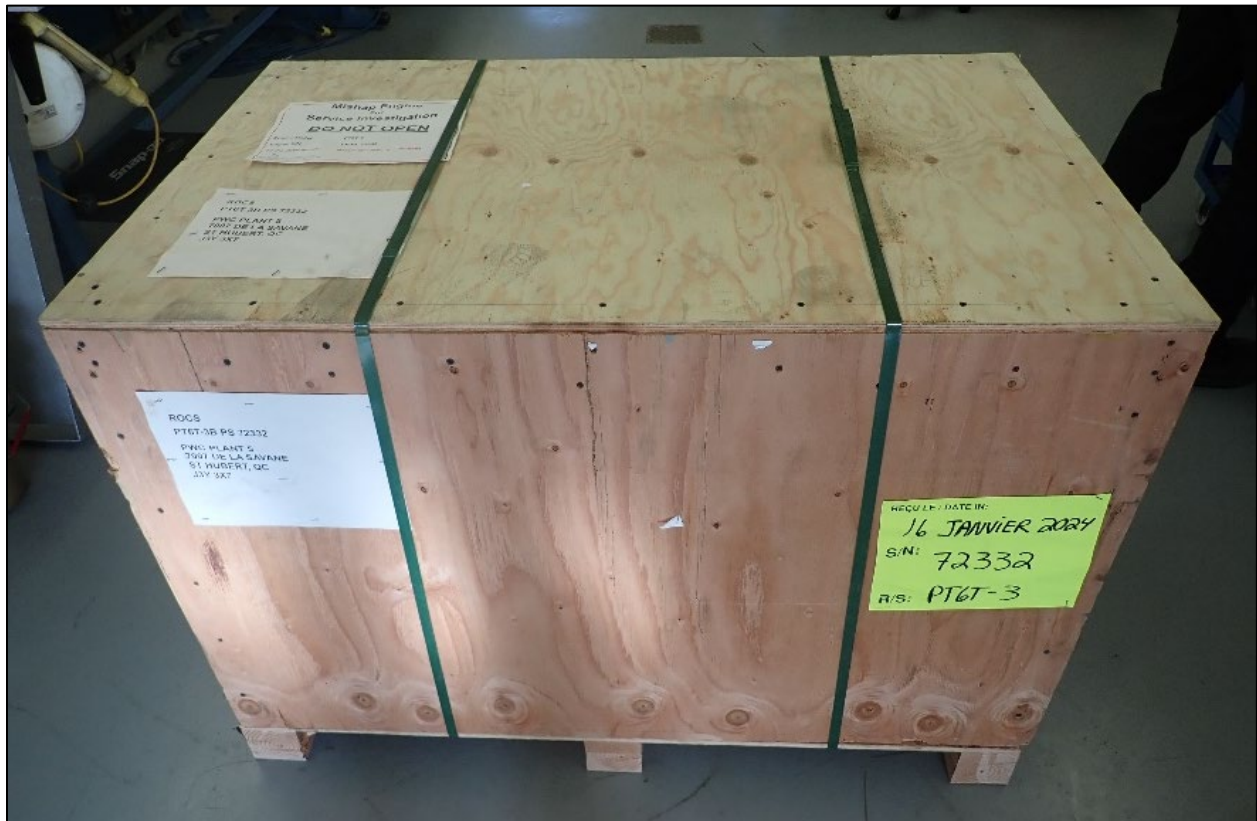
The left engine was secure in a wooden box (Figure 2). According to the engine data plate, the left engine was s/n CP-PS 60529 but its box was mislabeled "s/n 72332" (Figure 3). The accessory gearbox's internal components were in a separate bag inside the box.

**Figure 2.** Box mislabeled as "s/n 72332" containing the left engine, s/n CP-PS 60529

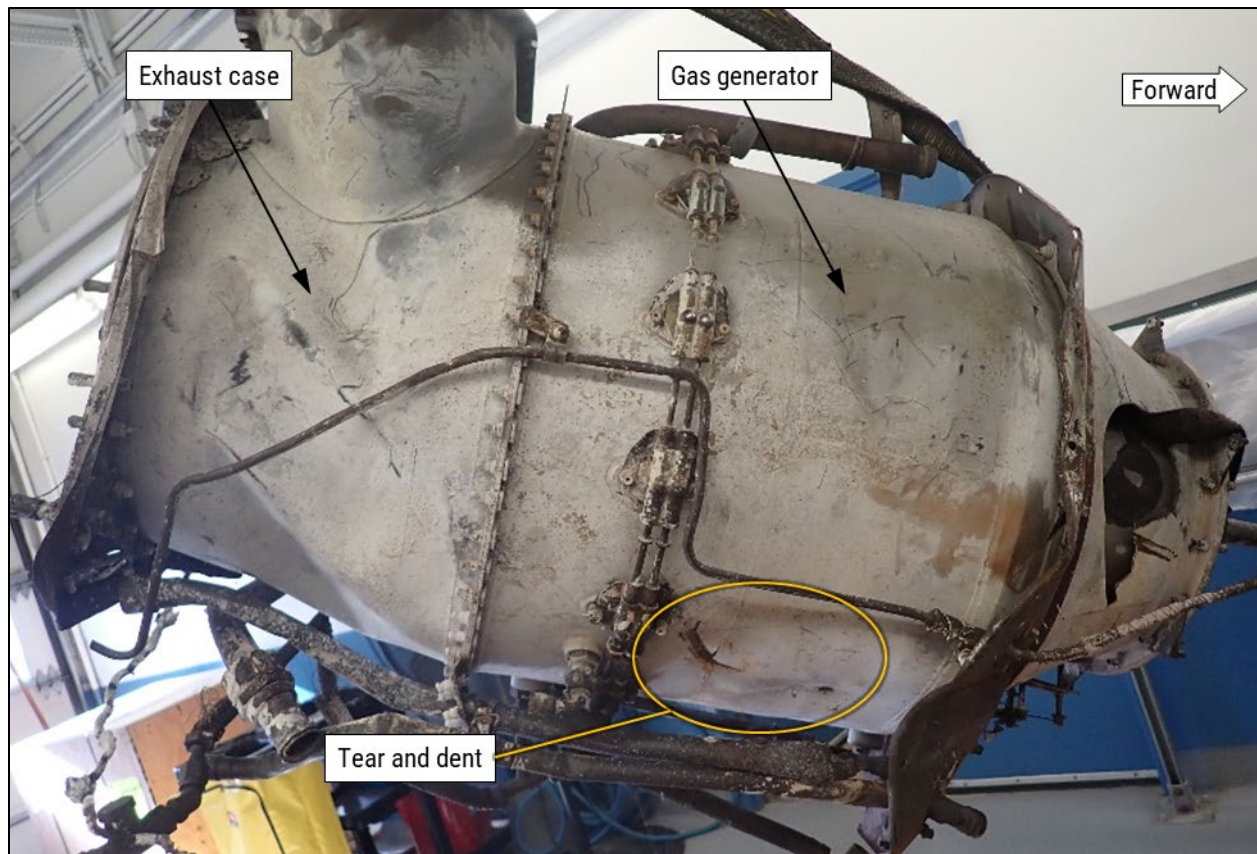
The engine's external surfaces from 2 to 6 o'clock were coated white along the entire length of the engine (Figure 4). The gas generator case had a dent and small tear at 5 o'clock but had no evidence of uncontainment (Figure 5). All visible external tubes and wirings had post-crash damage such as bends and breaks.

**Figure 4.** Right side of left engine

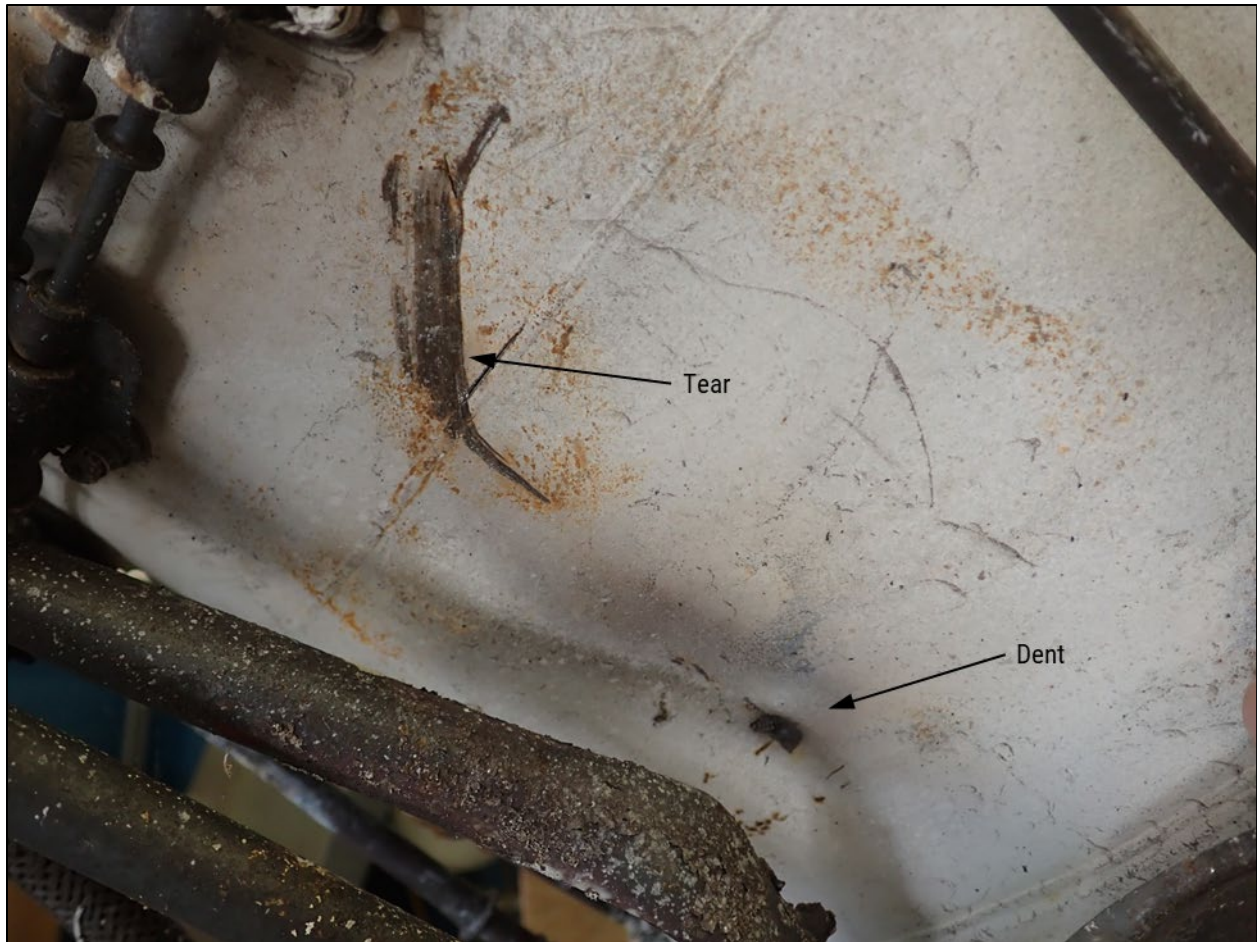
**Figure 5.** Tear and dent in left engine's gas generator case

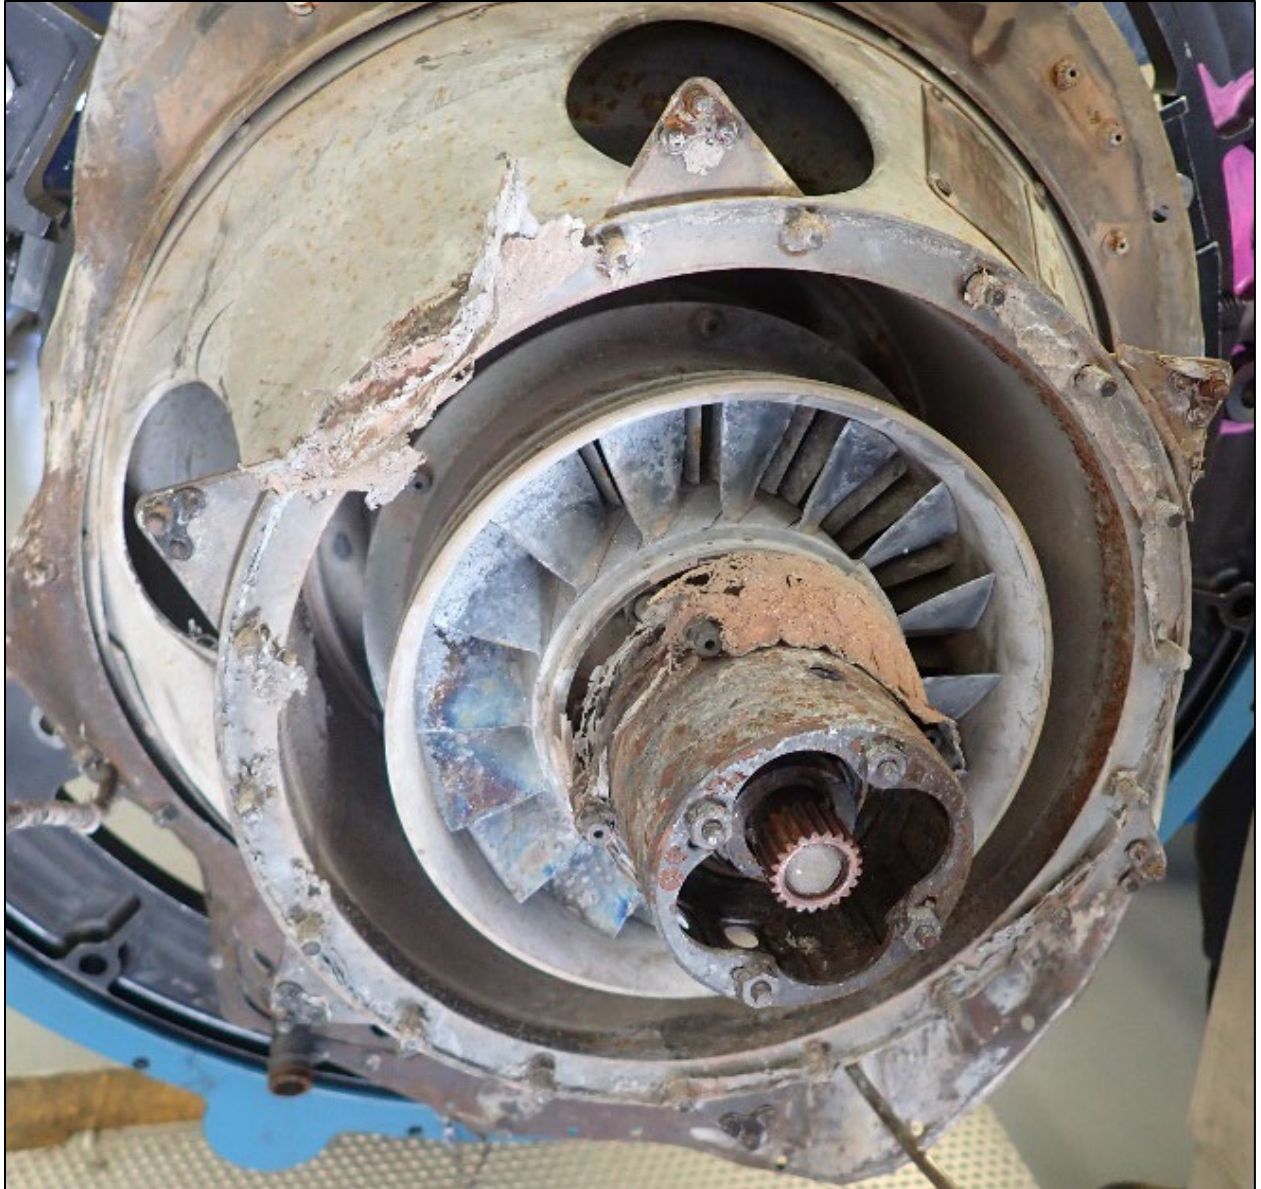
The inlet screen, inlet case, front oil tank, bleed valve, and accessory gearbox housing were missing. Remnants of the magnesium inlet case were still attached to the front inlet case mating surface. The front of the stage 1 compressor blades appeared full length, bluish in color, and the airfoil surfaces were coated white when viewed through the inlet. The compressor section could not be rotated by hand. The front fire shield was thermally damaged, bent forward at 7 o'clock, and bent aft at 4 o'clock (Figure 6). The front cone of the gas generator case at 9 o'clock was torn (Figure 7).

**Figure 6.** Front of left engine

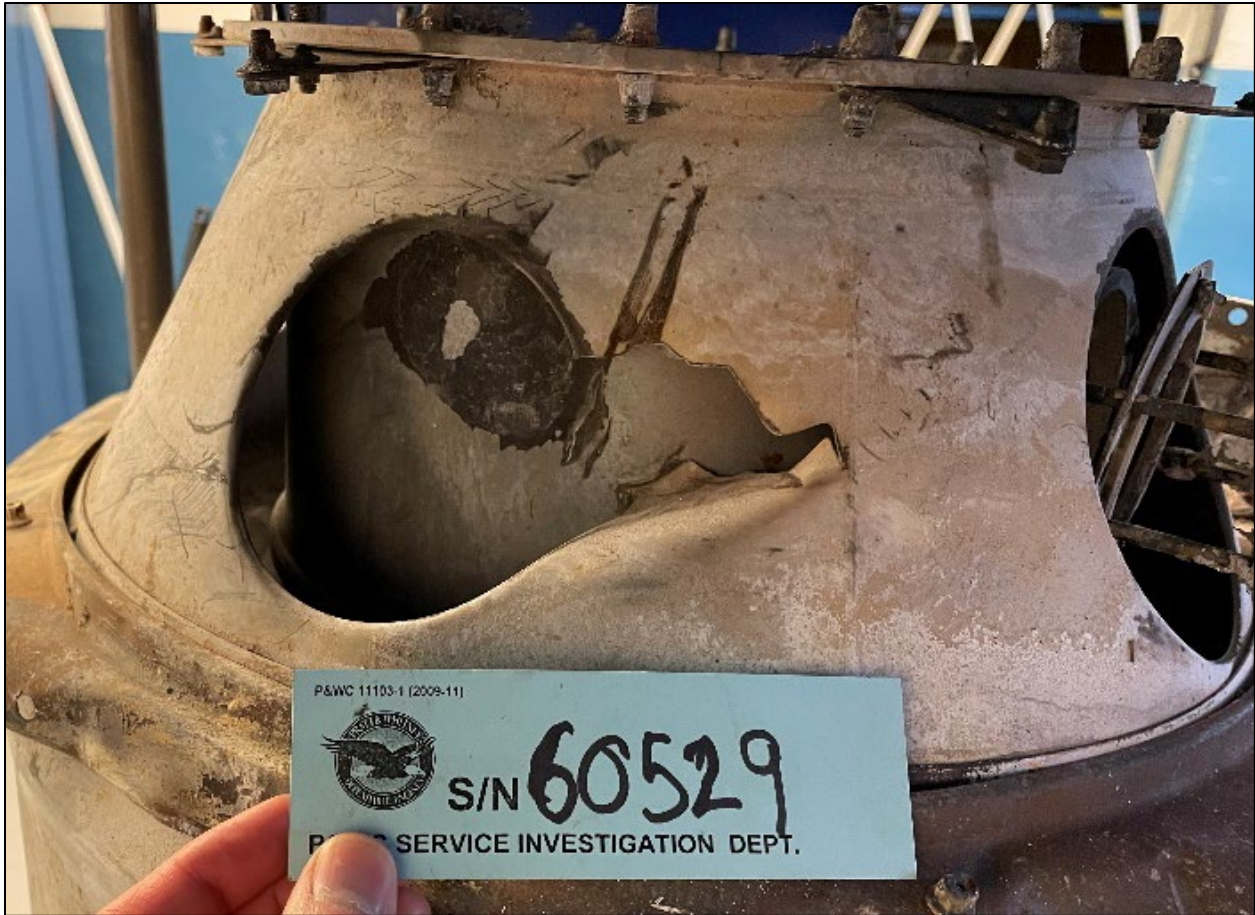
**Figure 7.** Tear in gas generator case

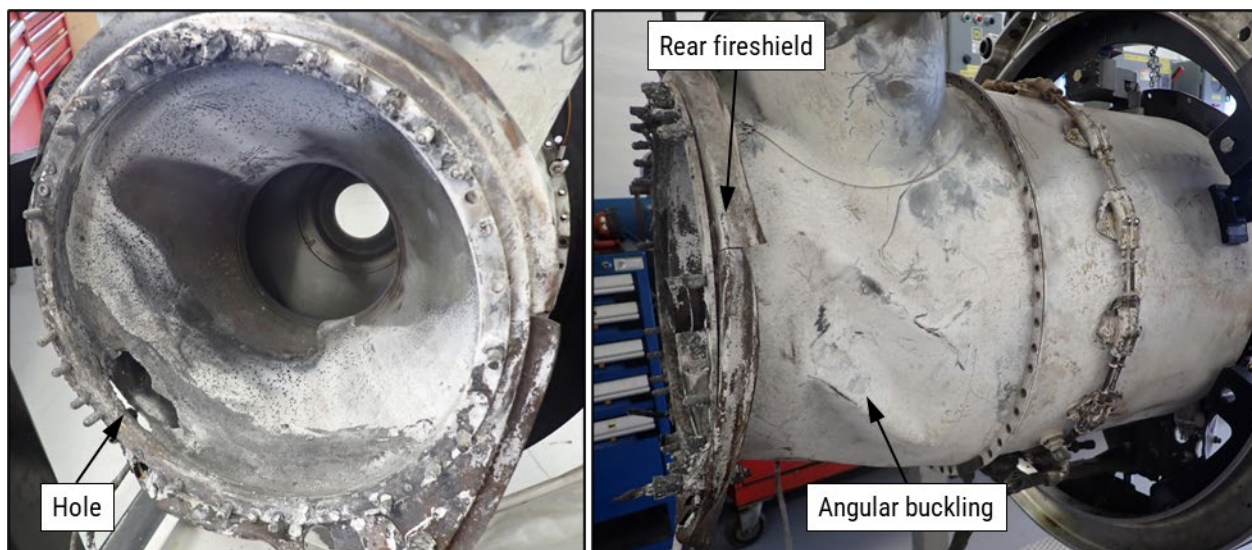
The combining gearbox was missing, but 22 connecting bolts (of 23 total) that secured the gearbox to the exhaust case flange were still present and molten metal was adhered to the flange. The rear fire shield was thermally damaged all around, bent forward at 7 o'clock and bent aft at 4 o'clock. The bottom half of the exhaust case was angularly buckled, most pronounced from 3 to 6 o'clock. The exhaust case had a burned through hole at 7 o'clock near the gearbox mating flange (Figure 8).

**Figure 8.** Left engine exhaust case damage

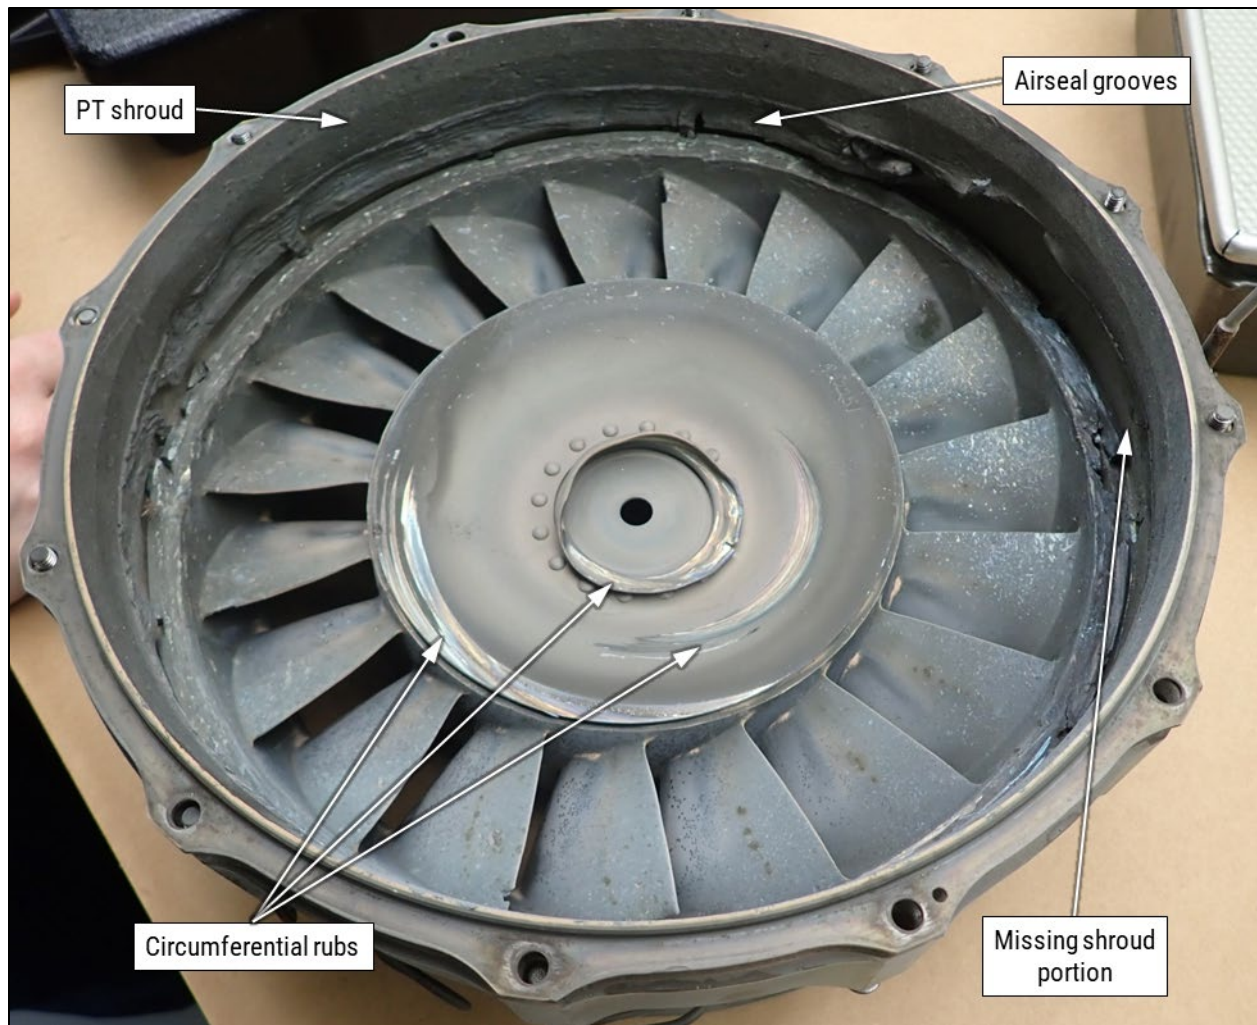
The PT stator housing was intact and its exterior surfaces had rust spots. The PT outer blade airseal shroud was deformed radially outward and stuck within the stator housing. A portion of the airseal shroud at 9 o'clock was rubbed away and missing and what remained of the airseal grooves were rubbed away 360° around. The stuck airseal shroud prevented removal of the PT vane ring from the housing. The aft edge of the PT vane's outer diameter platform was damaged at 9 o'clock while the suction side and trailing edges airfoils had nicks and dents. The aft side of the PT interstage baffle had three locations with circumferential rubs. The front of the PT vanes and baffle appeared undamaged (Figure 9).

**Figure 9.** PT stator housing with PT vane pack and PT outer blade airseal shroud

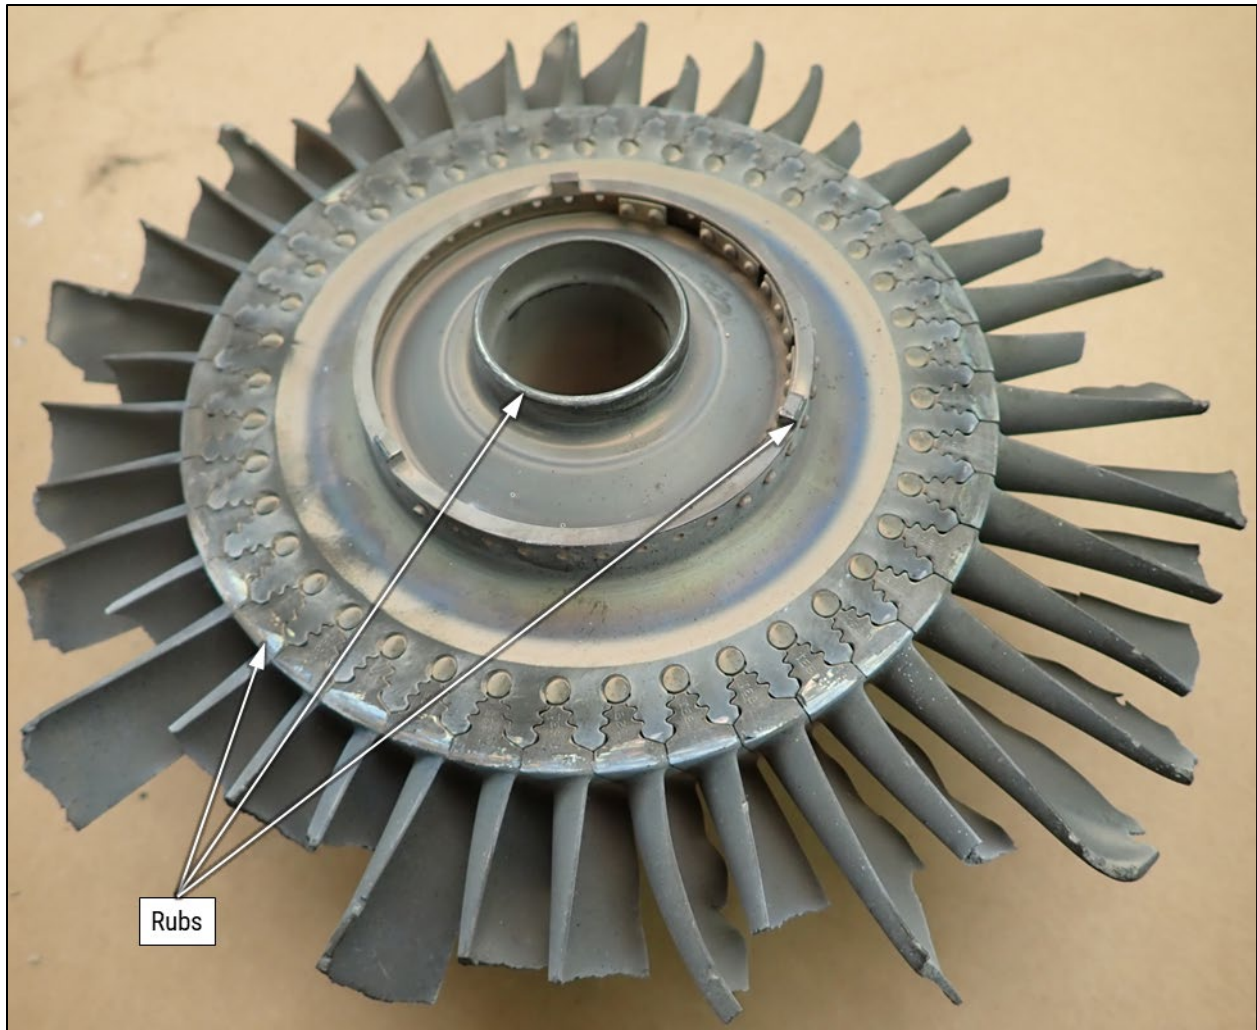
Three circumferential rubs were found on the forward face of the PT disk assembly: the front edge of the PT blade platforms, the assembly tabs on the balancing flange, and on the inner hub surface. All the PT airfoils were fractured transversely across the airfoil at various lengths and their trailing edges were wavy, dented, or both. Some airfoils were bent opposite the direction of rotation. All PT blade fracture surfaces appeared jagged and rough. The PT disk had bluish discoloration outboard of the balancing flange and the aft spline teeth appeared in good condition (Figure 10). The PT disk and blades were held for further examination.

**Figure 10.** PT disk assembly circumferential rubs

Thirty-five of the 41 blades showed evidence of material microstructural overheating throughout the entire blade length (from blade root to airfoil tip), specifically reprecipitation/solutioning. According to PWC, the microstructural overheating was likely produced during initial manufacture or during a subsequent heat treatment and not during engine operation.

The remaining six blades had different heat codes and no evidence of material overheating compared to the above mentioned 35 blades. These six blades were installed in the PT disk as two sets of three blades 180° apart from each other. The different heat codes, material conditions, and install locations suggest these six blades were installed during an engine overhaul to replace blades from the original blade set. The date these six blades were installed could not be determined.

Visual examination of the 41 PT blades found all fracture surfaces had fractographic features consistent with overload failure. Scanning electron microscope examination of a subset of turbine blades found no metallurgical anomalies on any of the fracture surfaces. Measured blade material hardnesses were within the range specified by the drawing requirements. Energy dispersive spectroscopy of select blades found the blade material compositions conformed to the specified drawing requirements. No evidence of creep (blade elongation due to operating at elevated temperatures) damage was found on any blades.

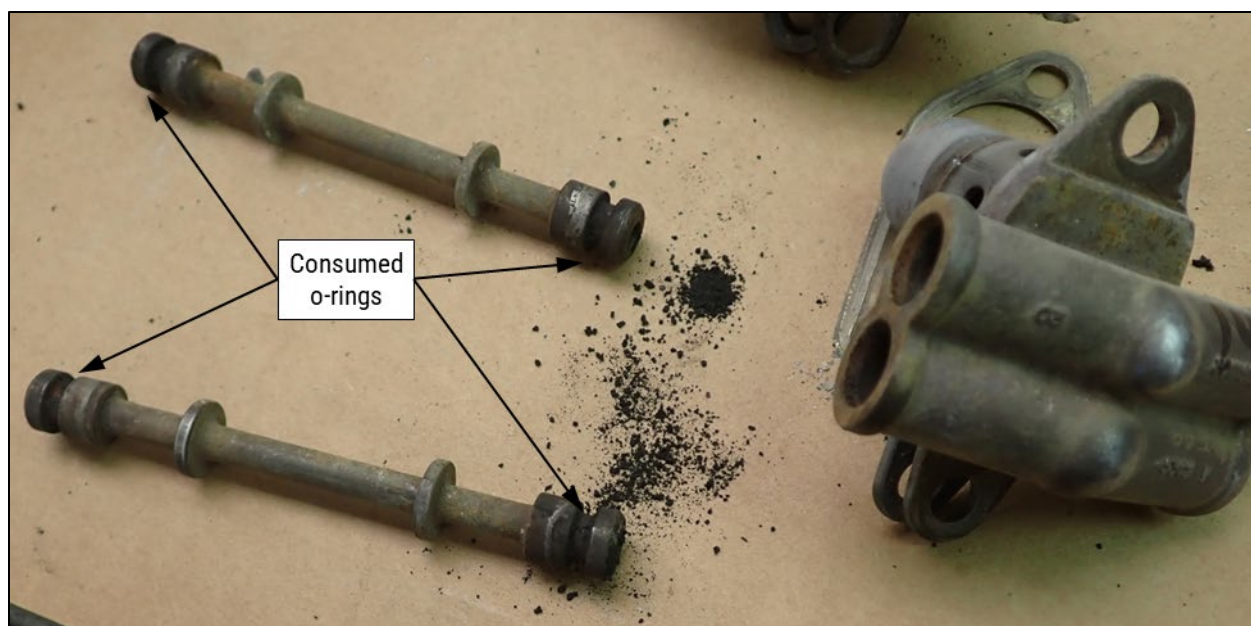
The fuel manifold adapters were numbered clockwise (aft looking forward) from one to 14 with adapter one located at 12 o'clock. Nozzles five through 10 were more difficult to remove compared to the other nozzles. All transfer tubes that connect the adapters were present and intact, but all sealing o-rings were consumed by the post-crash fire (Figure 11).

**Figure 11.** Fuel nozzle manifold and transfer tubes

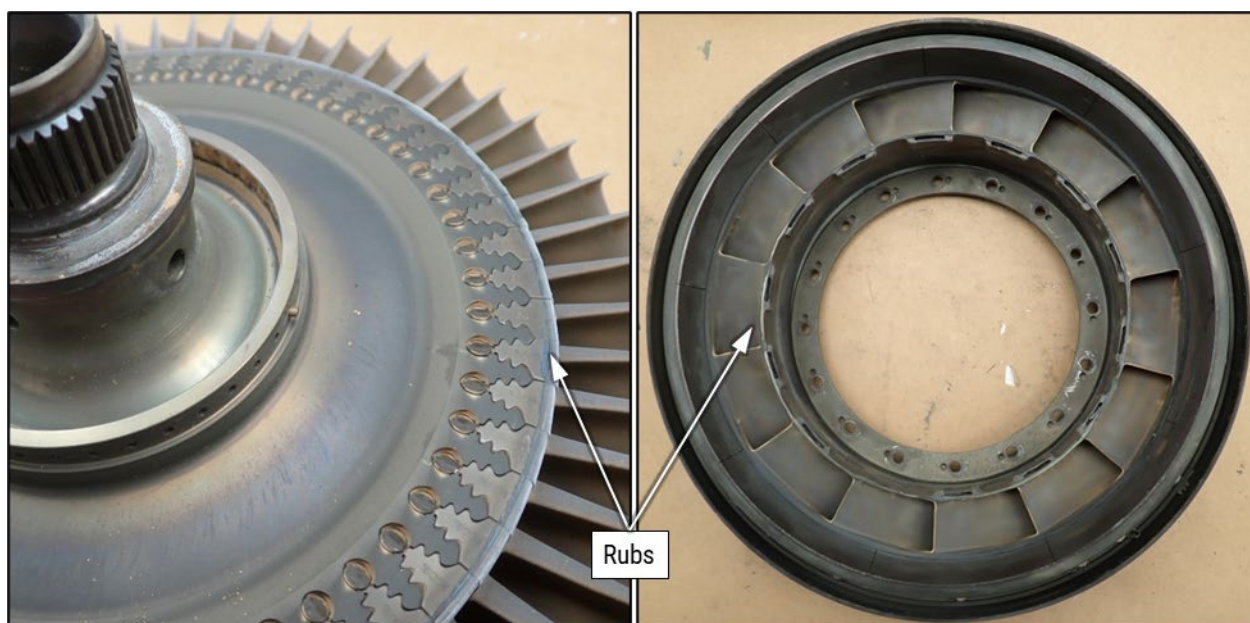
The CT disk, combustion chamber liner, large and small exit ducts, and CT vane ring appeared in good condition consistent with normal engine operation. The CT disk forward splines were undamaged. The front of the CT blade platforms had circumferential rubs. Corresponding rub marks were found on the aft side of the inner diameter (ID) vane ring platform. The CT blade airfoil tips had light circumferential rubs (Figure 12).

**Figure 12.** CT disk (left) and CT vane pack with small exit duct (right)

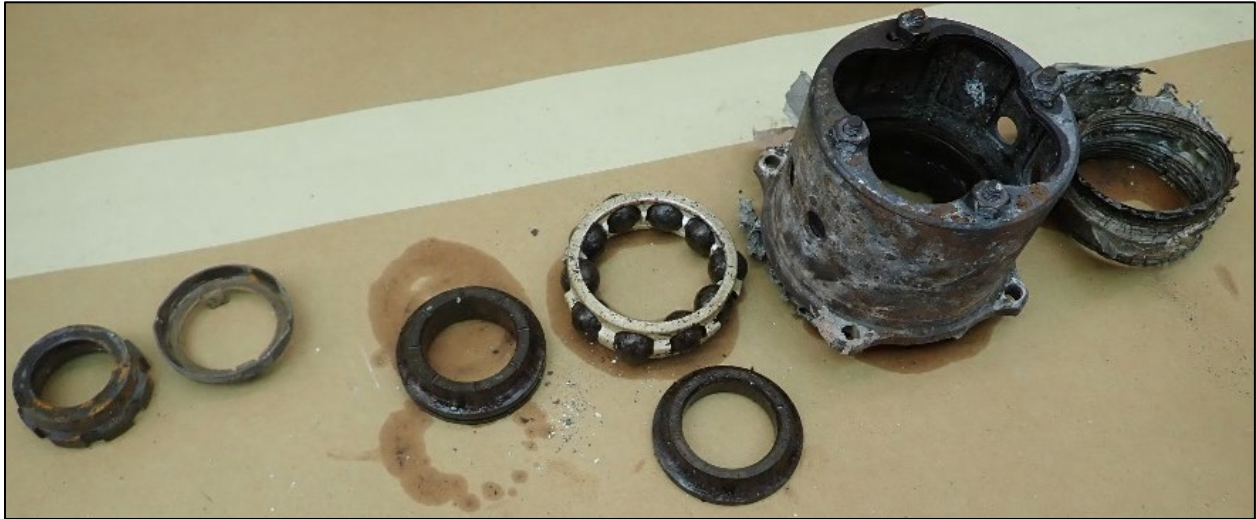
Penetrating oil was used to remove the No. 1 ball bearing assembly. All parts were thermally distressed. The No.1 ball bearing housing, inner and outer races, ball elements, lock nut, and lock washer had darkened appearances and coked oil on their surfaces. The No.1 ball bearing flexible housing was mostly melted and consumed. The lock washer anti-rotation tabs were still present and engaged with the bearing nut locating slots. Multiple parts had indications of surface corrosion/oxidation. The ball bearing cage had a yellowish tint. No evidence of pre-impact damage was found on any parts (Figure 13).

**Figure 13.** No. 1 ball bearing components

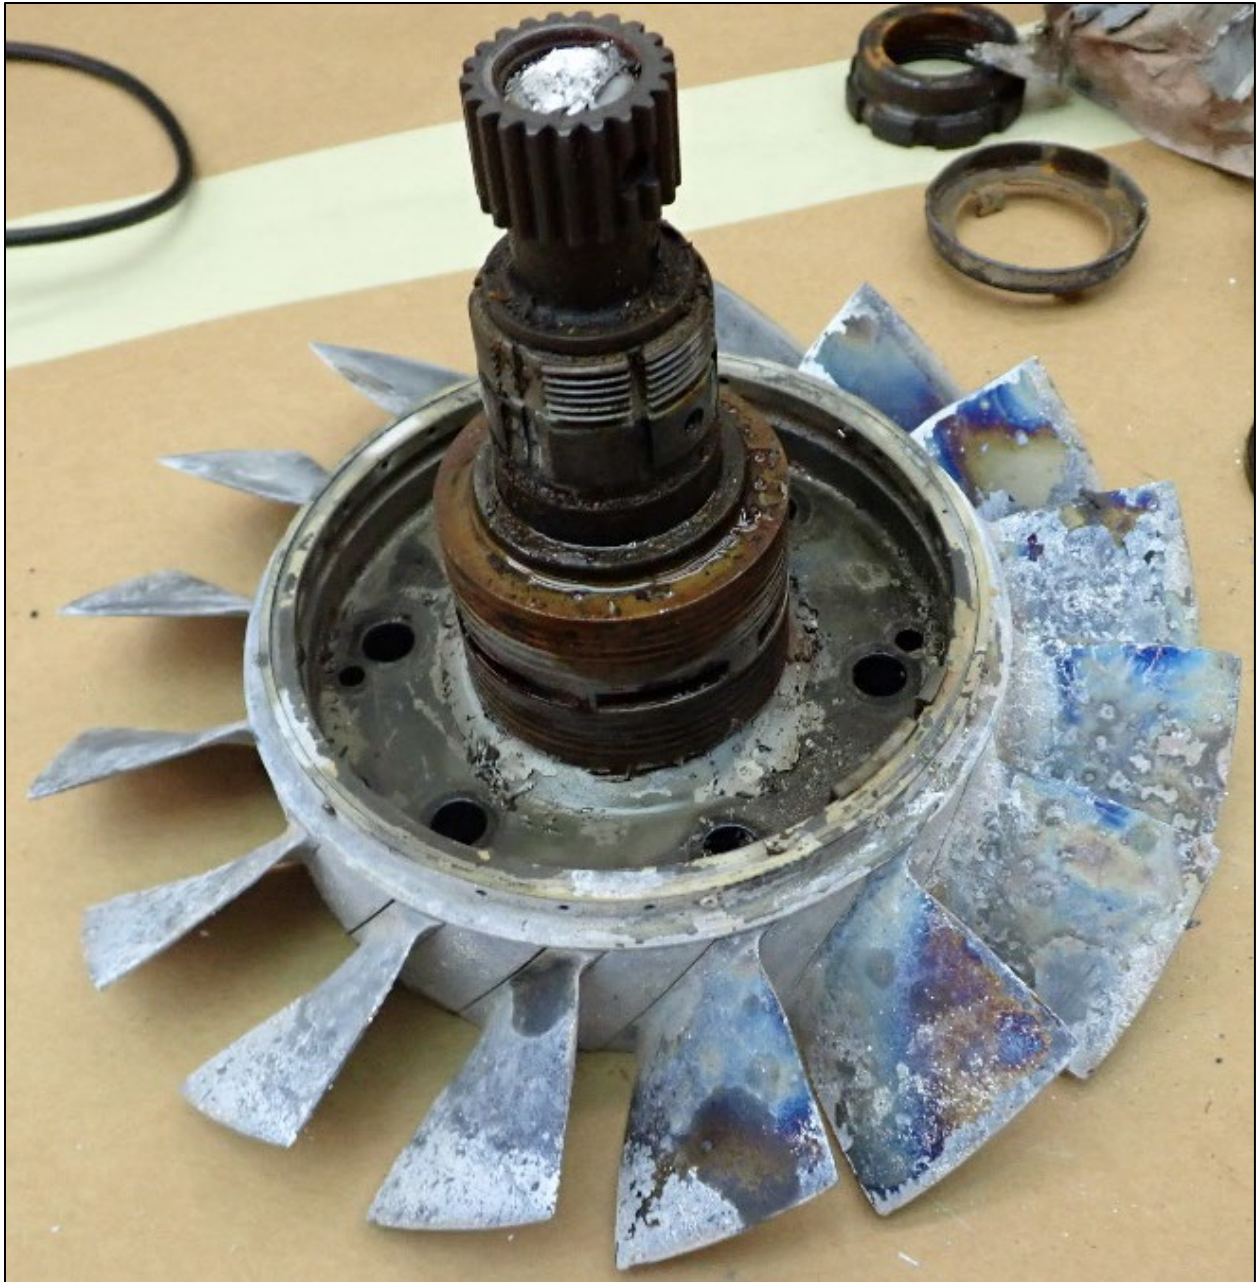
All three stages of the axial compressor blade airfoils had white coating. All compressor blade and vane airfoils appeared to be full length. All stage 1 blades had a bluish color (Figure 14). Some stage 2 and 3 blades had small trailing edge dents. All compressor section parts had indications of surface corrosion/oxidation. The centrifugal impeller appeared intact. Circumferential rub marks were found on the shroud edge lines closer toward the exducer (Figure 15) and corresponding 360° rubbing was found on the impeller shroud (Figure 16). Deposits on the impeller and external housing surfaces were flaking off. The No. 2 roller bearing was dry and seized to the compressor stub shaft. All No. 2 roller elements were present and no dents, nicks, or spalling were seen. The six tie rods that secure the compressor rotors together were present and appeared intact.

**Figure 14.** Stage 1 compressor disk assembly covered in white coating

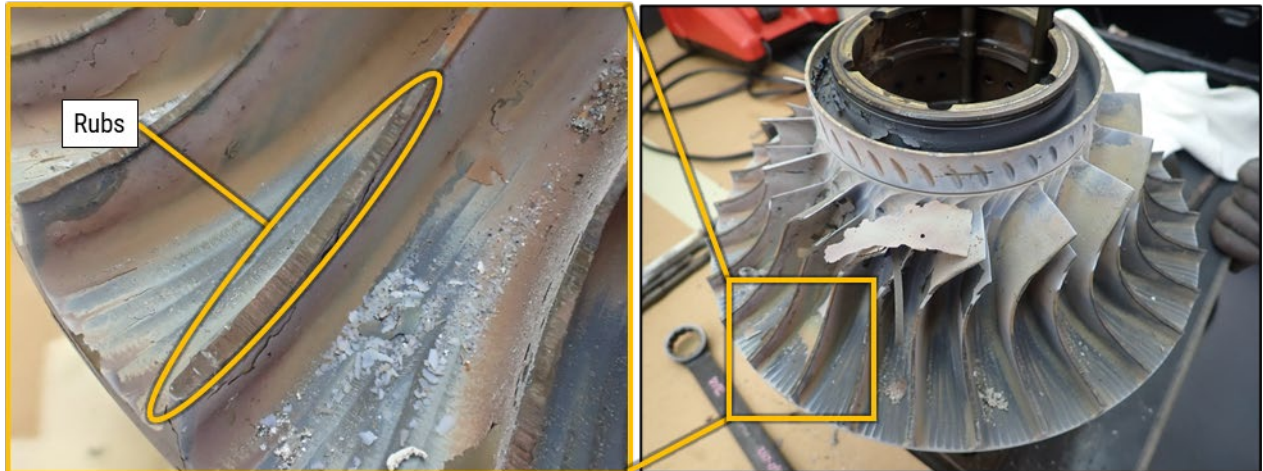
**Figure 15.** Centrifugal impeller with circumferential rub on the shroud line edges

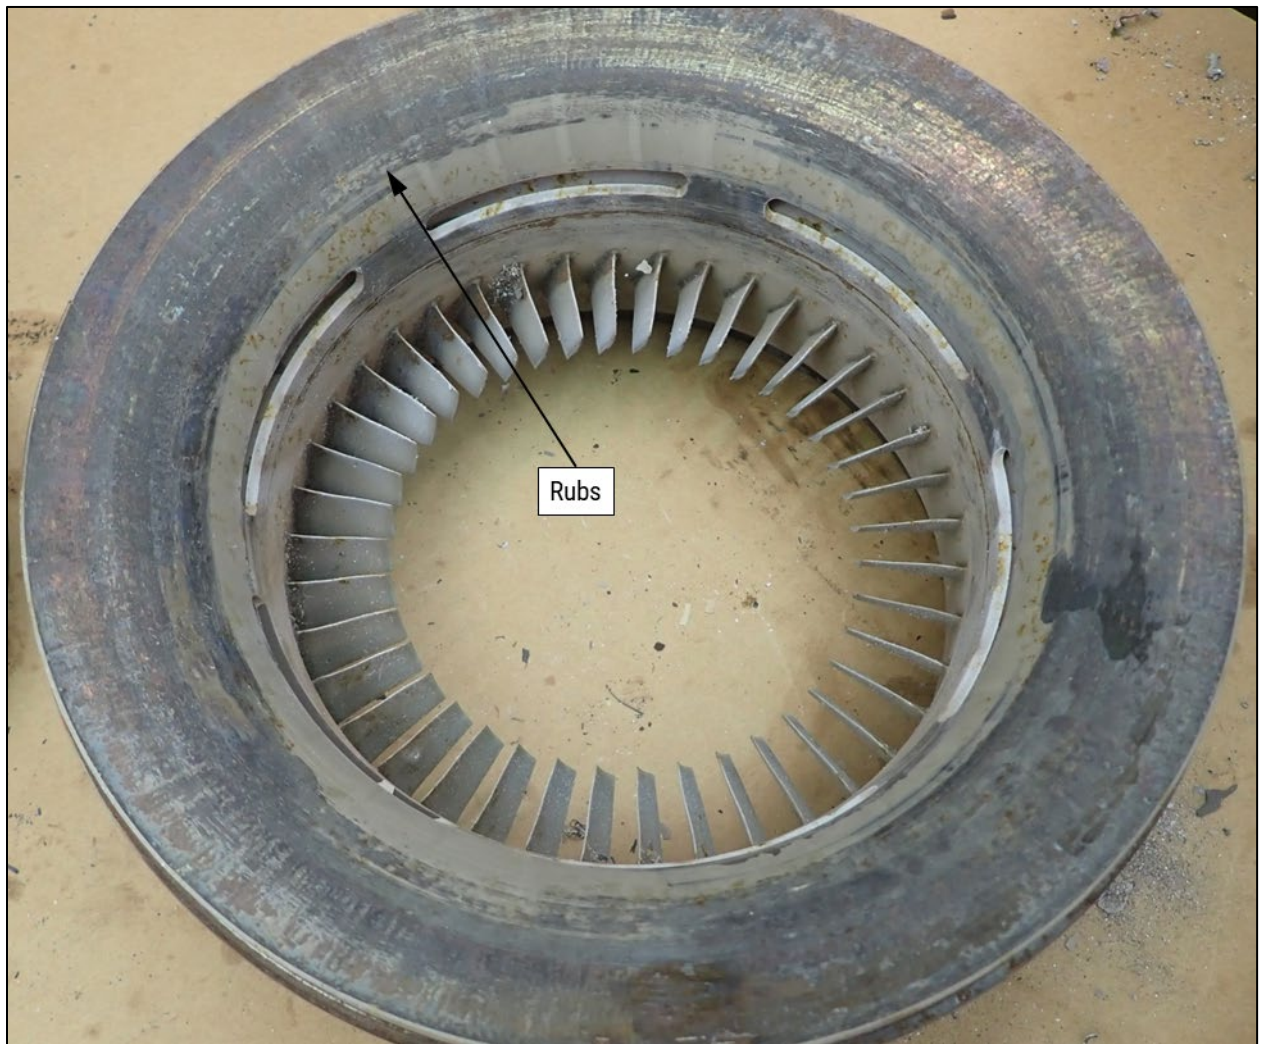
**Figure 16.** Impeller shroud with circumferential rub

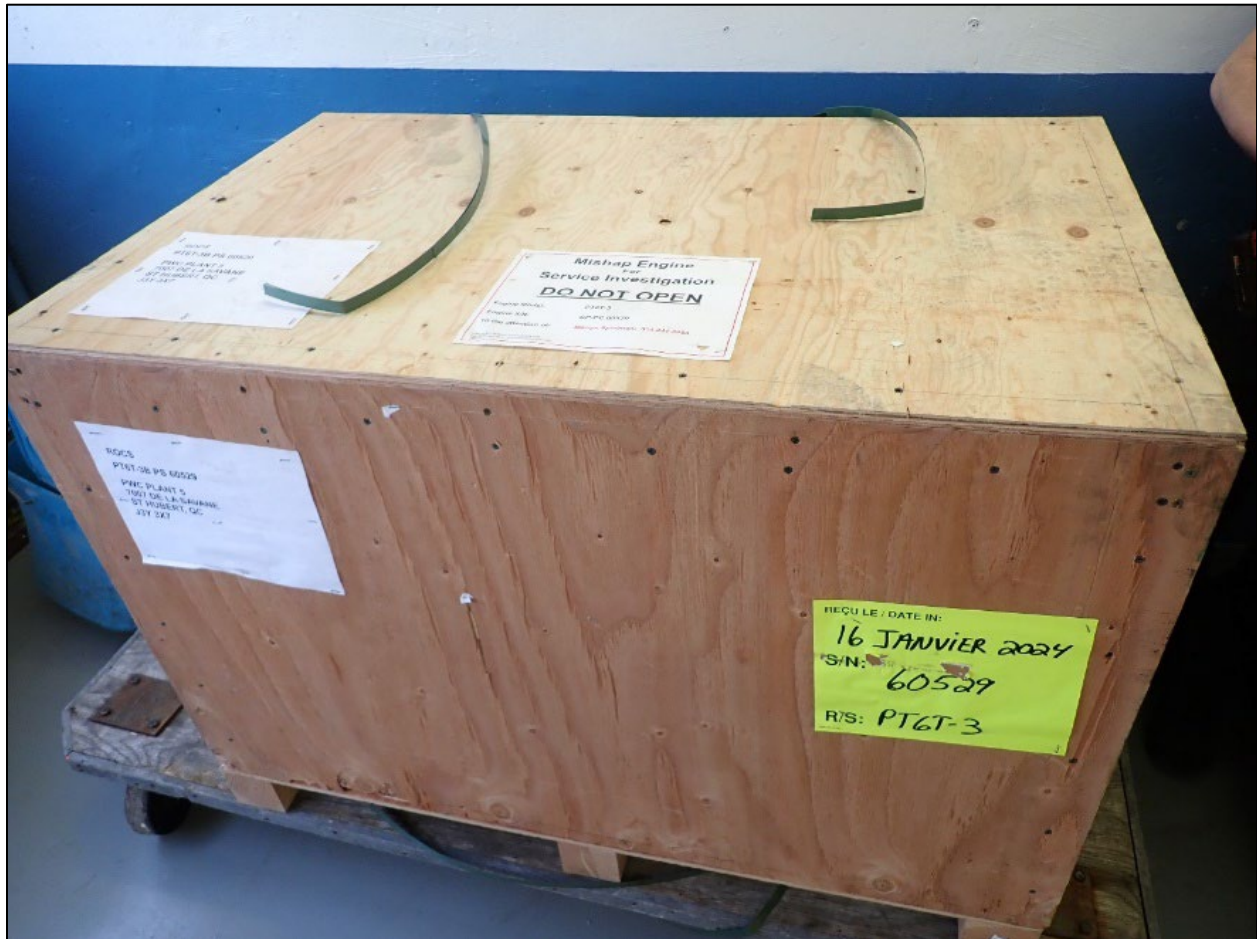
The right engine was secure in a wooden box (Figure 17). According to the engine data plate, the right engine was s/n CP-PS 72332 but was in the box mislabeled "s/n 60529" (Figure 18). Internal components from the accessory gearbox and the combining gearbox were included in separate bags inside the box.

**Figure 17.** Box mislabeled "s/n 60529" containing the right engine, s/n CP-PS 72332

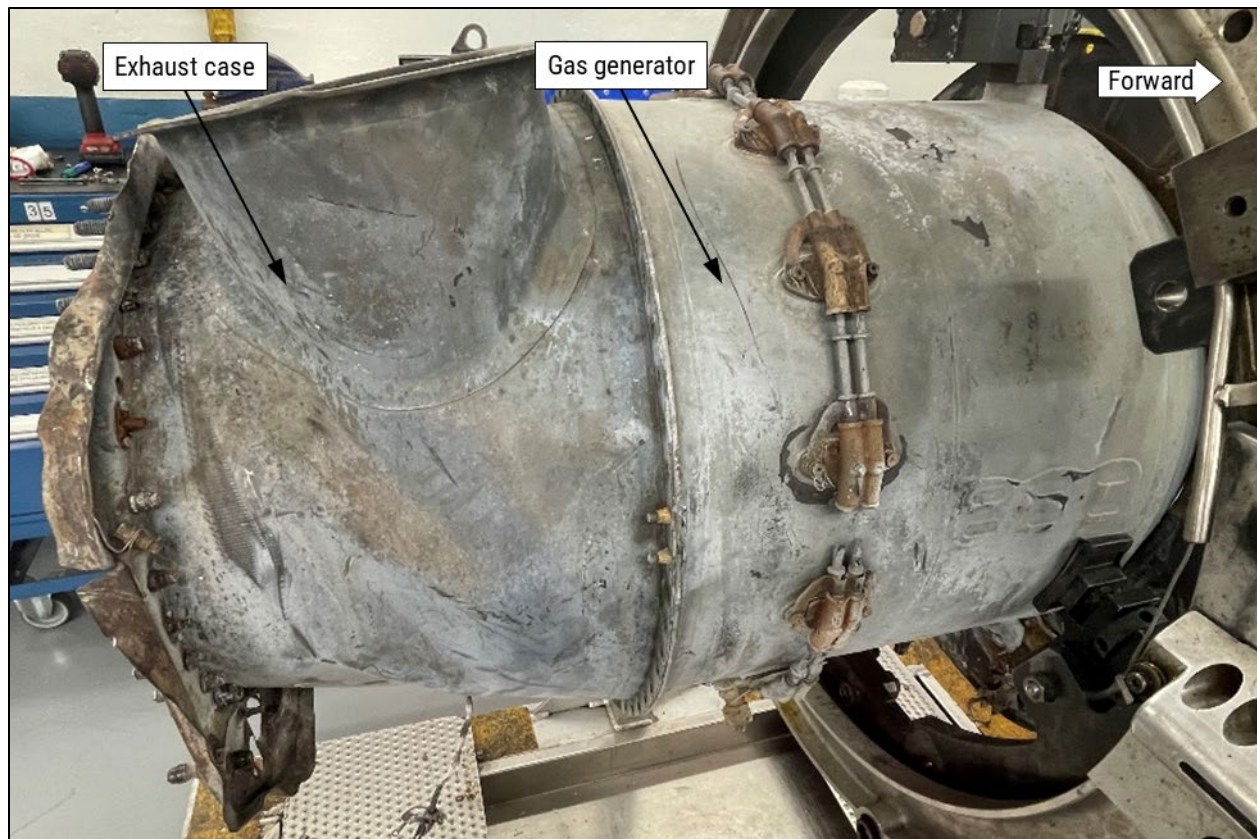
The gas generator's external surfaces had spots of flaking paint and was coated white. The gas generator case was dented at 3 o'clock but had no evidence of uncontainment. The Pg line located on the right side of the exhaust case provides a pneumatic signal from the power turbine governor to the automatic fuel control unit. The Pg line's outer silicon rubber sheathing was thermally consumed, exposing the underlying fiberglass insulation and heating element. The front fire shield was thermally damaged and bent forward at 7 o'clock (Figure 19).

**Figure 19.** Right side view of right engine

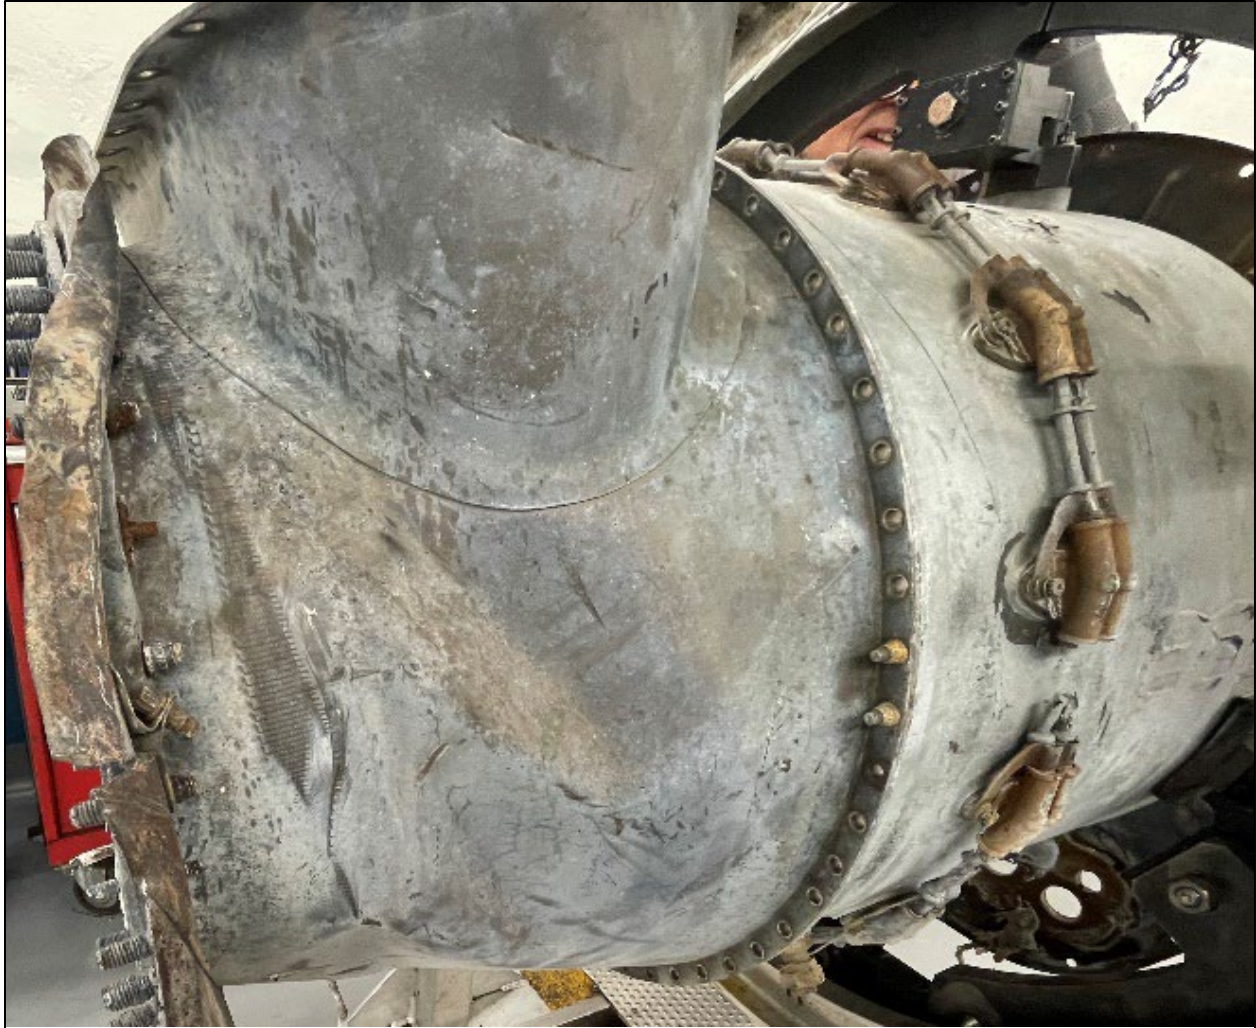
The exhaust case had a white coating over all external surfaces. The exhaust case flange where the combining gearbox attaches had all 23 connecting bolts still installed. Looking through the exhaust port, PT blades that were visible appeared full length. The right side of the exhaust case from 3 to 6 o'clock was angularly buckled. The rear fire shield was thermally damaged all around and crumpled at 7 o'clock, bent aft at 3 o'clock, and bent forward at 5 o'clock (Figure 20).

**Figure 20.** Right engine exhaust case covered with a white coating

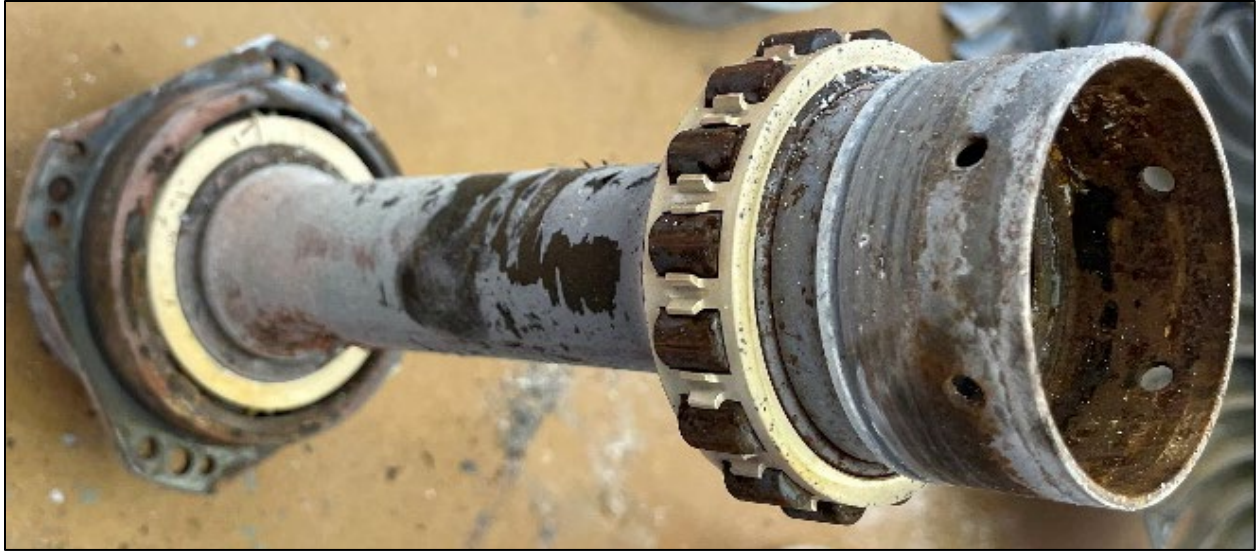
The PT stator housing was intact and undamaged with rust spots on its external surfaces. The PT shaft housing and coupling shaft were intact and coated white. The PT shaft, No. 3, and No. 4 bearings were removed together from the PT shaft housing. Both bearings could not rotate and could not be removed from the shaft. All No. 3 roller and No. 4 ball elements were present and visible portions appeared dry and dark in color with black-colored coking. The shaft and bearings were not further disassembled. Most of the No.1 bearing's flexible housing was thermally consumed. All parts had no evidence of pre-impact damage (Figure 21).

**Figure 21.** PT shaft with No.3 roller and No. 4 ball bearings
