# National Transportation Safety Board

WPR23LA338

## **POWERPLANTS**

Group Chair's Factual Report

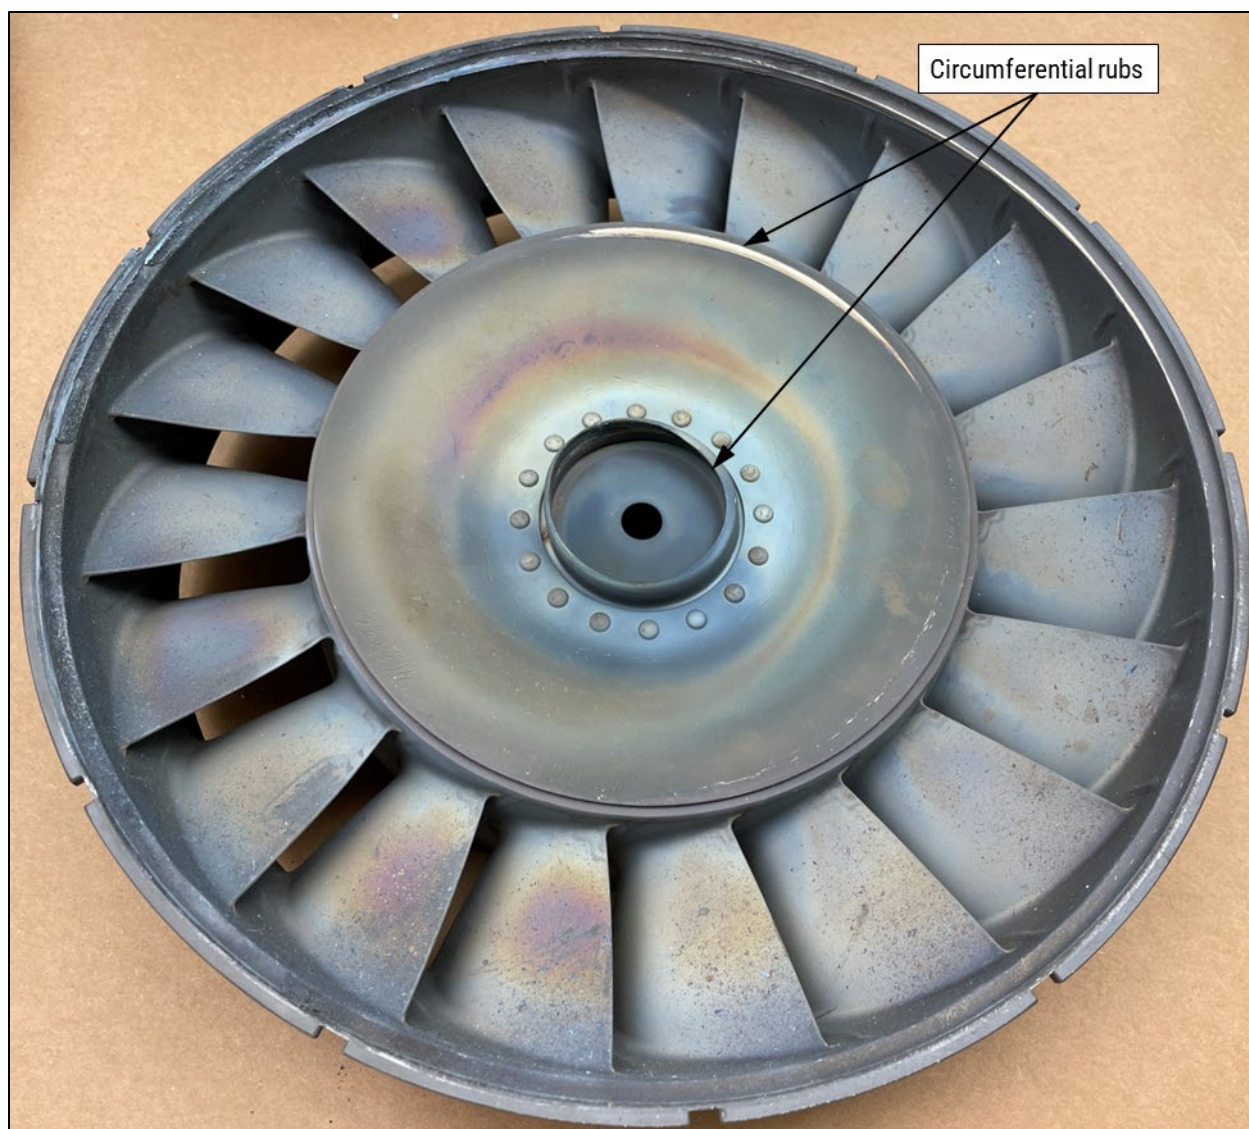
The PT vane ring was intact. The aft side of the interstage baffle had two rub locations and areas with bluish color. The PT vane airfoils appeared full length and undamaged (Figure 22).

**Figure 22.** Aft side of PT vane ring with interstage baffle

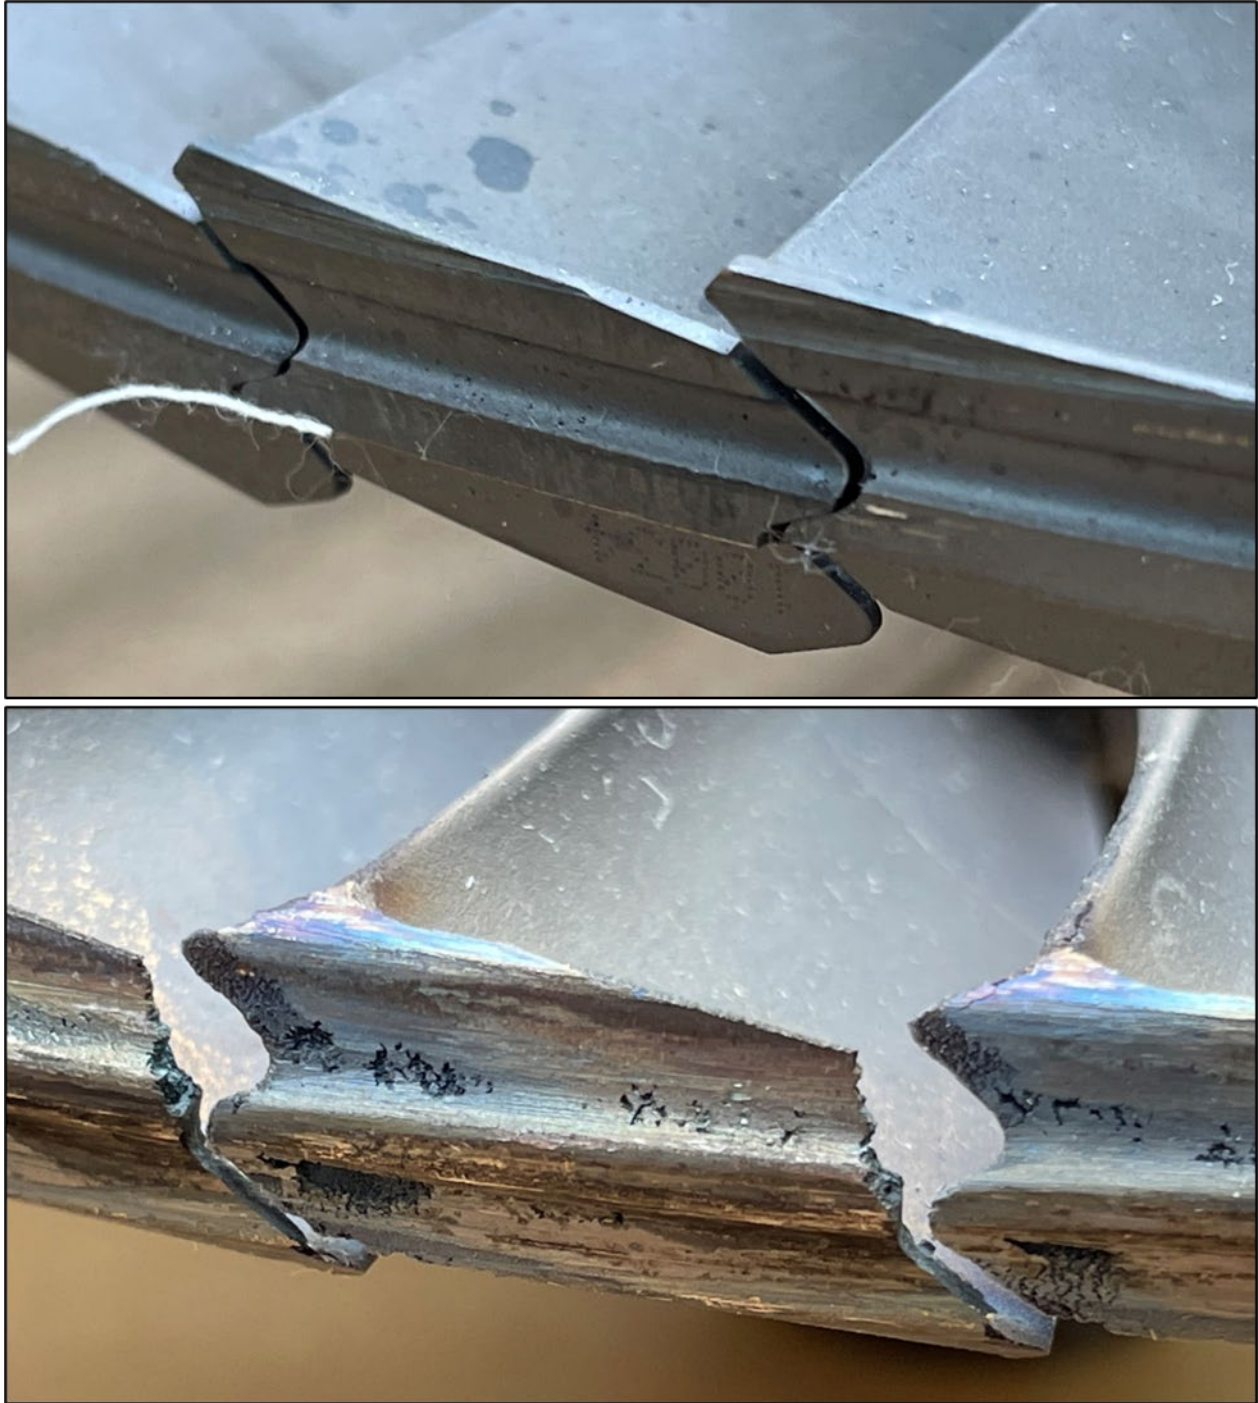
The PT disk was intact and all PT blades appeared full length. The disk aft splines appeared in good condition. The suction sides of all the PT airfoils were blue in color and all their shroud tips were circumferentially rubbed (Figure 23). Two circumferential rub marks were found on the forward side of the PT disk, one near the top of the blade firtree and one near the ID bore lip (Figure 24).

**Figure 23.** Shroud tips of exemplar PT blades (top) and event blades (bottom)

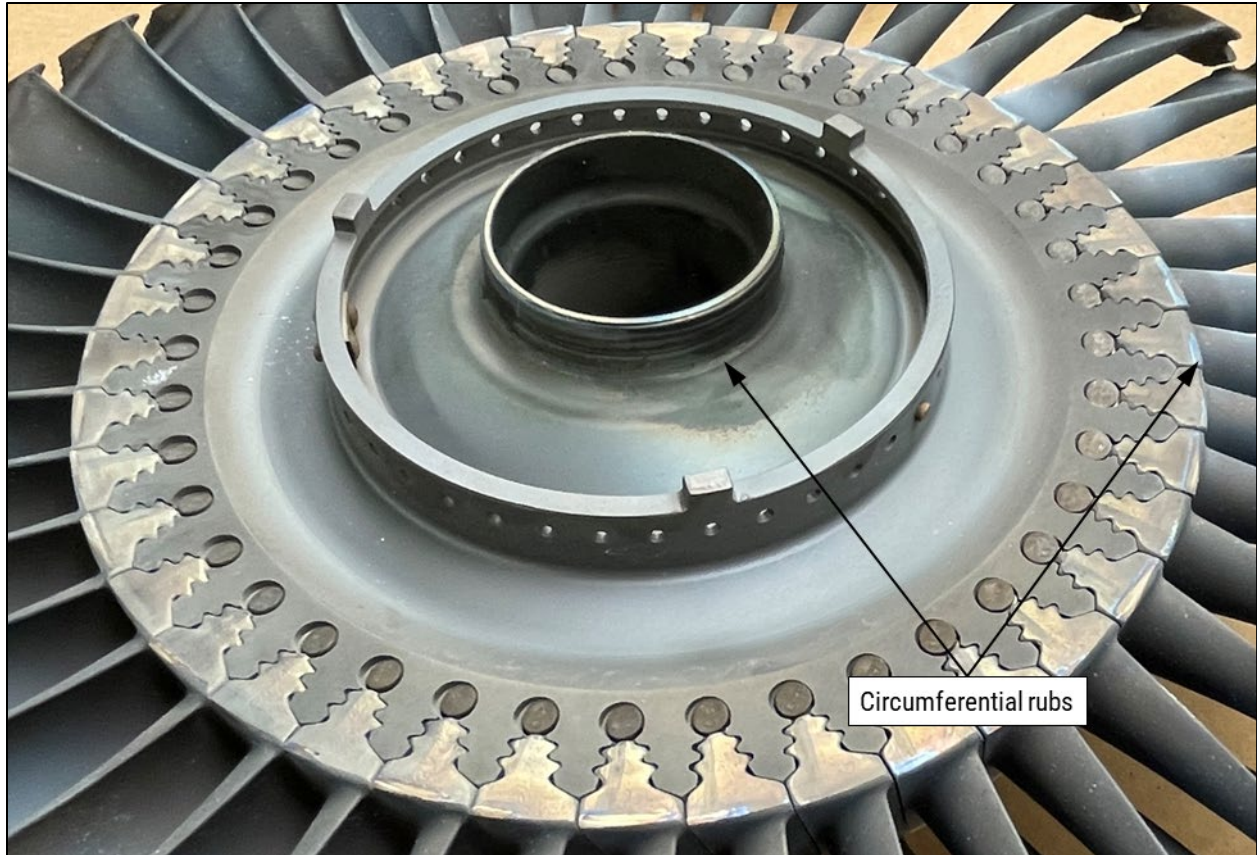
**Figure 24.** Forward side of PT disk assembly

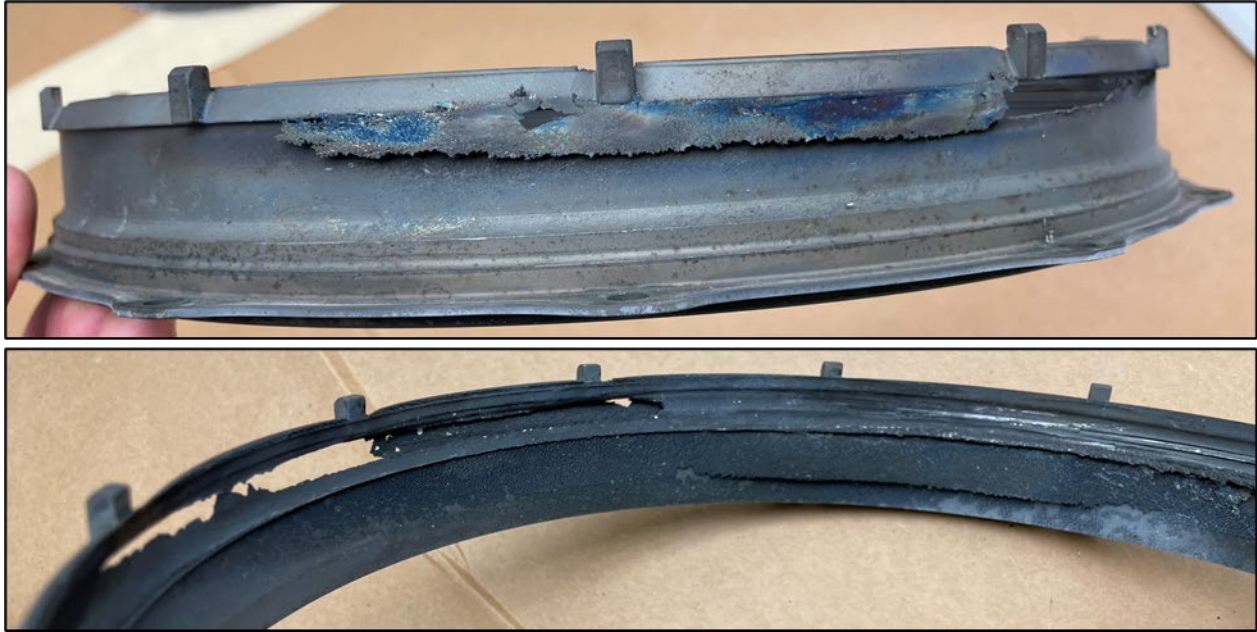
The PT outer blade airseal shroud had 360° rubs to the inner surface most significant from 9 to 12 o'clock. A small section of the shroud was machined away and displaced outward at 9 o'clock (Figure 25).

**Figure 25.** PT outer blade airseal shroud outer (top) and inner (bottom) surfaces

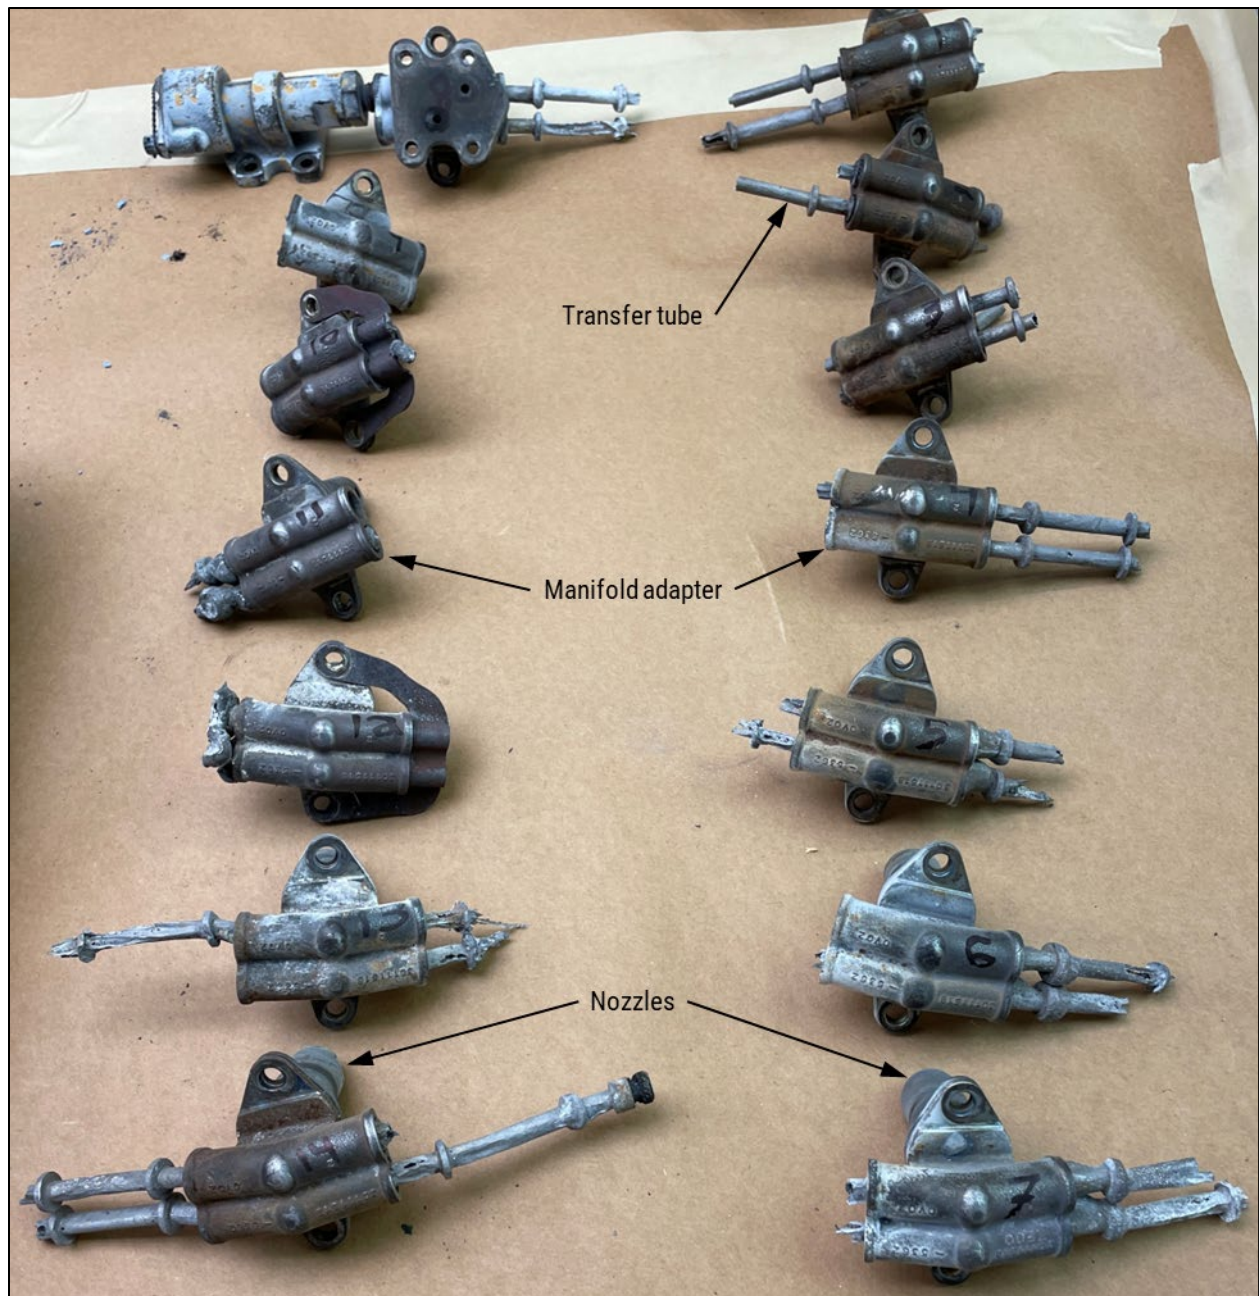
The fuel manifold adapters were numbered like the No. 1 engine's adapters. Most of the transfer tubes that connect the adapters were either missing or thermally damaged. All the transfer tube o-rings were consumed by the post-crash fire (Figure 26).

**Figure 26.** Fuel manifold adapters, nozzles, and transfer tubes

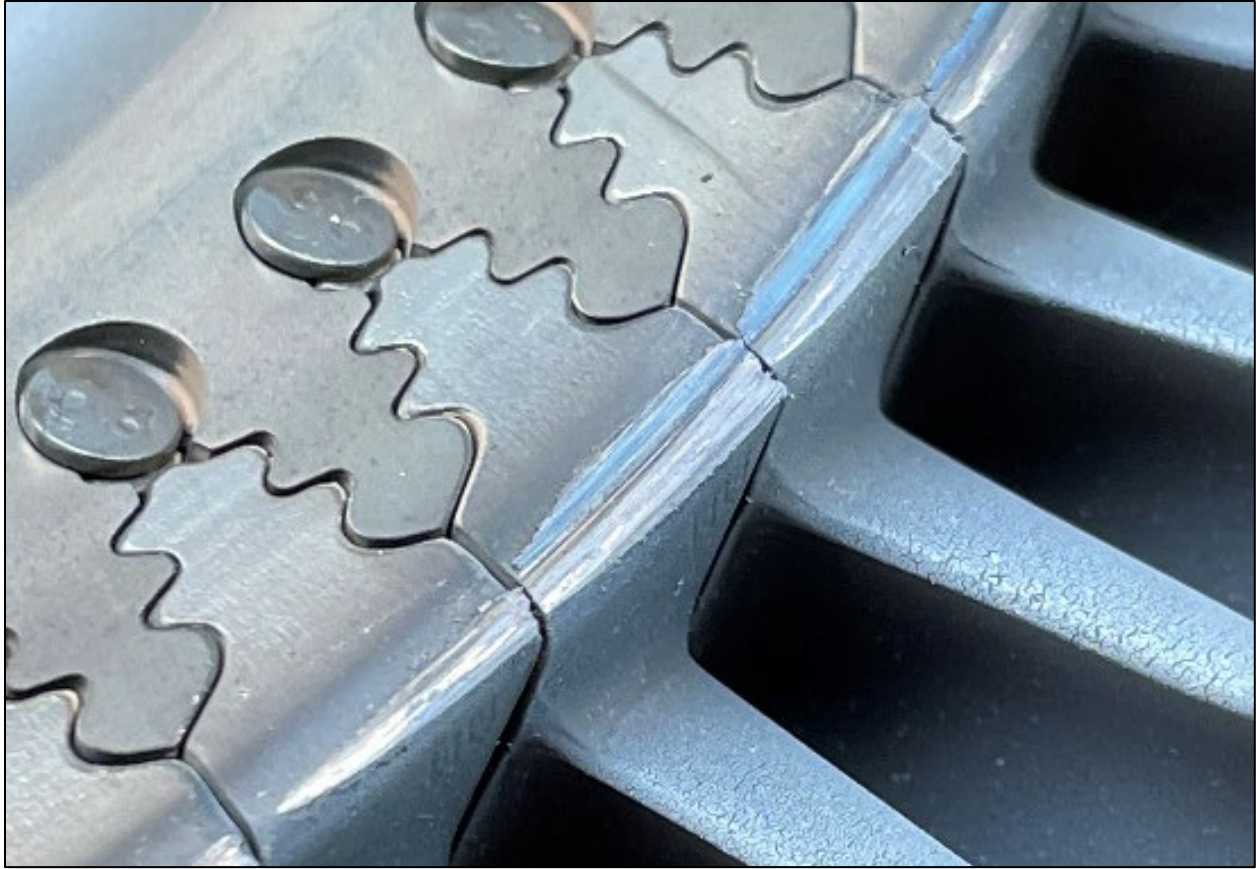
The CT disk appeared intact and mostly undamaged. The disk forward splines appeared in good condition. The forward face of the CT blade firtrees had circumferential rubs. All CT blade airfoils were lightly coated with white powder (Figure 27).

**Figure 27.** Circumferential rubs on the forward side of CT blade firtrees

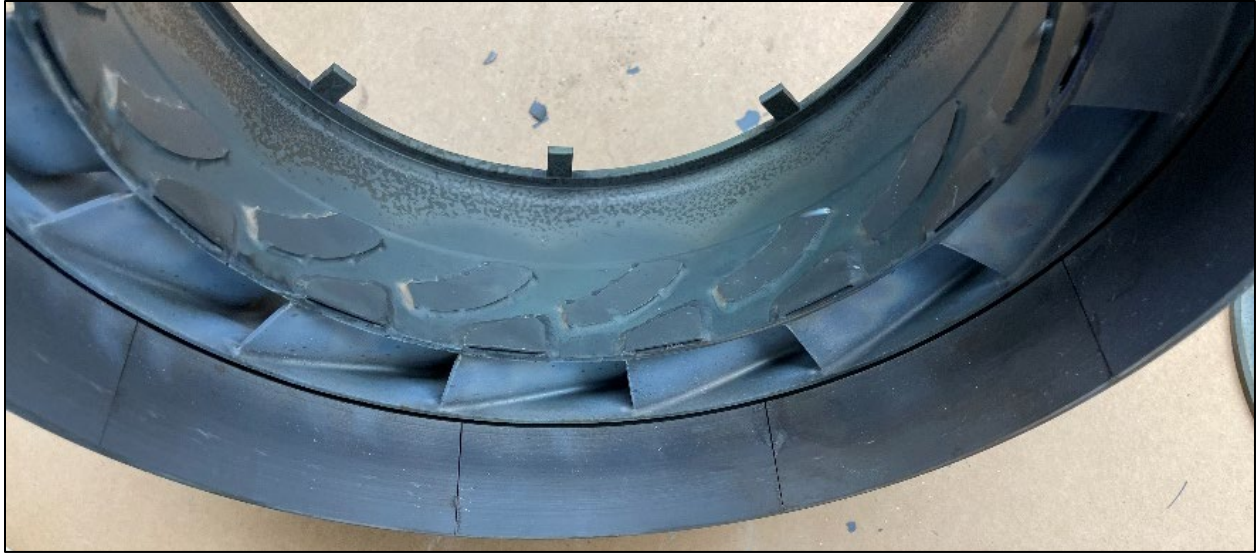
The small exit duct and CT vane ring were intact and lightly coated with white powder. The suction side of the CT vane airfoils were bluish in color. The CT vane aft ID platform had light circumferential rubs. The CT vane shroud segments had shiny axial chatter marks from the disassembly process, but otherwise appeared consistent with normal engine operation (Figure 28).

**Figure 28.** CT vane ring and shroud segments

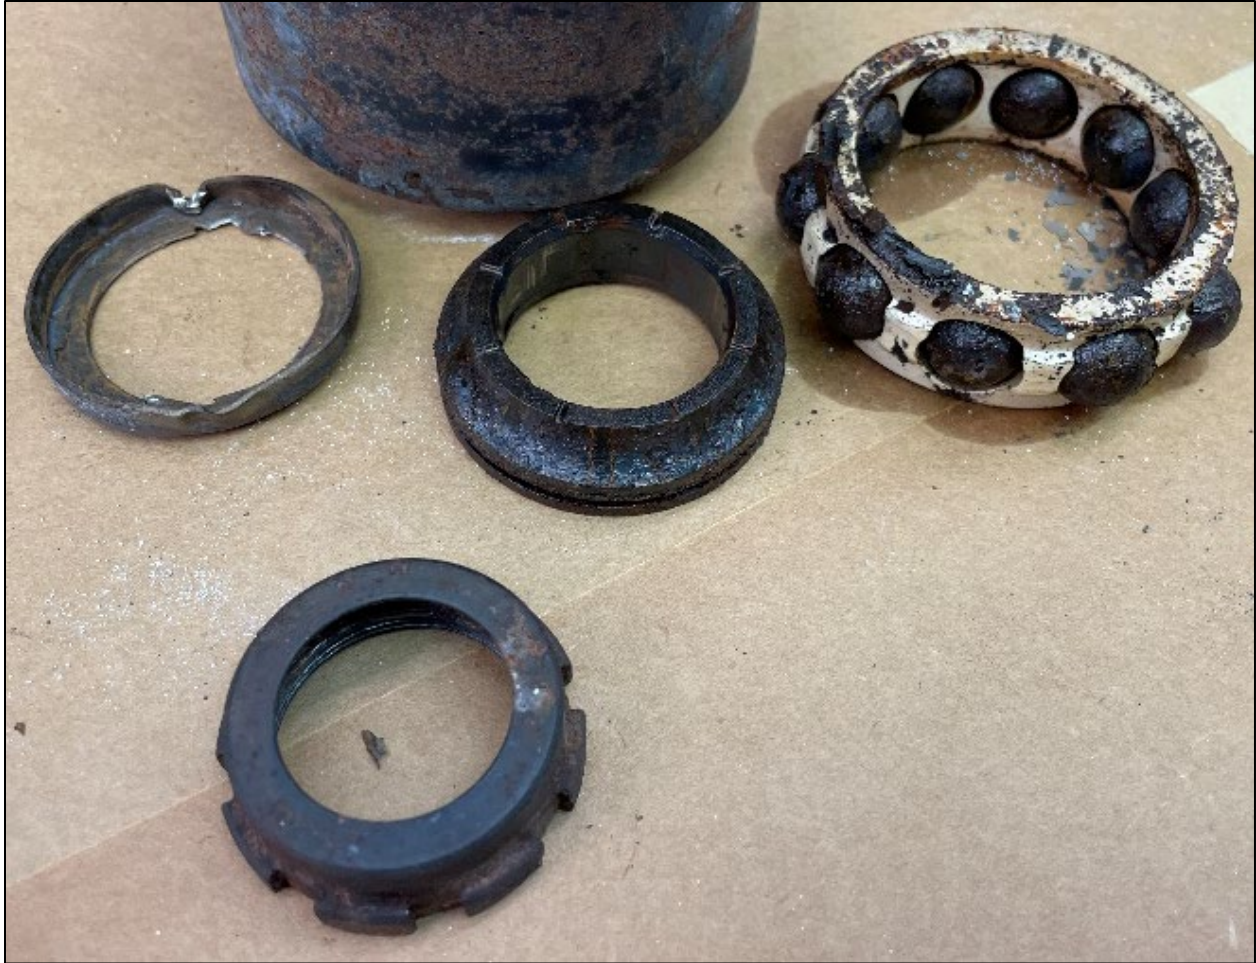
Penetrating oil was used to remove the No. 1 bearing assembly. All parts were thermally distressed. The No. 1 ball bearing housing, inner and outer races, ball elements, lock nut, and lock washer had darkened appearances and coked on the surfaces. The aft half of the No. 1 ball bearing inner race and the inner airseal land were stuck to the compressor shaft. The lock washer's anti-rotation tabs were mostly missing, but remnants of the tabs were still aligned with the No. 1 ball bearing lock nut locating slots when it was disassembled. Multiple parts had indications of surface corrosion/oxidation. The ball bearing cage had a yellowish tint. All parts showed no evidence of pre-impact damage (Figure 29).

**Figure 29.** No. 1 ball bearing components

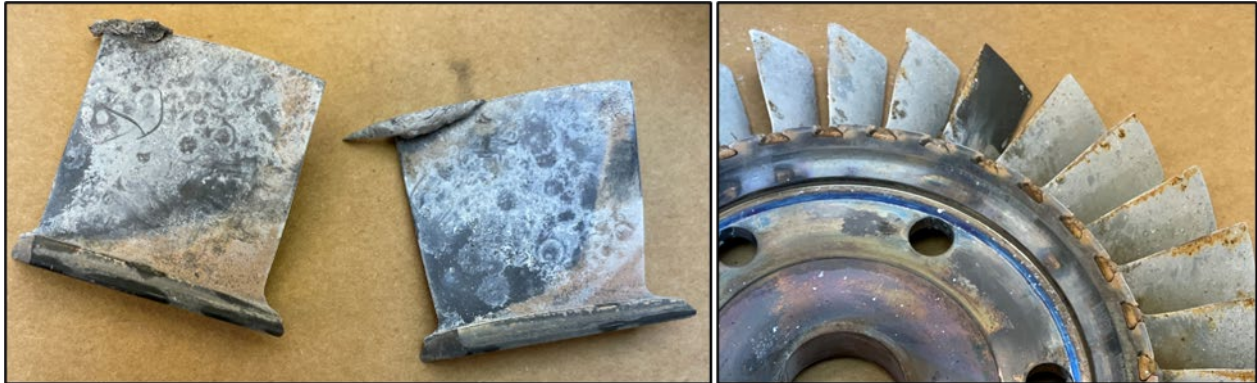
All three stages of the axial compressor had a white coating primarily on the gas path and airfoil surfaces. All parts had surface corrosion and oxidation in various locations. The six tie rods that secure the compressor rotors together were present and intact. All blade and vane airfoils appeared full length. Five stage 1 blade airfoils had blue-colored spots and two other blades had resolidified metal on the airfoil tips. Some stage 2 and 3 blades had rust spots. The forward-facing side of one stage 2 airfoil was distinctly cleaner than the rest (Figure 30).

**Figure 30.** Resolidified metal on stage 1 compressor blade tips (left) and single clean stage 2 compressor airfoil (right)

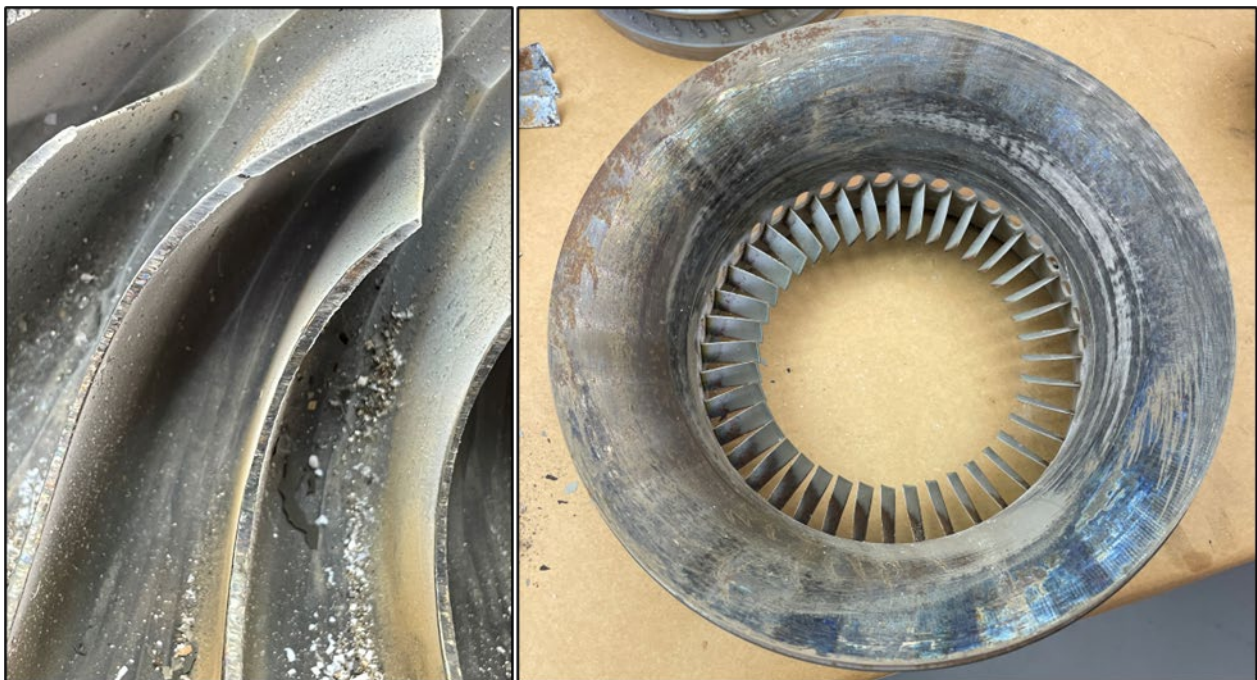
The impeller appeared intact. Circumferential rub marks were found along the entire length of the shroud edge lines and corresponding 360° rubs were found on the impeller shroud (Figure 31). The No. 2 roller bearing was dry and seized to the compressor stub shaft.

**Figure 31.** Rubs on impeller shroud edges (left) and on impeller shroud (right)

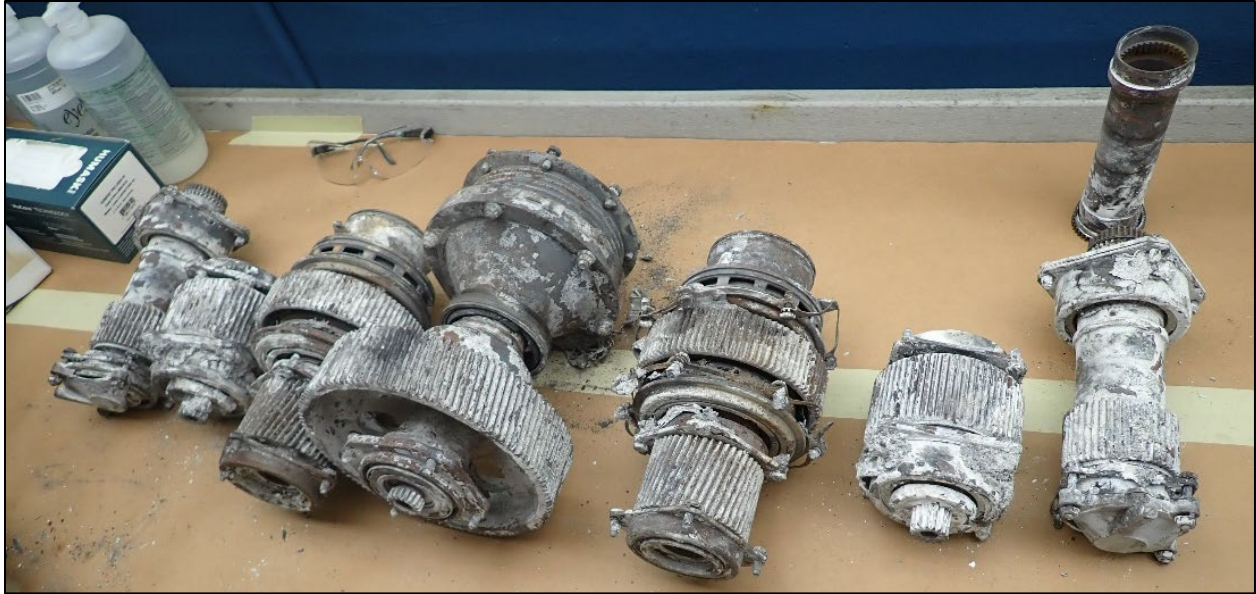
All combining gearbox gears were recovered. No gear teeth were missing and none of the gears appeared to have any pre-impact damage. All gears were coated white, had extensive thermal damage, and some had resolidified metal adhered to them. None of the components could be rotated by hand (Figure 32).

**Figure 32.** Reduction gearbox components

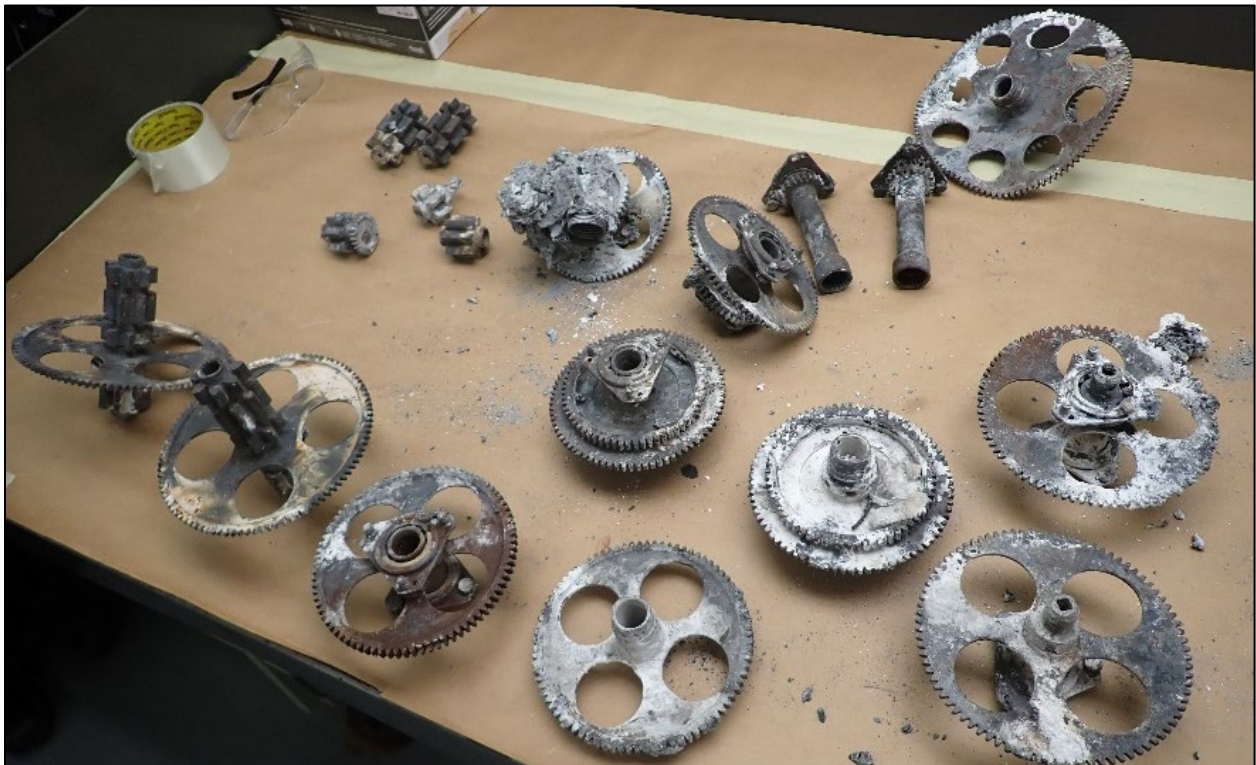
All accessory gearbox gears from both engines were recovered except for one “fuel pump/automatic fuel control unit” gear. No gear teeth were missing and no gears were found with pre-impact damage. All gears were coated with a white powder, had extensive thermal damage, and some had resolidified metal adhered to their surfaces (Figure 33).

**Figure 33.** Accessory gearbox gears
