# Materials Investigation – Laboratory Report

| Part No.: 3120872-01 | RFA No: [REDACTED] | Report No.: [REDACTED] |
| Part Name: BLADE-TURBINE | Date Received: 2024-03-20 | Page 3 of 17 |
| Serial No.: Various | Engine Model: PT6T-3 | Eng. Serial No.: 60529 |

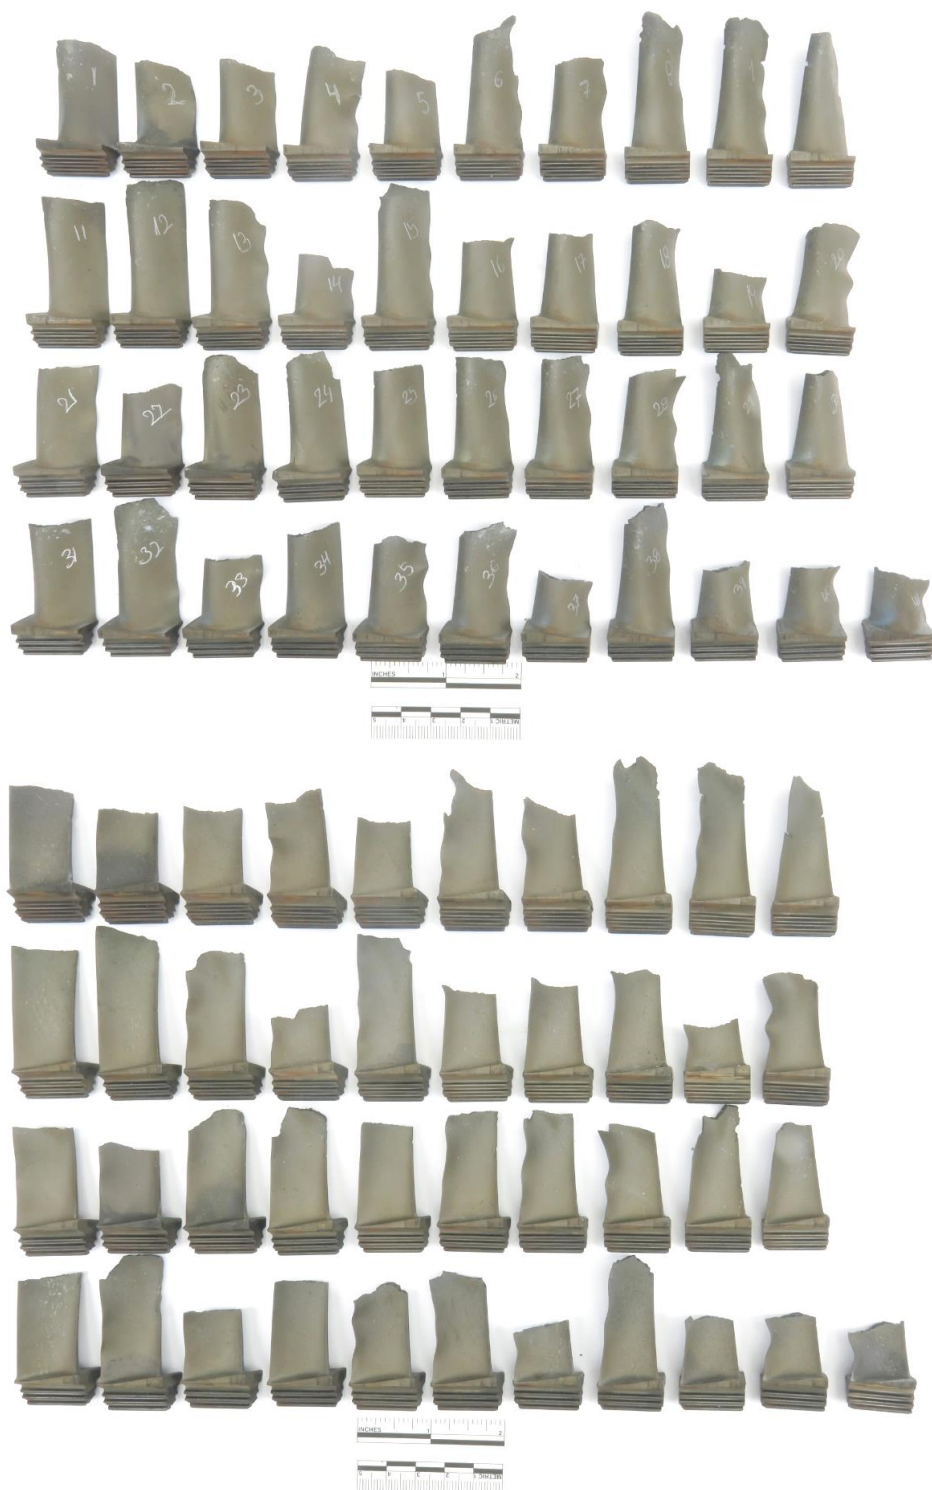
- Visual examination of all 41 turbine blades (P/N 3120872-01) showed fractographic features consistent with overload fracture. Plastic deformation and **mechanical** damage (such as rubbing damage, scrapes, dents and tears) elsewhere on the blades was consistent with **secondary** damage sustained during blade fragmentation during rotational motion. Consequently, it is likely that fracture and release of the outermost fragment(s) of the blades led to a cascade of fracture and damage during the distress event. No evidence of cracking by any progressive mechanisms such as fatigue, thermal fatigue or creep were observed.

**Figure 1** General view of forty-one (41) turbine blades (P/N 3120872-01) viewed from the suction (top) and pressure (bottom) sides, as received for examination. The blades were numbered at disassembly. The blades mostly generally displayed markings associated with heat codes [REDACTED] and [REDACTED] excluding two sets of three blades located diametrically opposite as assembled on the disc (blades #41: [REDACTED], #1: [REDACTED], #2: [REDACTED], #21: [REDACTED], #22: [REDACTED], #23: [REDACTED]). All blades were fractured at various heights and exhibited mechanical damage consistent with impact damage (i.e. most likely domestic object damage or DOD). Limited evidence of necking was observed.

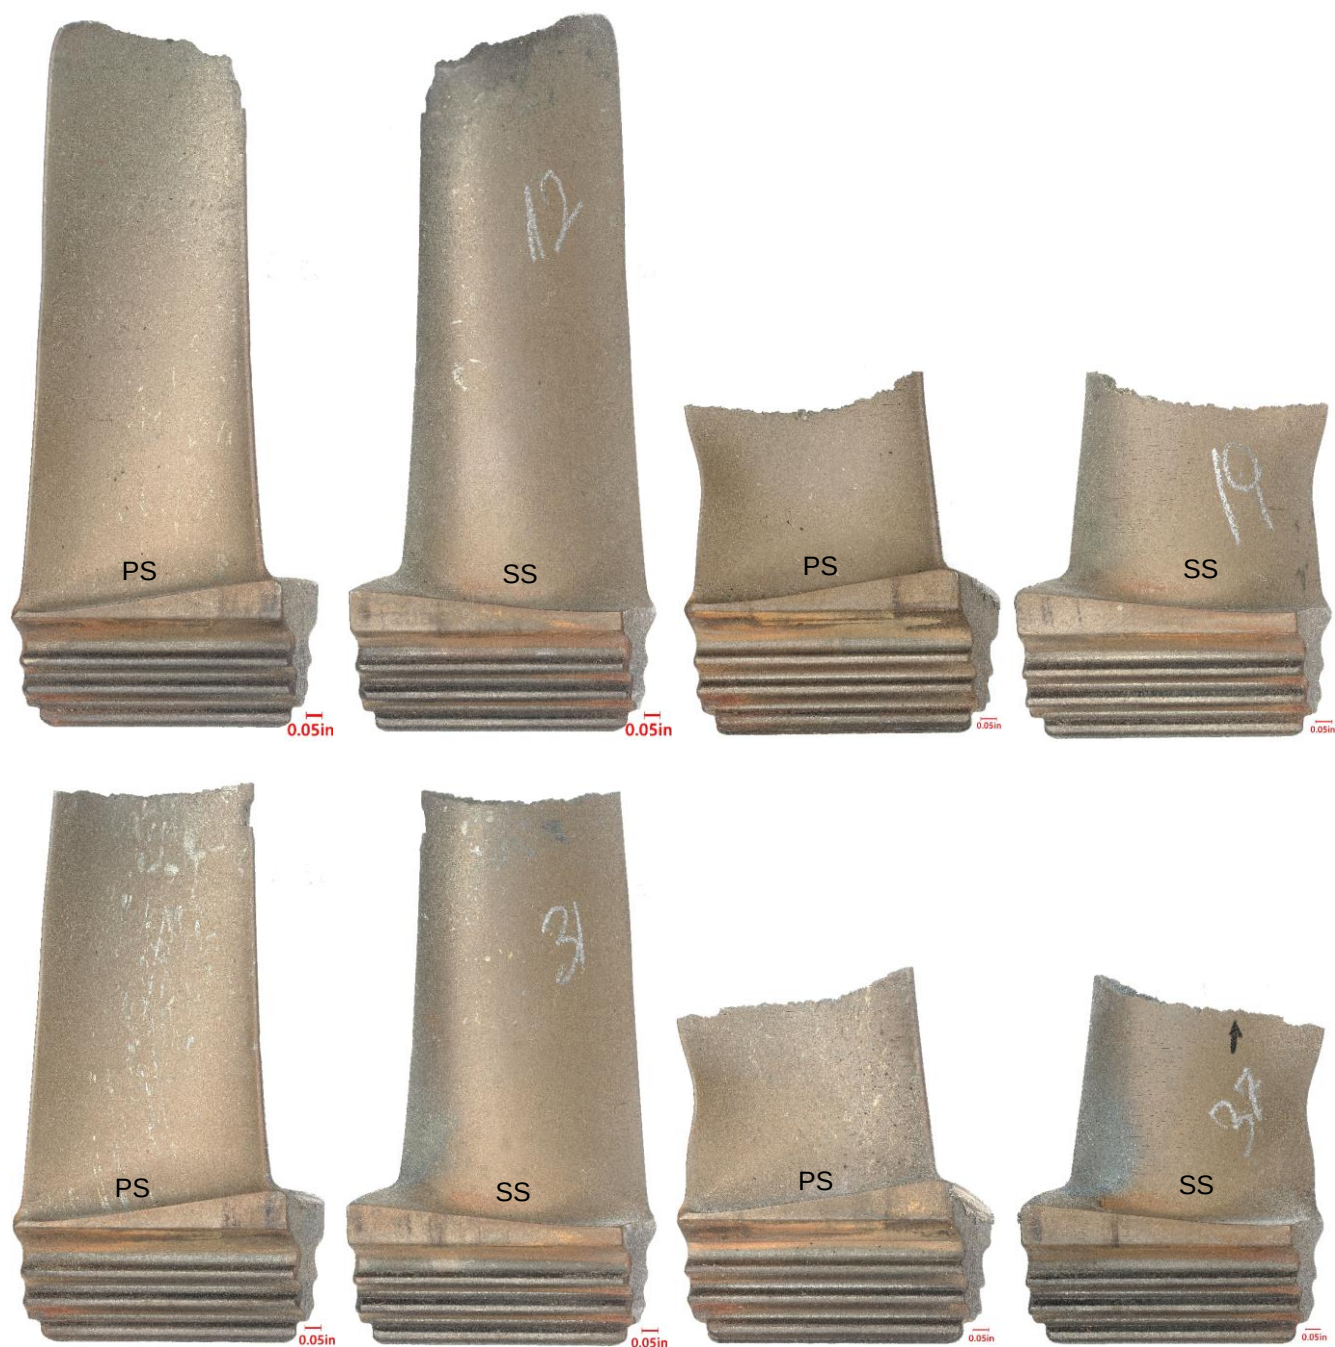
**Figure 2** General view of typical blades (#12, #19, #31 and #37) from the set (shown from the pressure and suction sides). Blades #19 and #37 were fractured at approximately 0.595in and 0.630in above the platform respectively. The trailing edge of both these blades was distorted due to impact damage. In contrast, blades #12 and #31 were fractured further up the blade (i.e. approximately 1.769in and 1.302in above the platform respectively) and exhibited limited impact damage apart from small chips/dents on the trailing edges of the blades. All examined blades exhibited limited evidence of necking which suggests no contribution from creep damage lead to the distress.

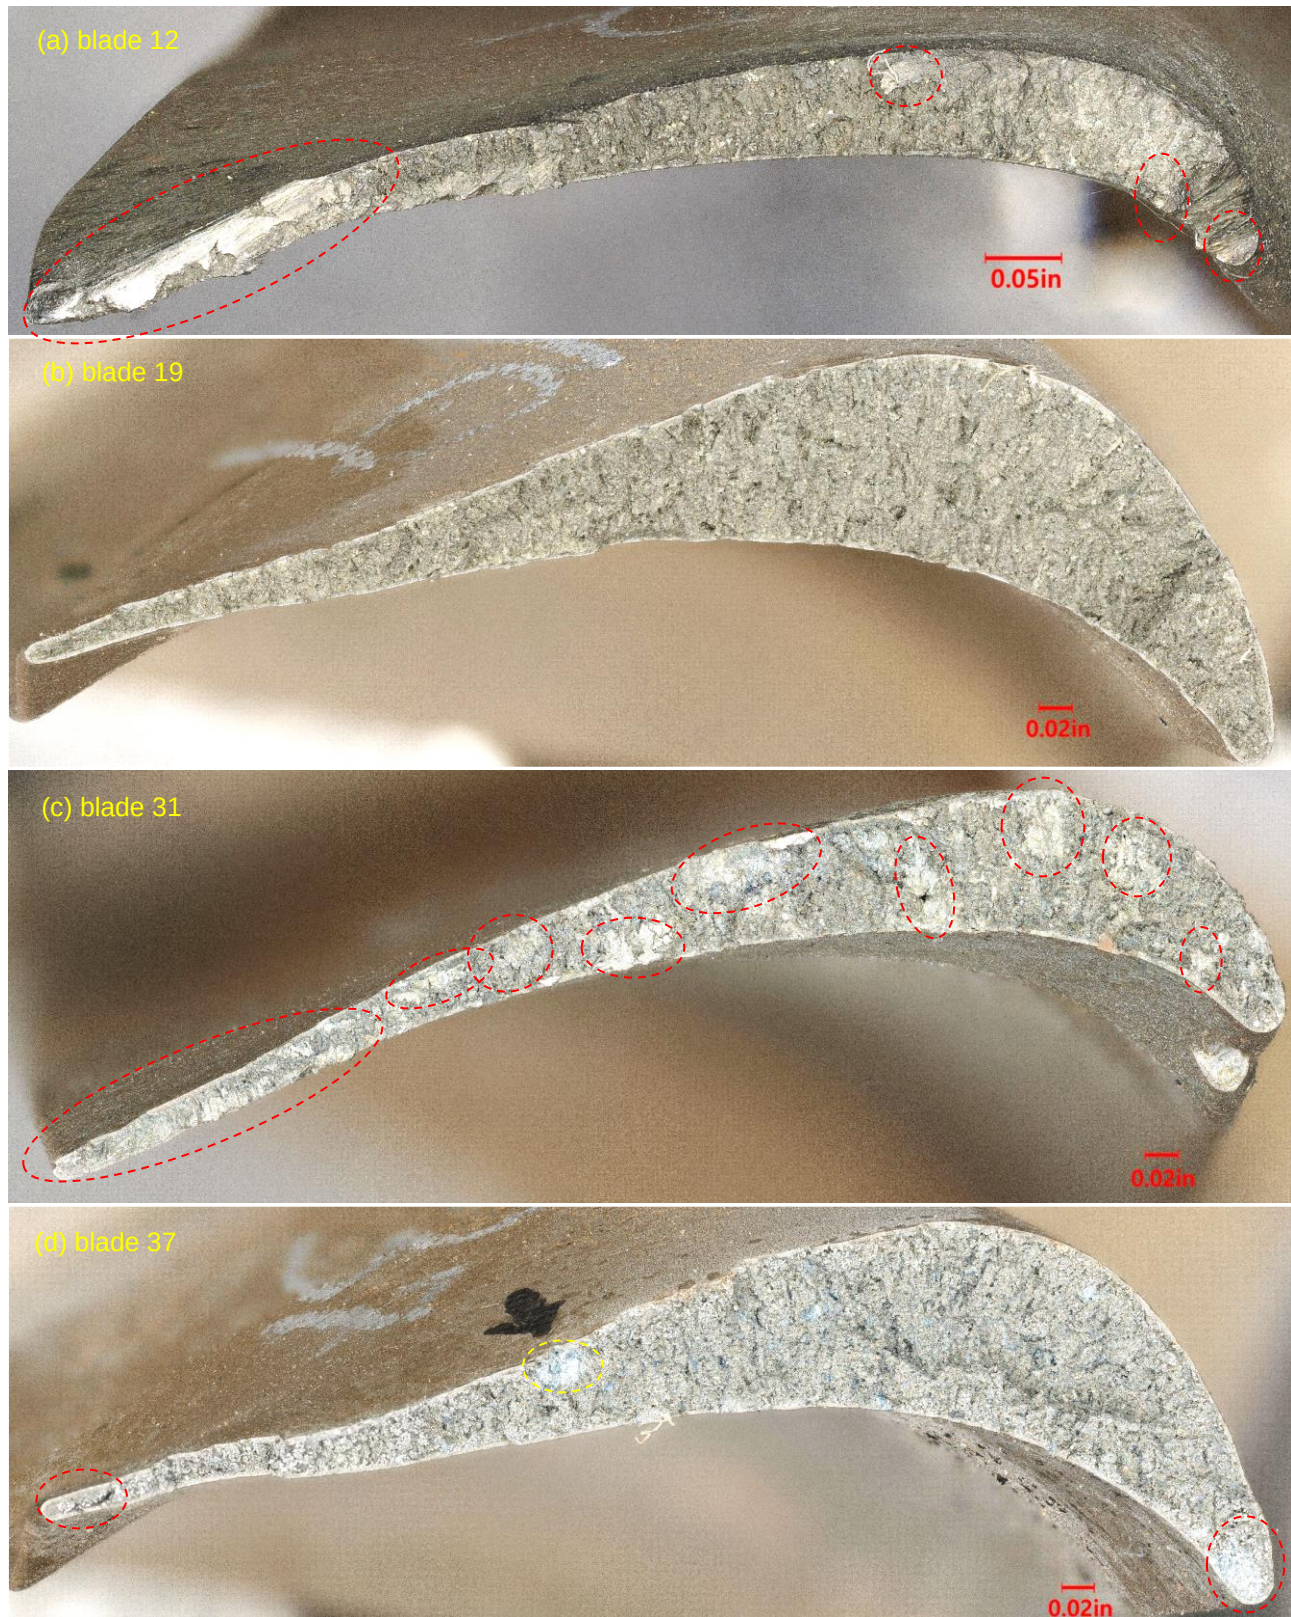
**Figure 3** Stereoscopic microscopy showed that the fracture surface of all turbine blades generally exhibited comparable rough topography. Typical fracture surface appearance of blades #12, #19, #31 and #37 is shown above. One area exhibiting a lustrous surface appearance on blade #37 (circled in yellow) which was not consistent with smearing or rubbing damage (as observed on other blades in the regions outlined in red). Figure 4e shows the typical appearance (by SEM) of these regions.

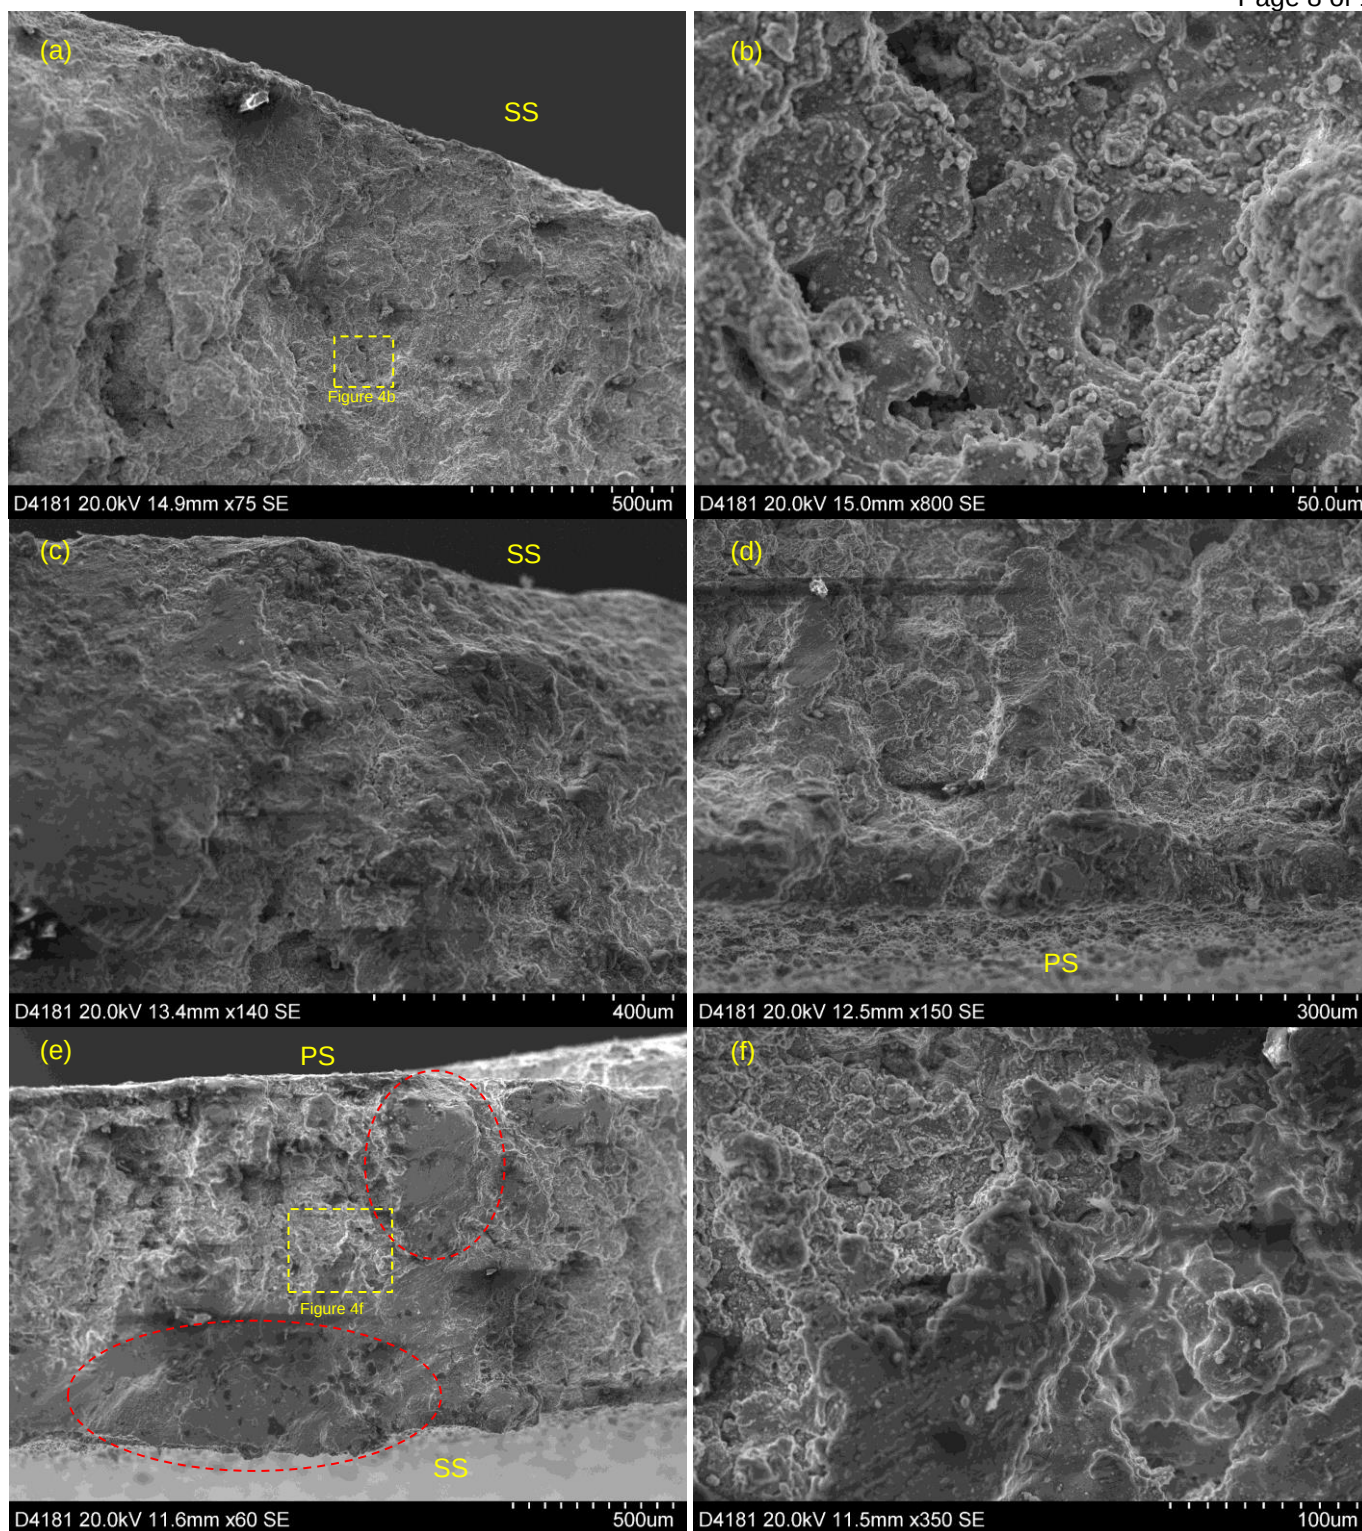
**Figure 4** Appearance of typical fracture regions on blade #12. The fracture surface was generally covered with splattered material and dispersed areas of post-fracture mechanical damage such as smearing/rubbing. Despite the fused appearance and dispersed areas of post-fracture damage, the blade fracture exhibited features consistent with overload fracture. Smearing and rubbing damage features generally had a flattened appearance, like those circled in red in Figure 4e, **consistent with secondary rubbing damage**.

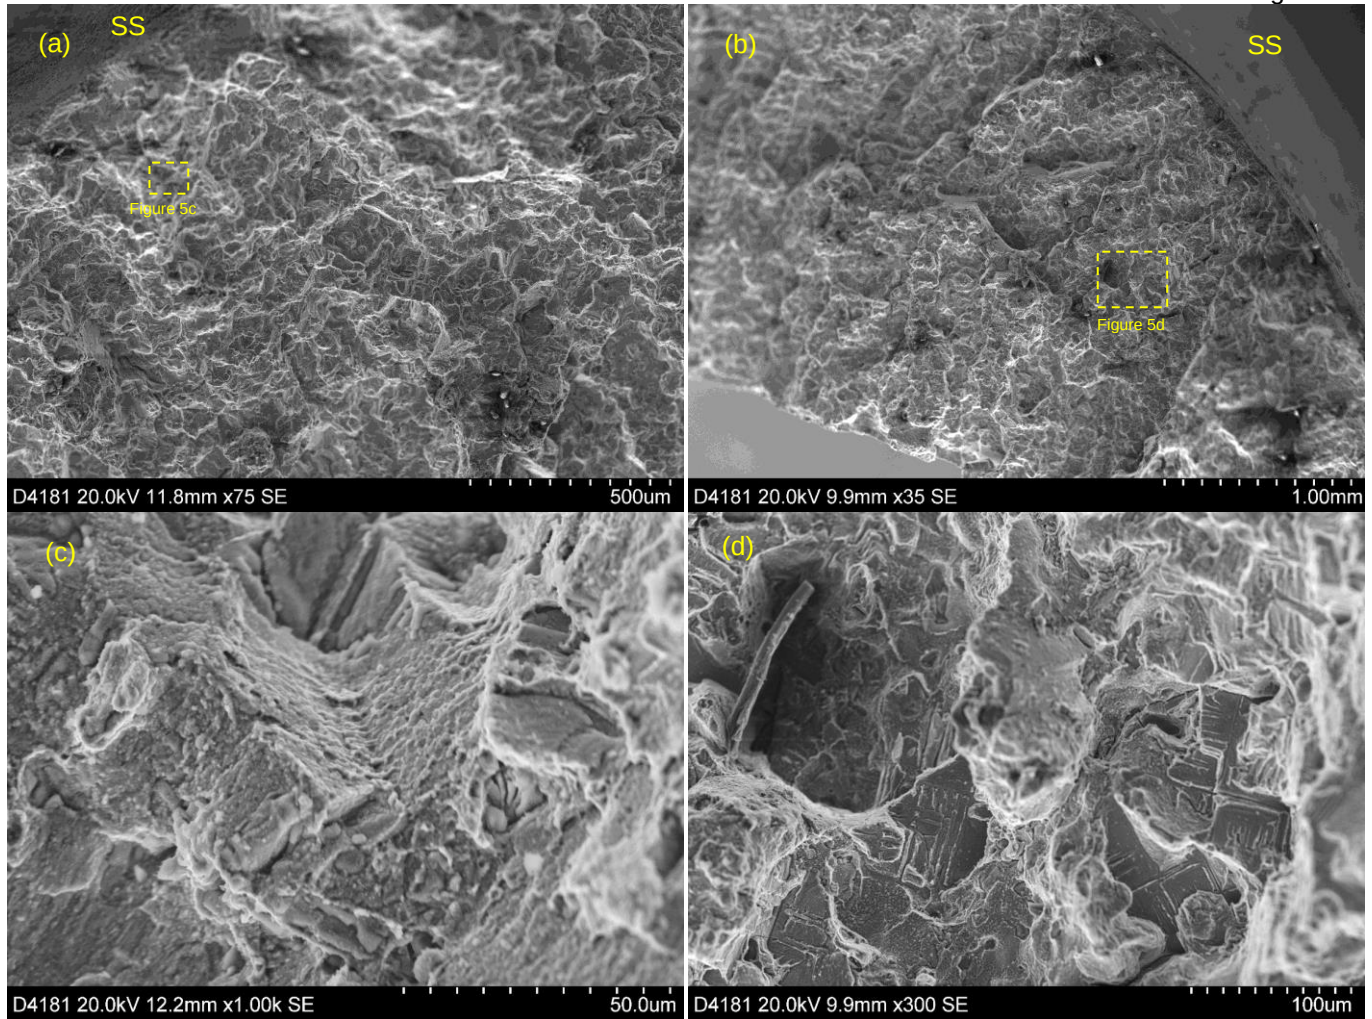
**Figure 5** Blade #19, which fractured much closer to the platform than blade #12, did not exhibit a splattered appearance. In lieu of splattered material, the fracture generally exhibited a fine dimpled appearance with select areas exhibiting cleavage-like fracture from secondary phases (such as Chinese script carbides) as shown in Figure 5d. The fracture surface appearance was consistent with ductile overload.

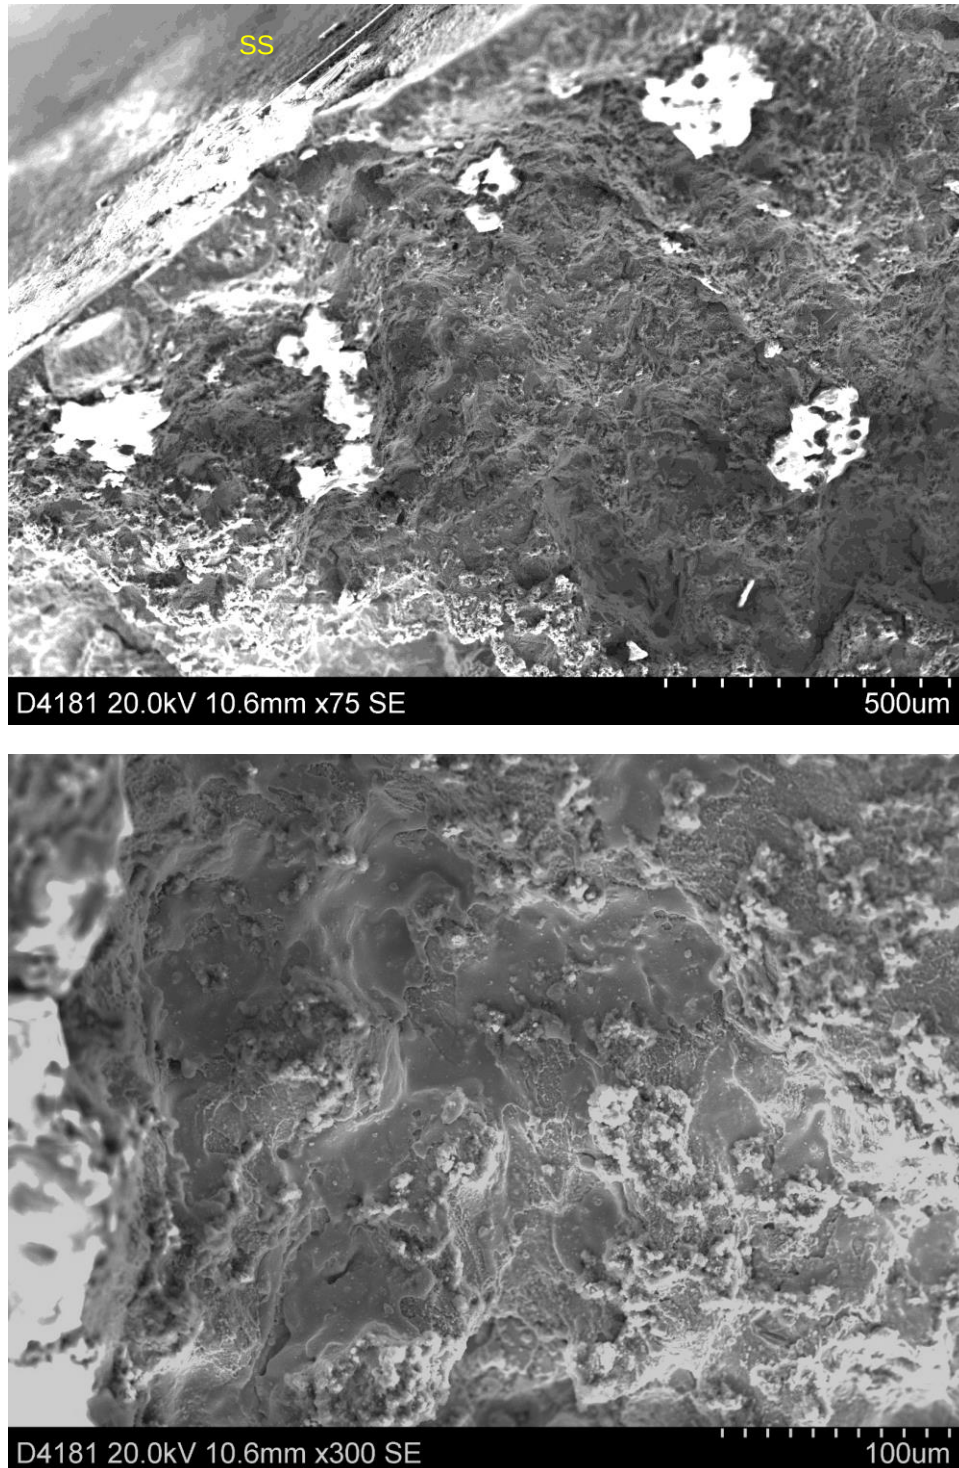
**Figure 6** General view of the lustrous region on the fracture surface of blade #37. This region exhibited a melted appearance similar to that observed on blade #12. The splattered/fused material generally flowed over the fracture surface from the suction side towards the pressure side. The remaining fracture surface appearance exhibited a morphology similar to that shown in Figure 5: namely fracture features consistent with “ductile overload”.

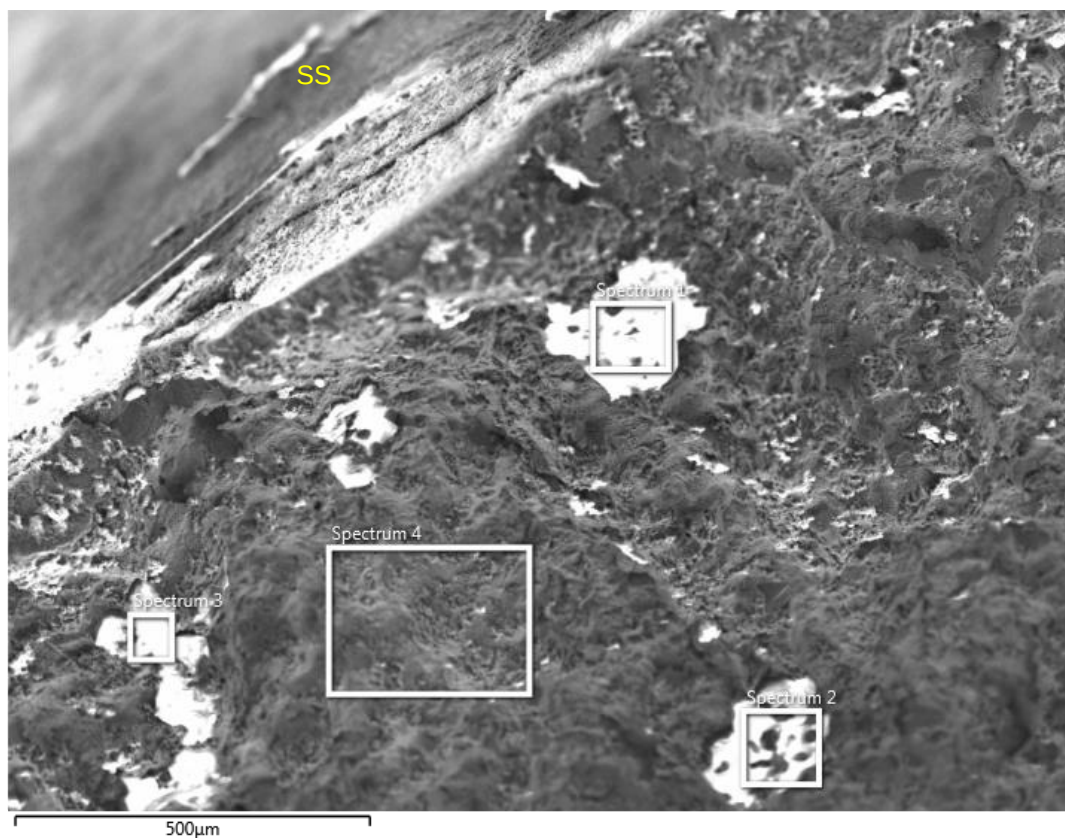
**Figure 7** Semiquantitative and standardless EDS completed on the lustrous region of the fracture surface from blade 37 showed notably high levels of magnesium. This suggests the resolidified material likely deposited/splattered onto the fracture surface from another magnesium-rich part (most probably the casing) after fracture occurred.

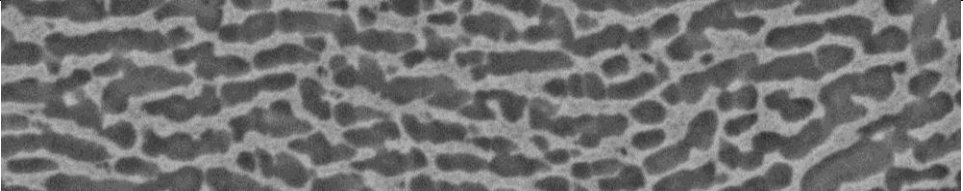
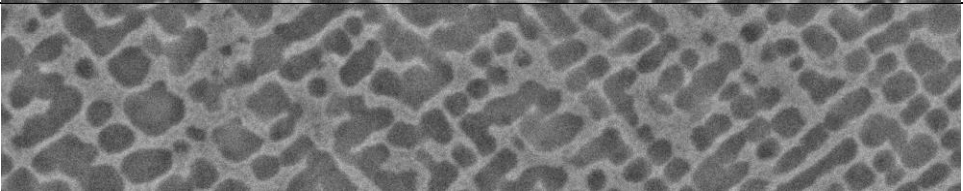
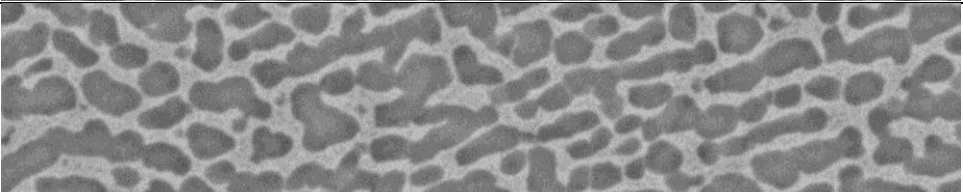
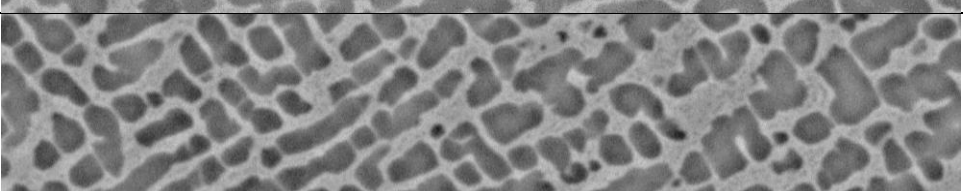
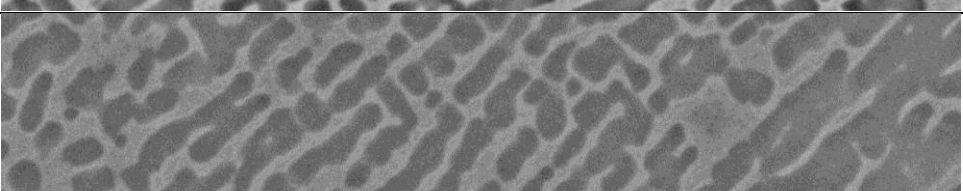
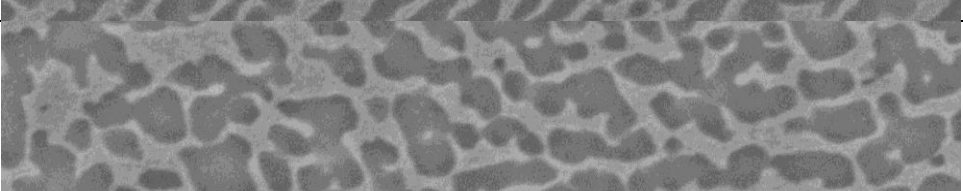
- Metallurgical cross sectioning of blades #1, #12, #23, #24, and #32 revealed that blades from heat codes [REDACTED] exhibited coarsening, rafting, solutioning and local reprecipitation of  $\gamma'$  phases (evidence of overheating leading to microstructural alteration) while blades from heat codes [REDACTED] did not. As heat codes [REDACTED] represented most of the two sets of three blades (positioned diametrically opposite to one another) and did not exhibit any microstructural evidence of overheating, it is likely that these six blades were replaced during an overhaul after the original blades were subjected to overheating cycle(s).

- Consequently, as evidence of overheating was observed on the entire cross section of the affected blades (including in the root) with no evidence of microvoids or microfissures (which would suggest creep damage) it is unlikely that this microstructure developed during service. It follows that the overheated microstructural condition (specifically reprecipitation/solutioning on the entire length of the blade) likely developed during manufacturing (or a subsequent heat treatment).

**Figure 11** Microstructure evaluation of blade 24 (HC [REDACTED]) at 0.125" from the trailing edge. The evaluation was completed up to 40mm (1.57 in) from the platform due to the fractured condition. The microstructure of the blade (including in the Root) exhibited solutioning as well a reprecipitation which would be consistent with overheating. Etchant: [REDACTED].

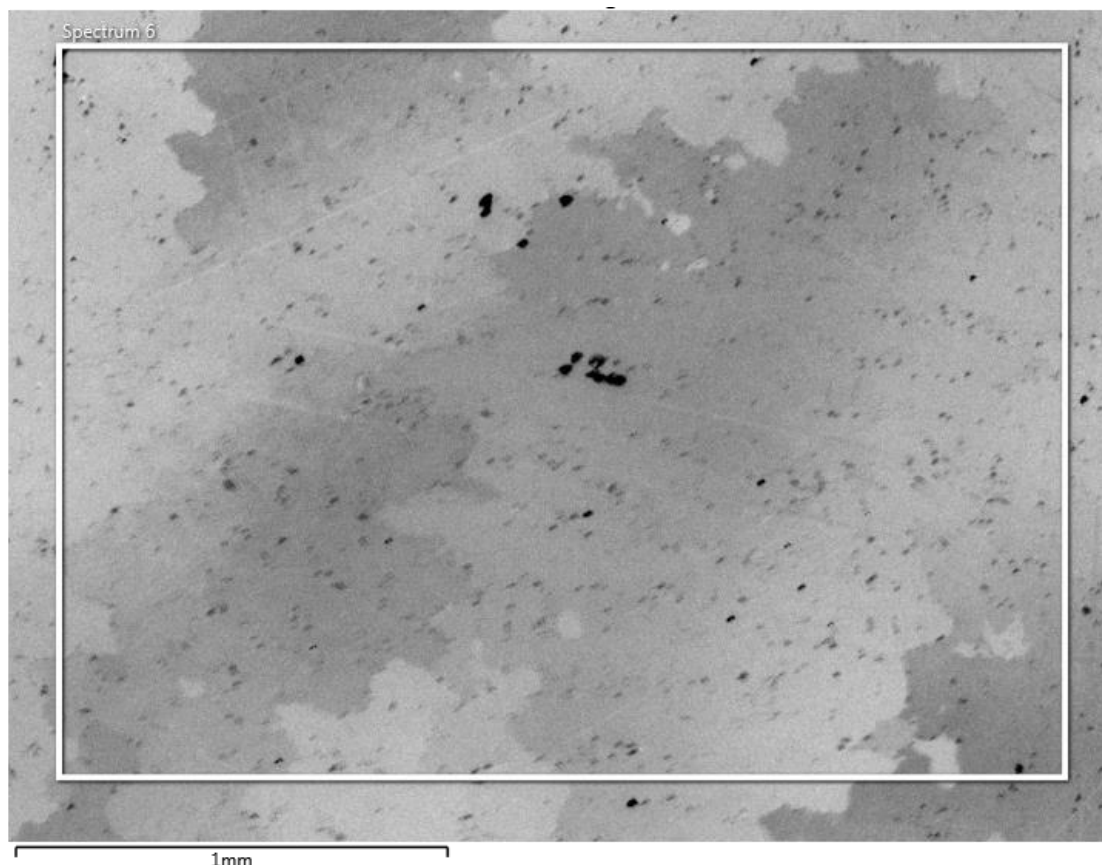
**Figure 13** Semiquantitative and standardless EDS was completed on the metallographic sections through blades #1, #24 and #32. The major alloying elements of the blade material were present in ratio's essentially consistent with the requirements of and no significant difference was noted between the blades from heat code and heat code .

Hardness testing of blades #1, #24 and #32 was completed on the same metallographic sections using the Vickers microhardness testing method. The average hardness of the blades measured , and respectively which converts to , and per ASTM E140. All individual and average hardness values met the requirements specified in .
