# National Transportation Safety Board

## **MATERIALS LABORATORY**

Factual Report 23-092

Location: Bullhead City, Arizona  
Date: September 5, 2023  
Vehicle: Rutan Long EZ, N58JB  
Investigator: Zoë Keliher, AS-WPR

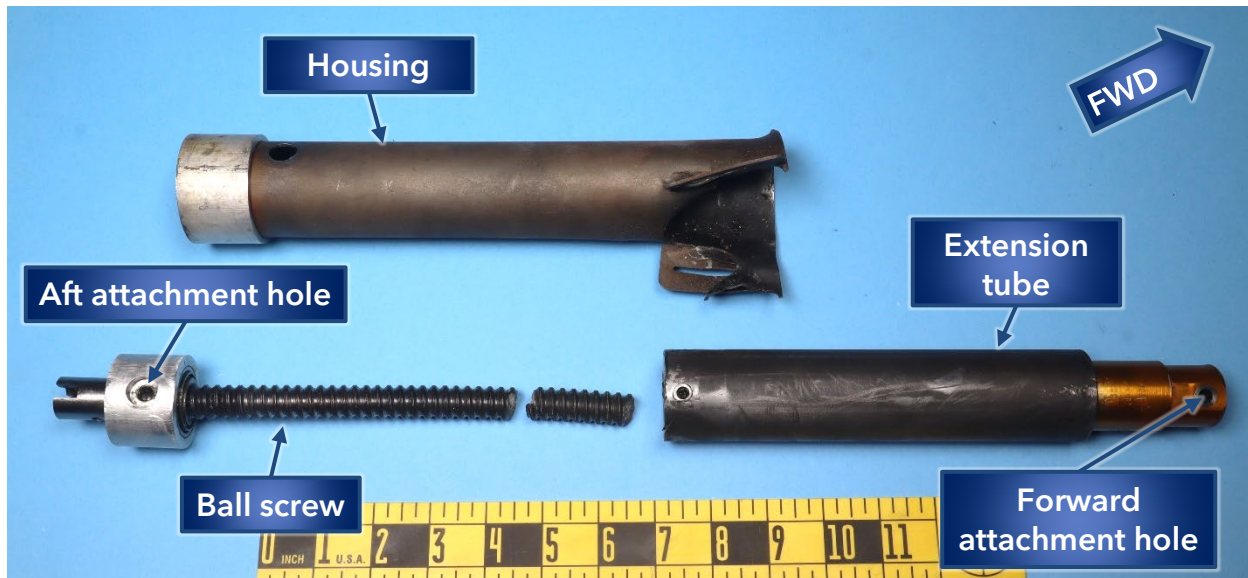
An overall view of the submitted components is shown in figure 1. The ball screw was bent and fractured in two locations. The forward end of the housing for the extension tube was fractured and splayed outward. No manufacturer or model number markings were observed on the submitted assembly pieces.

**Figure 1.** Overall view of the submitted ball screw assembly.

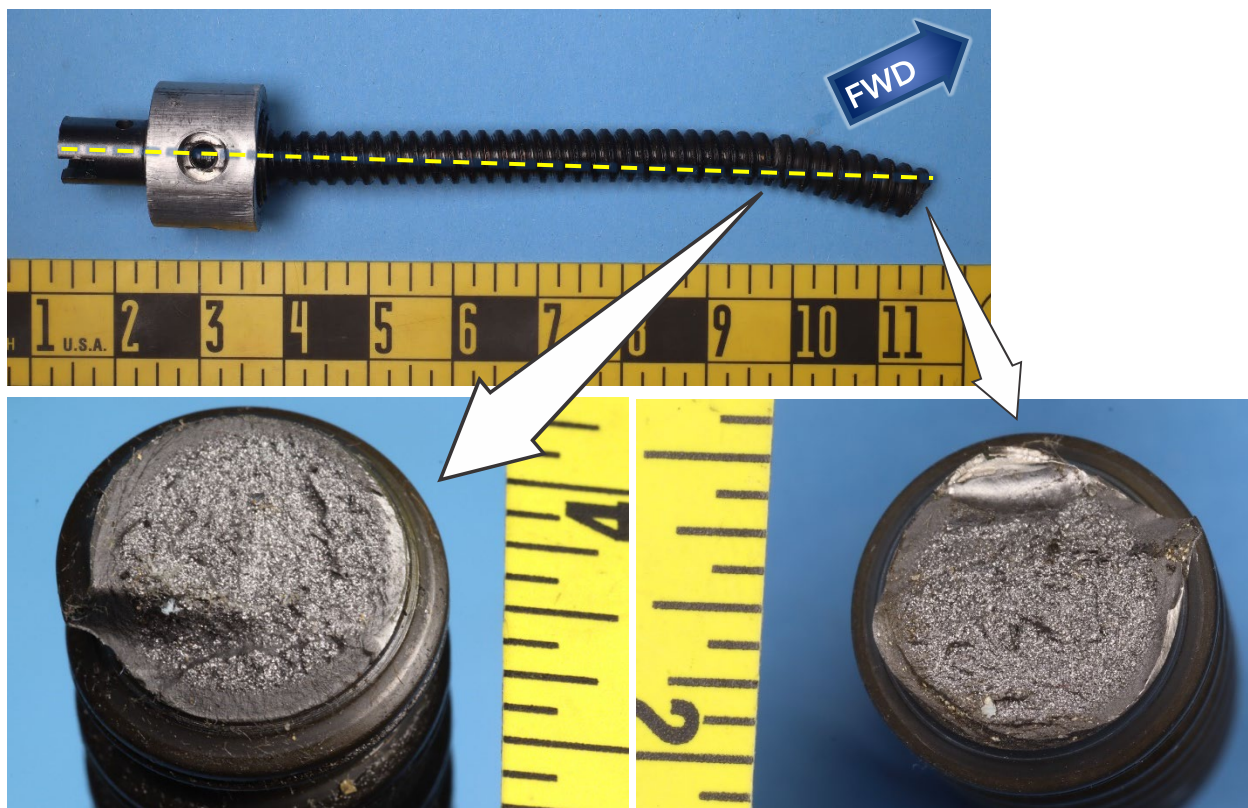
The ball screw was bent near the bearing at the aft end of the screw and in the opposite direction at the fracture locations near the forward end of the screw. In the upper image in figure 2, the original axis of the ball screw is indicated with a straight dashed line aligned to the aft end of the shaft, which highlights the deformation of the ball screw which formed an elongated "S" shape. Fracture features associated with the ball screw fractures are shown in the lower images in figure 2. The fractures showed matte gray features on slant angles around the circumference with a middle portion that was rougher and more reflective. Overall, the deformation and fracture features associated with the ball screw were consistent with buckling deformation and overstress fracture. No evidence of a preexisting crack was observed.

The total length of the exposed ball screw pieces shown in figure 2 were measured with calipers, and the length of the screw portion of the assembly from the bearing face at the aft end of the screw to the fracture surface at the aft end of the extension tube was approximately 7.42 inches. Additionally, the overall length of the ball screw assembly between the attachment hole centers at the time of fracture was measured by adding (1) the distance from the aft attachment hole center to the aft ball screw fracture, (2) the distance between the two ball screw fractures, and (3) the distance from the aft end of the extension tube to the forward attachment hole center. The total length obtained by adding the three measurements was 17.41 inches. For comparison, an engineering drawing for the EZ-Noselift NL1-12 for installation on the Long EZ aircraft measures 16.711 inches between the forward and aft attachment hole centers when fully extended.

**Figure 2.** The upper image shows the ball screw with mating fracture features in close proximity where a dashed line indicates the original axis. The lower images show the aft side of the fracture at each of the two fracture locations.

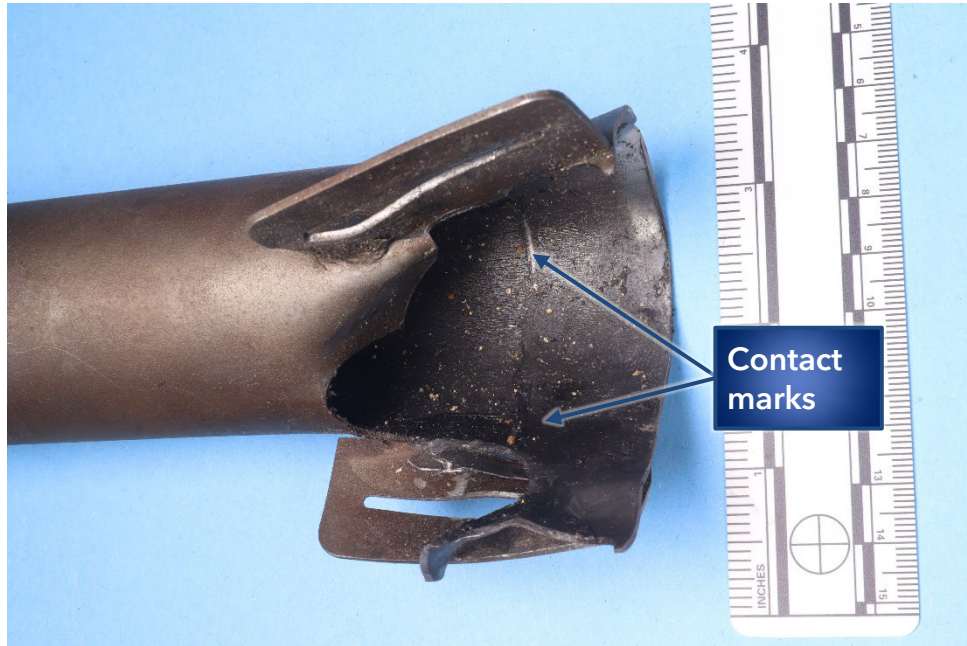
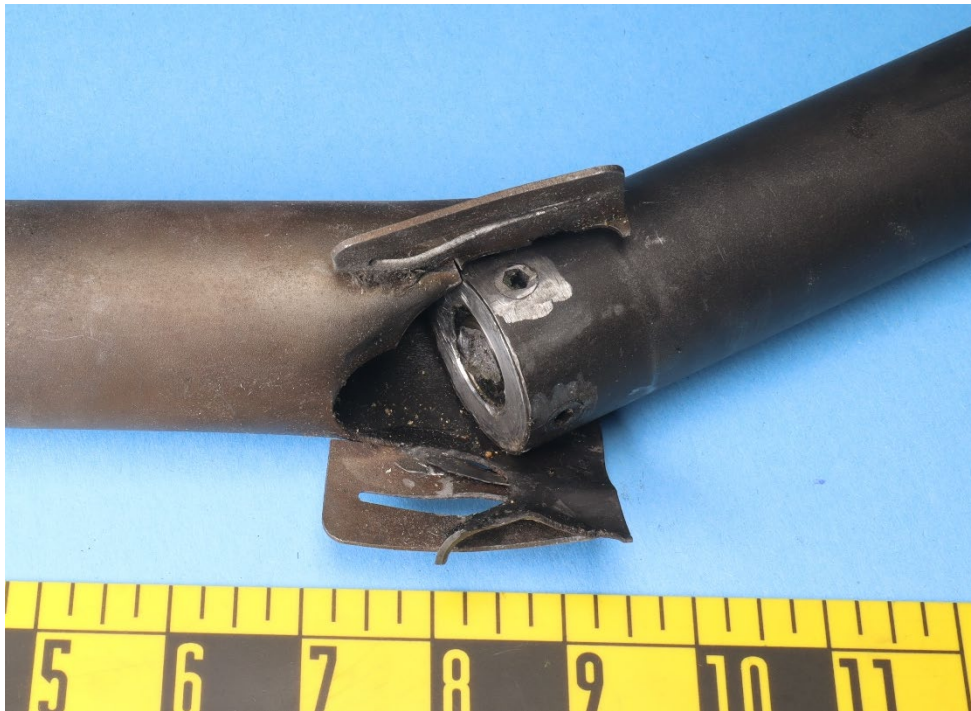
The forward end of the housing was fractured and splayed outward as shown in figure 3. The housing fracture surfaces were on slant angles consistent with ductile overstress fracture. Contact marks were also observed on the interior surfaces of the tube. The overall deformation and contact patterns were consistent with off-axis contact between the housing and the extension tube. In the lower image in figure 3, the extension tube is shown resting against the deformed surfaces of the housing, illustrating relative axial displacements associated with the observed deformation patterns and contact marks.

**Figure 3.** Forward end of the housing showing contact marks and deformation patterns (upper image). In the lower image, the extension tube is shown placed against the deformed surfaces at the forward end of the housing.
