# National Transportation Safety Board

WPR23LA340

## **MATERIALS LABORATORY**

Factual Addendum 23-092B

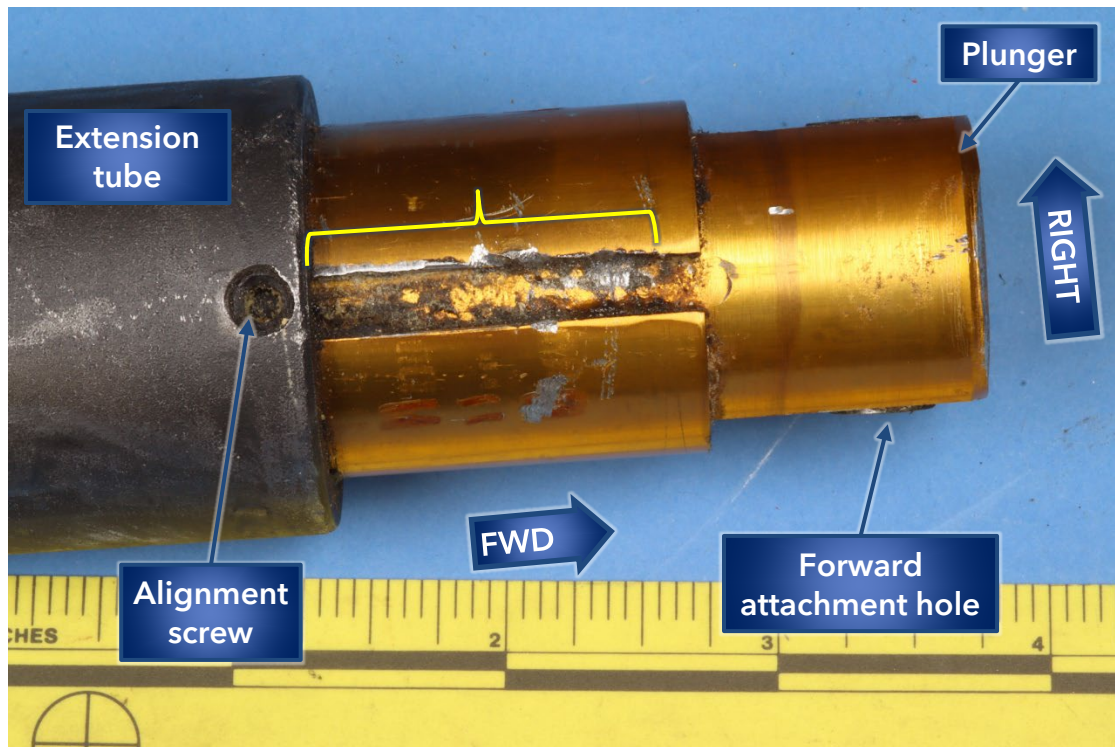
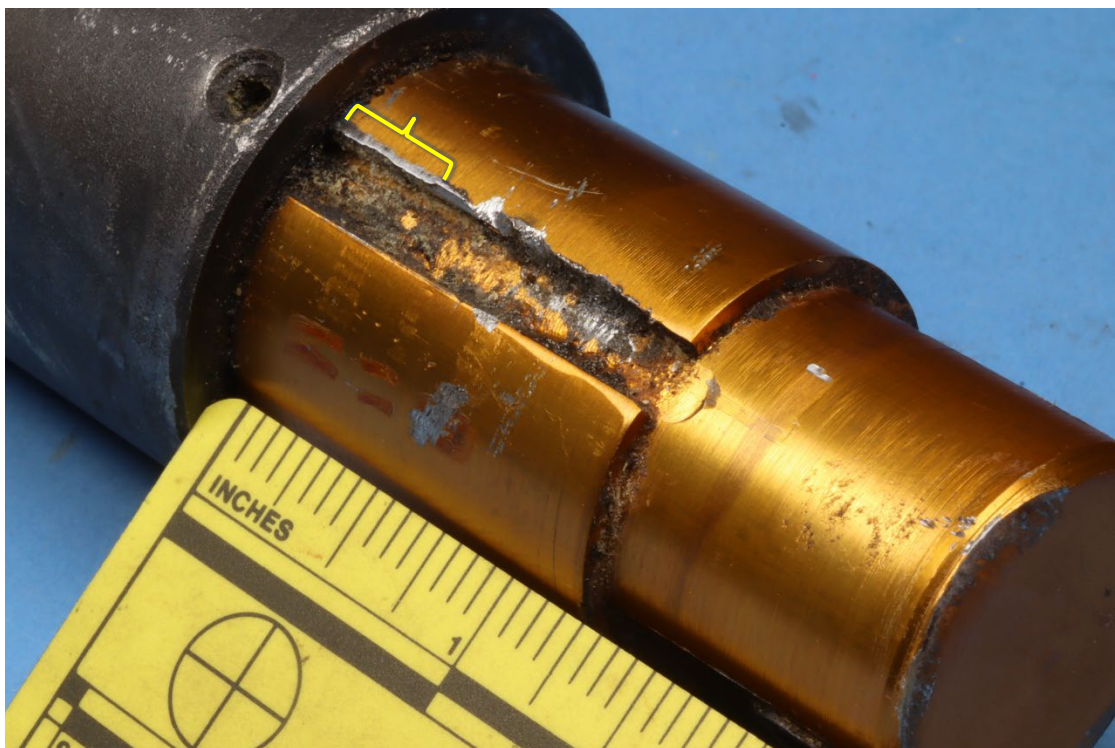
As shown in figure 1, within approximately 1.194 inches from the forward end of the extension tube, the right side of the keyway slot in the plunger was deformed and damaged with material that was lipped radially outward (unlabeled bracket in the upper image in figure 1). Within approximately 0.394 inch from the forward end of the extension tube, the deformed material at the right side of the keyway appeared flattened (see unlabeled bracket in the lower image in figure 1).

The center of the alignment screw was located approximately 0.156 inch aft of the extension tube forward end, and a step change in diameter of the plunger was located 1.327 inches forward of the extension tube. By calculation, if the center of the alignment screw was aligned with the lower forward end of the damage on the right side of the keyway slot, the plunger would be compressed 1.350 inches into the extension tube, and the lower forward end of the extension tube would extend 0.023 inch beyond the change in diameter of the plunger. Disturbed metal was observed on the right and left sides of the extension tube at the forward end.

**Figure 1.** Close views of the lower side of the plunger at the lower forward end of the extension tube. An unlabeled bracket in the upper image indicates contact damage at the right side of the keyway for the plunger consistent with contact with the alignment screw. An unlabeled bracket in the lower image indicates an area where the raised lip at the deformed edge of the keyway was flattened.
