# National Transportation Safety Board

WPR23LA343

## **AIRFRAME AND ENGINE EXAMINATION**

Location: Monticello, Utah  
Date: September 13, 2023  
Time: 1100 Mountain daylight time  
Airplane: N10KP, Boeing A75N1

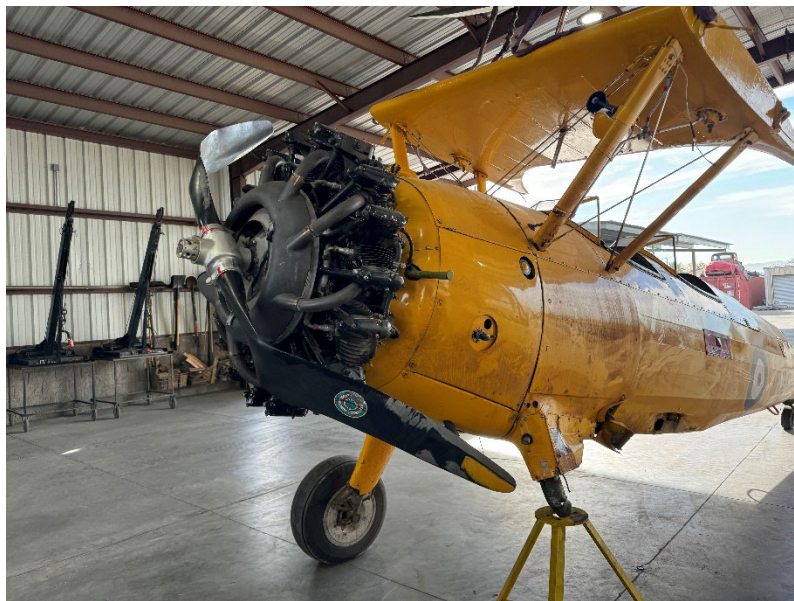
Examination of the recovered airframe and engine revealed that the left main landing gear was separated, the upper and lower wings, vertical stabilizer, rudder, elevators, and horizontal stabilizer were removed to facilitate transport. Throttle and mixture control continuity was established from the rear cockpit controls to the engine. All fuel lines and fittings were found secure. No evidence of any fuel leaks was observed throughout the fuel system.

**Figure 1: Recovered engine and airframe.**

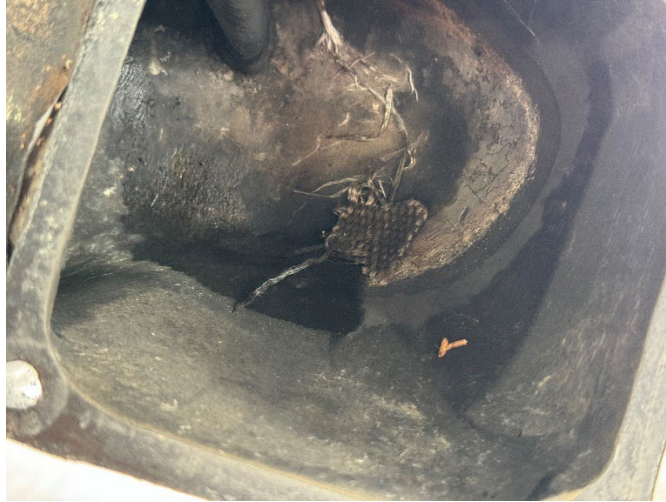
the starter was engaged. Spark was obtained on all 18 ignition leads. The induction system was removed. Remains of high temperature cloth was found between the air filter and particle screen and appeared to have been in place for some time. No cloth debris was observed in the filter or induction screen.

**Figure 2: Remains of the high temperature cloth in the induction system.**
