WPR23LA346

## INVESTIGATION PHOTOGRAPHS

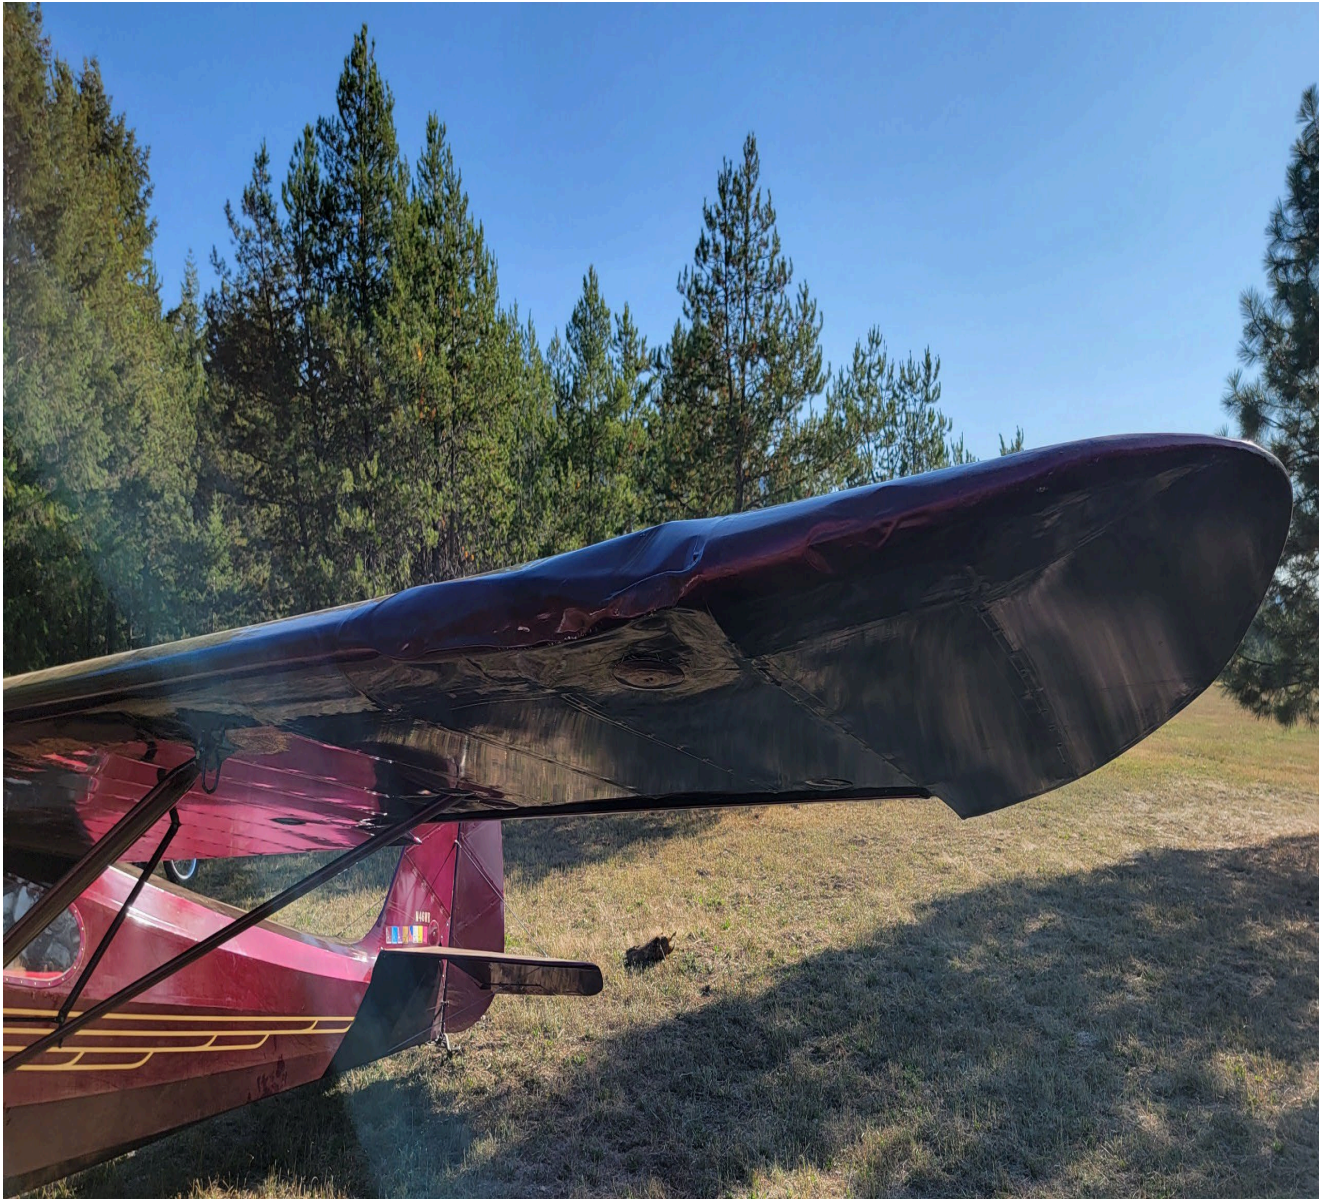
**Photograph 1 - View of damage to left wing (photo courtesy of law enforcement officer)**

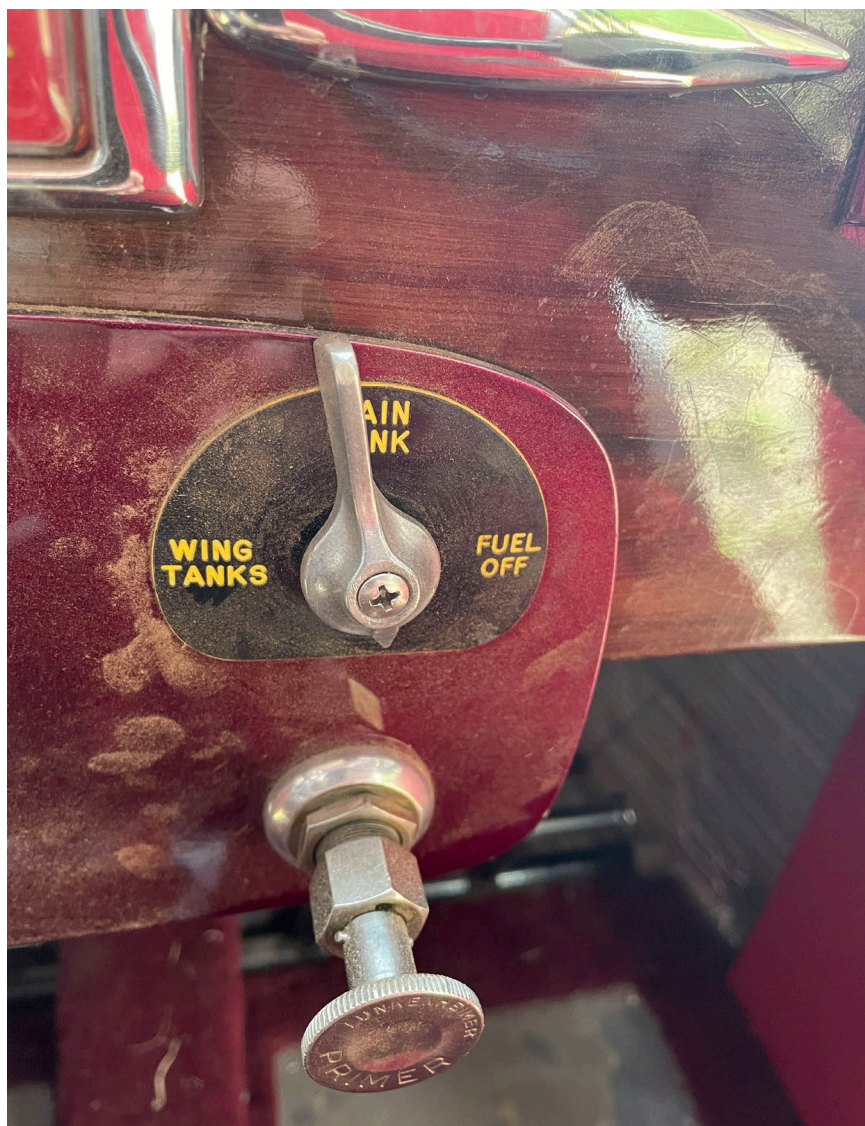
**Photograph 2 -View of fuel selector valve pointer positions (photo courtesy of FAA inspector)**
