Photo 1 –N3932G at the accident site. Photo courtesy of the owner.

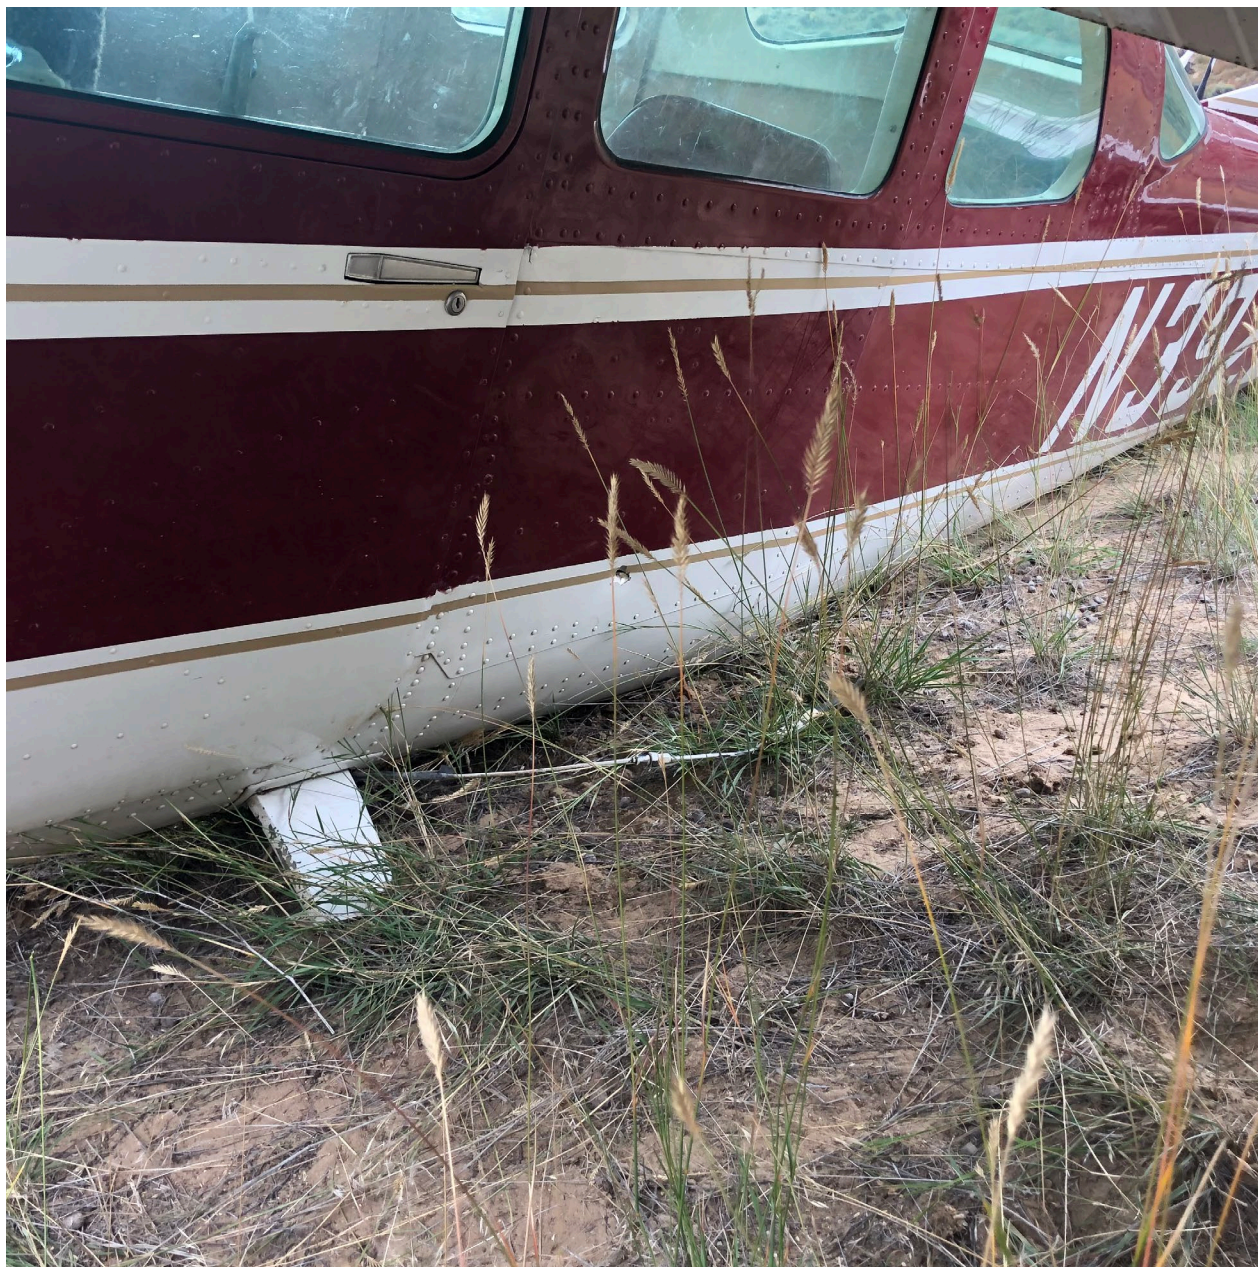
Photo 2 – Left main landing gear station. Photo owner.

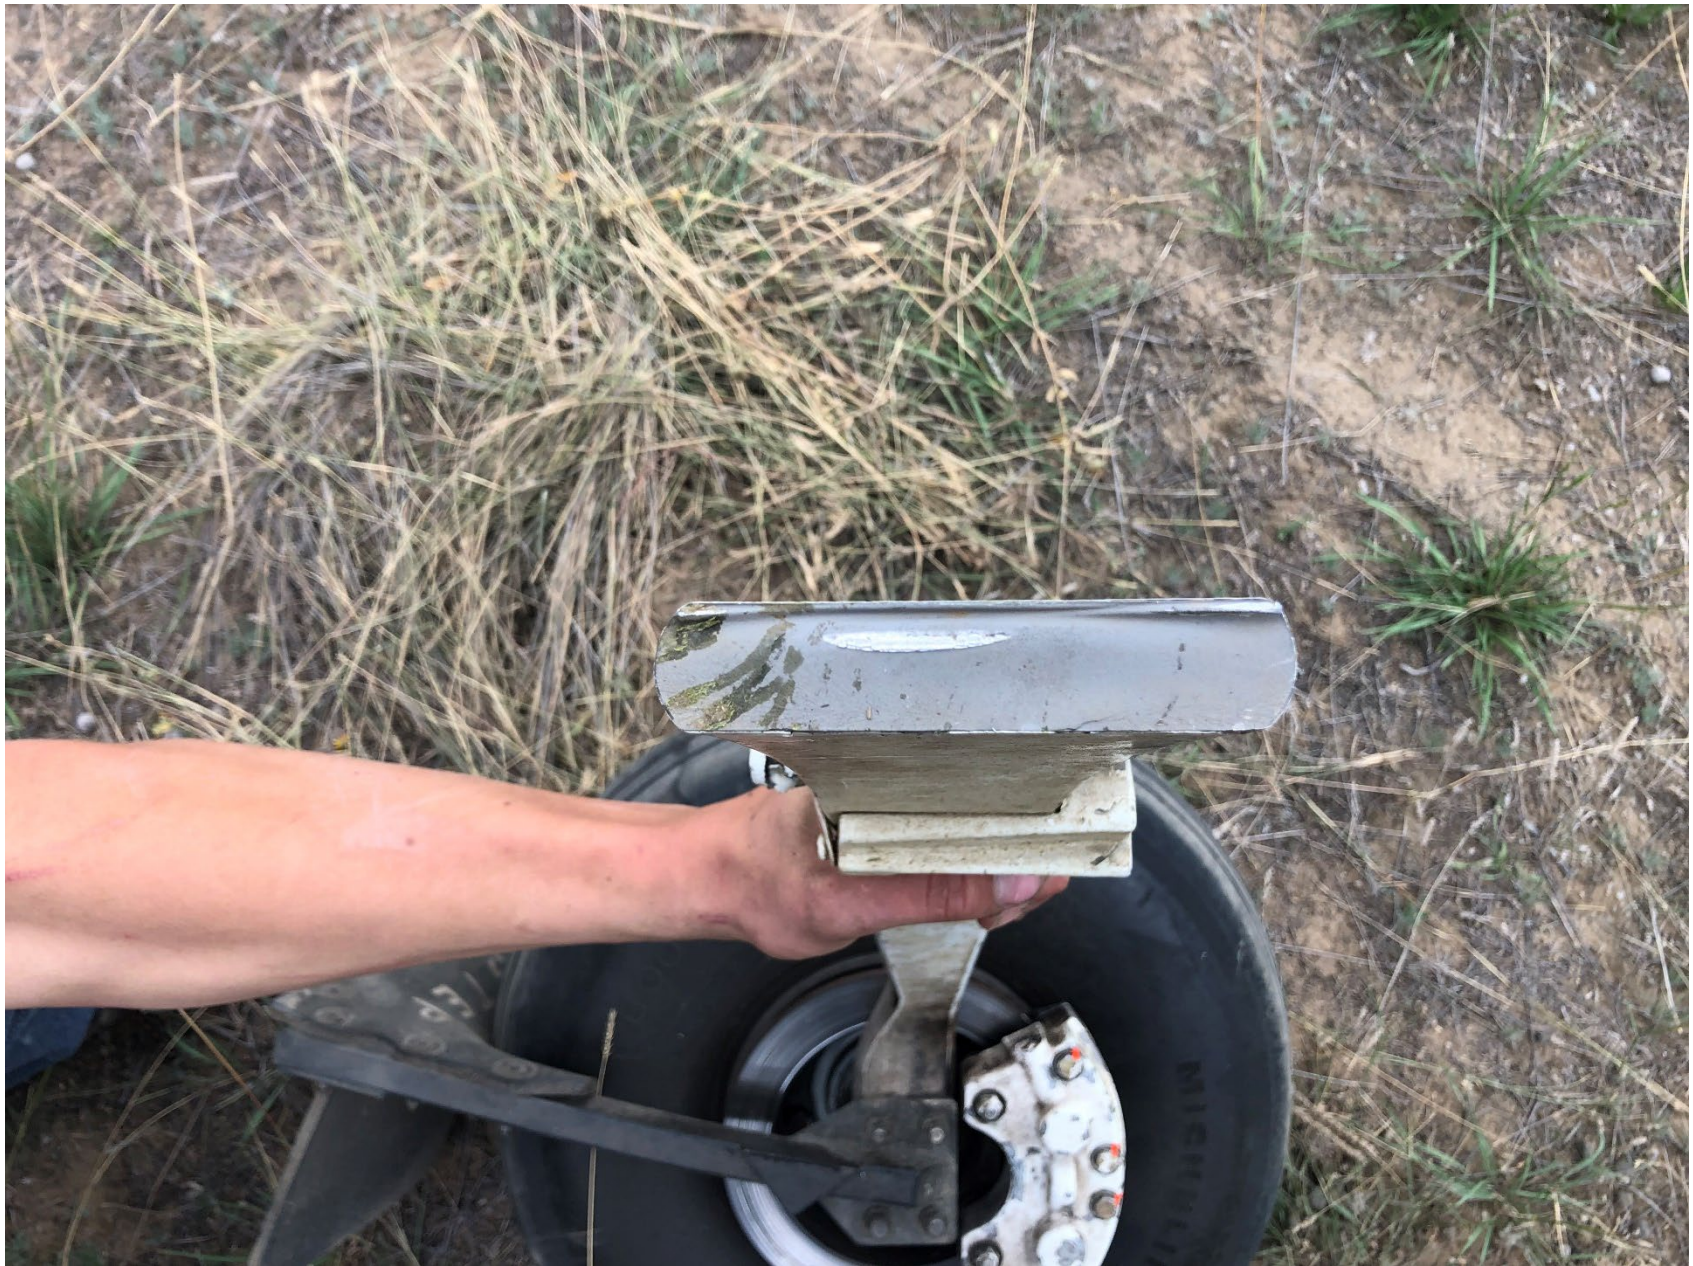
Photo 3 – Left main landing gear assembly. Photo owner.
