# National Transportation Safety Board

WPR23LA350

## **MATERIALS LABORATORY**

Location: Challis, ID  
Date: 9/20/2023  
Vehicle: Cessna U206C, N2923G  
Investigator: Fabian Salazar, AS-WPR

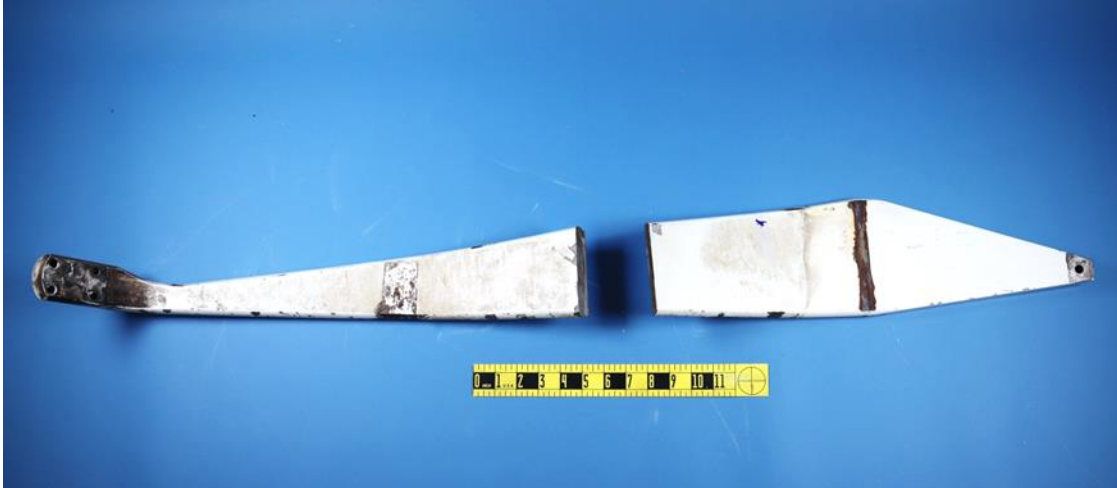
**Figure 1** shows the landing gear leg as received. The leg had fractured into two parts. The inboard piece was approximately 20.5 inch in length, and the outboard piece was approximately 22.75 inch in length.

**Figure 1.** Left landing gear leg as-received.

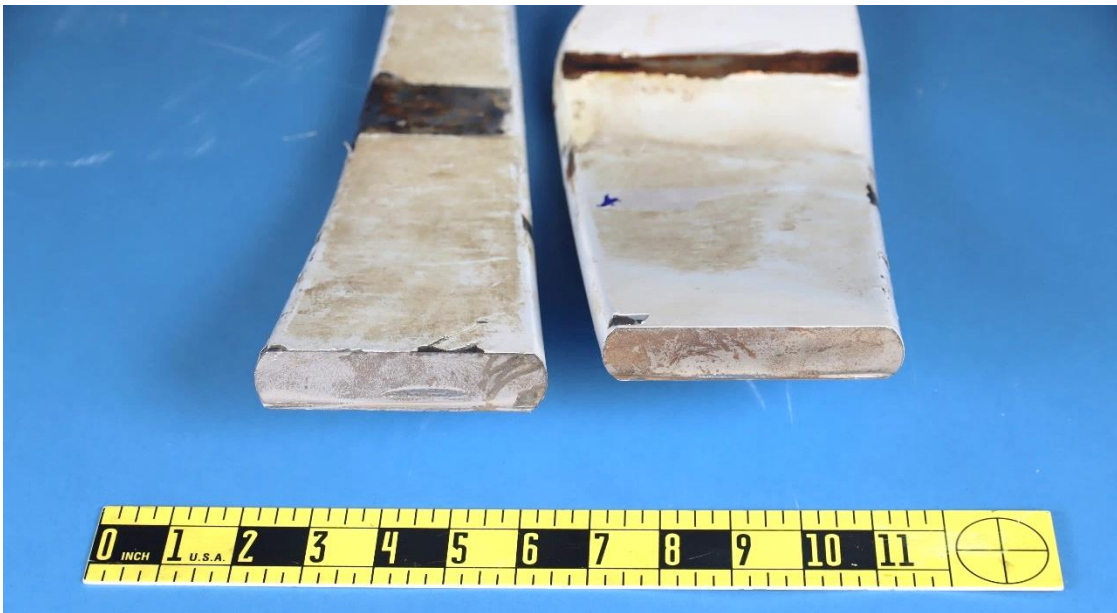
The fracture surfaces are pictured side-by-side in **Figure 2**. The surfaces were mostly planar and perpendicular to the length of the leg. The appearance of the surfaces was rough and dull, consistent with ductile overload failure. Areas of corrosion product were present in this region of the surface

**Figure 2.** Fracture surfaces side-by-side.

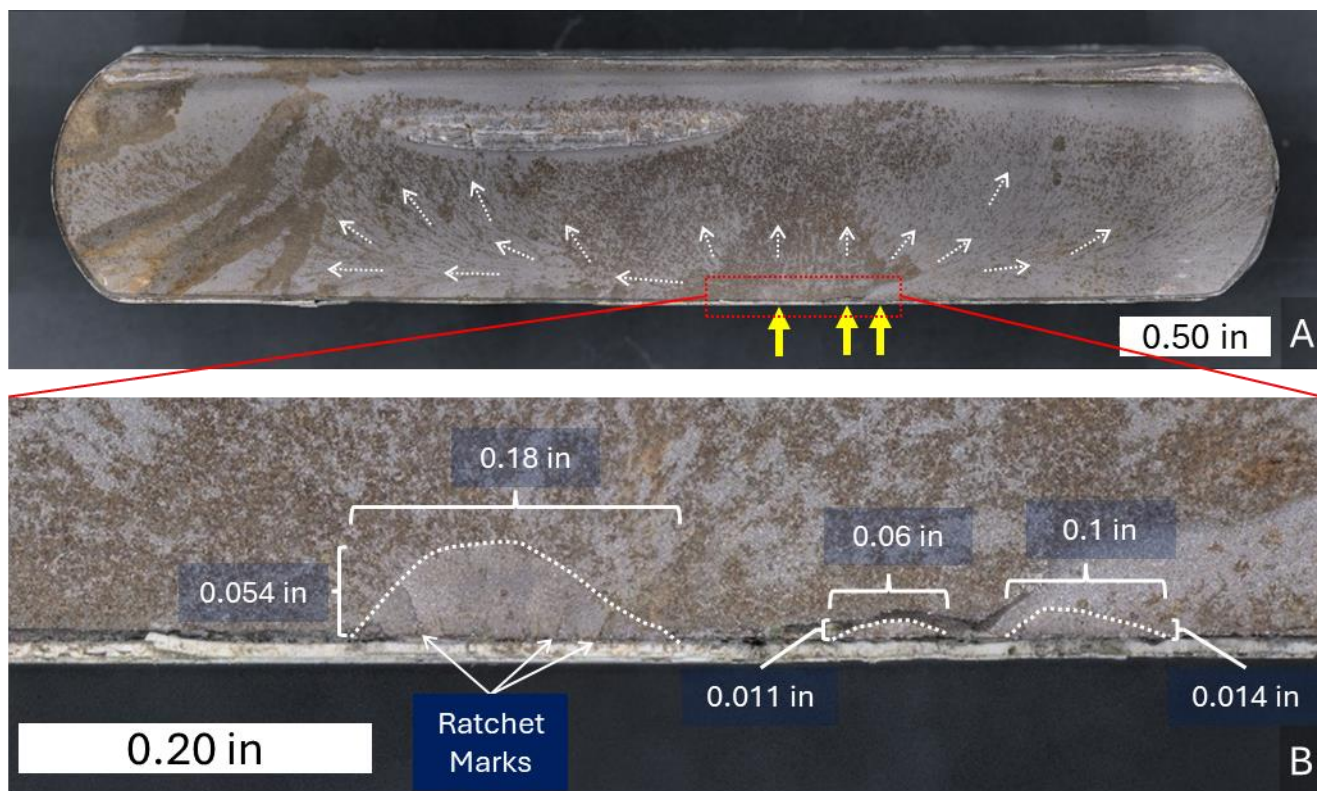
The outboard fracture surface was subjected to cleaning with acetone and closer examination. The surface exhibited chevron marks radiating from an area on the lower surface, shown in **Figure 3**. Three adjacent thumbnail-shaped features were present on the lower surface. The largest of these features measured 0.18 inch across, with a depth of 0.054 inch. This feature exhibited a series of parallel ratchet marks, consistent with multiple small cracks joining into a larger singular crack.

**Figure 3.** A) Outboard fracture surface. Yellow arrows mark the location of three thumbnail crack features at the lower edge, and white dashed arrows indicate the direction of crack propagation. B) Closer view and measurements of the thumbnail crack features.

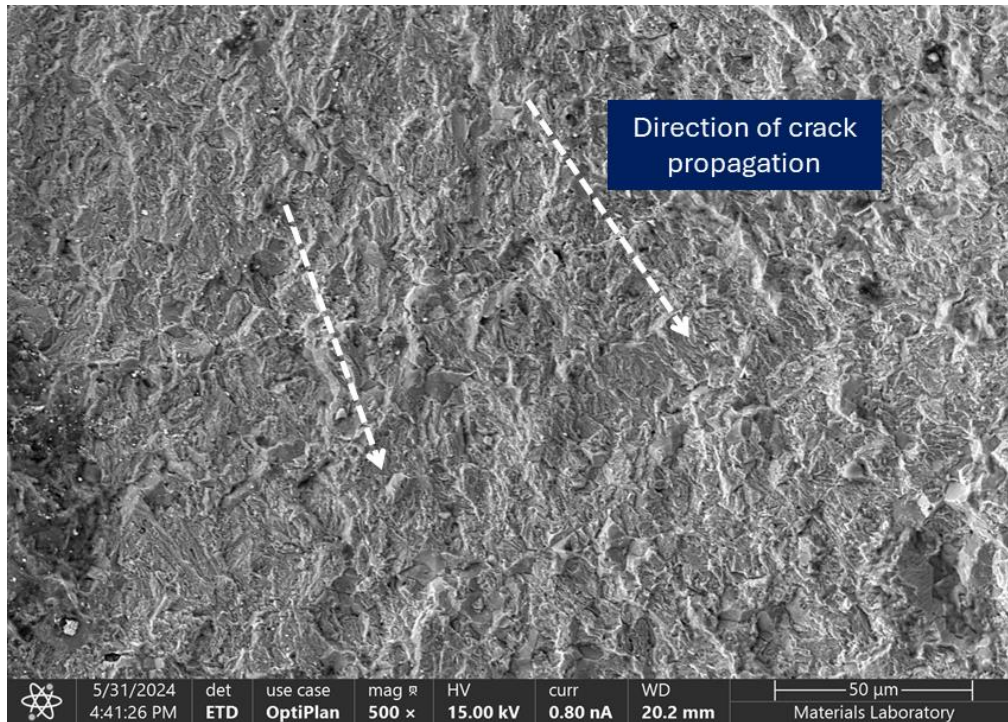
The piece was re-cleaned using acetone in an ultrasound bath. It was then examined in a field-emission scanning electron microscope (SEM). The surface in the thumbnail features (**Figure 4**) exhibited a mix of crack progression striations and intergranular decohesion features. Outside of these regions, the surface showed primarily ductile dimpling interspersed with intergranular facets (**Figure 5**), consistent with overstress.

**Figure 4.** Secondary Electron (SE) image of the thumbnail surface showing striations interspersed with intergranular facets.

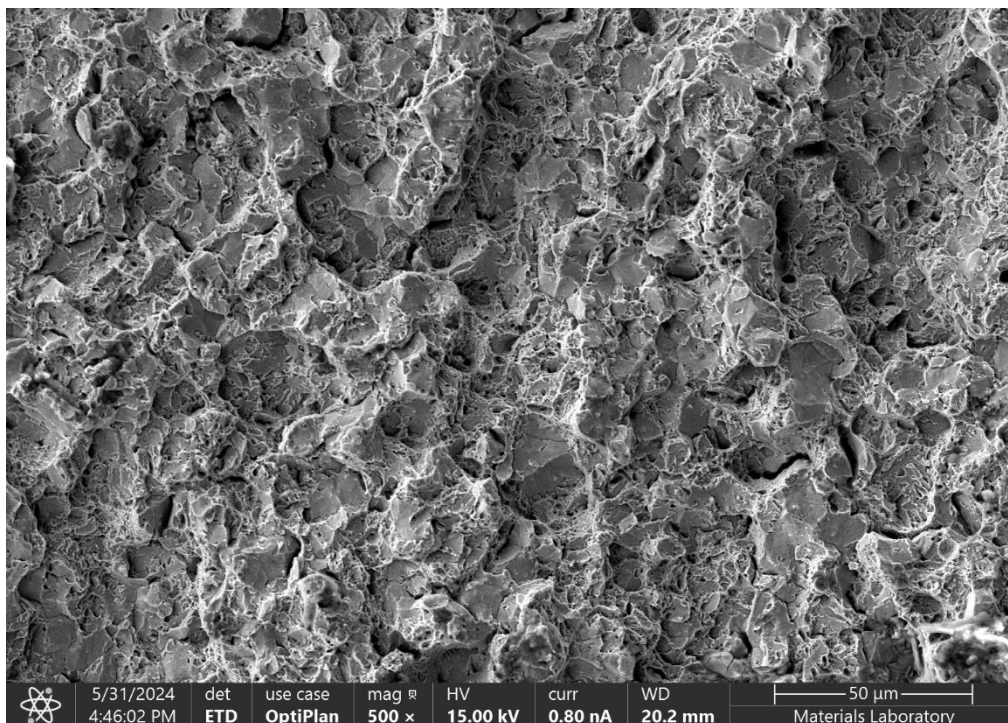
**Figure 5.** SE image of fracture surface outside the thumbnail region showing a mix of ductile dimpling and intergranular decohesion features.

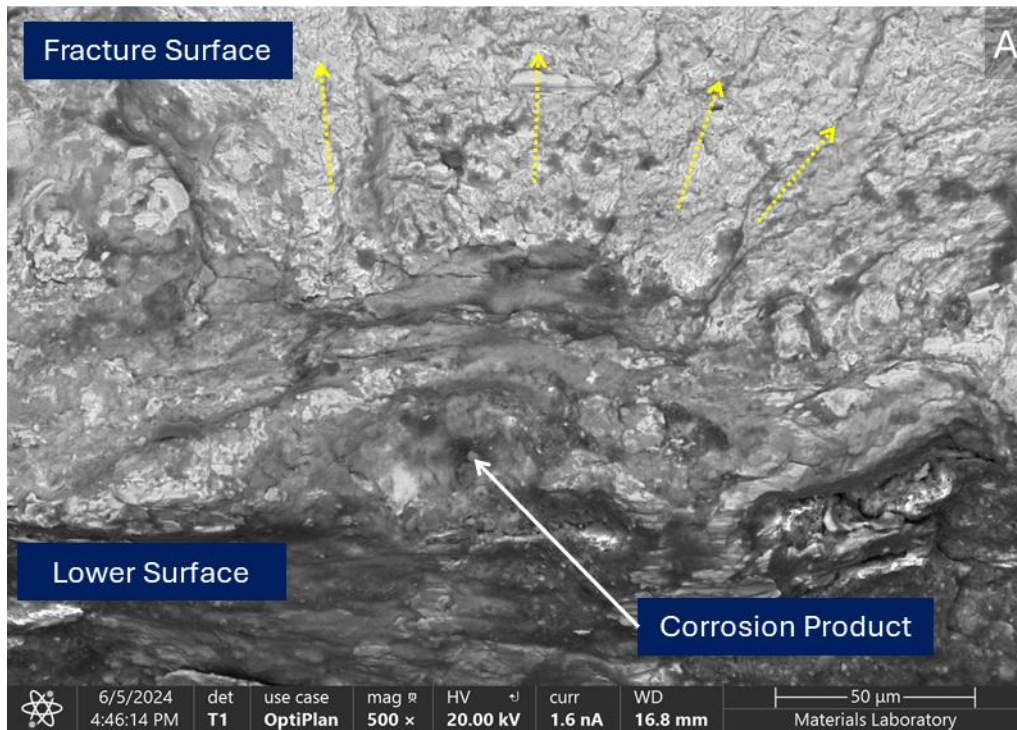
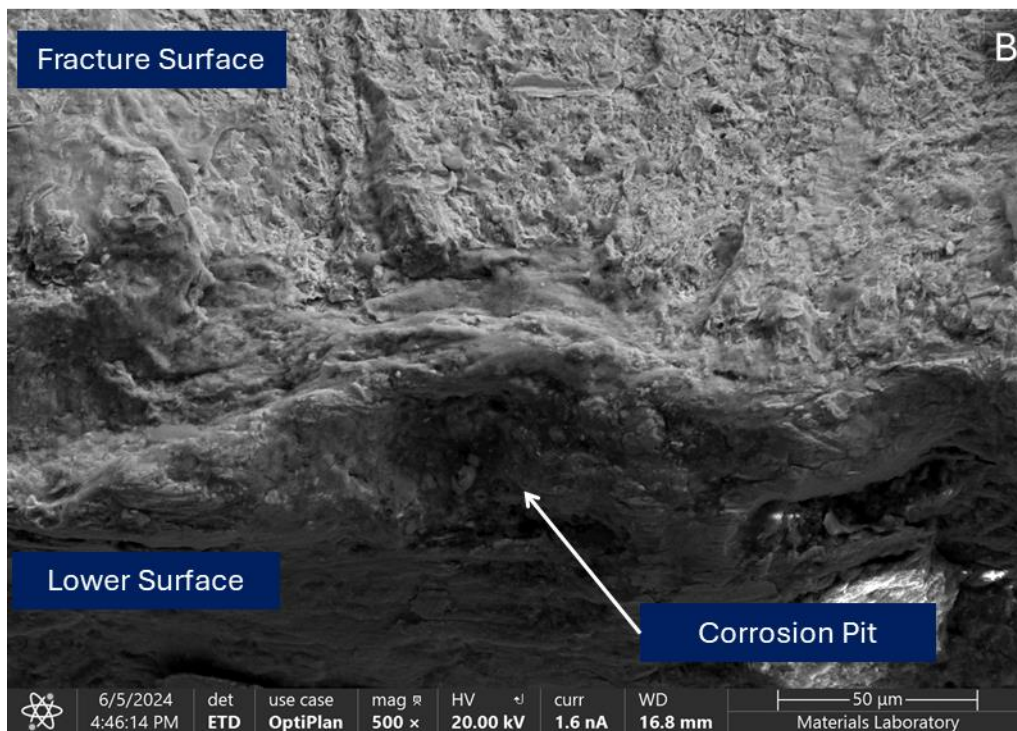
Examination of the roots of the thumbnail features revealed radial marks emanating from dimple features on the bottom surface, as shown in **Figure 6**. Backscattered electron (BE) imaging of these dimples revealed a nonconductive phase in the dimple. Energy Dispersive Spectroscopy (EDS) of the phase revealed the presence of iron and high amounts of oxygen, consistent with iron oxide. Acetate tape was employed to remove obscuring corrosion product and depth of one such pit was measured to be approximately 0.001 inch.

**Figure 6.** A) BE image of a corrosion pit at the base of a thumbnail feature. Yellow arrows indicate crack progression direction. B) SE image of same area showing corrosion pit.

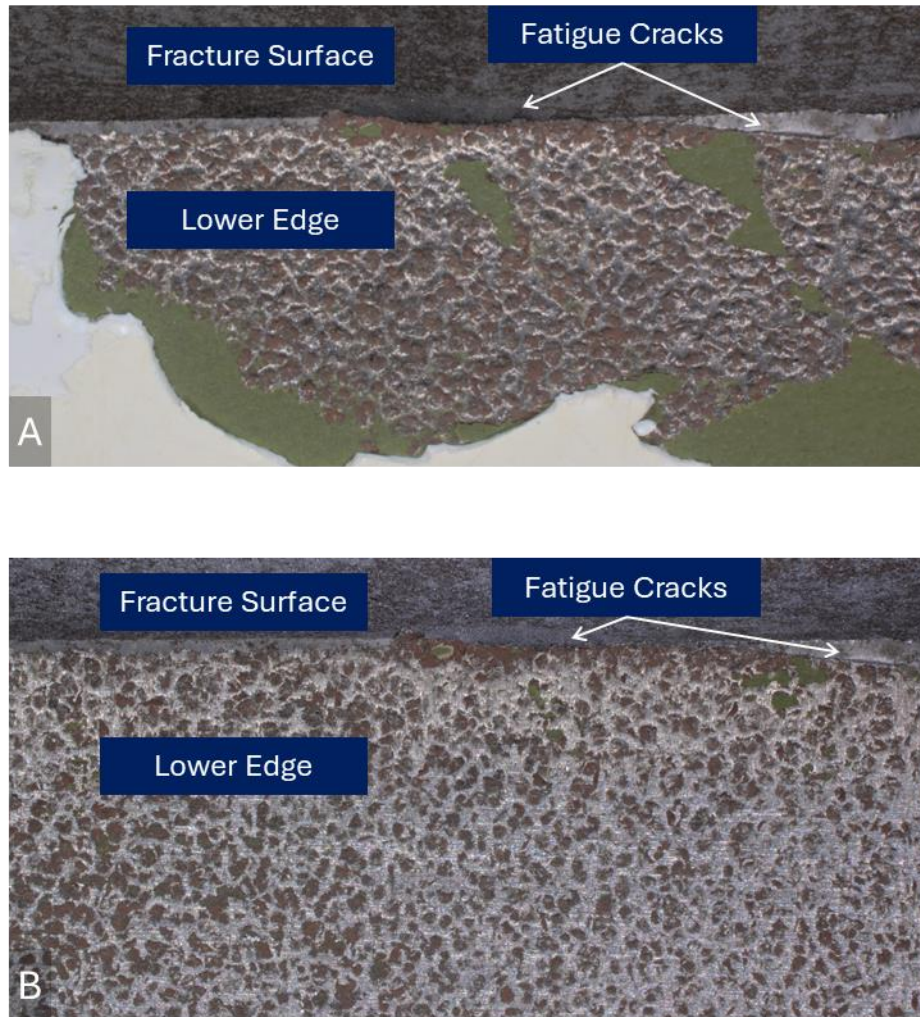
The piece was again subjected to acetone cleaning in an ultrasound bath to strip paint and primer away from the bottom edge of the leg. The surface had a dimpled appearance, consistent with shot peening. Corrosion product was observed in the dimples. The piece was subjected to further cleaning in acetone and a soft scrubbing pad was used to remove primer that continued to adhere. This progression is shown in **Figure 7**. Corrosion product was observed on the surface after the primer was removed.

**Figure 7.** Bottom surface near the thumb nail cracks A) after initial cleaning with acetone in ultrasound bath and B) after repeated cleanings in an acetone ultrasound bath and application of a soft scrubber. Brown corrosion product was found in dimples where paint was removed.
