# National Transportation Safety Board

WPR23LA350

## **AIRFRAME AND ENGINE EXAMINATION REPORT**

Location: Challis, Idaho  
Date: September 20, 2023  
Time: 1445 mountain daylight time  
Airplane: Cessna U206 / N3932G

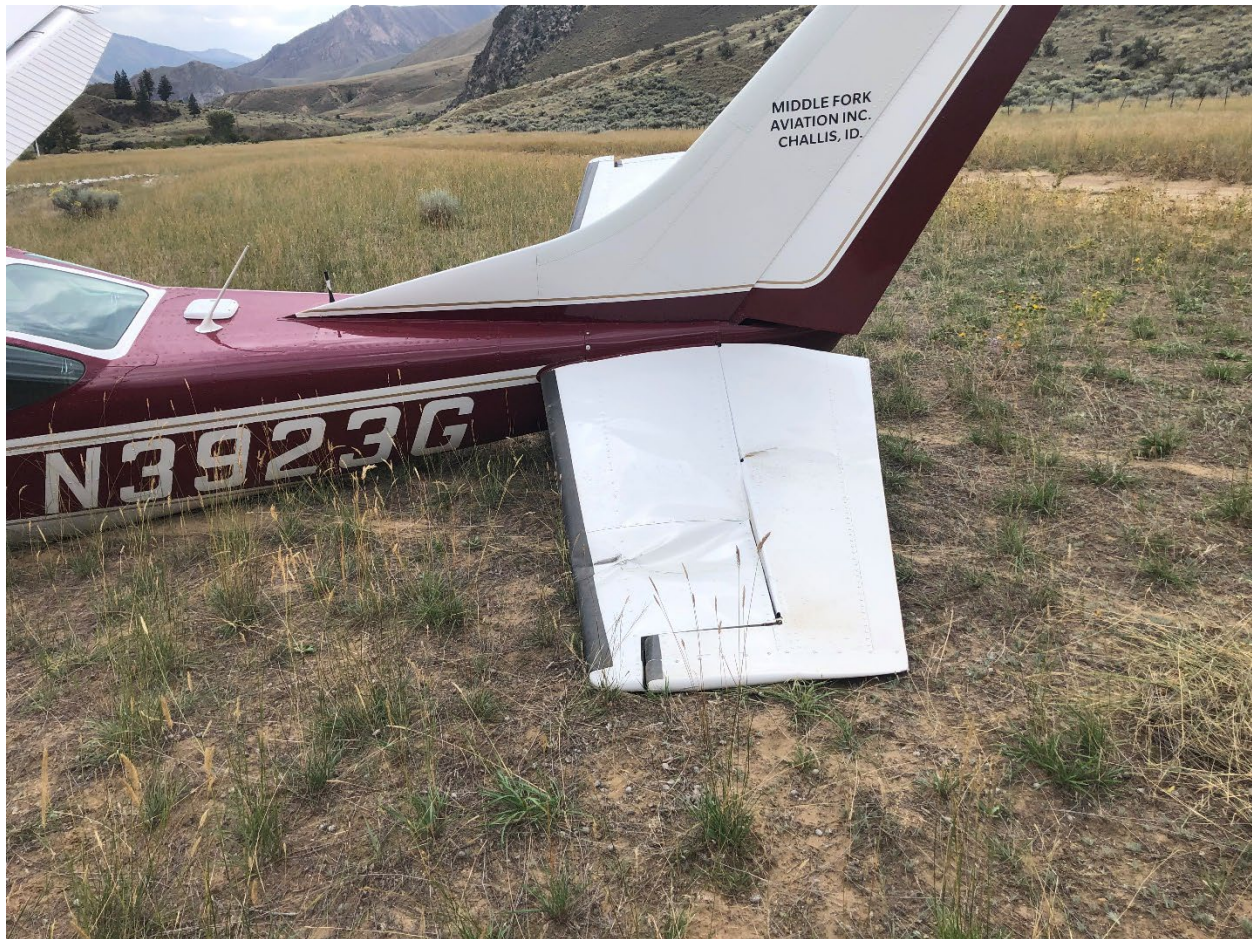
The left-side horizontal stabilizer and elevator were substantially damaged with upward bending and wrinkling of the internal structure and sheet metal.

Figure 1. Substantial damage to the left horizontal stabilizer and elevator. Photo courtesy of the pilot.

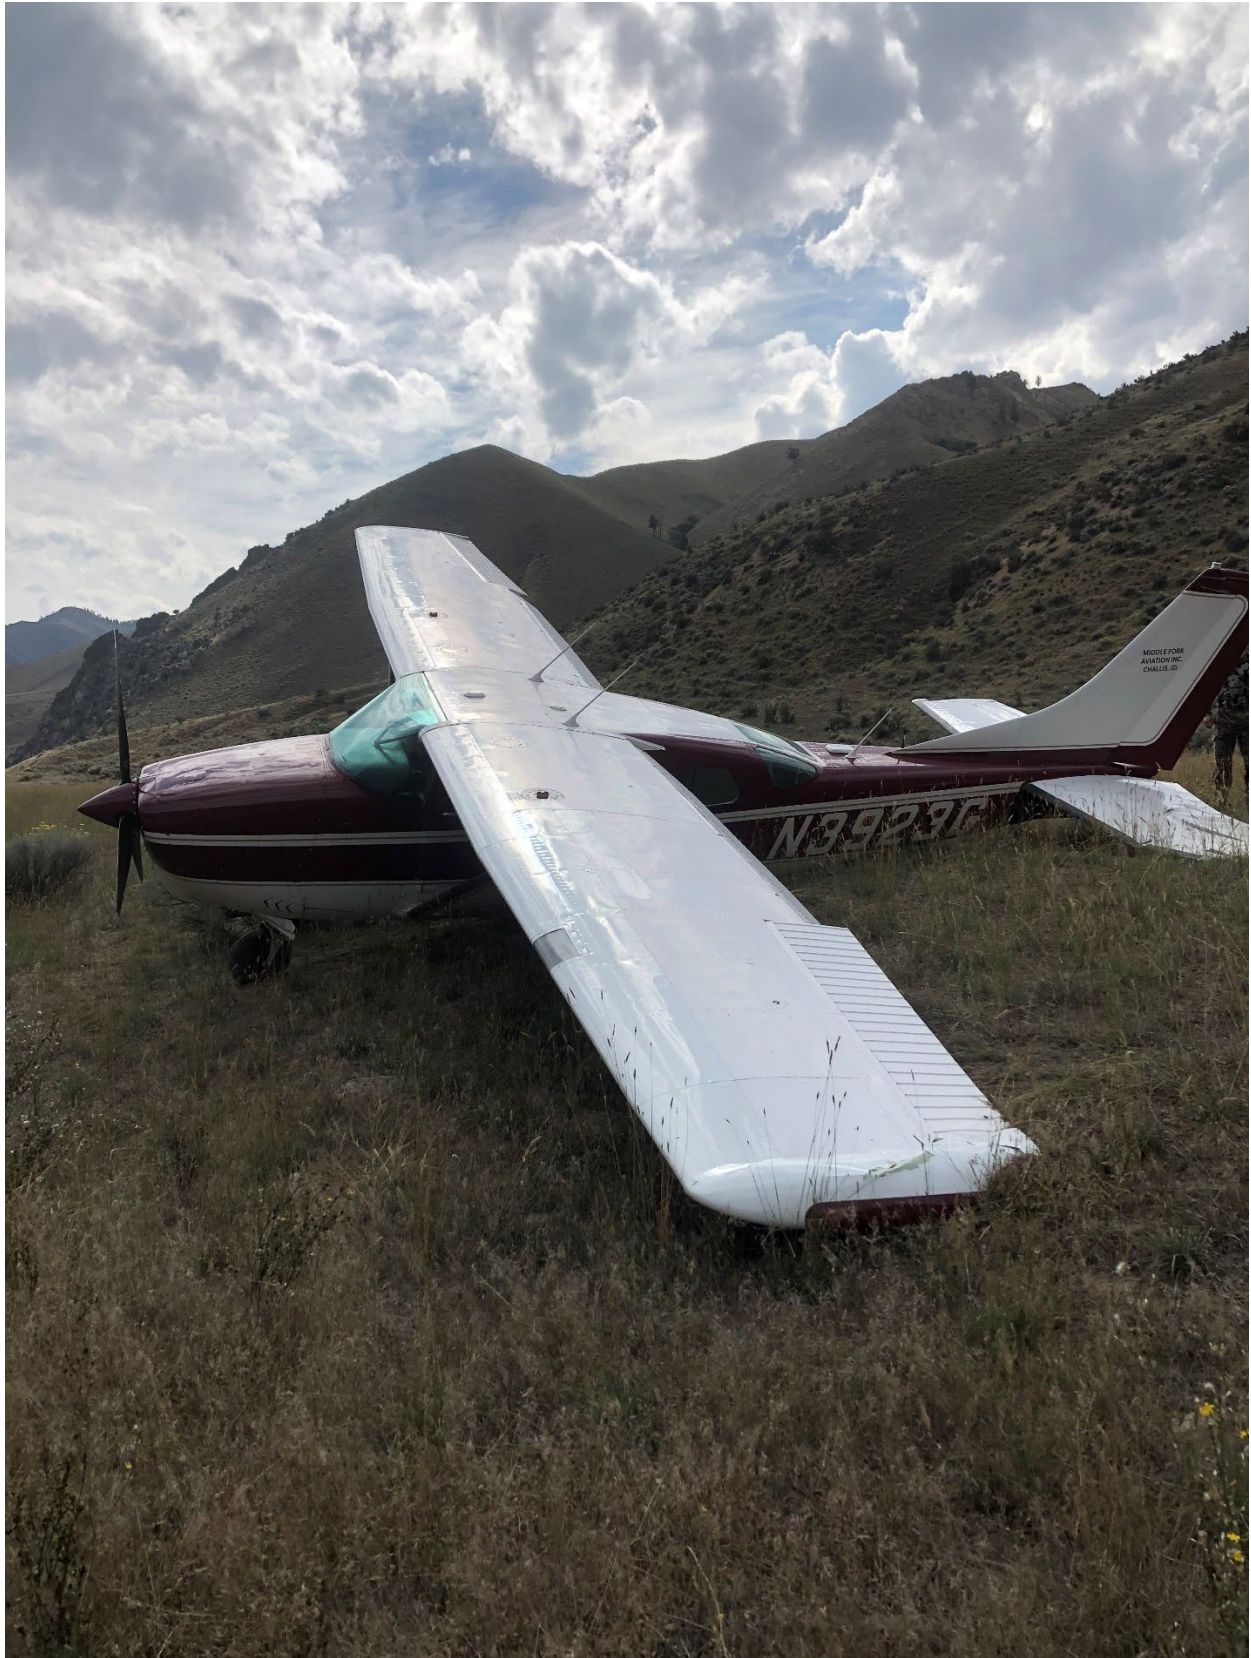
The left wing sustained non-substantial damage to the wing tip. The right wing, aileron, and flap received no damage.

Figure 2. Left wing damage. Photo pilot.

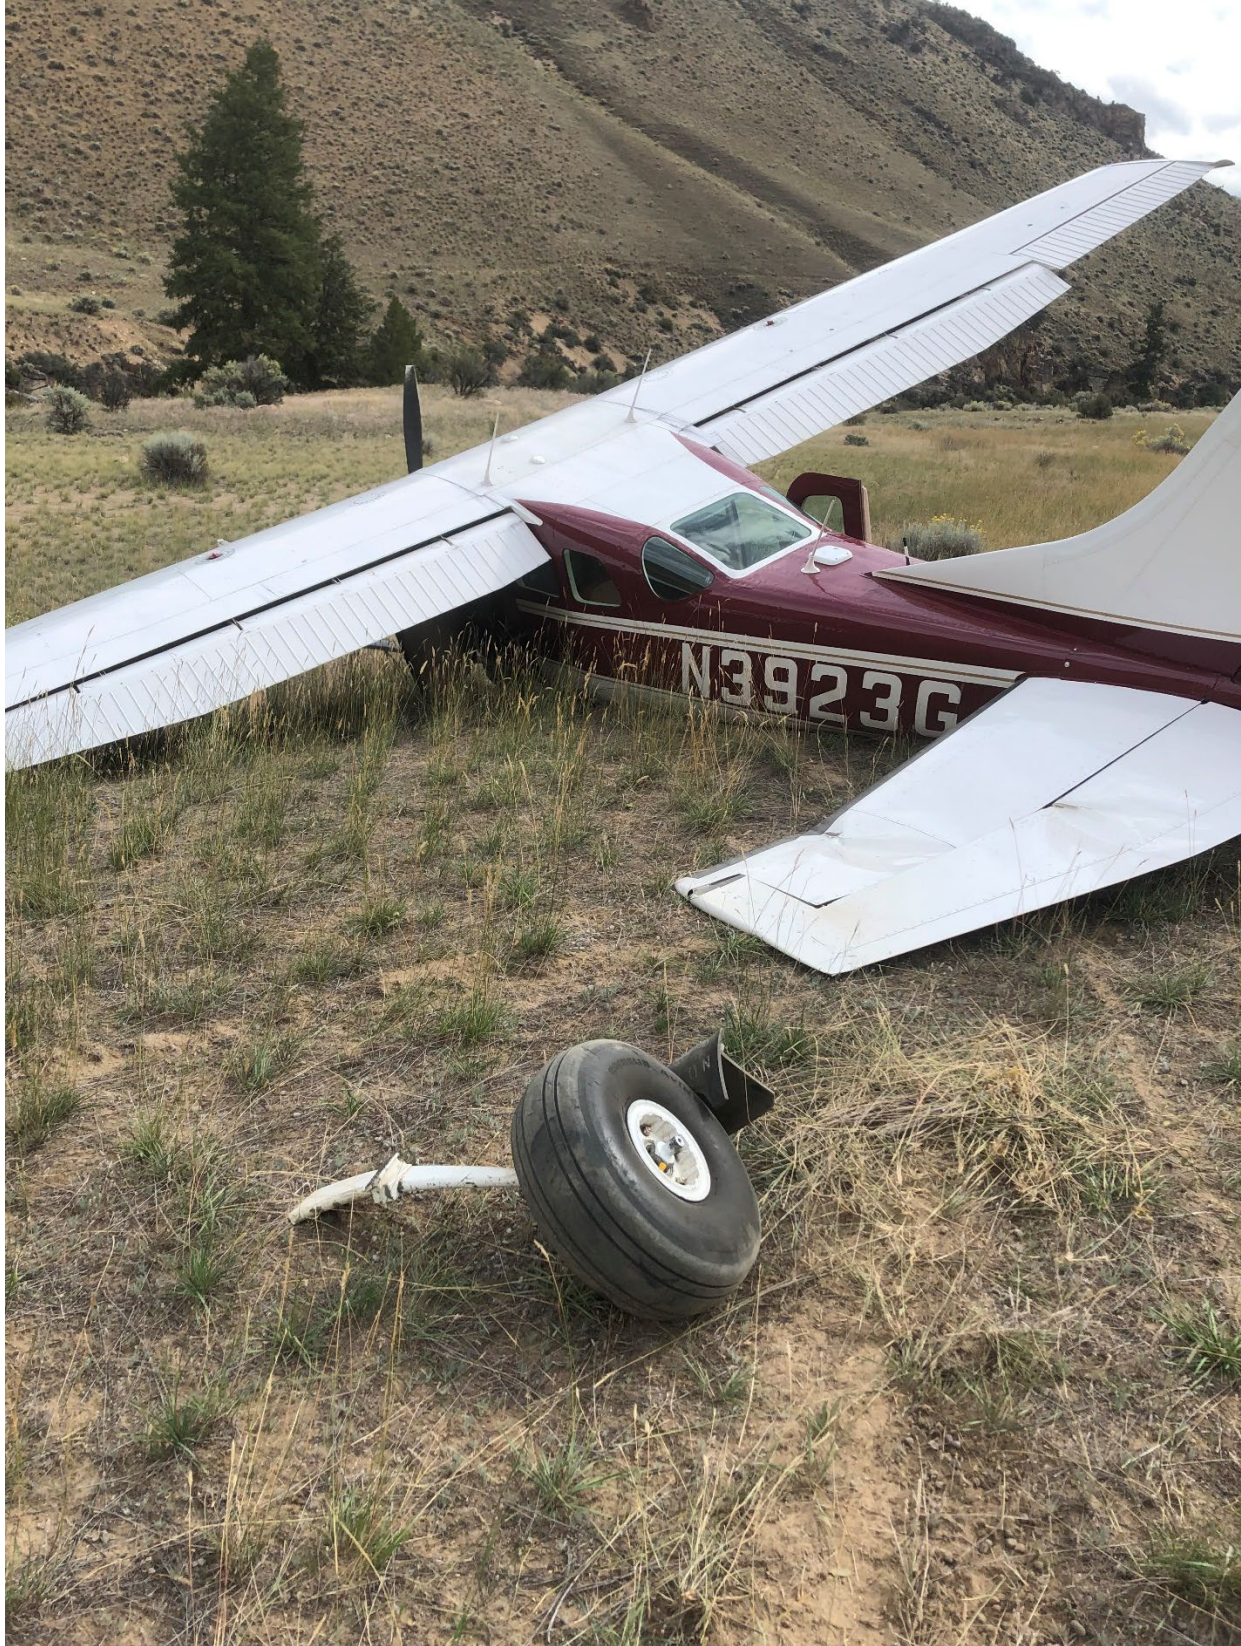
The left main gear spring assembly (MGSA) fractured and separated from the lower fuselage. A section remained attached to the lower fuselage at the mount. Both sections of the left MGSA were shipped to the National Transportation Safety Board (NTSB) Materials Laboratory for further examination. The right main gear spring assembly and the nose gear assembly remained secured to the lower fuselage at their respective mounts.

Figure 3. Left main gear spring assembly. Photo pilot.

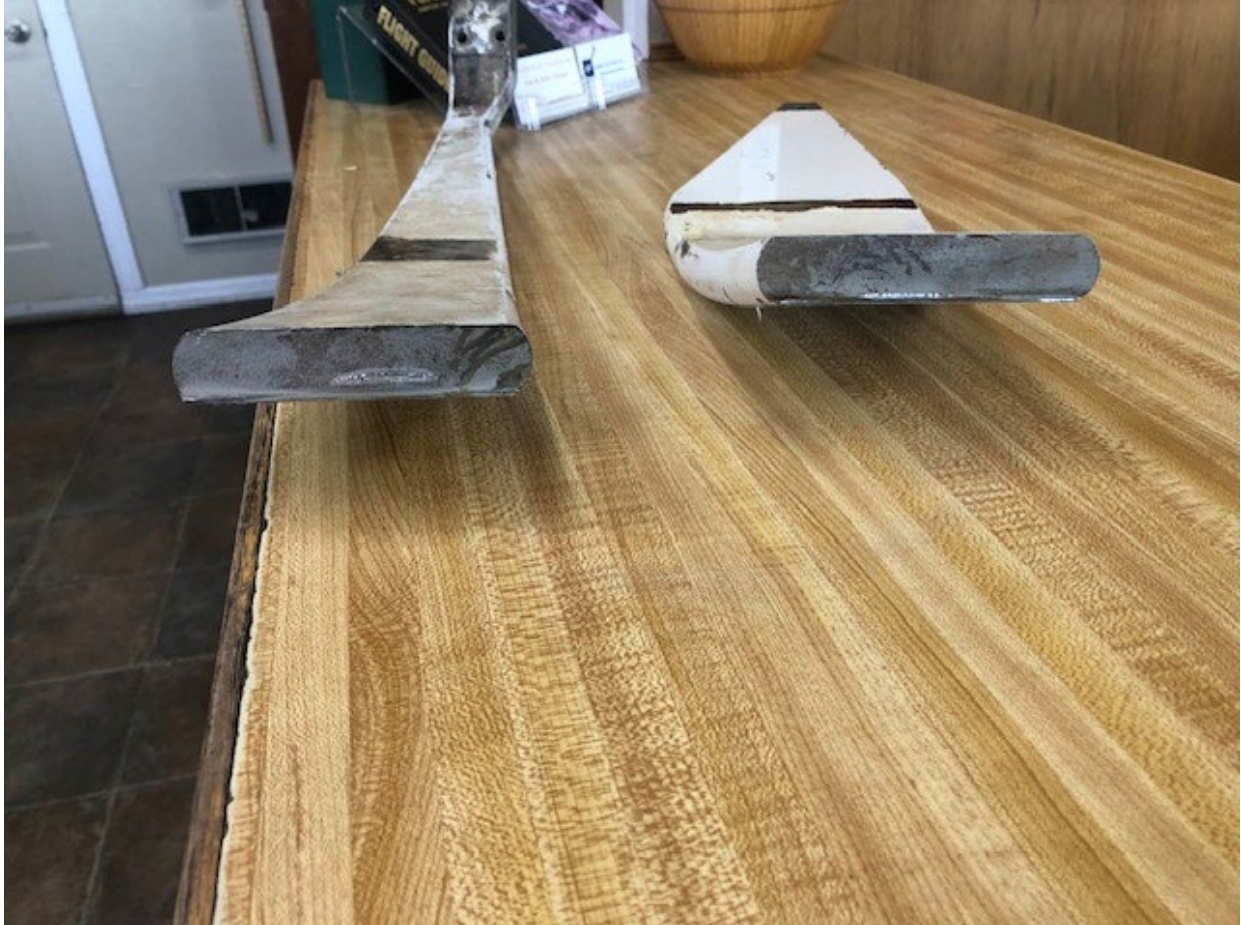
Figure 4. View of the fractured surface of the left main gear spring assembly. Photo owner.

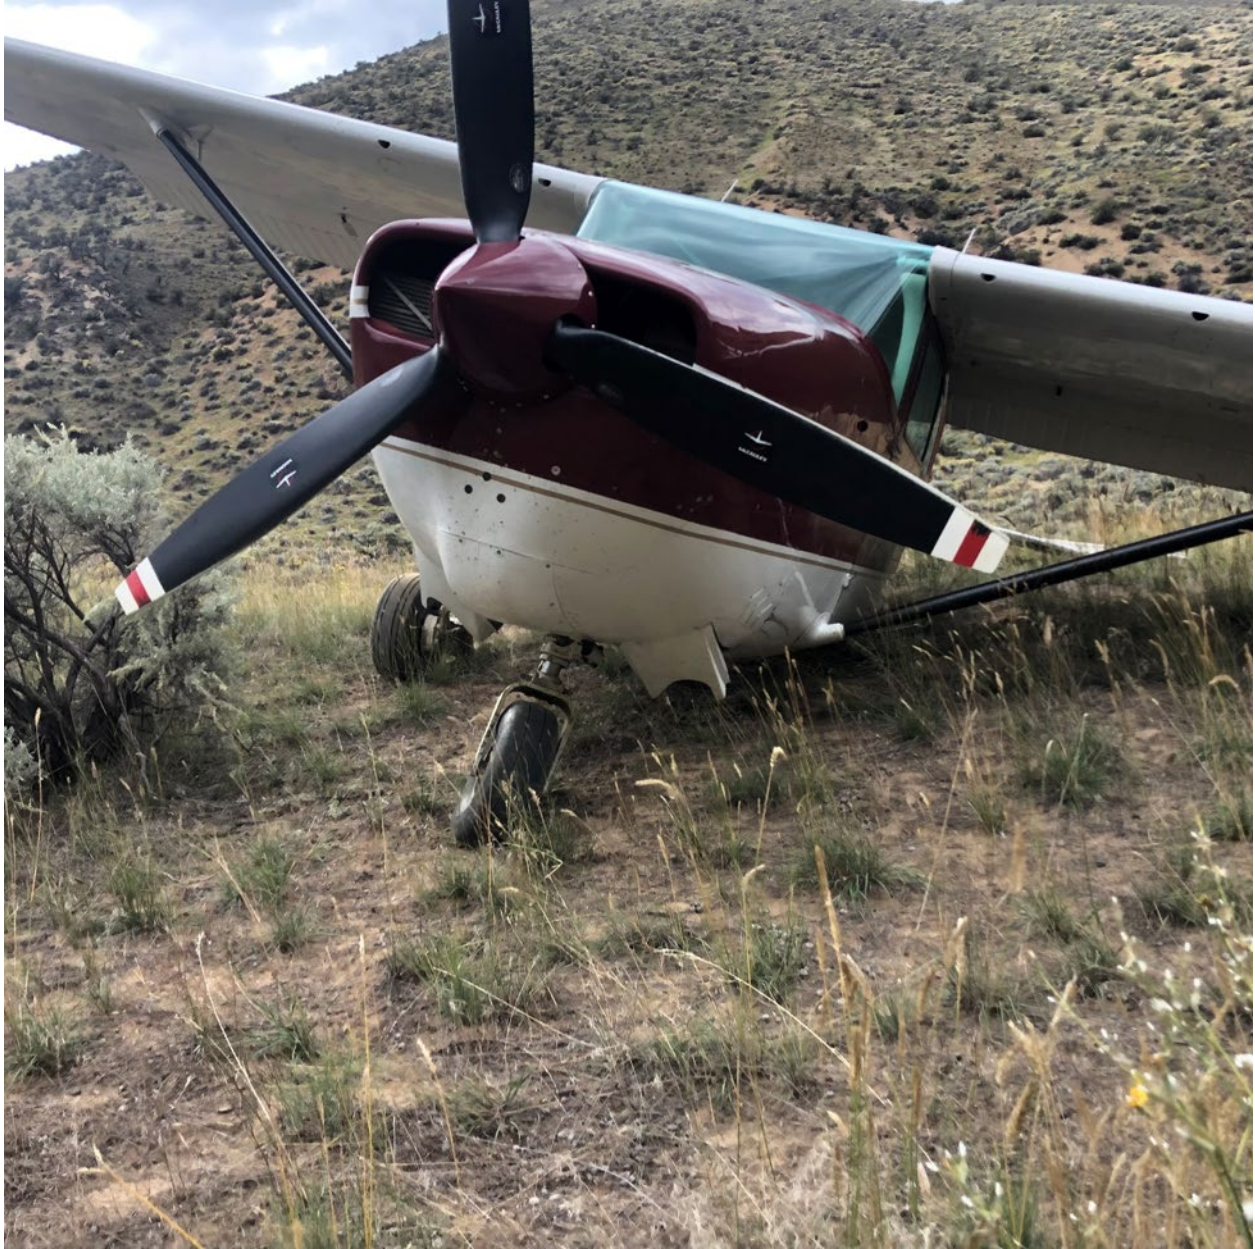
The three-bladed aluminum propeller remained installed to the engine as was not damaged.

Figure 5. Front view showing the propeller, engine nacelle, nose and right main gear spring assembly.  
Photo pilot.
