# National Transportation Safety Board

WPR23FA352

## **WRECKAGE EXAMINATION REPORT**

Location: San Pedro, California  
Date: September 25, 2023  
Time: 1250 Pacific Daylight Time  
Airplane: Sling 4 TSI, Registration N135WT

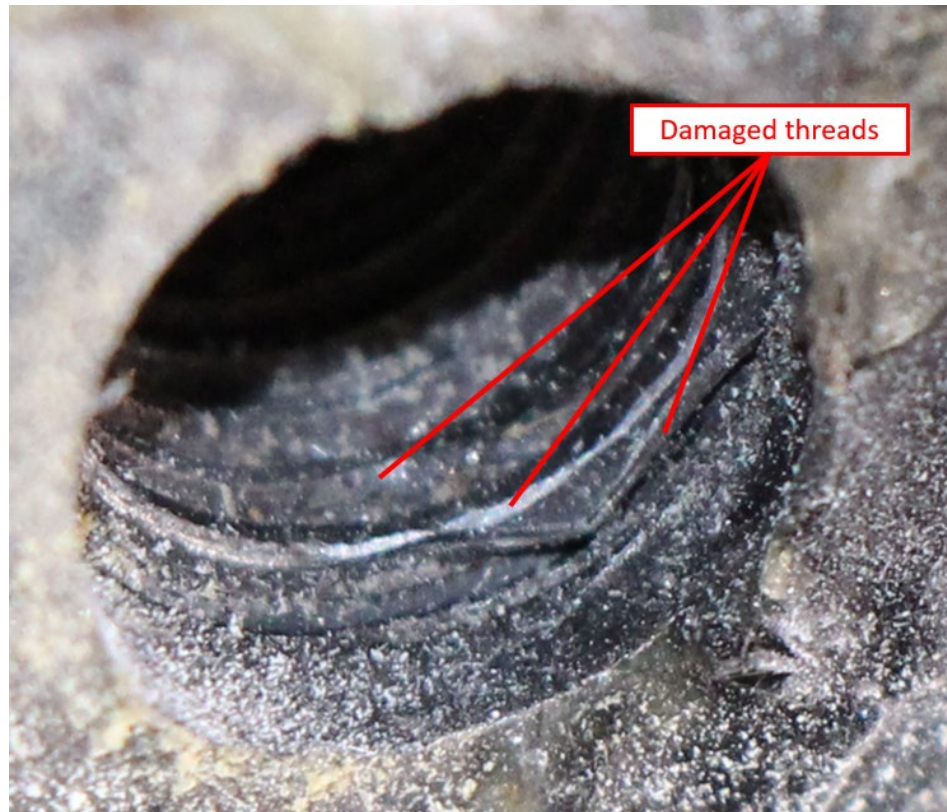
The right seat shoulder harness separated from the fuselage canopy frame along with the hex bolt, lock washer and shim. The bolt and shim were recovered and the lock washer could not be located within the recovered wreckage. The bolt hole was attached to the canopy frame and exhibited thread damage at the remaining three threads. (See Figure 1). The hole was partially occluded by a section of the carbon fiber canopy. The bolt threads were intact. The inertial reel remained attached to the fuselage and the latch remained attached to the center console. The latch functioned normally when the clasp was inserted. A measurement of the distance between the interior canopy carbon fiber frame and the left side bolt hole compared to the length of the bolt used to secure the support to the canopy revealed that only about 0.25" of bolt shaft (the equivalent of three threads) were available to thread the bolt to the bolt hole.

**Figure 1: Right Seat Canopy Restraint Bolt Hole**

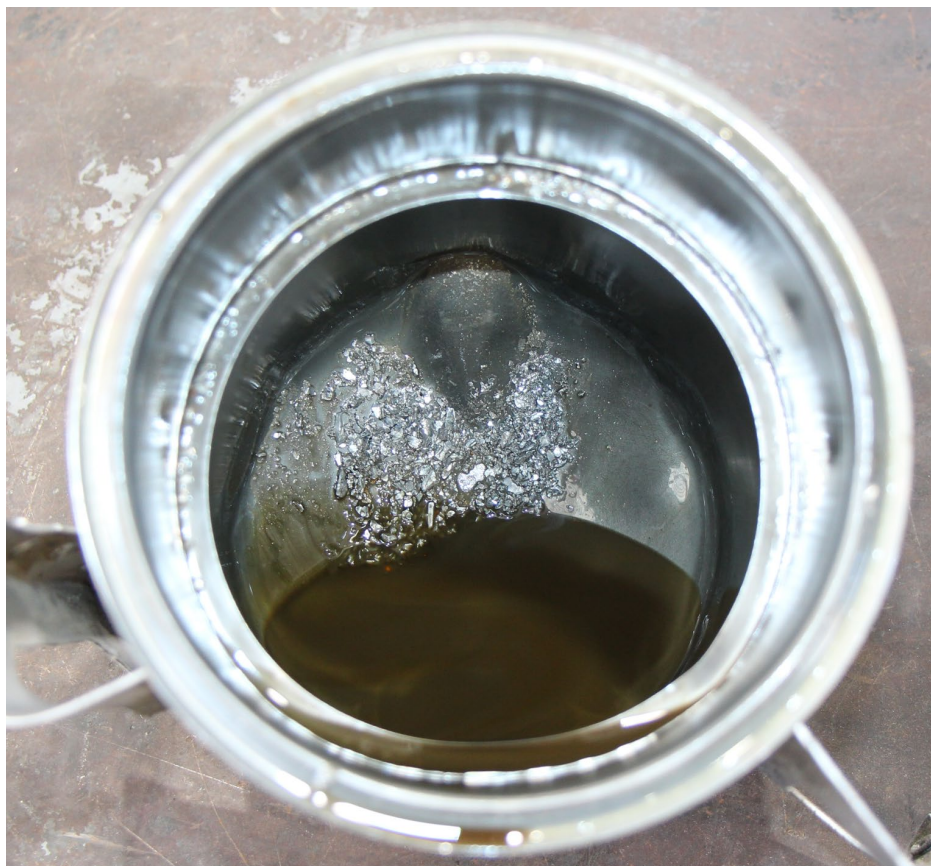
Approximately 250 mL of oil was drained from the oil sump, which also contained a trace amount of liquid that had an orange hue consistent with engine coolant. The oil sump contained metallic fragments. The magnetic plug showed minimal evidence of fragmentation consistent with normal wear.

**Figure 2: Metallic fragments and bottom of oil sump**

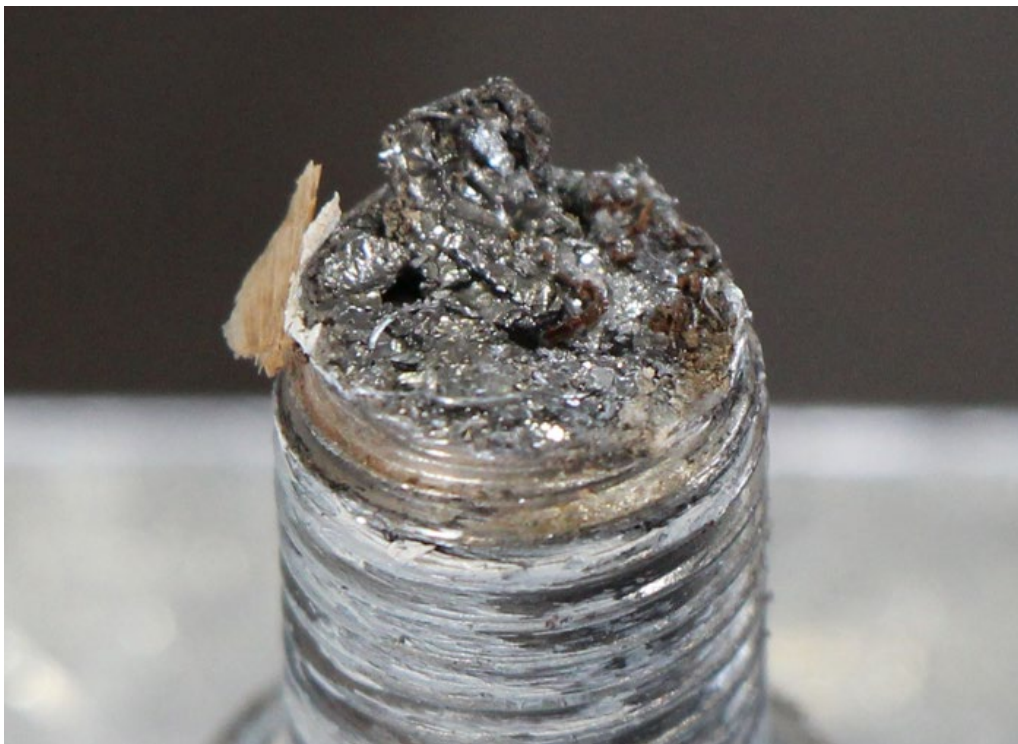
| Plug no | 1 | 2 | 3 | 4 |
|---|---|---|---|---|
| Top | Soot, carbon fouling, overall condition normal | Oil residue | Normal in appearance | Mechanical damage |
| Bottom | Oil fouled (gray in color), overall condition normal | Ground and center electrode damaged, oil residue | Oil residue | Mechanical damage |

**Figure 3: Cylinder 4 top spark plug**

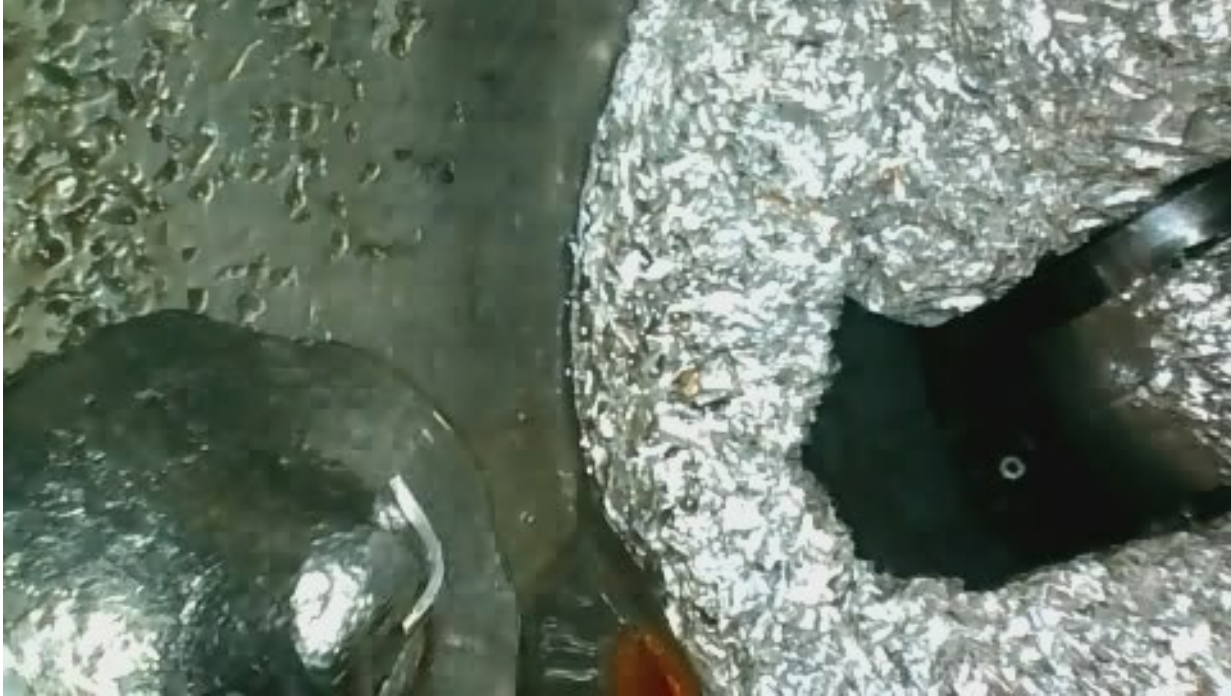
A lighted borescope was used to examine the condition of the cylinders. Cylinders 2 and 4 exhibited evidence of foreign object debris (FOD) damage. A large hole was observed in the cylinder 4 piston with corresponding damage to the cylinder 4 spark plugs and exhaust valve. No evidence of FOD damage was observed in cylinders 1 and 3. The remaining valves were not examined due to instrument limitations.

**Figure 4: Cylinder 4 pitting on cylinder wall, penetrated piston face, and broken exhaust valve**
