# National Transportation Safety Board

WPR23FA352

## **ENGINE TEARDOWN REPORT**

Location: San Pedro, California  
Date: September 25, 2023  
Time: 1250 Pacific Daylight Time  
Airplane: Sling 4 TSI, Registration N135WT

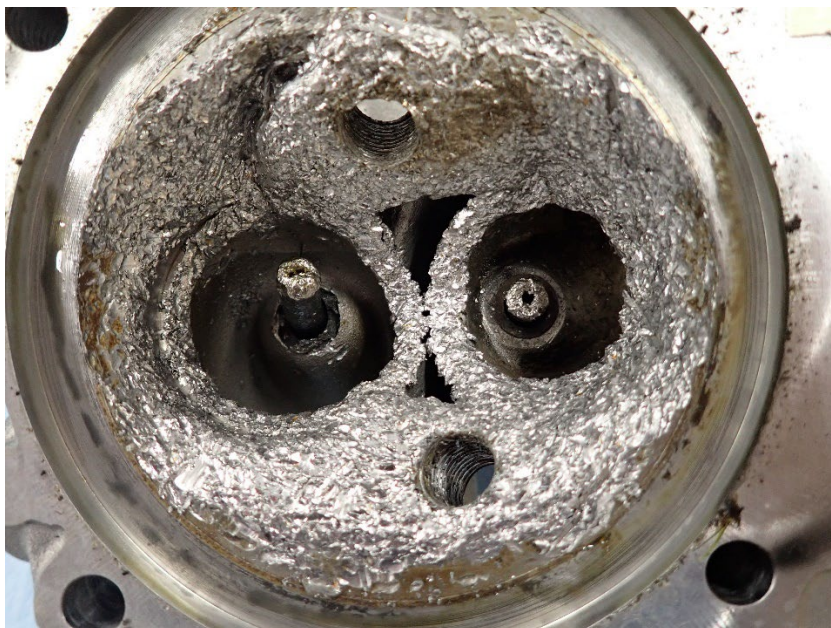
The cylinders remained installed on the crankcase with all the securing hardware properly attached. Each cylinder and piston were removed and documented. Cylinder 4 exhibited extensive mechanical damage and gouging throughout the cylinder head (both spark plugs had been previously removed). The cylinder 4 piston also displayed extensive mechanical damage and gouging (consistent with the damage to the cylinder head interior). The no. 4 intake valve was separated and resting along the bottom of the cylinder wall with extensive gouge markings and deformation. The cylinder 4 exhaust valve was found inside the airbox heavily damaged and fragmented.

**Figure 3: No. 4 interior cylinder head and valve stems**

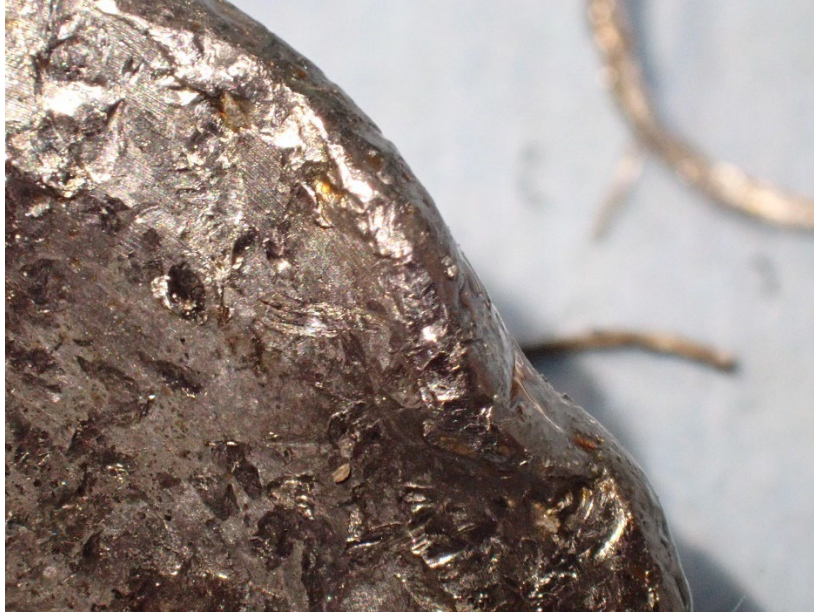
The cylinder 4 valve rockers, keepers and washers were unremarkable. The intake valve could not be removed; the valve face had separated, the valve stem was bent

and the upper portion of the valve stem below the keeper displayed some mushrooming. The exhaust valve also could not be removed; the valve face had separated, the valve stem was loose and exhibited some play within the guide, and the upper portion of the valve stem below the keeper displayed a hardened black material.

**Figure 4: Intake valve face circumference with deformation and gouge markings**

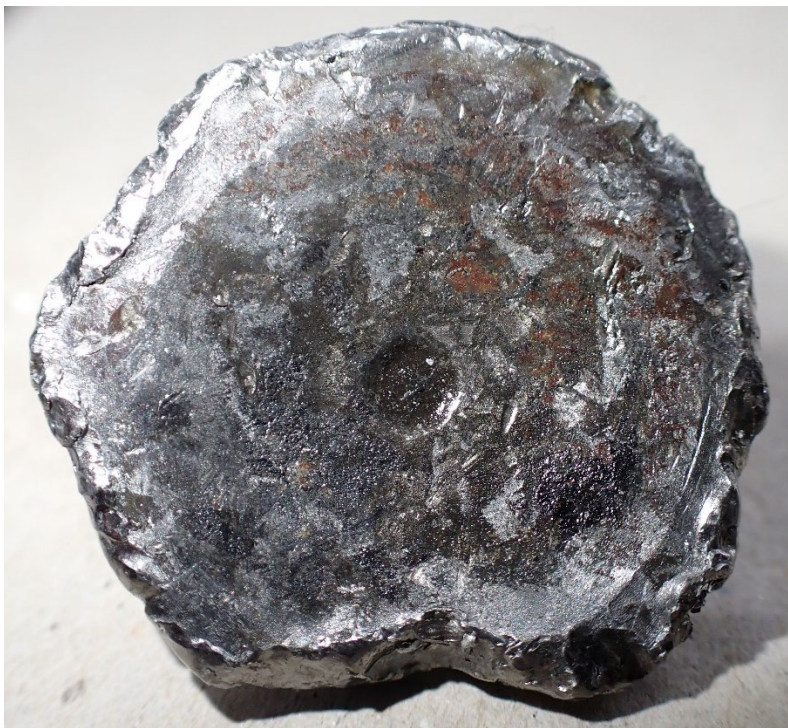
**Figure 5: Cylinder 4 exhaust valve face**

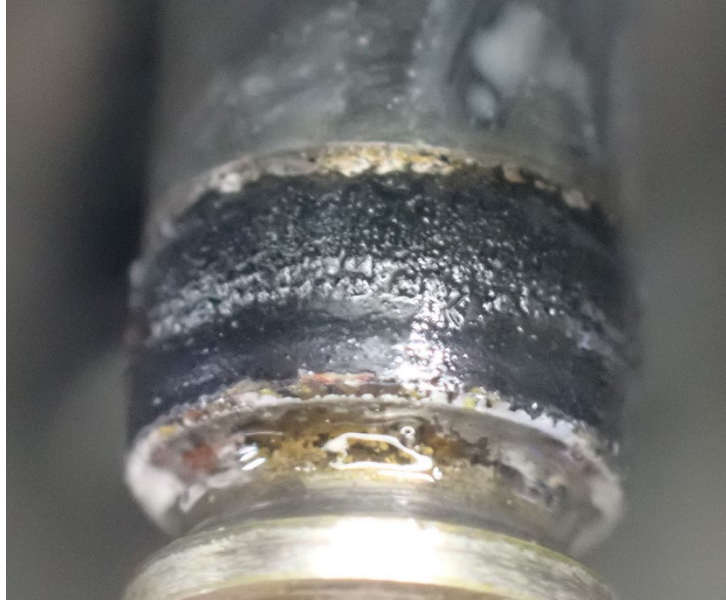
**Figure 6: Cylinder 4 upper portion of valve stem below keeper**

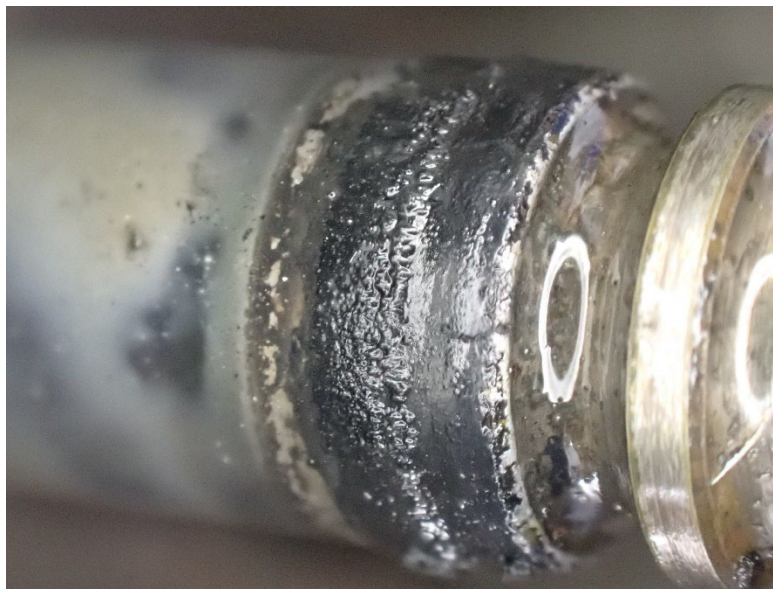
**Figure 7: Closeup of black hardened material on upper portion of exhaust valve stem below keeper**

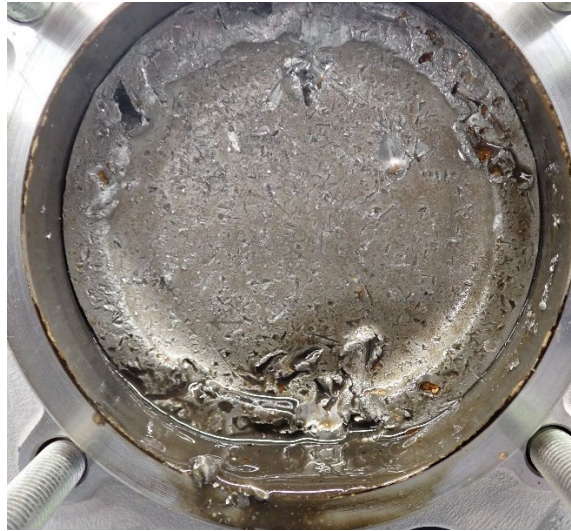
The cylinder 2 piston face exhibited deep gouge marks along the circumference and shallow gouge marks towards the center with a trace amount of coolant and oil that had pooled at the bottom of the cylinder. A trace amount of coolant had also pooled within some of the cavities at the piston face. Fragments were also observed along the cylinder wall. Both valves (exhaust and intake) remained installed at the cylinder head, which displayed deep gouge marks near the top and bottom of the interior cylinder head and pitting at the center. The exhaust and intake valves displayed some pitting. The exhaust valve also displayed a circumferential white residue at the center. A piece of the cylinder skirt was embedded at the bottom of the interior cylinder

**Figure 8: Cylinder 2 piston face**

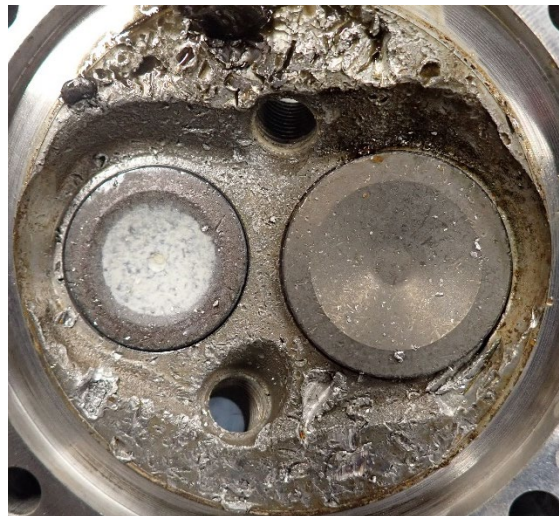
Disassembly of the cylinder 2 valve assemblies did not reveal any mechanical anomalies with the rocker assembly, coils, keepers, washers, or push rods.

**Figure 9: No. 2 cylinder head and valves**

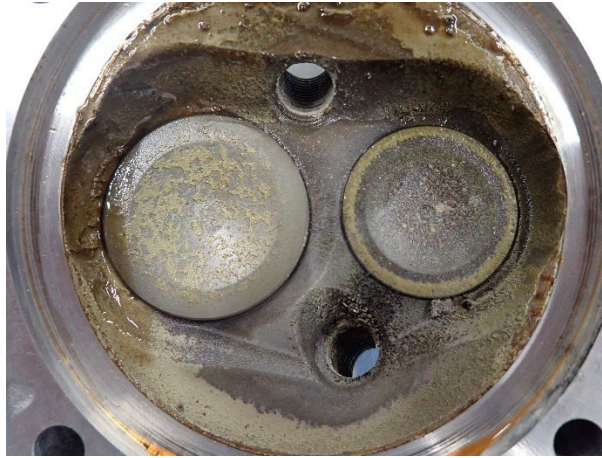
The no. 1 cylinder head contained some loose metallic fragments along the circumference and also some dark debris at the top of the exhaust valve near the top spark plug porthole. Both the intake and exhaust valves exhibited normal concentric burn patterns. The piston face exhibited normal burn signatures at the top and bottom of the piston at the spark plug firing positions. A dark material consistent with the debris near the exhaust valve was located at the top of the piston face. A trace amount of oil and coolant had pooled at the cylinder wall.

**Figure 10: No. 1 cylinder head and valve faces**

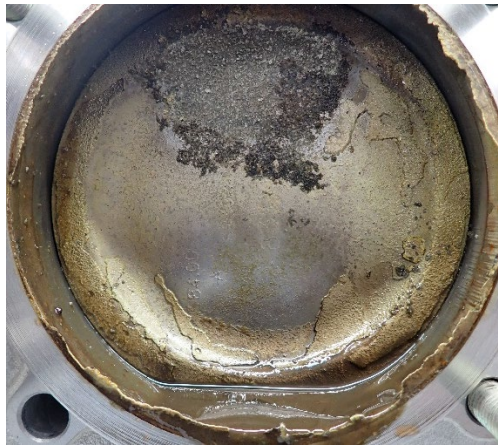
**Figure 11: Cylinder 1 piston face inside cylinder**

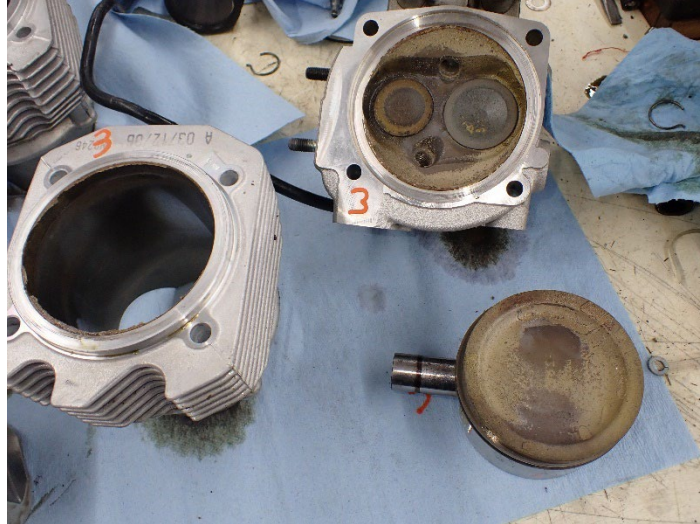
The cylinder 3 piston face displayed normal burn signatures at the face with burn patterns at the top and bottom consistent with the spark plug positions. The intake and exhaust valve remained installed within the cylinder head and both showed concentric burn patterns consistent with normal wear. Some pitting was observed inside the interior cylinder head.

**Figure 12: Cylinder 3 piston, cylinder head, and cylinder**

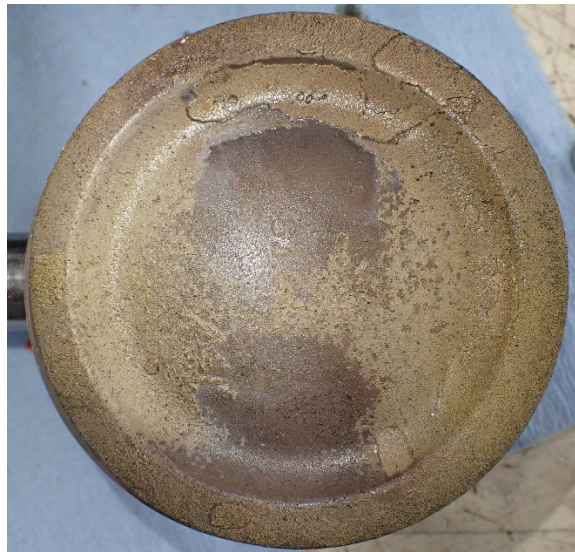
**Figure 13: Cylinder 3 piston face**

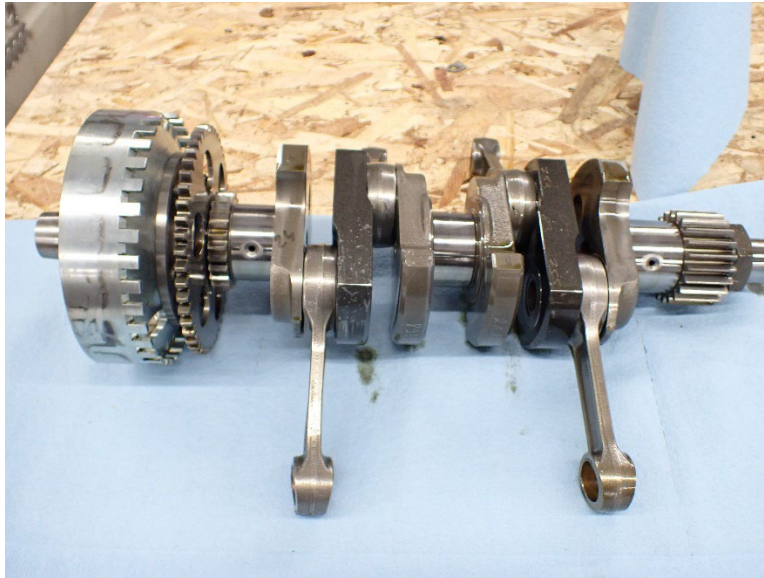
Crankshaft and camshaft continuity to the accessory case was achieved after the cylinders and pistons were removed when the propeller flange was rotated using a hand tool. The connecting rods were all installed at their respective connecting rod journals and the counterweights and crankwebs were in place. The main journals appeared normal and the bearings exhibited some scoring with normal wear and some of the bearings had evidence of foreign object contact. The cylinder 4 connecting rod displayed gouge marks at the rod bushing. The camshaft lobes were normal and unremarkable.

**Figure 14: Crankshaft with counterweights, crankwebs, and connecting rods**

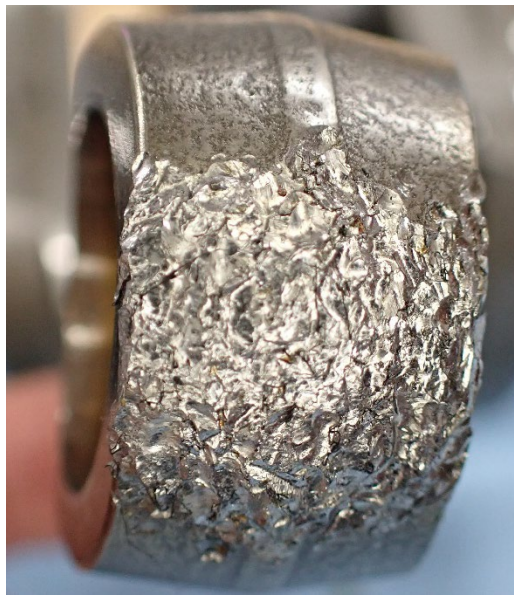
**Figure 15: Cylinder 4 connecting rod damaged bushing**

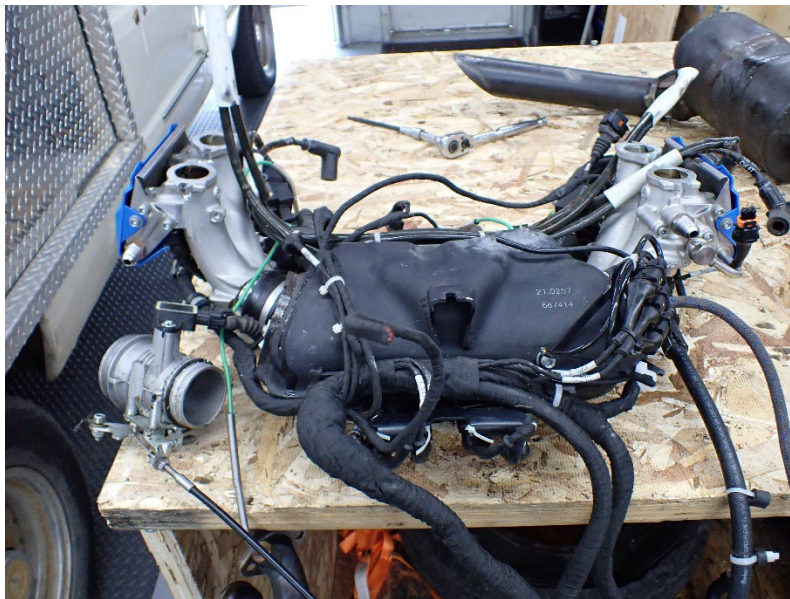
The induction tubes were attached at each cylinder with their securing hardware in place. Each tube contained metallic fragments. The airbox contained numerous large metallic fragments including the cylinder 4 exhaust valve.

**Figure 17: Airbox and induction**

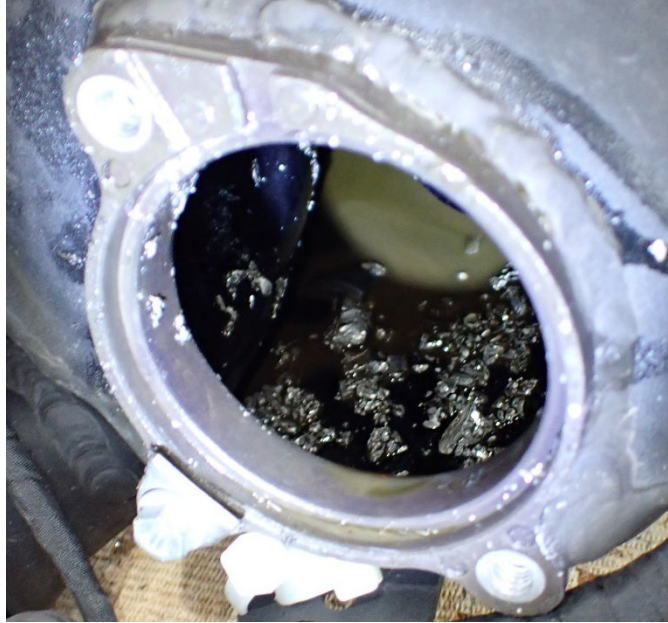
**Figure 18: Metallic fragments inside airbox**

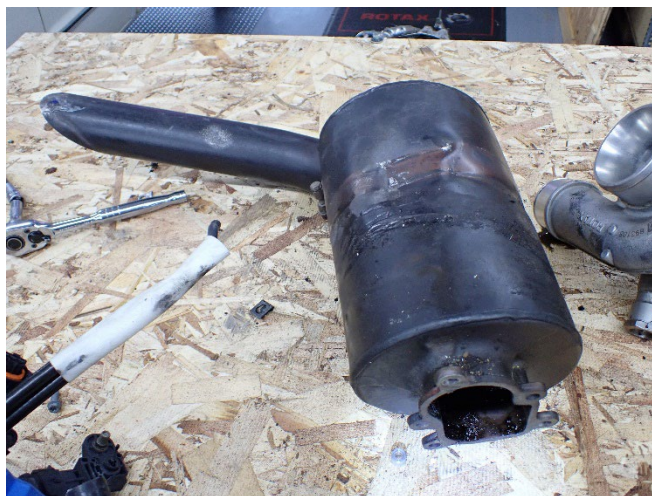
The exhaust system was partially damaged from the accident sequence. The cylinder 1, 2, and 4 exhaust tubes had been disconnected previously when the airplane was examined in Phoenix, Arizona. The cylinder 3 exhaust tube remained attached to the cylinder head. The exhaust muffler was unremarkable and exhibited some organic debris inside the internal baffling. The turbo impeller spun normally by hand and some metallic debris was observed within the turbo.

**Figure 19: Muffler**

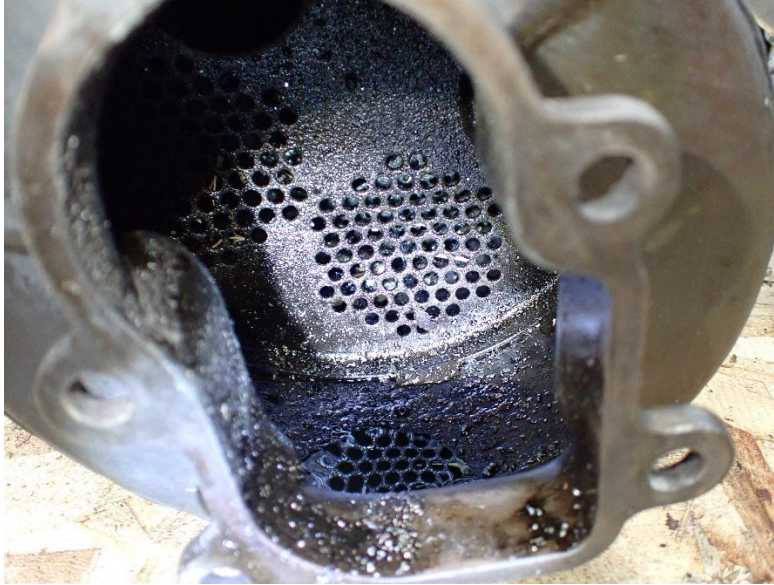
**Figure 20: Interior muffler at baffling**
