## ***ROTECH FLIGHT SAFETY INC.***

# **INVESTIGATION REPORT**

| <b>Aircraft Make:</b> | Sling | <b>Aircraft registration:</b> | N135WT |
| <b>Aircraft Model:</b> | 4 TSI | <b>Aircraft S/N</b> | 131S |

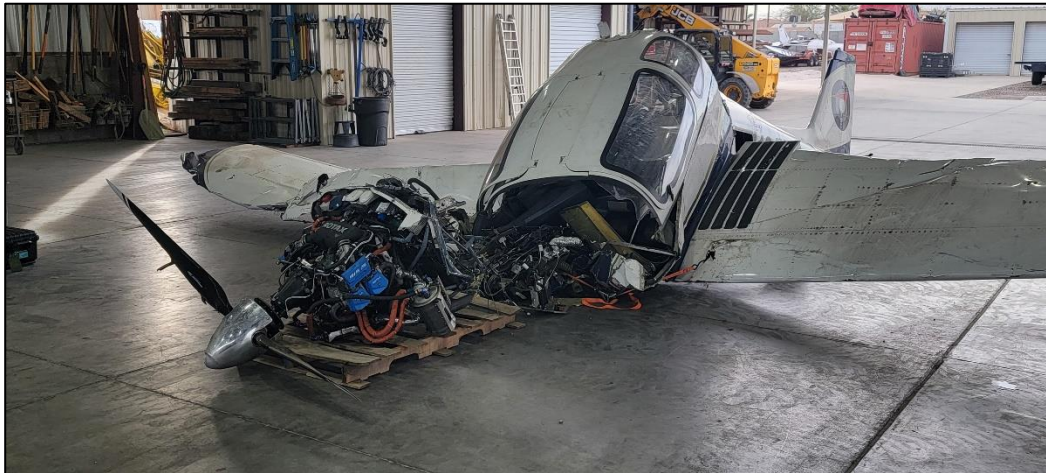
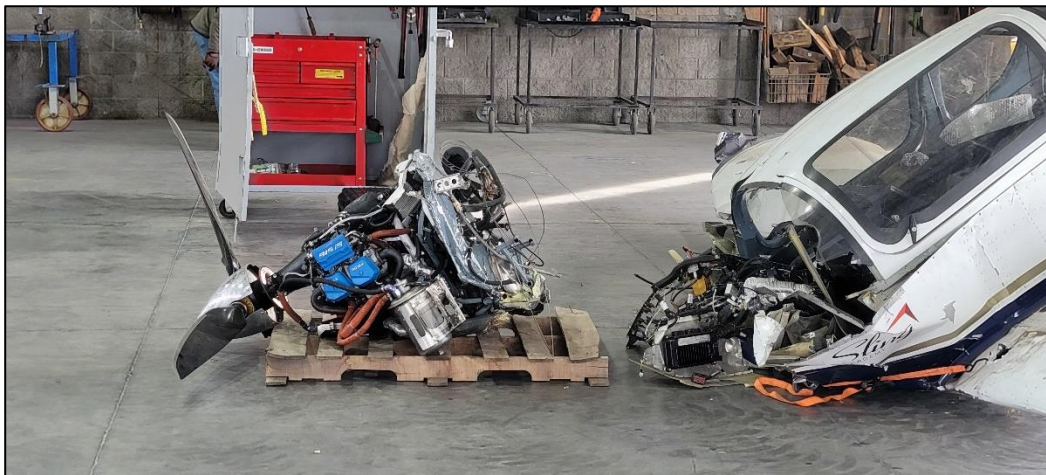
On January 17, 2024, an on-site investigation was conducted at Air Transport in Phoenix, Arizona, under the supervision of NTSB Aviation Accident Investigator Stephen Stein. The inspection revealed extensive impact damage to the aircraft. While the engine was in generally good physical condition and remained attached to its mount, both the engine mount and firewall had separated from the main wreckage.

The aircraft was equipped with a three-bladed electric constant-speed propeller. One blade was completely sheared off at the root, while the remaining blades showed no signs of rotational scoring.

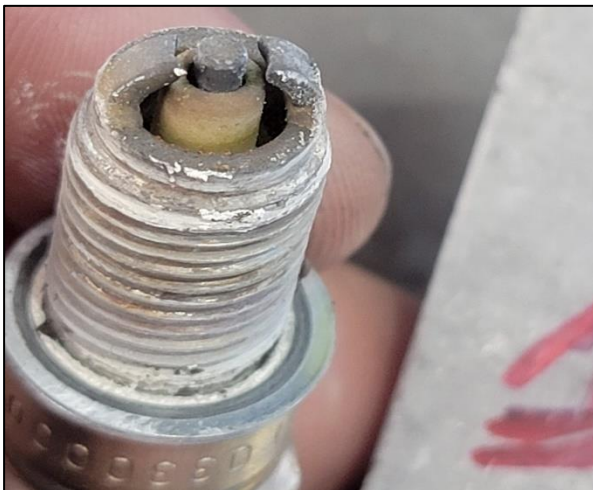
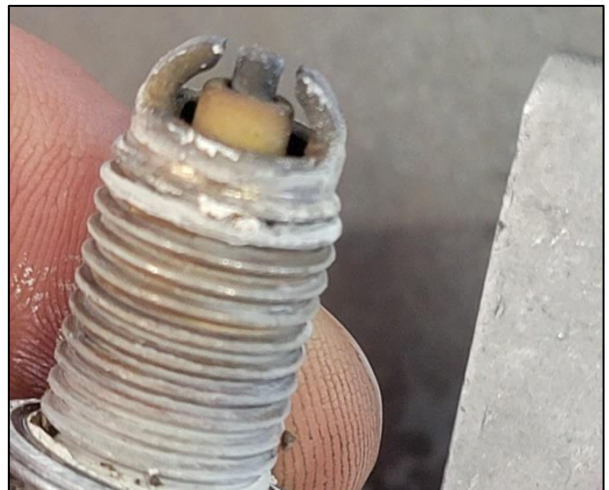
**#1 Cylinder - Top Spark Plug:** The #1 top spark plug appeared in normal condition, with electrode coloration indicating a proper fuel-to-air ratio. This suggests that combustion was occurring within expected parameters.

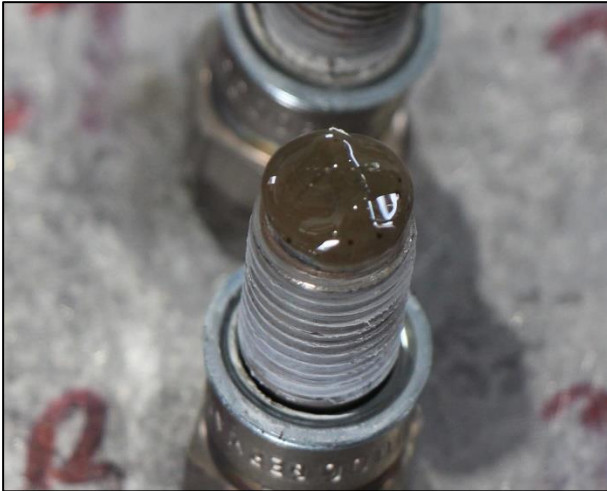
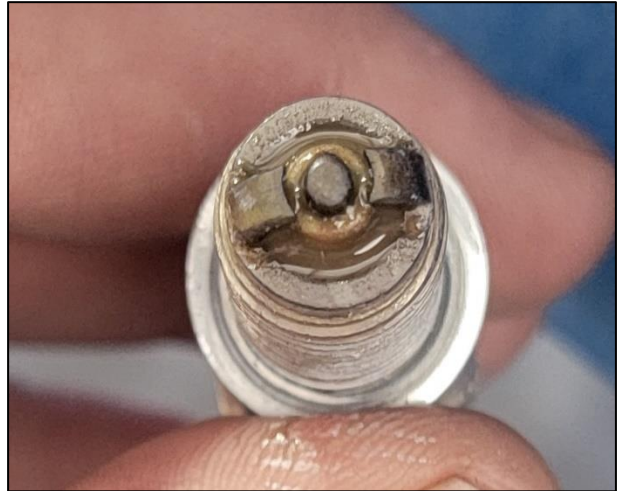
**#1 Cylinder - Bottom Spark Plug:** The bottom spark plug for the #1 cylinder displayed a substantial buildup of a liquid substance consistent with engine oil, likely due to the engine's storage position, which may have allowed oil to migrate into the combustion chamber. Electrode coloration indicated a proper fuel-to-air ratio, with no evidence of oil consumption.

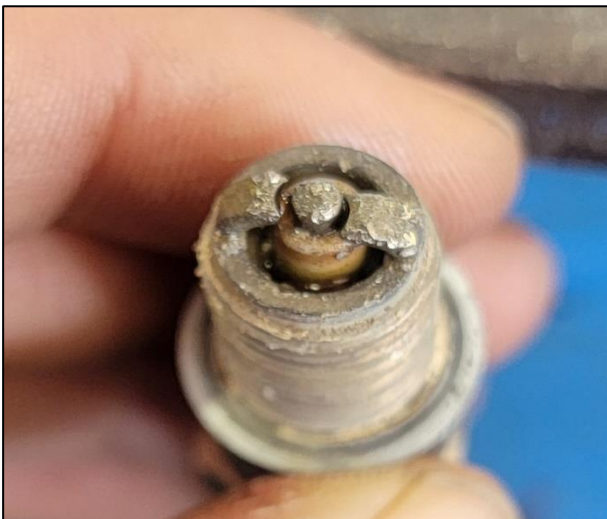
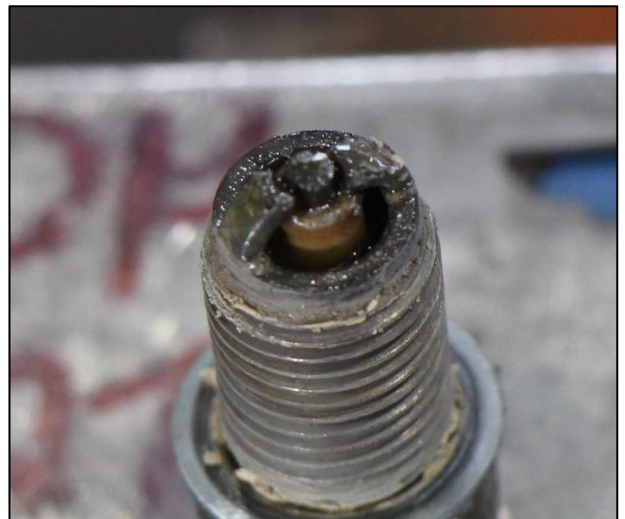
**#2 Cylinder - Top Spark Plug:** The top spark plug for the #2 cylinder exhibited impact damage on the electrodes, and metallic flakes were observed on the insulator. It was also wet with a liquid substance consistent with engine oil, likely due to the engine's storage position. Electrode coloration indicated a proper fuel-to-air ratio, with no evidence of oil consumption.

Both the #2 spark plug—and especially the #4—showed extensive damage, likely due to intense internal forces caused by valve fragments colliding within the combustion chamber.

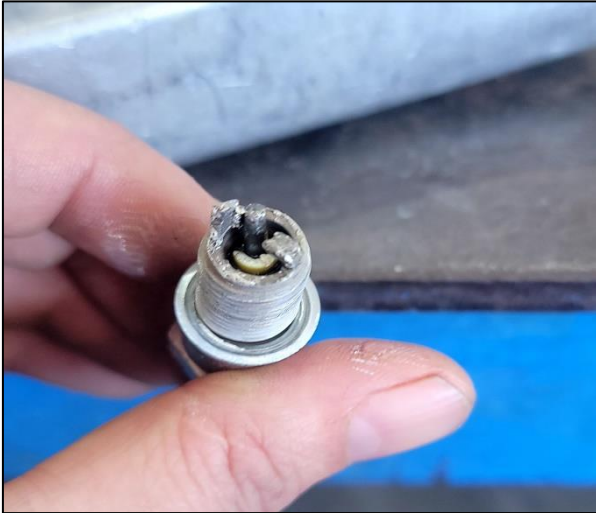
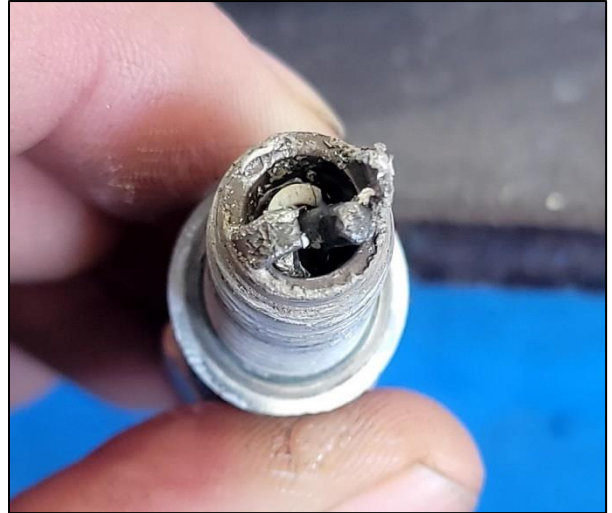
**#2 Cylinder - Bottom Spark Plug:** The bottom spark plug for the #2 cylinder showed substantial impact damage on both the electrodes and insulator, with metallic flakes present on the insulator. It was also wet with a substance consistent with engine oil, likely due to the engine's storage position.

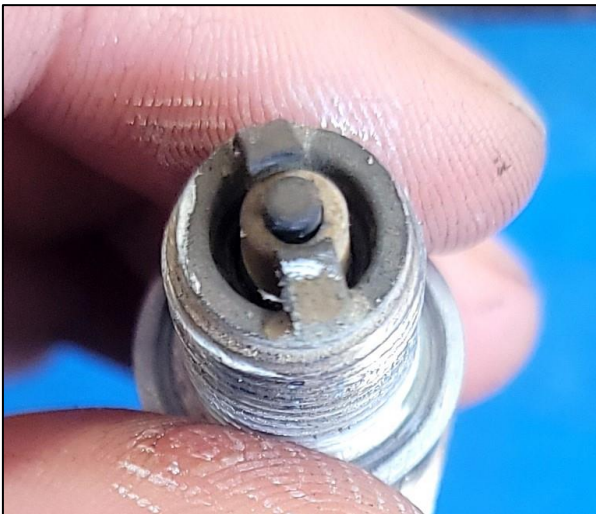
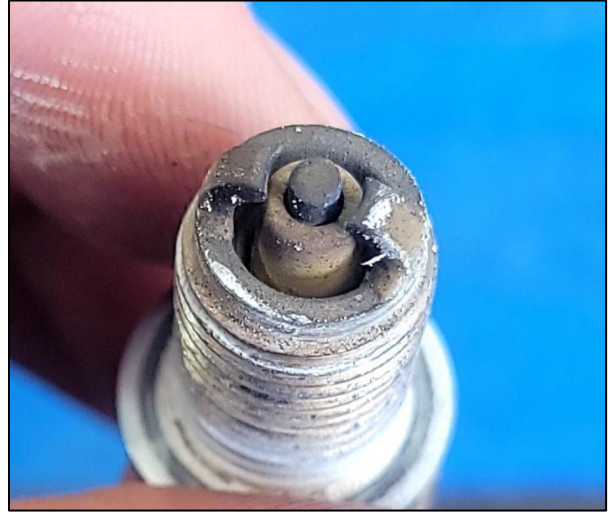
**#3 Cylinder - Top Spark Plug:** The top spark plug for the #3 cylinder was in normal condition, with electrode coloration indicating a proper fuel-to-air ratio, suggesting that combustion was within expected parameters. However, thermal paste was observed on the ground electrodes, indicating possible over-application.

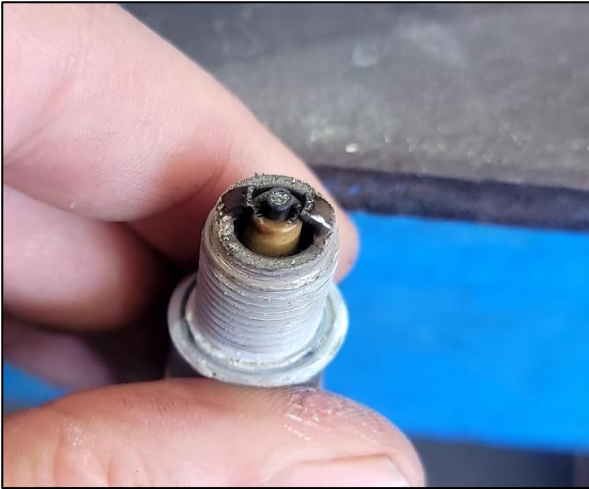
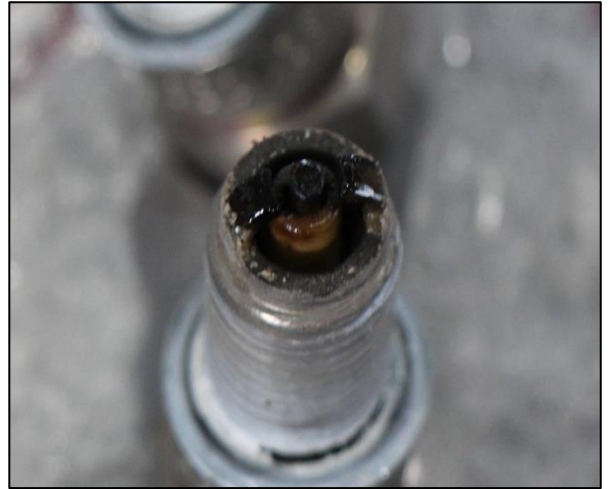
**#3 Cylinder - Bottom Spark Plug:** The bottom spark plug for the #3 cylinder displayed darker electrodes and insulator compared to the other plugs, with coloration indicating a richer fuel-to-air ratio. The plug was also slightly wet with a substance consistent with engine oil.

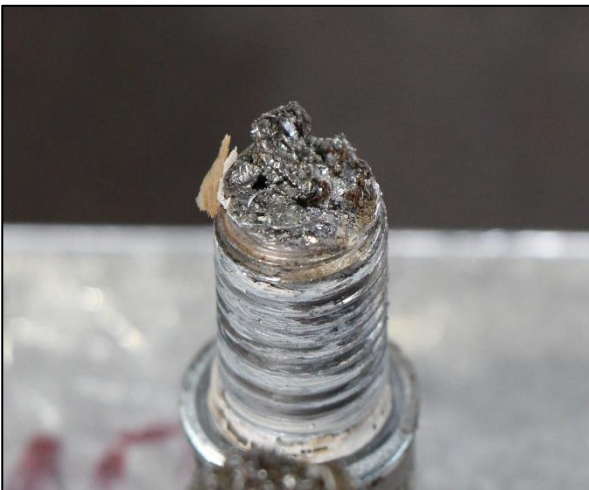
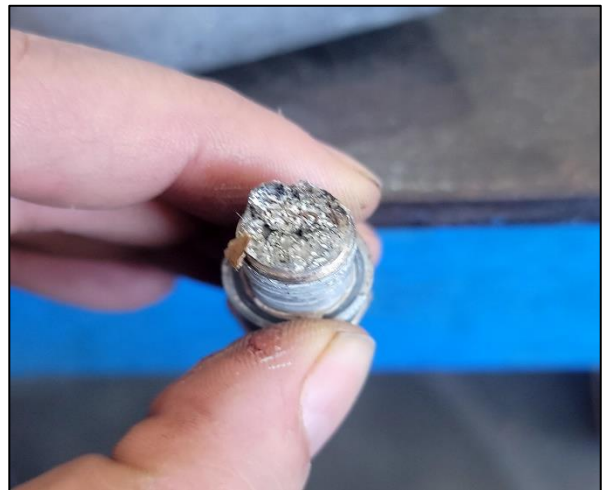
**#4 Cylinder - Top Spark Plug:** The top spark plug for the #4 cylinder exhibited substantial impact damage, with broken and crushed electrodes and insulator.

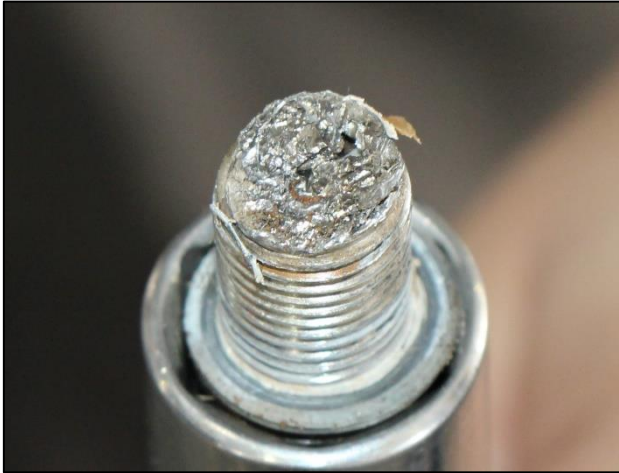
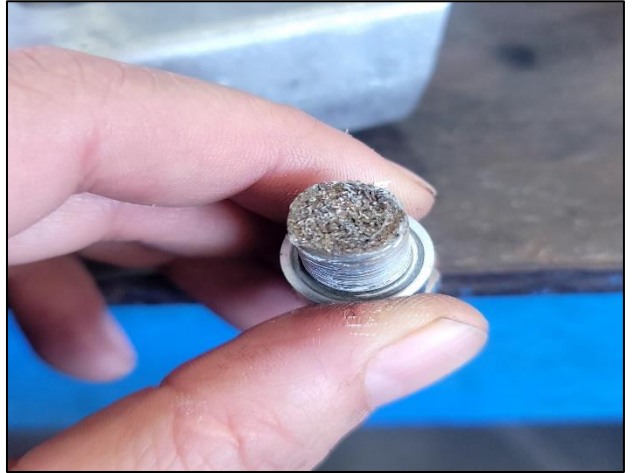
**#4 Cylinder - Bottom Spark Plug:** The bottom spark plug for the #4 cylinder also exhibited substantial impact damage, with broken and crushed electrodes and insulator.

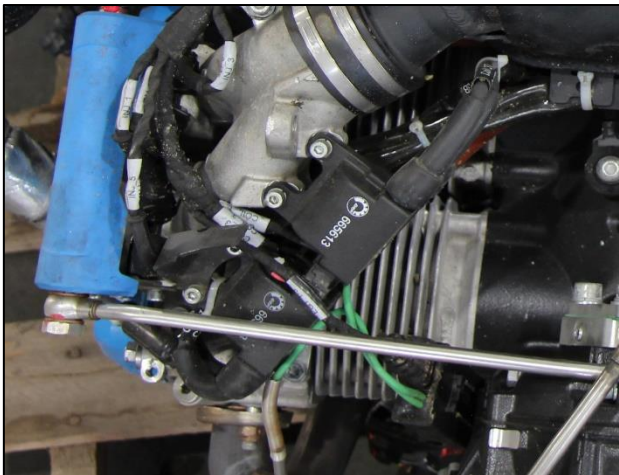
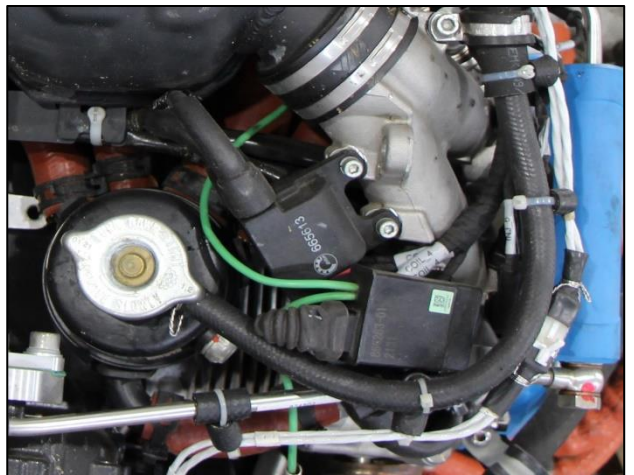
**Ignition System:** The ignition system components, including the ignition coils and plug leads, were inspected for physical condition but were not functionally tested. The system appeared to be in good physical condition, with no visible impact damage.

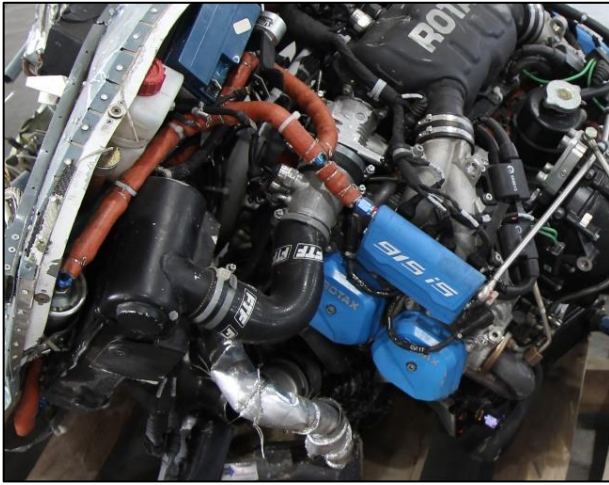
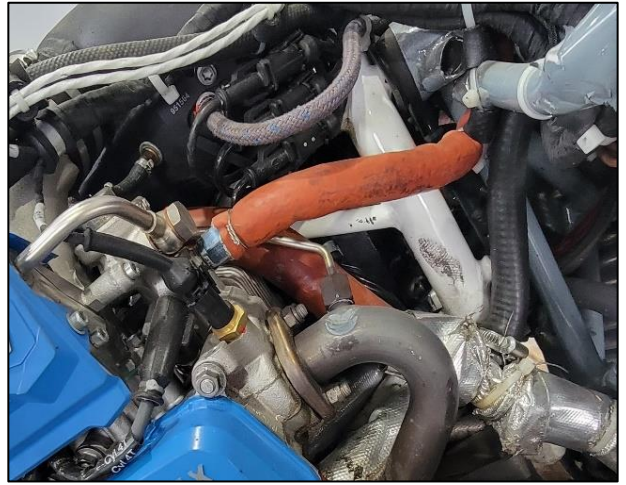
**Fuel System:** The fuel lines were found breached at the firewall, with a small quantity of fuel recovered from the lines on the airframe side. The inlet and return fuel lines remained securely attached to their respective ports on the fuel rail (inlet side) and the fuel pressure regulator (return side). The crossover feed line between the inlet and return sides was also intact. All fuel lines were protected with a fire sleeve and appeared to be in good overall condition. The injectors and fuel pumps were not removed, inspected, or tested.

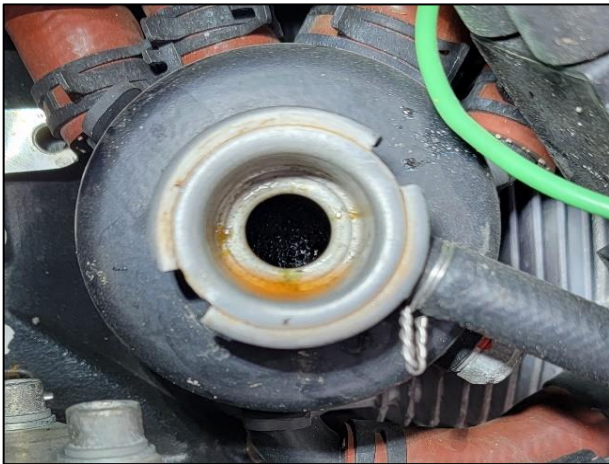
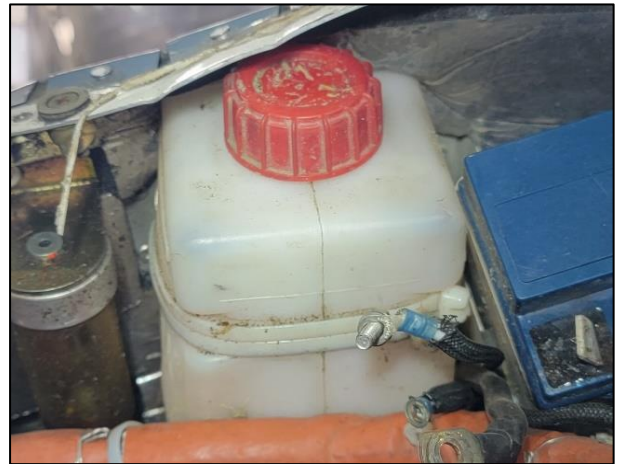
**Cooling system:** The coolant expansion chamber and expansion tank were both opened and found empty, with no coolant present. The cooling system had been breached due to impact damage sustained by the coolant radiator and coolant lines.

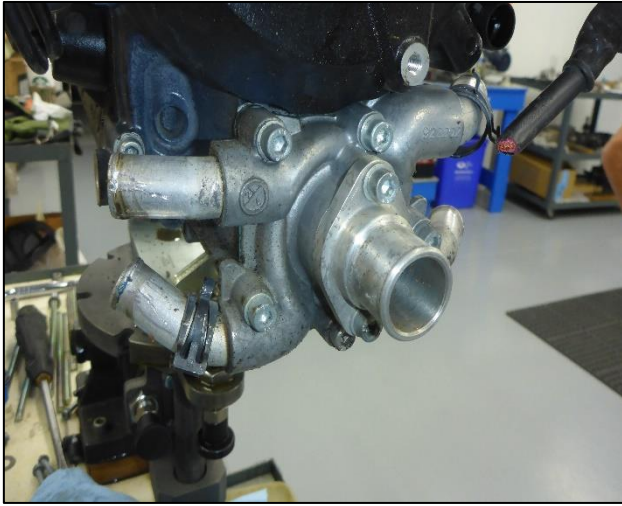
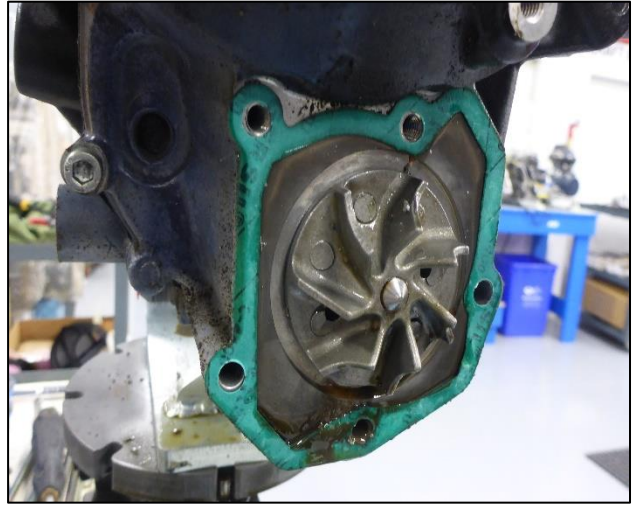
**Cooling system (Continued):** The water pump housing was removed, and the impeller was inspected. No anomalies were observed.

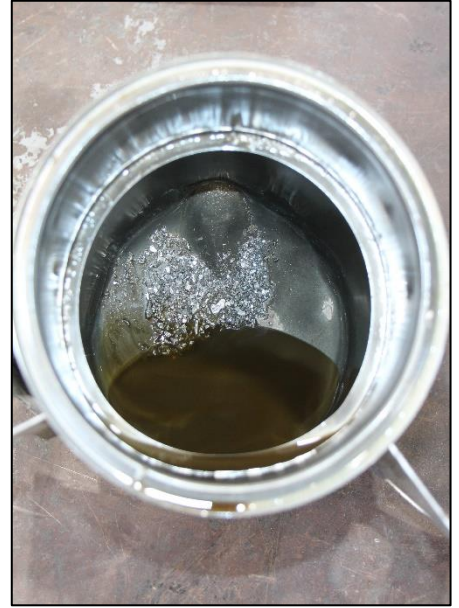
**Lubrication system (Continued):** Upon internal inspection, a significant amount of foreign object debris (FOD) was observed at the bottom of the oil tank.

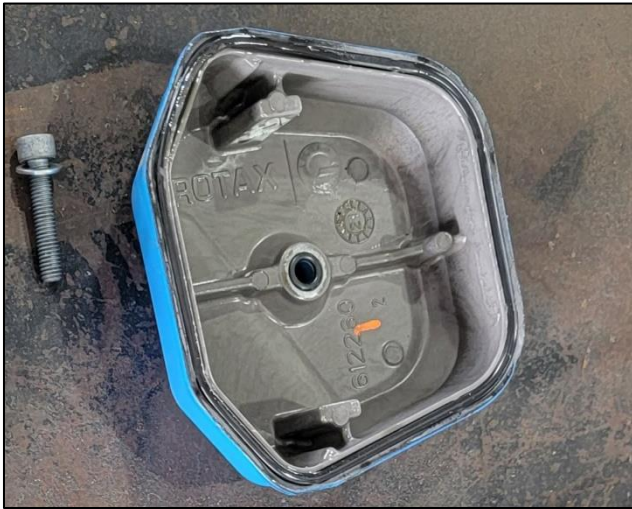
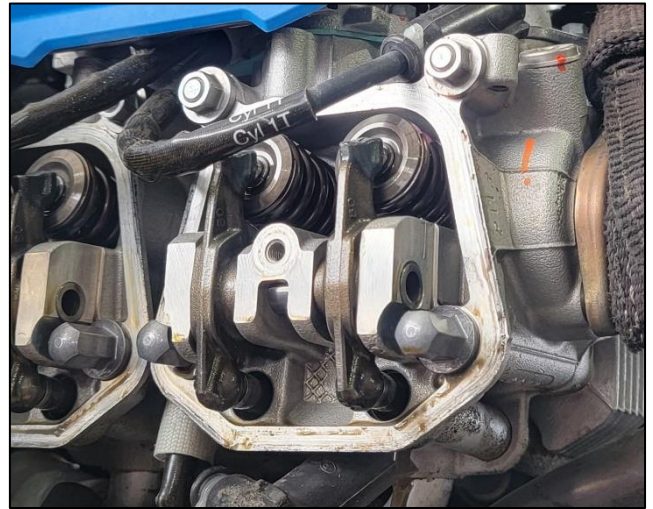
**#1 Cylinder head:** The rocker cover was removed to expose the rocker arms, rocker arm shafts, valve spring retainer washers, valve spring keepers, valve springs, and pushrods. Evidence of lubrication oil was observed within the valve cover. All components appeared intact and in good physical condition.

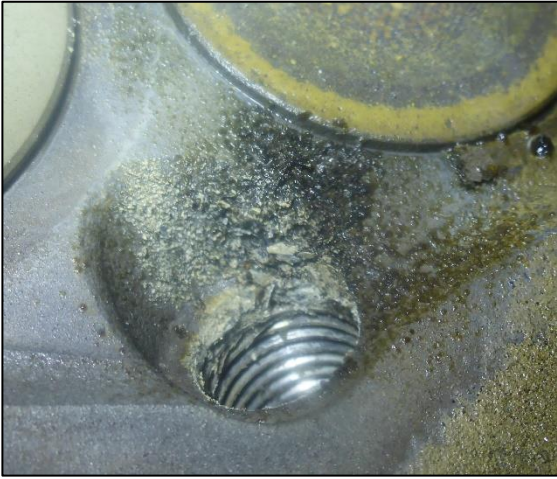
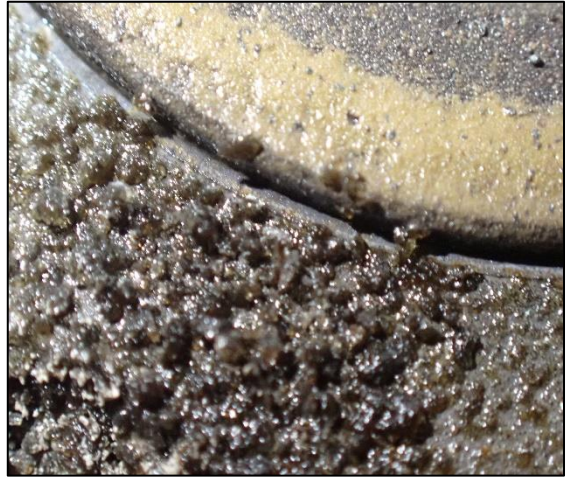
**#1 Cylinder head (Continued):** A buildup of engine oil, coolant, and a small amount of metallic material was observed on the face and combustion section of the cylinder head. Additionally, a small buildup of what appeared to be lead was found on the face of the cylinder head and on the intake and exhaust valves, indicating the engine was operating with 100LL Av-Gas fuel. Unusual burn patterns and material buildup were observed near the top spark plug and the exhaust valve.

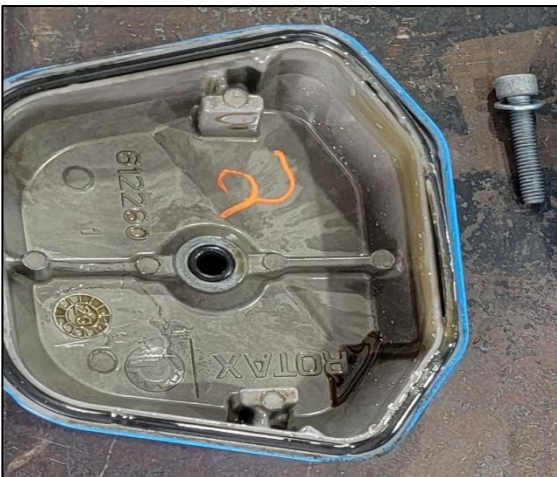
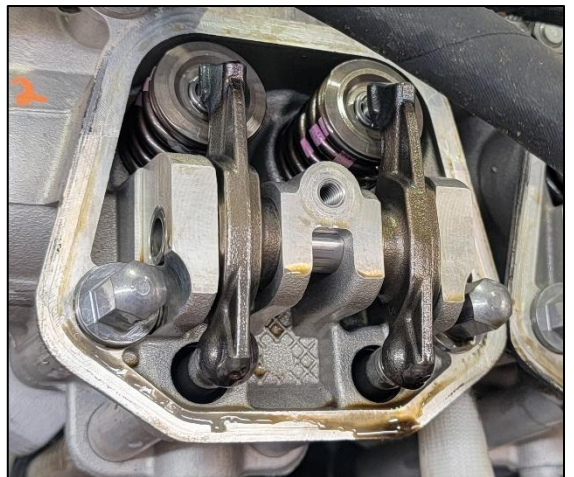
**#2 Cylinder head:** The rocker cover was removed to expose the rocker arms, rocker arm shafts, valve spring retainer washers, valve spring keepers, valve springs, and pushrods. Evidence of lubrication oil was observed within the valve cover. All components appeared intact and in good physical condition.

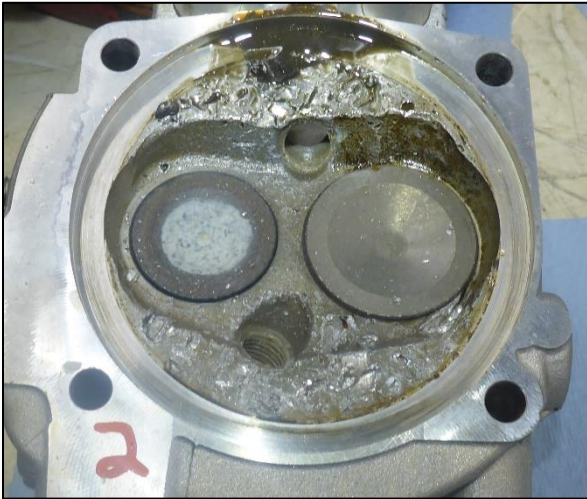
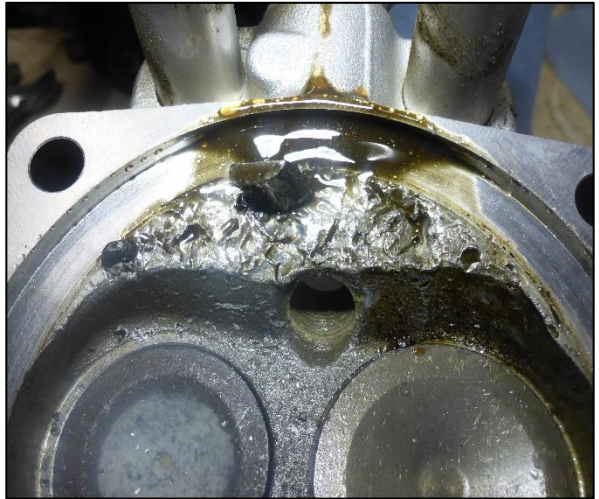
**#2 Cylinder head (Continued):** Impact damage was observed on the face and combustion section of the cylinder head, including the exhaust and intake valve faces. A metallic object was embedded in the cylinder head beneath the bottom spark plug hole on the combustion side. Additionally, a buildup of engine oil and metallic material was present on the face of the cylinder head.

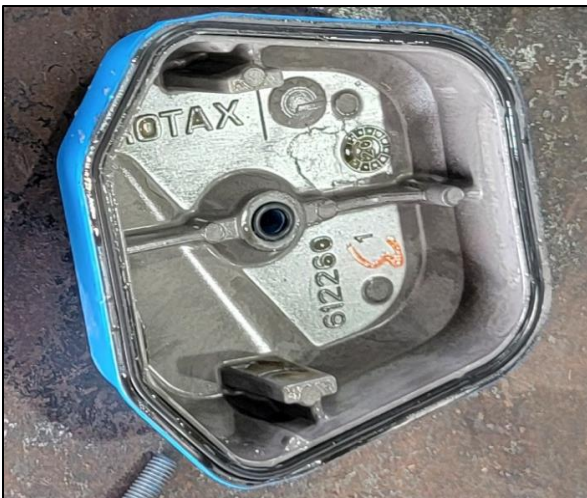
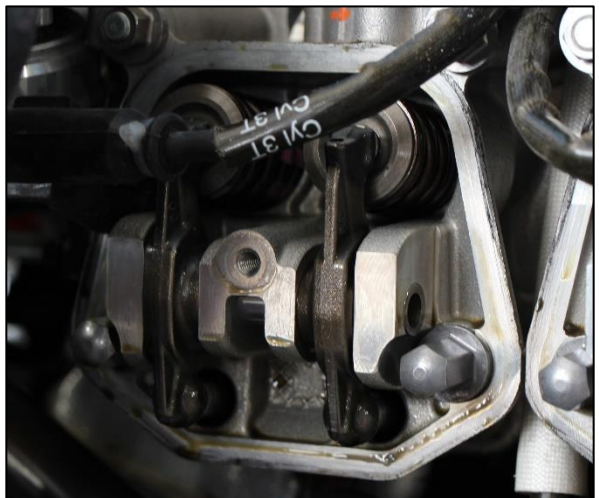
**#3 Cylinder head:** The rocker cover was removed to expose the rocker arms, rocker arm shafts, valve spring retainer washers, valve spring keepers, valve springs, and pushrods. Evidence of lubrication oil was observed within the valve cover. All components appeared intact and in good physical condition.

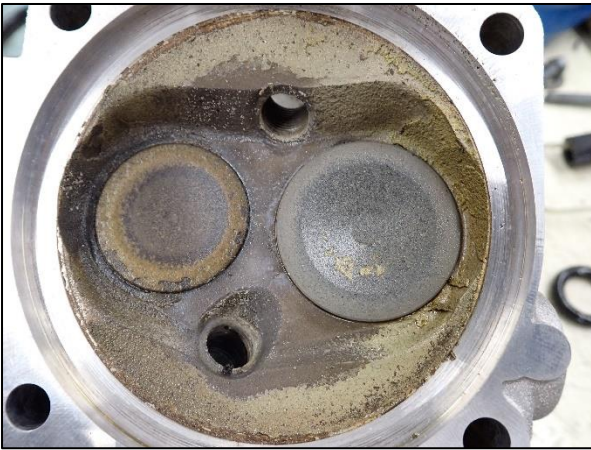
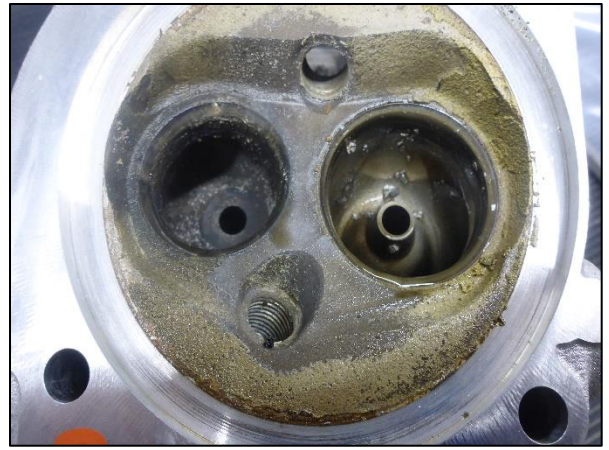
**#3 Cylinder head (Continued):** A small buildup of what appeared to be lead was observed on the face of the cylinder head and on the intake and exhaust valves, indicating that the engine was operating with 100LL Av-Gas fuel. No impact marks, metallic material, or unusual burn patterns were observed on the face of the #3 cylinder head. However, upon removal of the intake valve, small metallic particles were found in the intake bore of the cylinder head, behind the intake valve.

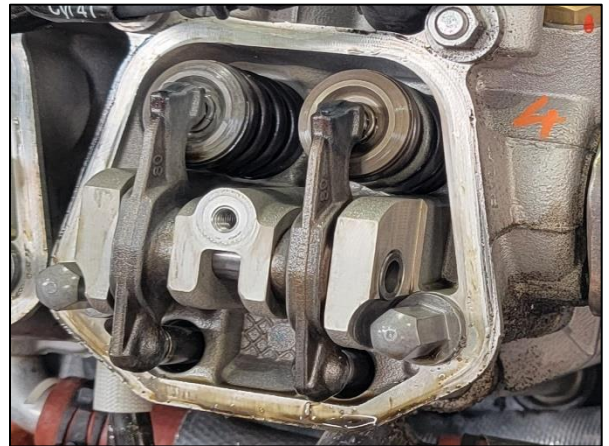
**#4 Cylinder head:** The rocker cover was removed to expose the rocker arms, rocker arm shafts, valve spring retainer washers, valve spring keepers, valve springs, and pushrods. Evidence of lubrication oil was observed within the valve cover. All components appeared intact and in good physical condition.

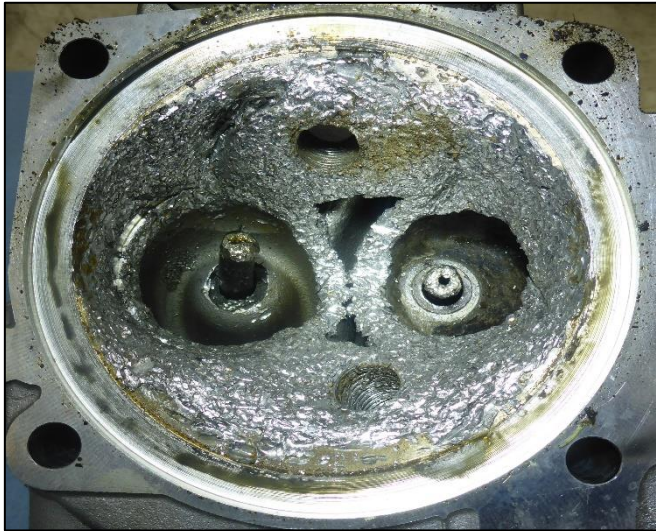
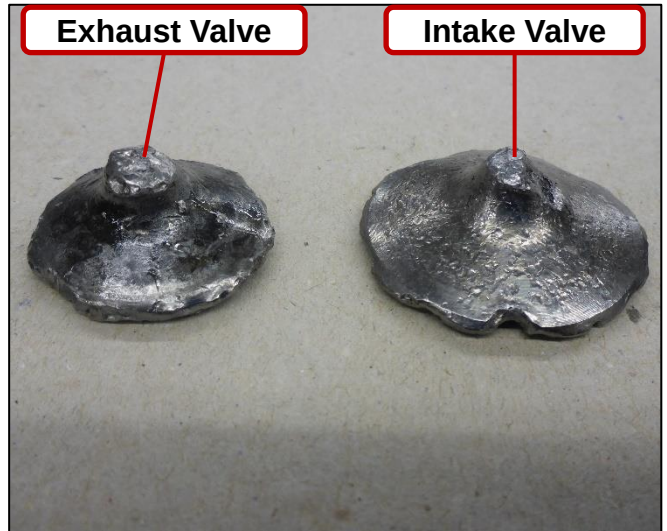
**#4 Cylinder head (Continued):** The #4-cylinder head was heavily damaged, with both intake and exhaust valve heads broken off. The intake valve head remained in the combustion chamber, while the exhaust valve head was found deep within the intake manifold. A breach in the coolant water jacket likely caused the coolant found in the oil tank. Additionally, the intake valve and pushrod were bent, suggesting impact by a solid object.

The engine sustained substantial internal damage, particularly within the #4 cylinder, which suffered a critical structural failure. Both intake and exhaust valve heads detached, with the exhaust valve head becoming lodged in the airbox. Additionally, a breach in the coolant water jacket allowed coolant to mix with the oil in the tank. The #4 piston was also severely compromised, exhibiting a large hole that exposed the connecting rod, while scoring on the cylinder walls suggested additional internal impact.

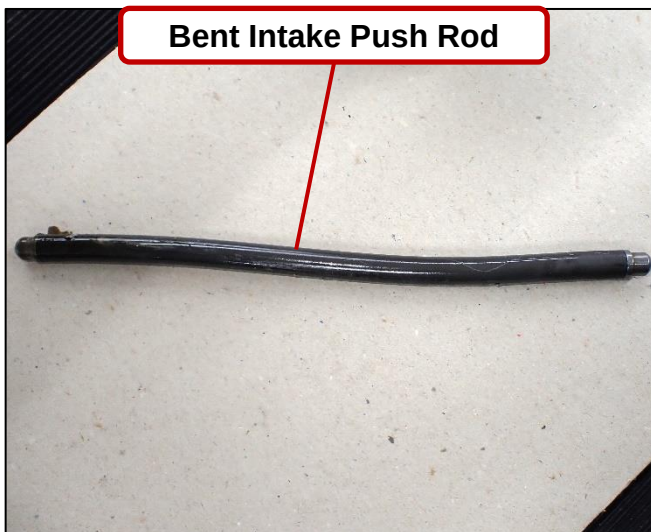
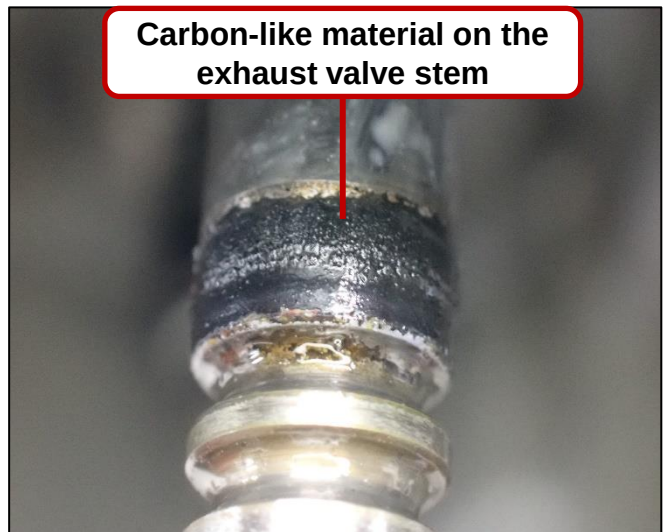
An unusual accumulation of carbon-like material was observed on the exhaust valve stem near the valve spring retainer, just below the cotter keeper grooves. This buildup was unique to this valve, as no similar deposits were found on any other valves.

No additional snags were recorded in the engine or airframe logbooks. One notable observation during the engine maintenance log review was the consistently lower compression readings for the #4 cylinder, averaging around 8 PSI lower than the other cylinders. This discrepancy was evident from the first compression test at the 100-hour inspection and persisted throughout the engine's service life, particularly affecting the #4 cylinder with the failed exhaust valve.

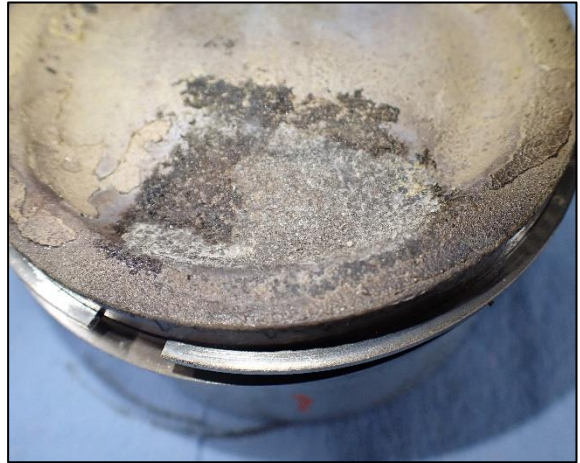
**#1 Piston:** A buildup of engine oil was observed on the combustion side of the piston. Additionally, a small accumulation of what appeared to be lead was found on the piston face, indicating the engine was operating with 100LL Av-Gas fuel. Unusual burn patterns and material buildup were noted near the top 12 o'clock position of the piston face.

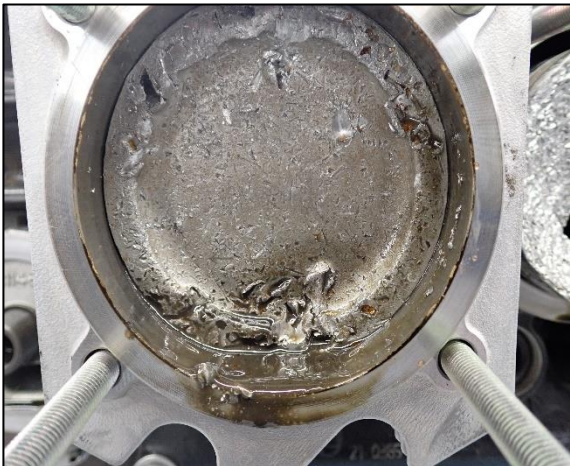
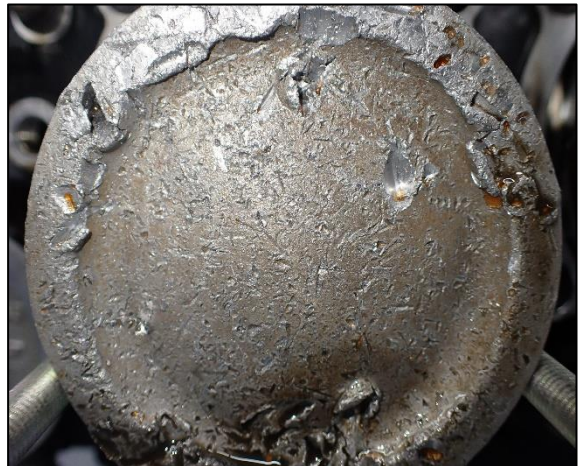
**#2 Piston:** Impact damage was observed on the piston face. Additionally, a buildup of engine oil was present on the combustion side of the piston.

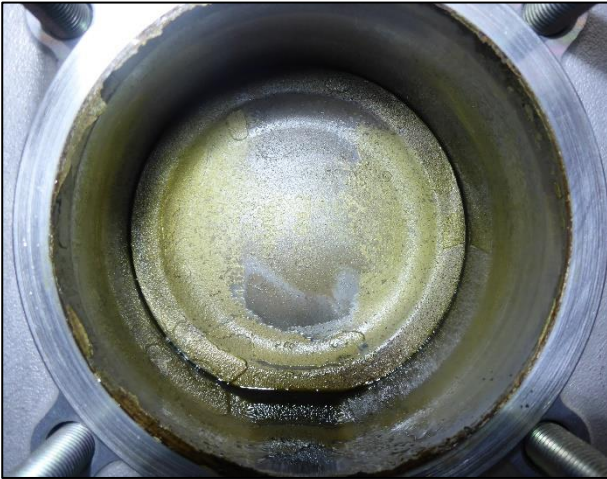
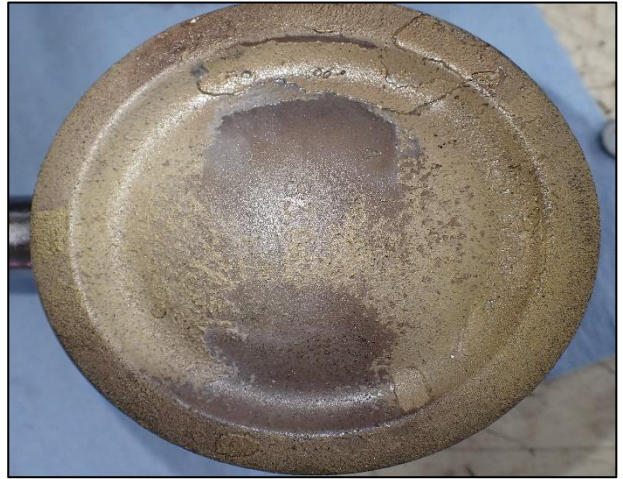
**#3 Piston:** A buildup of engine oil was observed on the combustion side of the piston. Additionally, a small accumulation of what appeared to be lead was found on the piston face, indicating the engine was operating with 100LL Av-Gas fuel.

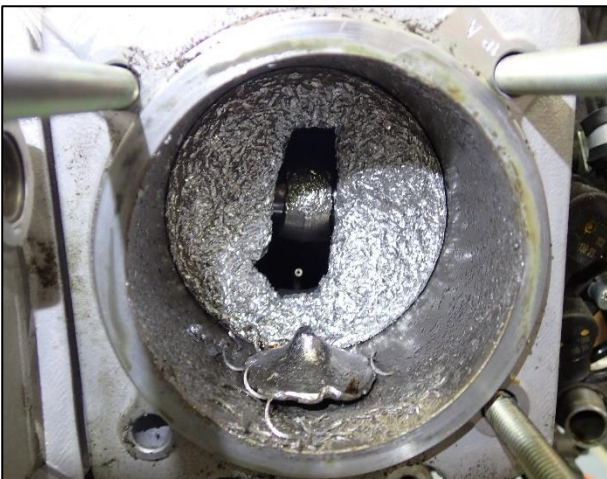
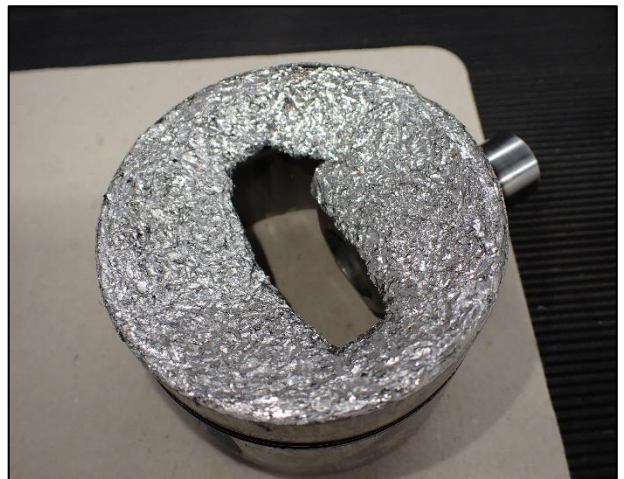
**#4 Piston:** The #4 piston sustained severe impact damage, resulting in a large hole in the center that exposed the connecting rod. The intake valve head was found resting at the bottom of the cylinder bore, on the combustion side of the piston.

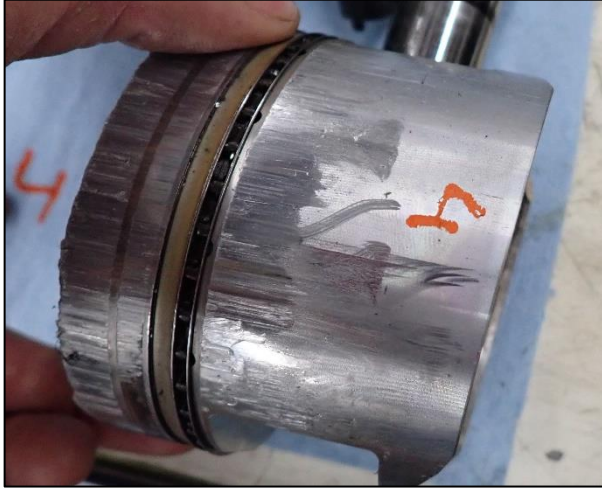
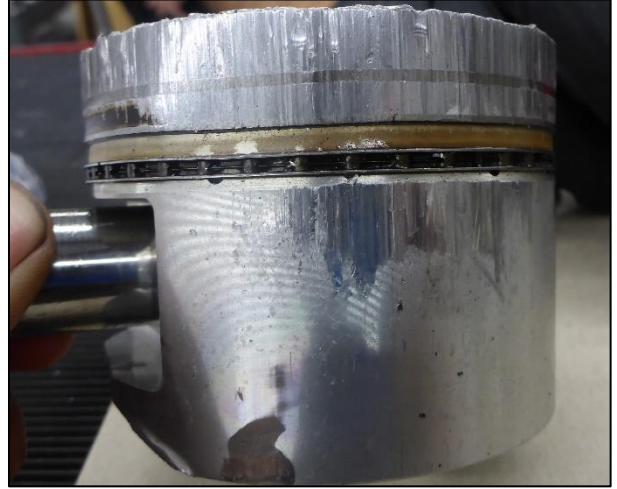
**#4 Piston (continued):** The #4 piston skirts and rings displayed vertical scoring marks, with both compression rings stuck within their land grooves.

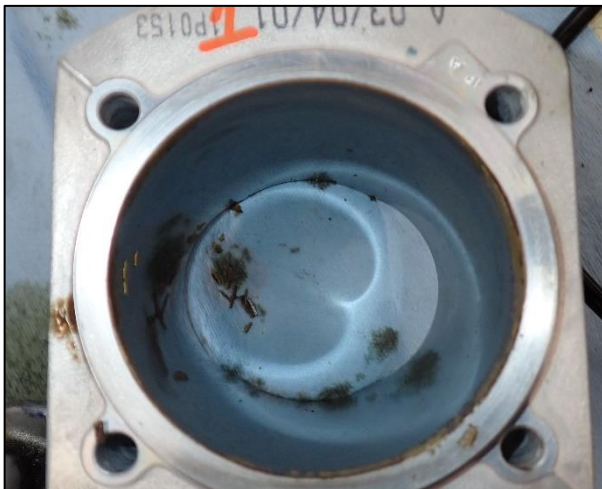
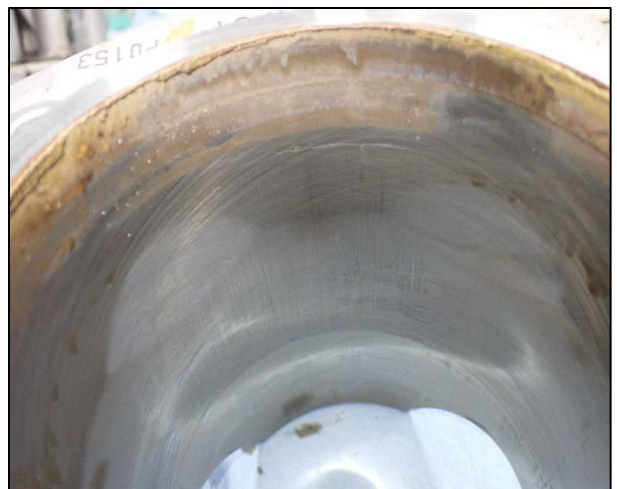
**#1 Cylinder:** The #1 cylinder was removed and examined. No damage was observed on the cylinder bore, including any signs of excessive heat or metal transfer. Evidence of oil lubrication was present, and the cross-hatching remained visible

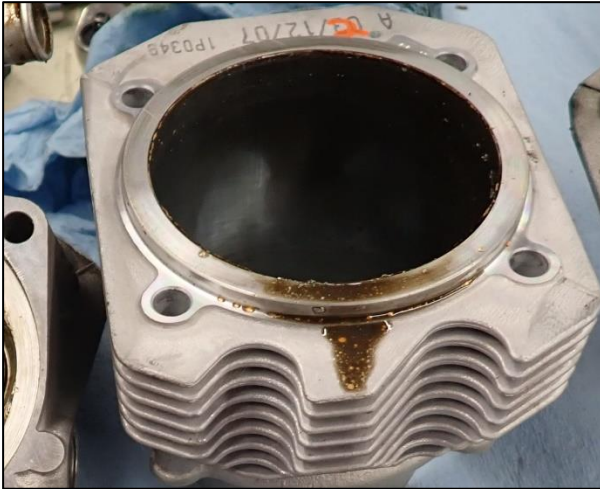
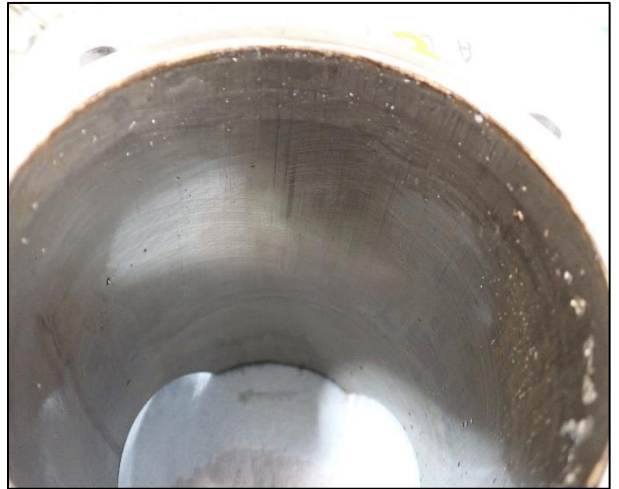
**#2 Cylinder:** The #2 cylinder was removed and examined. No damage was observed on the cylinder bore, including any signs of excessive heat or metal transfer. Evidence of oil lubrication was present, and the cross-hatching remained visible. A small buildup of metallic material was observed on the piston bore.

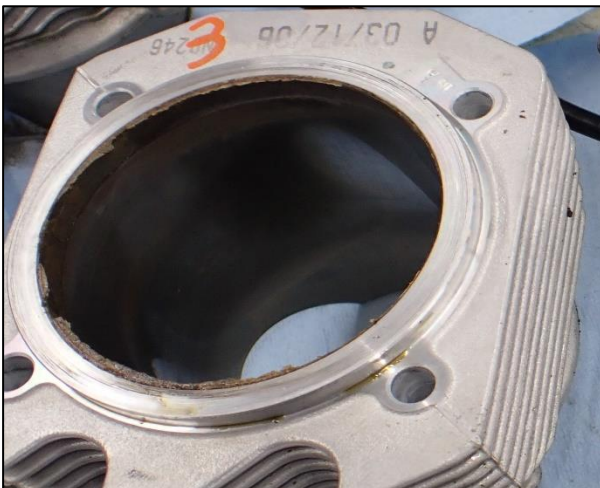
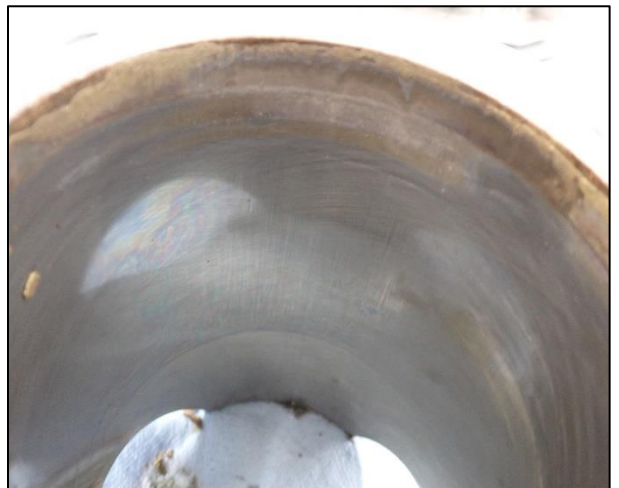
**#3 Cylinder:** The #3 cylinder was removed and examined. No damage was observed on the cylinder bore, including any signs of excessive heat or metal transfer. Evidence of oil lubrication was present, and the cross-hatching remained visible

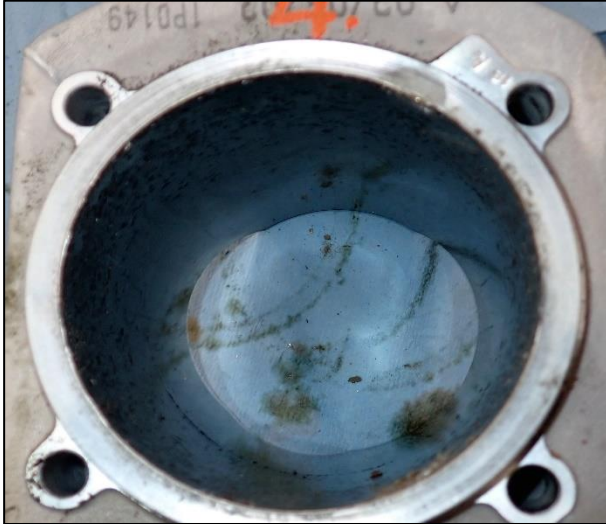
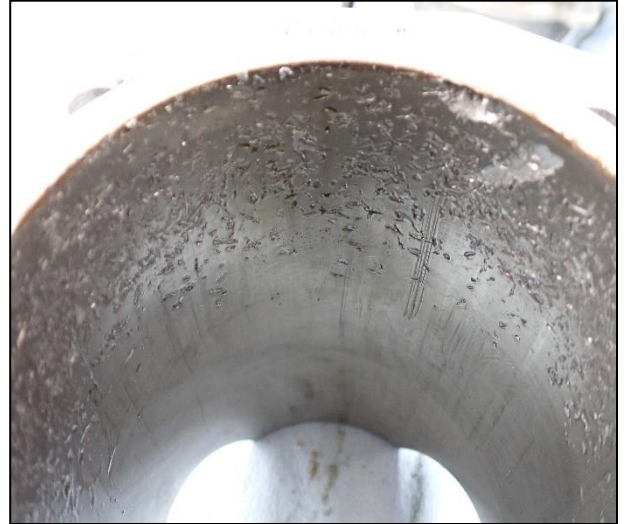
**#4 Cylinder:** The #4 cylinder was removed and examined. Deep gouges, scoring, and signs of impact damage were observed on the cylinder walls.

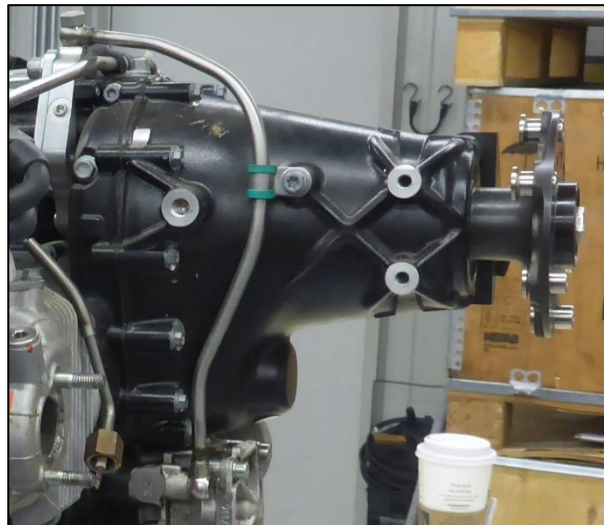
**Reduction Gearbox:** The reduction gearbox was removed and inspected. The prop shaft was rotated, and no unusual noises or roughness were detected in the propeller shaft bearing. The small drive gear and large gear within the gearbox were inspected in situ, as the gearbox was not disassembled. No anomalies were observed with the reduction gearbox.

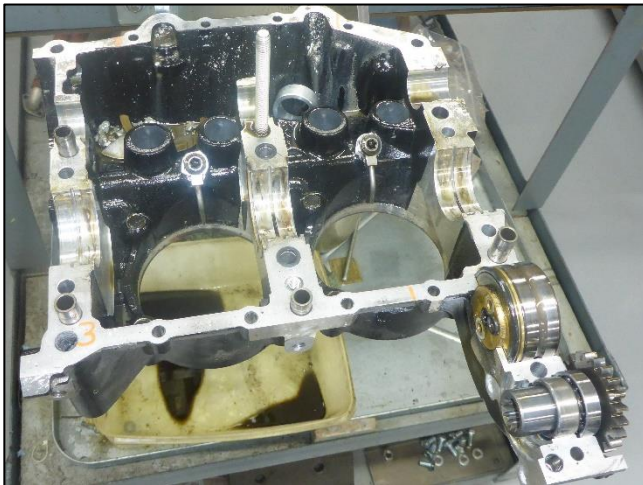
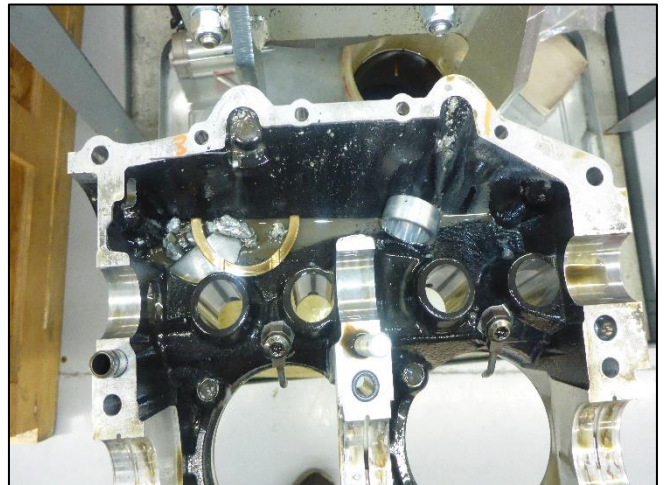
**Crankcase:** The crankcase halves were separated and inspected both externally and internally. Large pieces of metallic contamination were found at the bottom of the crankcase, with some fragments partially obstructing the oil return and transfer ports. The piston oil squirters were intact and undamaged. The camshaft bearings appeared to be in good condition, with minimal impact from the metallic contamination, while the crankshaft bearings showed some scoring. Beyond the metallic contamination and bearing surface scoring, no other anomalies were observed.
