## ***ROTECH FLIGHT SAFETY INC.***

# **INVESTIGATION REPORT**

| <b>Aircraft Make:</b> | Sling | <b>Aircraft registration:</b> | N135WT |
| <b>Aircraft Model:</b> | 4 TSI | <b>Aircraft S/N</b> | 131S |

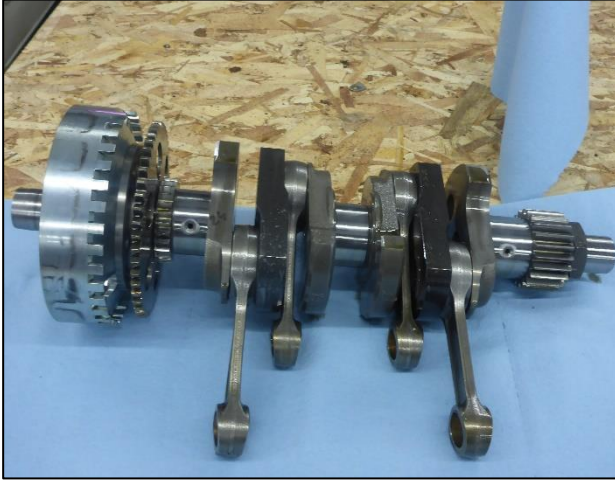
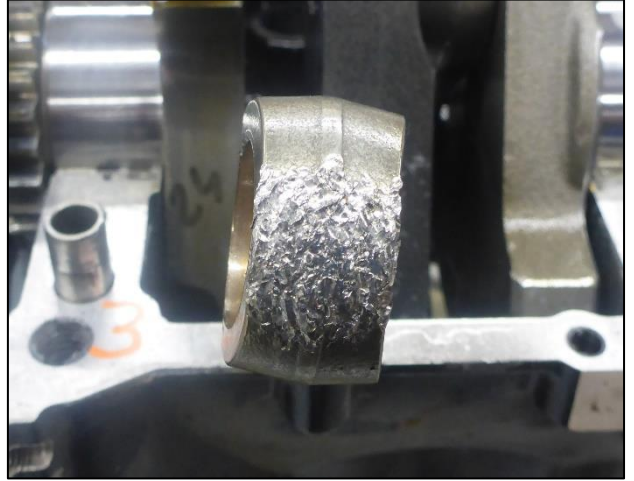
**Crankshaft:** The crankshaft was removed from the crankcase for inspection. It was found to be in good physical condition, except for impact damage observed on the wrist pin journal of the #4 connecting rod.

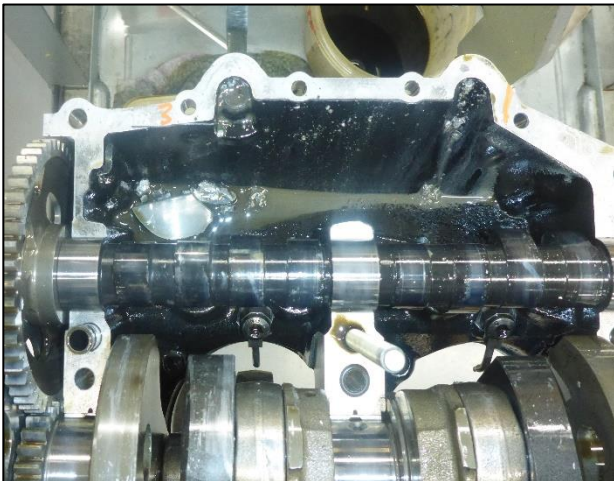
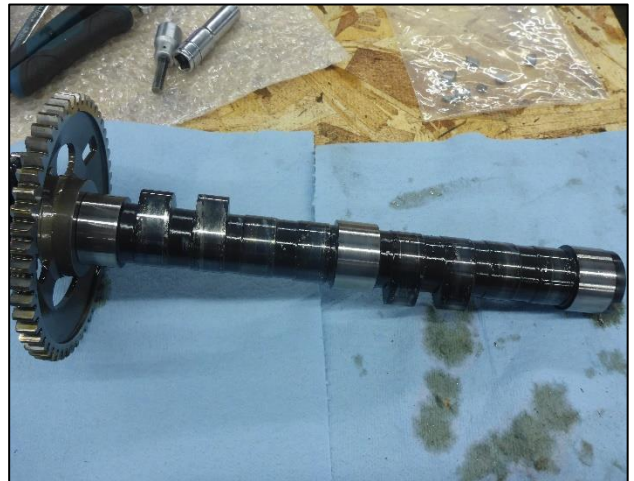
**Camshaft:** The camshaft was removed from the crankcase for inspection. Several cam lobes had metallic material embedded in their surfaces. No other anomalies were observed with the camshaft.

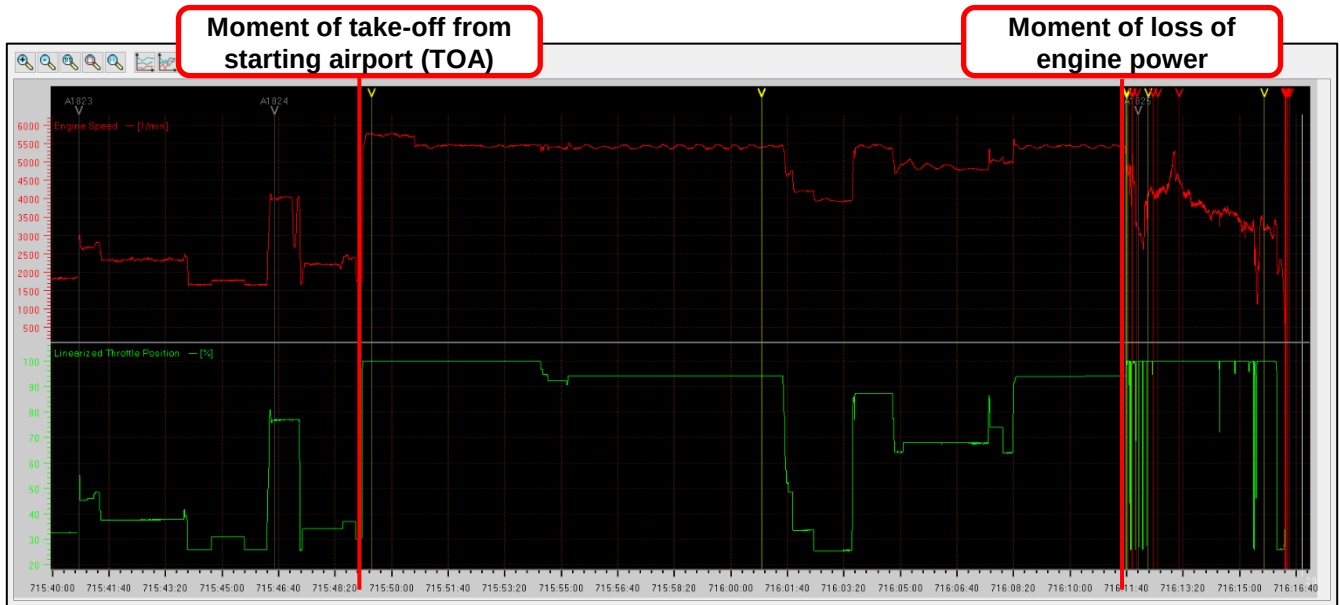
**Analysis of Throttle Position and RPM:** The throttle position and RPM were analyzed to assess if the engine responded correctly to the pilot's inputs throughout the flight. This analysis is essential for verifying the engine's performance under pilot command and for understanding the aircraft's behavior before the incident.

According to ECU data, the linearized throttle position remained synchronized with engine RPM for most of the accident flight, indicating that the engine was responding appropriately to the pilot's inputs. During the critical moments leading up to the accident, the throttle was set at 94%, with the engine running at 5427.93 RPM. Shortly afterward, the engine RPM began to decrease and fluctuate, indicating a rough running condition and a loss of engine power. In response, the pilot increased the throttle to 100%, but the engine did not respond.

The pilot then cycled the throttle between 25% and 100% several times in an apparent attempt to stabilize the RPM. Despite these efforts, the RPM dropped to 2615.80 with the throttle near 100%, briefly recovering to 5303.30 RPM before continuing to degrade and ultimately ceasing to respond to throttle inputs.
