# National Transportation Safety Board

WPR23LA352

## **MATERIALS LABORATORY**

Factual Report 24-069

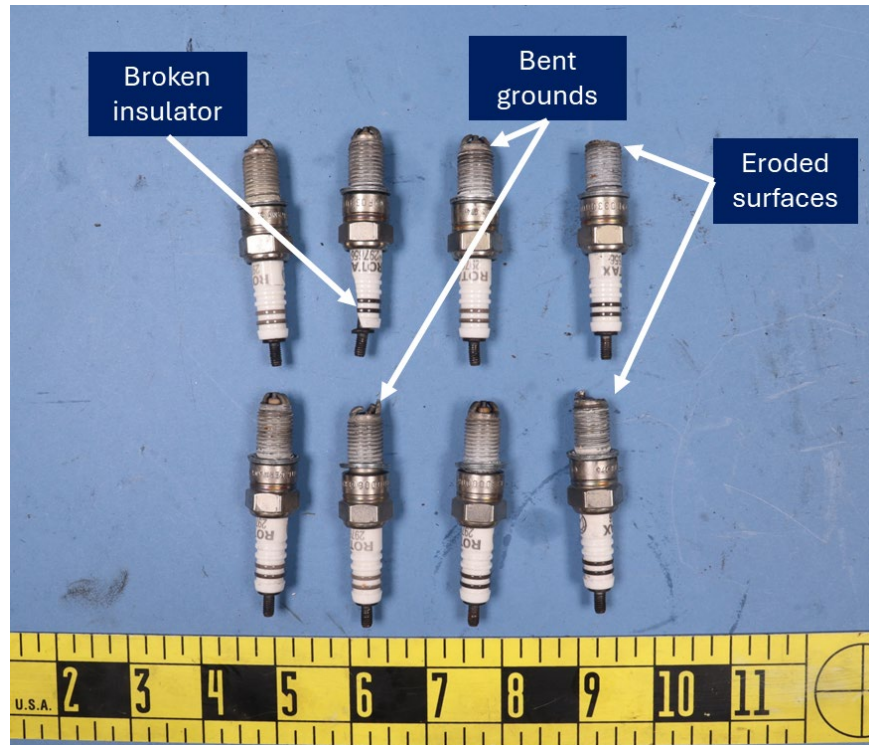
The eight spark plugs were submitted all together, and it was not possible to identify the cylinders that they came from (Figure 5). Four plugs showed damage to the electrode and grounds; in two plugs, the plugs and grounds were eroded away, and the surfaces showed damage consistent with repeated impact. Two other plugs had bent contacts and grounds. A fifth plug showed damage to the opposite end, where the terminal had bent and a piece of the insulator had broken off. The knock sensor showed no damage.

**Figure 5.** Four spark plugs showed damage to the ground and terminal surface. One spark plug had a broken insulator.

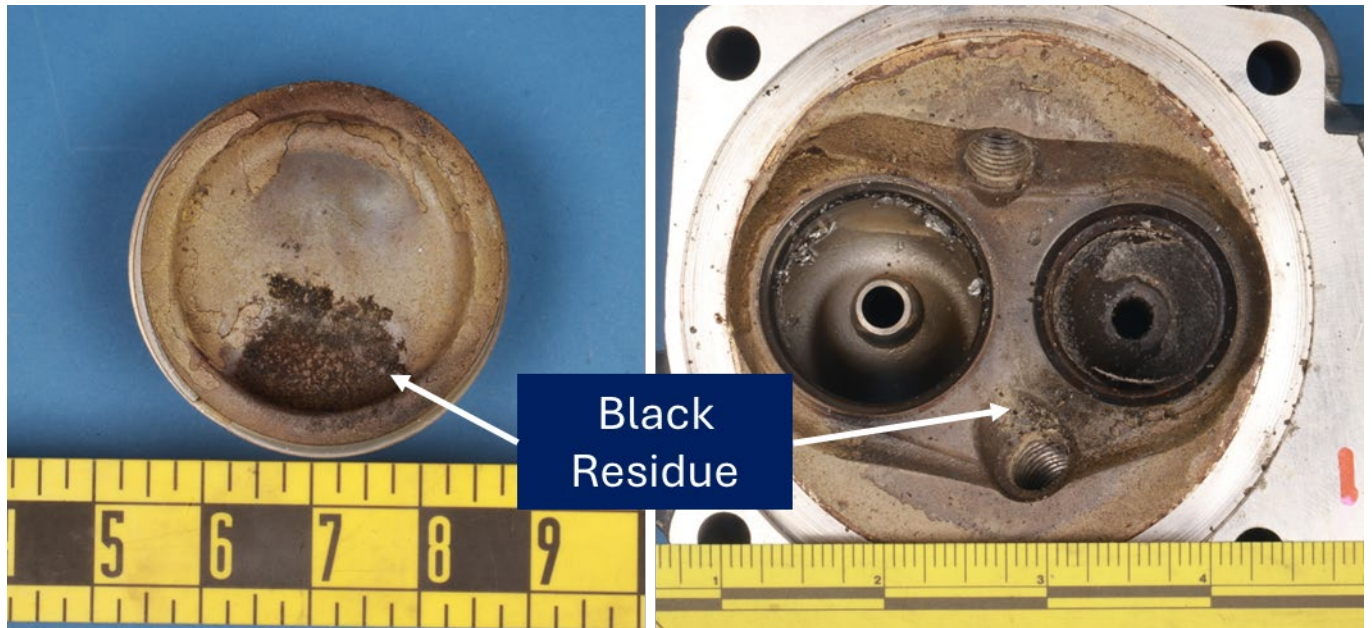
Cylinder 1 and its associated components showed no signs of mechanical damage. The piston had hard green deposits across its face. One quadrant of the piston face had a thin layer of hard black deposit sitting on top of the green deposit (Figure 7). The composition of this black deposit was not determined. The cylinder head also showed green deposit, and a small amount of black deposit was also visible between the spark plug port and the exhaust valve port. Loose metal flakes were visible in the intake port.

**Figure 7.** Black residue on the (left) piston and (right) cylinder head for cylinder 1.

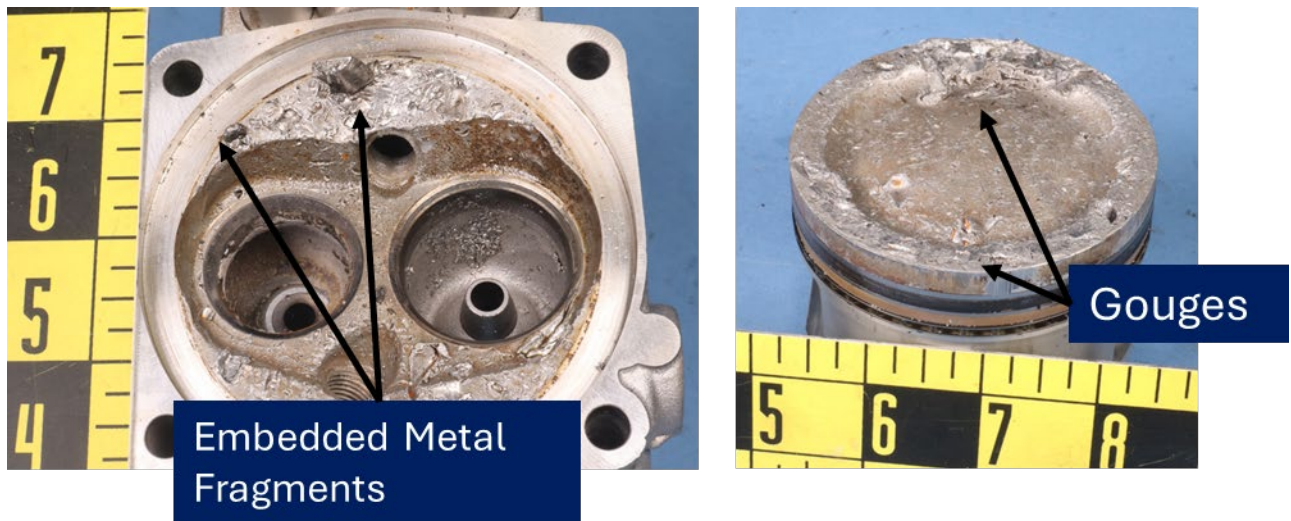
Cylinder 2 showed gouges on the interior of the cylinder head, piston, and interior wall of the cylinder (Figure 8). Several fragments of metal were embedded in the cylinder head, and metal fragments were present in the intake port. X-Ray Fluorescence measurements of one fragment removed from the cylinder head showed a composition (wt%) of 81.2% Fe, 9.7% Co, 2.6% Al, 2.2% Ni, 2.2% Mo, 1.2% S, 0.52% Si, and smaller amounts of other elements. The intake and exhaust valves

**Figure 8.** (Left) The cylinder head and (right) piston for cylinder 2 showed gouges across the surfaces. Metal fragments were embedded in the cylinder head.

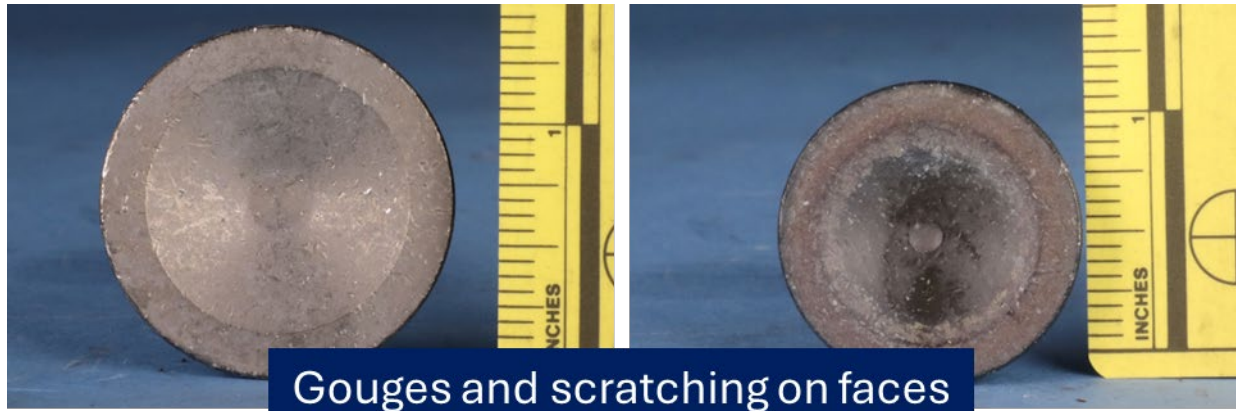
showed small scratches and gouges across the faces of the valves (Figure 9). No damage was seen in the other components of the valve train.

**Figure 9.** Both the (left) intake and (right) exhaust valves from cylinder 2 showed small gouges and scratches across their faces.

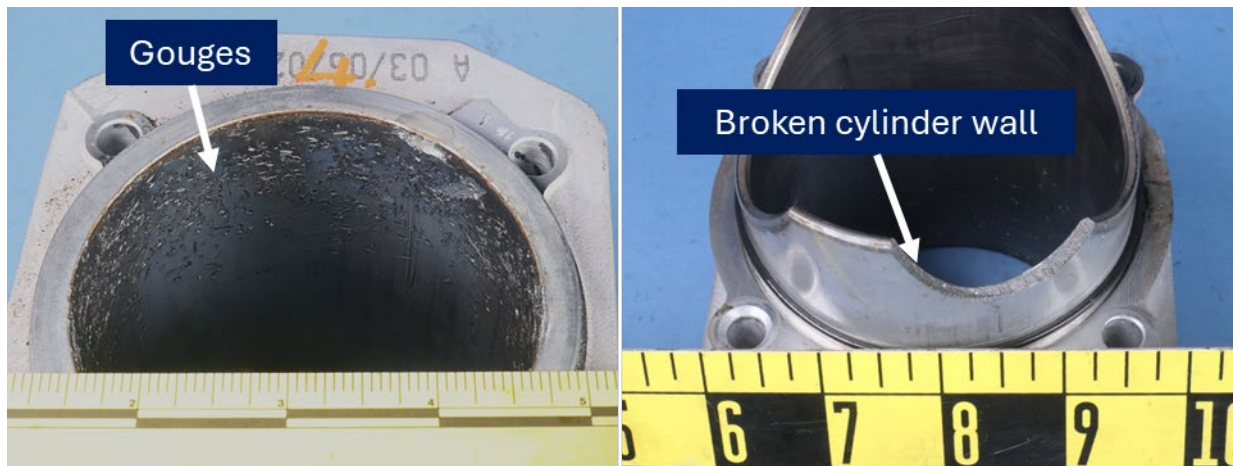
Cylinder 4 showed the most extensive damage. The cylinder wall showed gouging and scratching, and a portion of the wall was broken off with a rough and matte gray fracture surface, consistent with overstress fracture (Figure 10). The piston showed repeated impacts across its face, to the point where a hole had been punched through the center of the face (Figure 11). The head also showed extensive damage consistent with repeated impacts. Both the intake and exhaust valve heads were broken off their stems, and the stems remained in their guides. The intake stem was bent and immobile in its guide; the guide itself was deformed and fractured. The exhaust valve stem was straight. As received, the exhaust valve stem was stuck in a 'fully extended' position. The fracture surfaces on both stems showed smearing and gouging consistent with repeated impacts after fracture. Both the exhaust and intake valve heads (Figure 12) showed similar gouging and impact damage. The center of the fracture surface of the exhaust stem was open, revealing a hollow cylindrical core. This is consistent with a sodium-filled valve.<sup>1</sup> Manufacturer documentation confirmed that the valves were sodium-filled.

**Figure 10.** (Left) Gouges in the wall of cylinder 4 near the cylinder head. (Right) fractured section of cylinder wall.

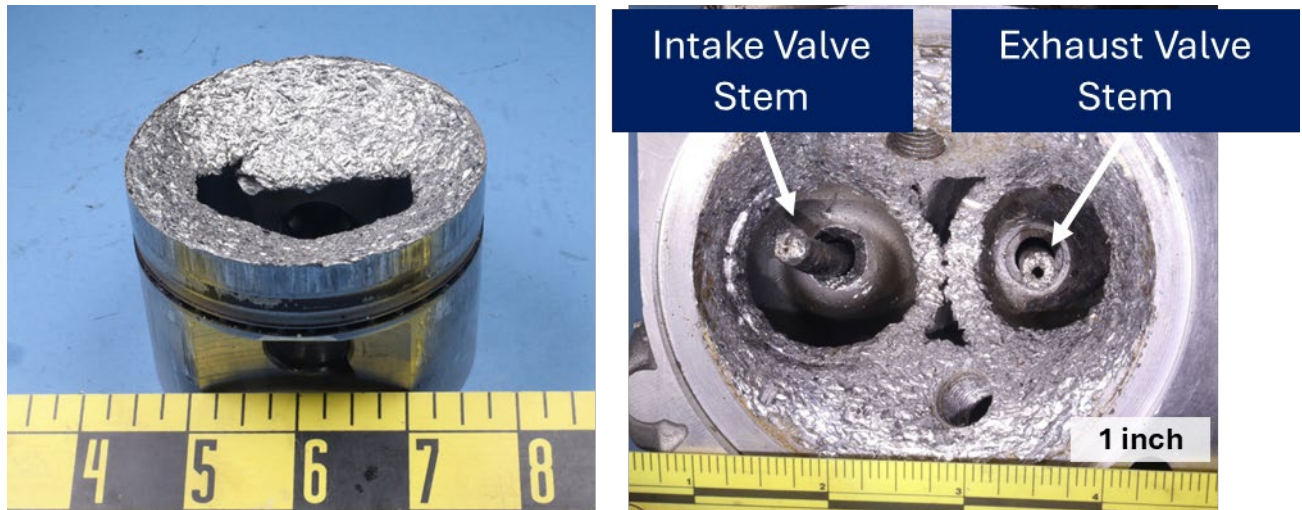
**Figure 11.** (Left) The piston and (right) cylinder head from cylinder 4 showed significant impact damage across their faces. The fracture surfaces of the valve stems showed similar damage.

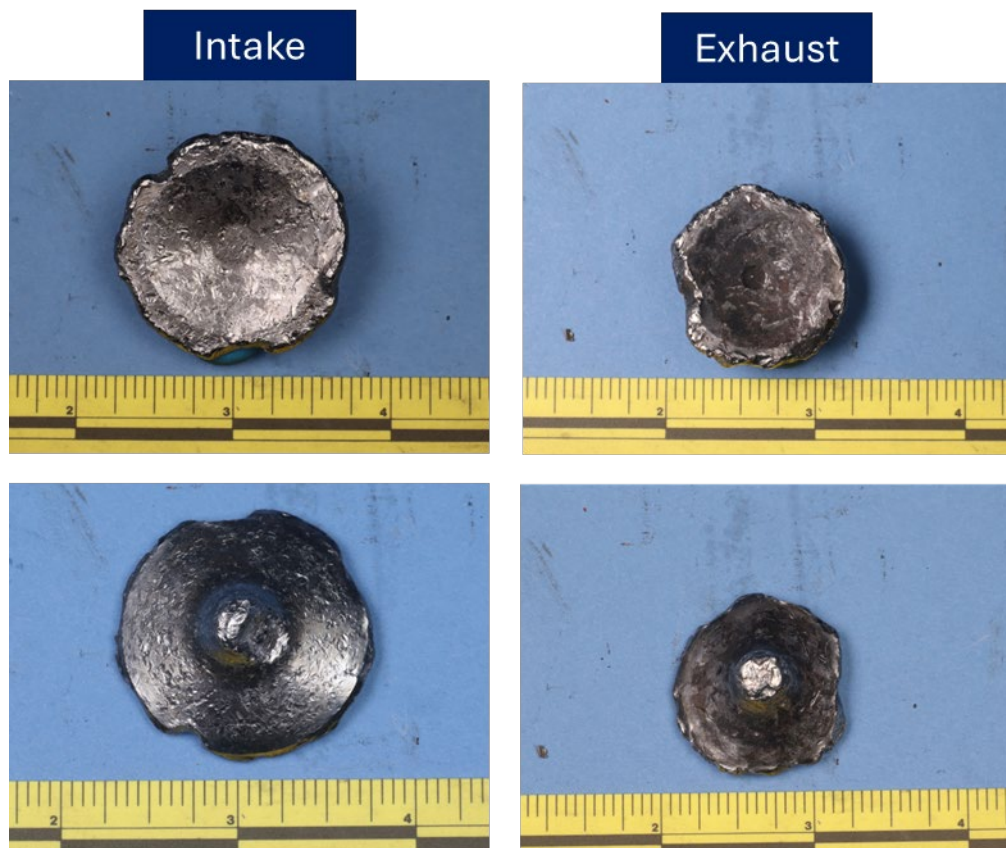
**Figure 12.** (Upper left) Intake valve face and (lower left) rear face. (Upper right) Exhaust valve face and (lower right) rear face. Both pieces showed significant gouging and impact damage.

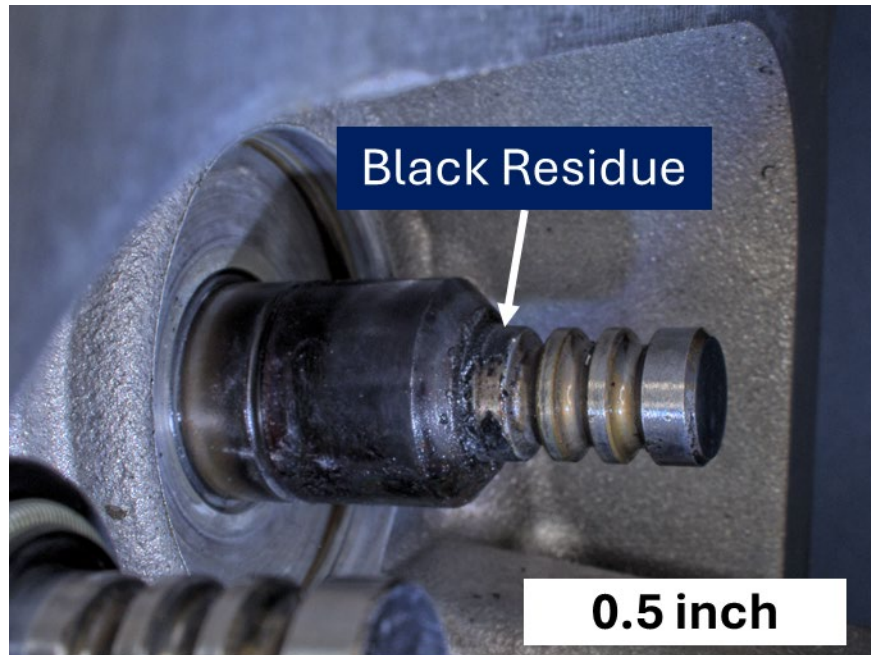
Black residue was found on the stem of the exhaust valve near the tip, below the cotter grooves (Figure 13). This residue was hard and brittle, preventing the stem from being removed from the guide. Later examination of this residue using Energy Dispersive Spectroscopy (EDS) showed high amounts of lead and carbon, consistent with leaded fuel combustion byproduct (Figure 14).

**Figure 13.** A black residue was visible below the tip of the exhaust valve.

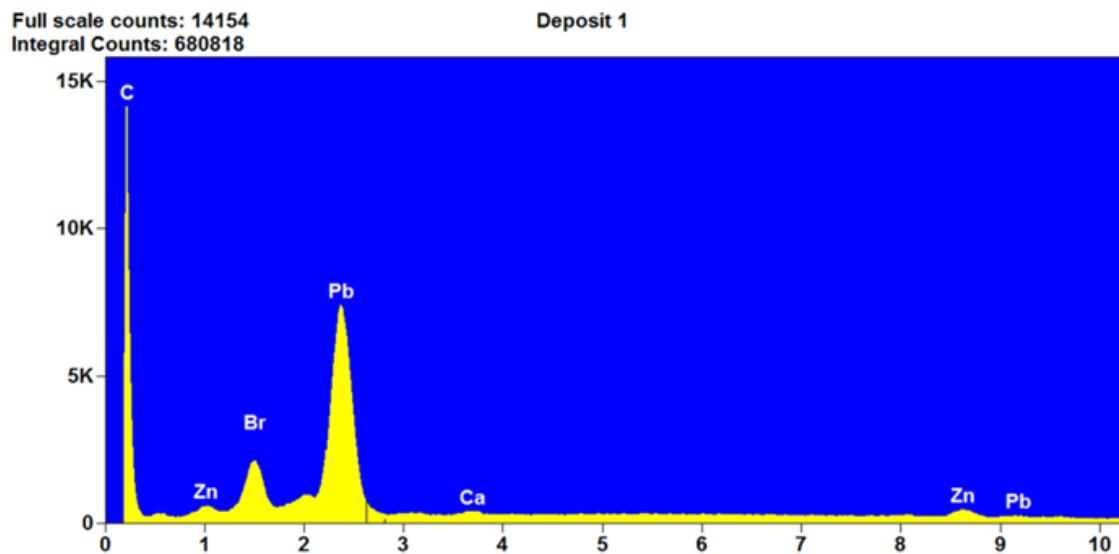
**Figure 14.** The EDS spectrum of the black deposits on the tip of the exhaust valve showed high amounts of lead and carbon.

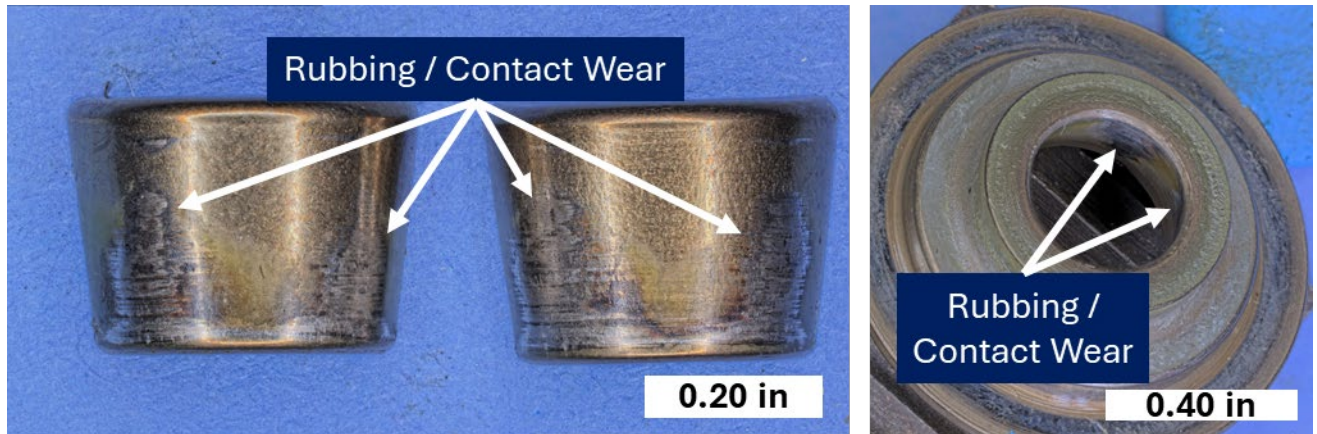
Mechanical damage was noted at several other points in the valve train in cylinder 4. The valve cotters for the exhaust valve showed damage consistent with rubbing or vibration on the outside of the sleeve (Figure 15). This damage was localized to four areas around the circumference of the valve, spaced roughly 90° apart when the two halves were assembled. Similar damage was seen on the inside of the valve spring retainer. The locations of the damage in the retainer roughly lined up with the locations on the outside of the cotter, where the two components would have been in contact during typical use. The foot of the exhaust rocker arm had a

**Figure 15.** (Left) The outer surface of the cotters from the exhaust valve on cylinder 4 showed contact wear localized to 4 areas approximately 90° apart. (Right) Contact wear on the interior wall of the valve spring retainer roughly lined up with the wear on the cotters.

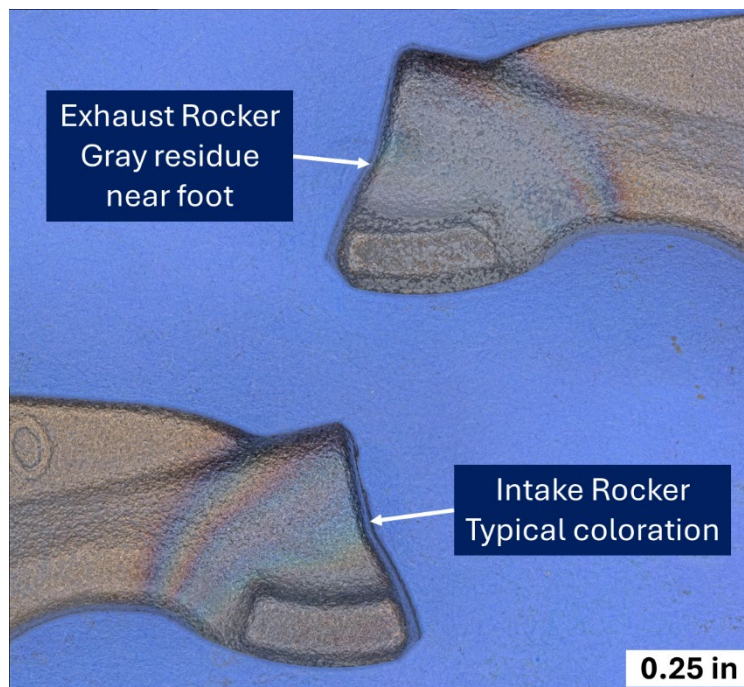
light coating of gray residue (Figure 16).<sup>2</sup> This residue resembled lighter residues found on the intact exhaust valves from other cylinders. Finally, damage was noted on the tip of the intake valve. One edge of the tip was dented as though by impact, but no corresponding mark was seen on the foot of the intake rocker arm. The oil return sleeve on the intake side of the engine was ovalized and dented along the body, and one of the valve push-rod assemblies showed damage consistent with buckling.

**Figure 16.** A light coating of gray residue was seen on the foot of the exhaust rocker arm from cylinder 4. The intake rocker arm shows the typical coloration.

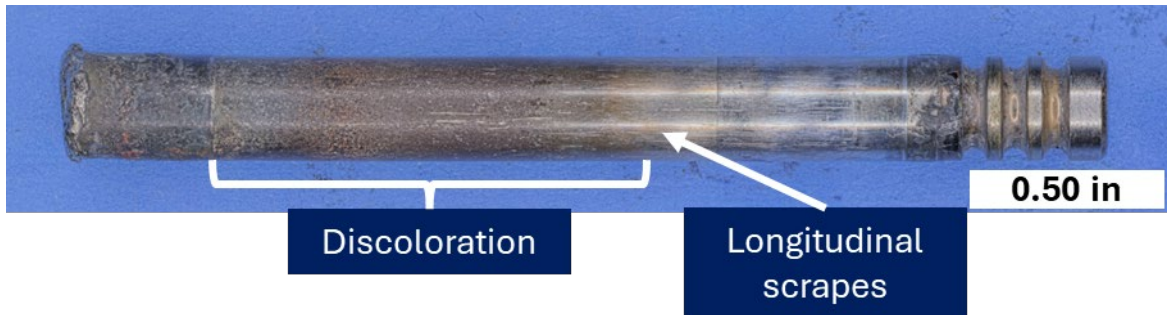
The black residue near the tip of the exhaust valve in cylinder 4 was scraped off with a metal razor blade. This allowed the tip of the stem to slide through the guide to be removed from the cylinder head. The stem showed black and brown discoloration starting at the fracture surface and extending towards the tip (Figure 17). Short (approximately 0.25 inch) longitudinal scrape marks were visible in the brown discoloration. The discoloration remained on the valve after cleaning in an Alconox solution in an ultrasound bath and after rinsing with ethanol. EDS spectra were taken of the base material (shiny metal stem material) and the discolored area (Figure 18). Higher amounts of carbon, bromine, and lead were detected on the discolored surface compared to the base material, consistent with aviation gas exhaust deposits. In a further inspection of the valve from cylinder 3 (documented further below), it was found that similar discolorations could be removed with an Alconox solution and scrubbing with a plastic scrubbing pad.

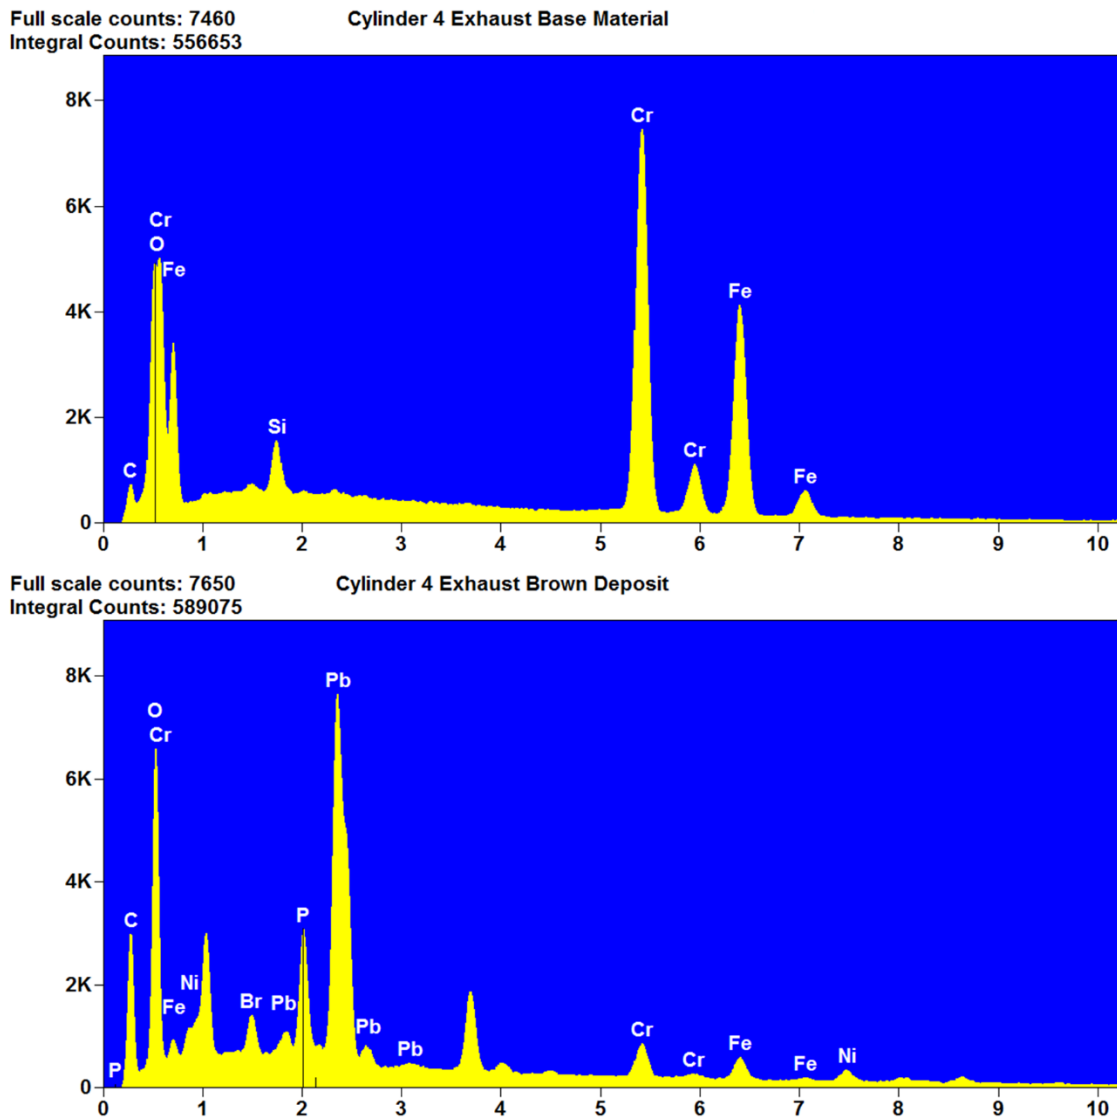
**Figure 18.** (Top) EDS spectra of the base material for the exhaust valve stem from cylinder 4. (Bottom) The EDS spectra of the brown deposit on the stem showed increased amounts of lead, bromine, and carbon.

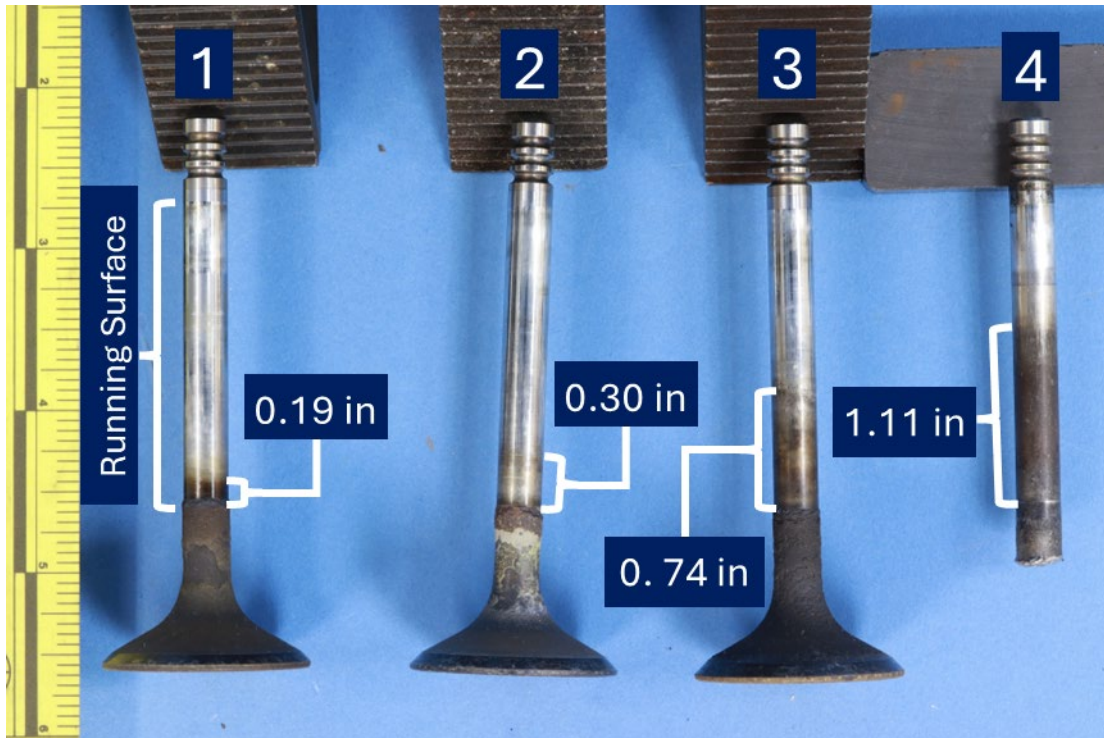
The three intact exhaust valves showed a buildup of hard black, white, and green deposits on the back of the face and the lower portion of the stem. On valve 4, a shiny silver-colored circumferential ring was noted on the stem approximately 0.75 inch from the fracture surface. When the stem was lined up next to other intact exhaust valves, this ring approximately lined up with the upper edge of the thick deposits on the intact valves.

Brown and black discoloration was noted on the stems of all valves above the deposit build-up. The discoloration was most uniform and extended up the stem furthest on valve 4. Table 1 notes the appearance and extent of the discoloration seen on all four valves. A warning in the maintenance manual states that oil residues are permissible on up to 20% of the running surface, else the valve may be at risk of failure at the weld point due to overheating. The manual further states that any valve showing higher amounts of residue must be replaced due to increased risk of failure at a weld in the valve.

**Figure 19.** The four exhaust valves (three intact, one fractured) from the cylinders had brown discoloration(s) on the stem above the faces of the valve.

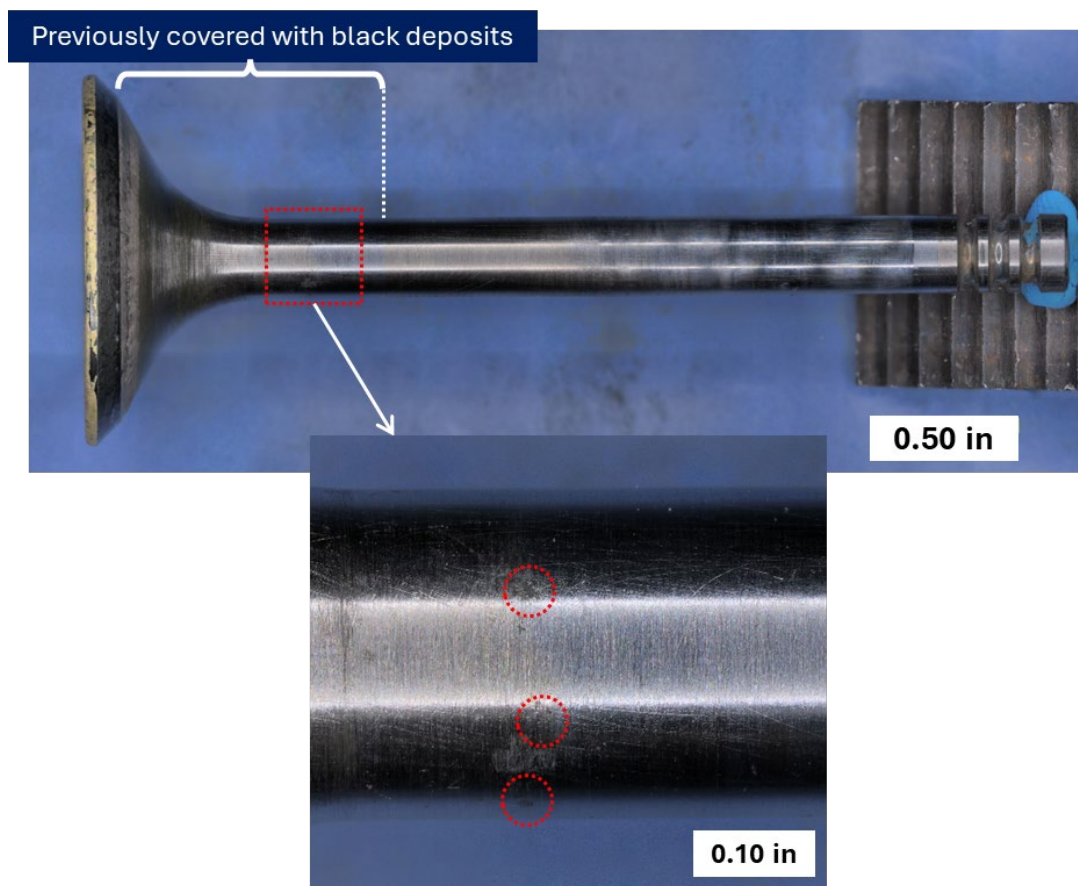
Valve 3 was cleaned and subjected to further inspection. A scrubbing pad and Alconox solution were used to remove the black residue on the stem near the face of the valve, in the region where valve 4 had failed. Removal of the caked-on residue revealed dispersed imperfections on the surface of the valve (Figure 22). The largest such imperfection was approximately 0.01 inch across. Examination of this imperfection in a field-emission scanning electron microscope (SEM) did not show

**Figure 22.** Valve 3 after cleaning with a scrubbing pad and Alconox solution. Red circles in the inset show visible surface imperfections.

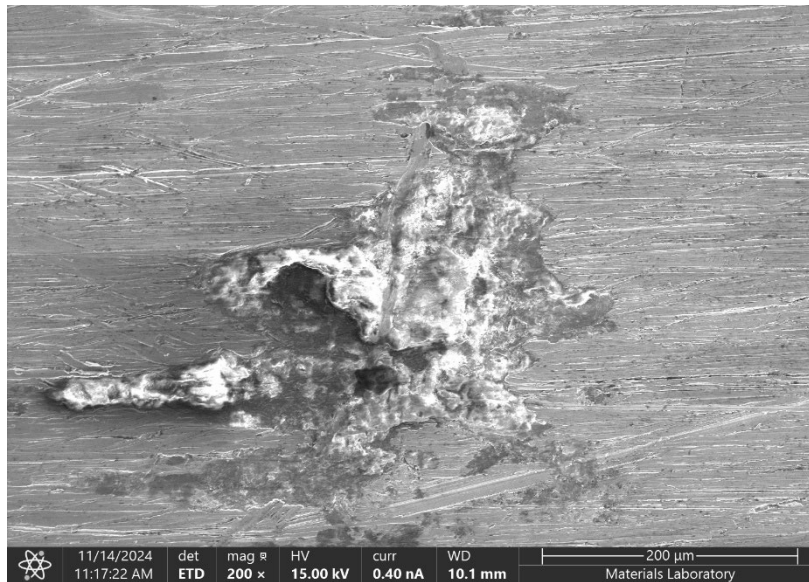
any cracks extending from the imperfection (Figure 23). EDS scans showed increased amounts of lead and carbon in the imperfection, consistent with exhaust residue (Figure 24).

**Figure 23.** Backscattered electron image of the largest surface imperfection seen on the surface of valve 3.

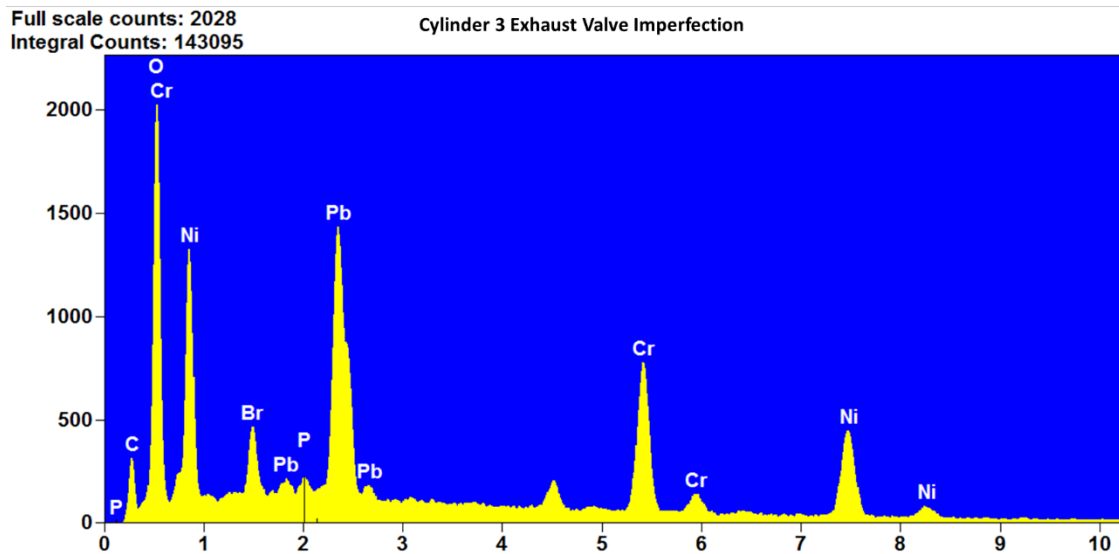
**Figure 24.** EDS spectrum of the surface imperfection in Figure 23.

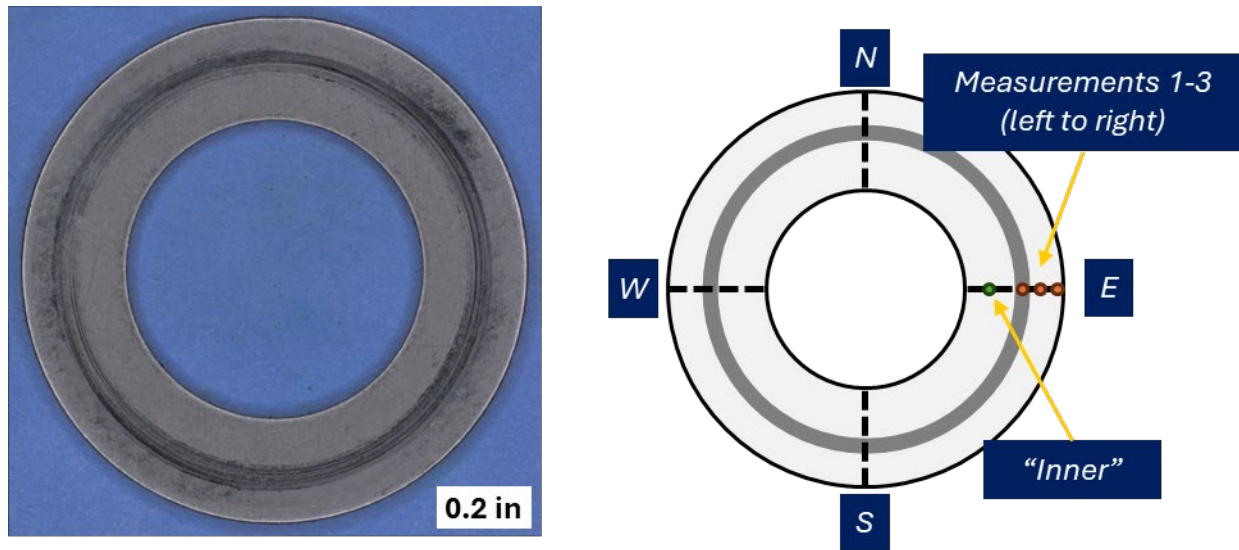
The valve train includes a washer placed between the valve spring and the cylinder head. The Rotax maintenance manual recommends inspection of the washers for damage and wear. The washers from the intake and exhaust valves on cylinder 4 were examined. The washer from the exhaust valve is shown in Figure 25. Each washer showed a dark gray ring on one face. The ring was circumferential around the approximate center of the face. A dial thickness gauge was used to measure the thickness of the washer at four locations on both washers, shown schematically in Figure 25. The measurement closest to the inner edge was used to establish the baseline thickness, and subsequent measurements closer to the outer edge were to check for a change in thickness. Measurements are detailed in Table 5. The maintenance manual states that a change of 0.0016 inch should result in valve train component replacements. No measurements showed a thickness change of that magnitude.
