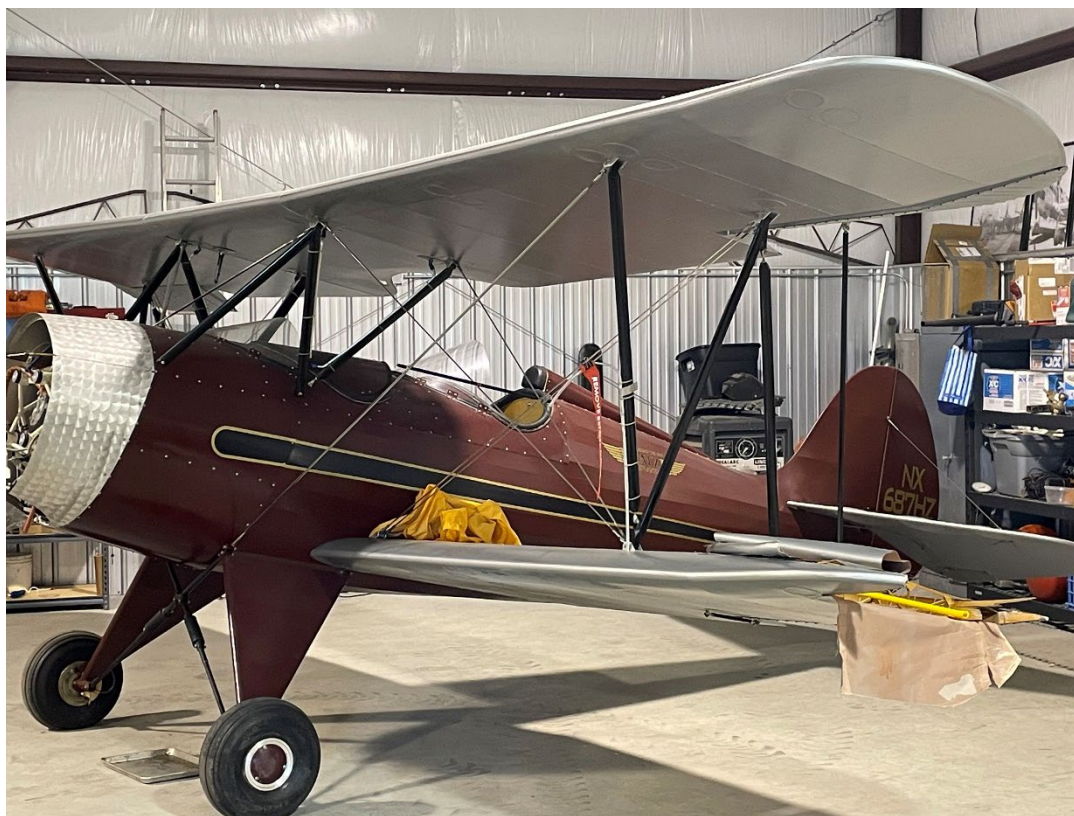
**Photo 1 – View of damage to the airplane’s lower left wing (Courtesy of Operator)**

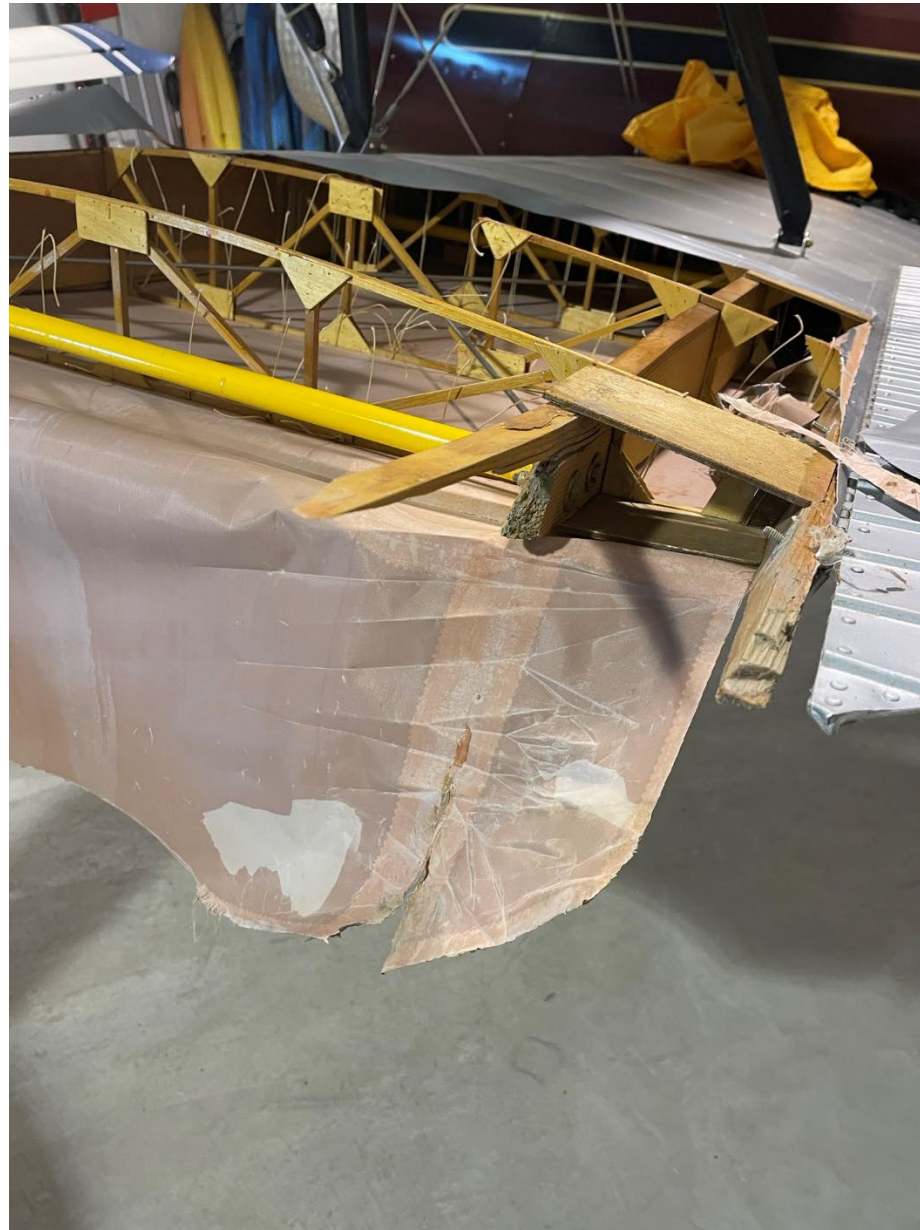
**Photo 2 – View of substantial damage to the lower left wing spar (Courtesy of Operator)**
