National Transportation Safety Board

WPR24FA001

## INVESTIGATIVE SUPPLEMENTAL MATERIALS

Location: Twisp, Washington  
Date: 10.01.2023  
Time: 1030 Pacific standard time  
Airplane: Cub Crafters

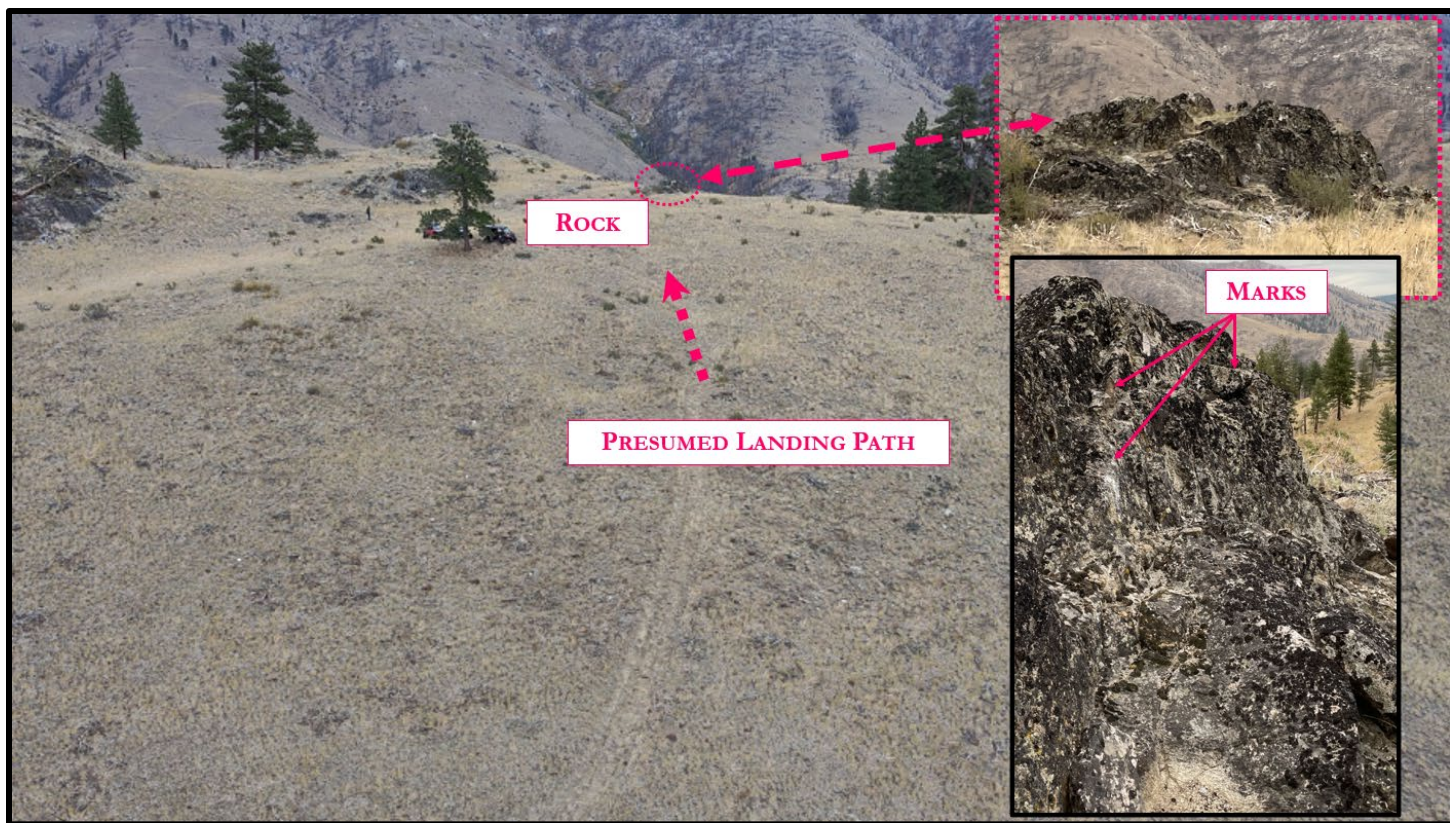
After a short landing roll, the pilot appeared to abort the landing and the airplane became airborne again. The airplane then collided with a large rock resulting in the airplane's left landing-gear folding under the fuselage.

Figure 2: Rock with marks

The initial touchdown area could not definitely be determined, but tracks in the dry grass were found on the slope consistent with the landing direction. A large rock was located on the saddle of the hill. There were numerous marks and scrapes found on the south rock face and on the top of the rock. In the surrounding area, there were several silver chips of paint and a zip-tie that would have been on the landing gear.

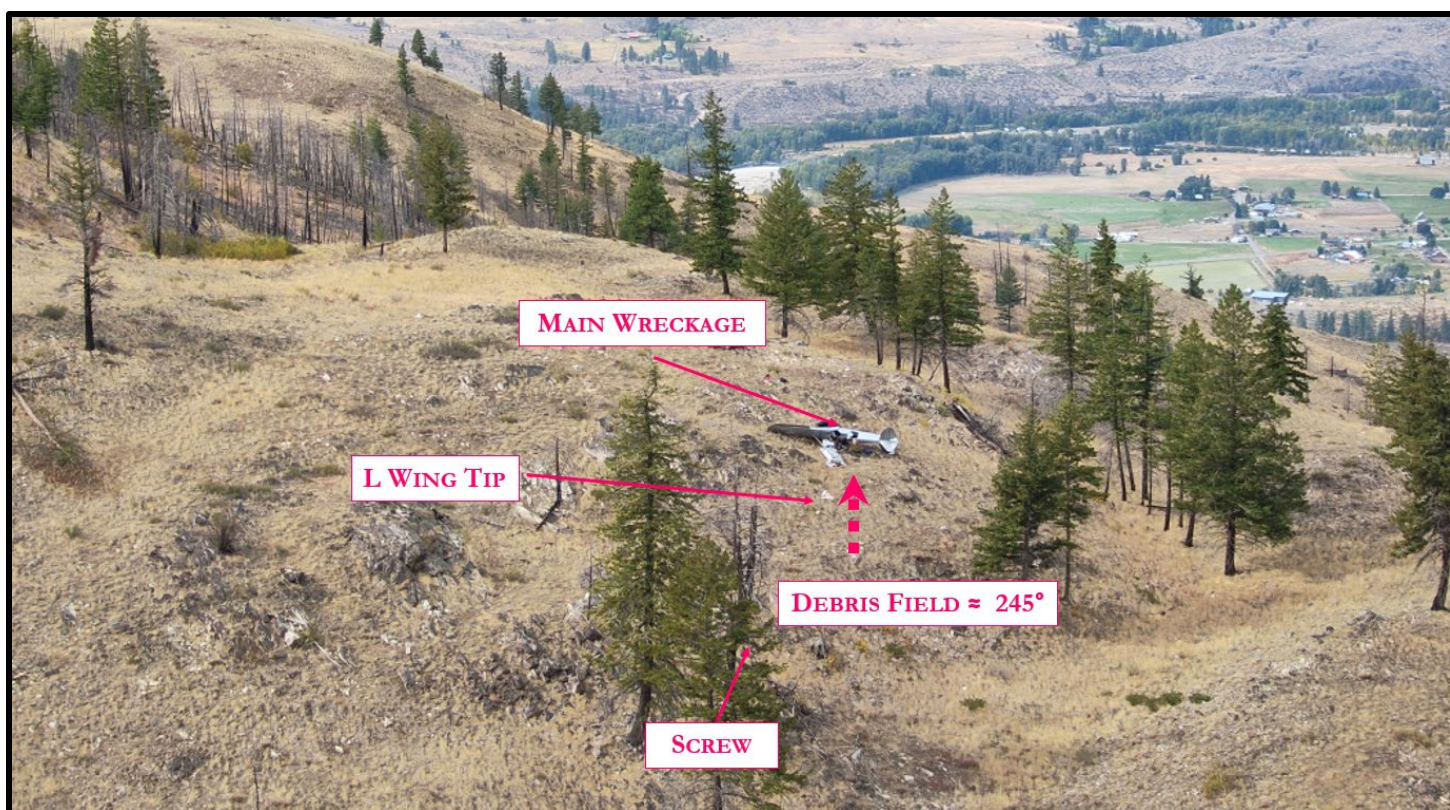
Figure 4: Main wreckage

The fuselage came to rest on its left side with the right wing folded forward over the engine. The left wing sustained crush deformation and came to rest inverted. The left forward and aft lift struts had separated, but remained attached to their respective fittings on the fuselage and wing. An approximate 1.5 ft piece of the left aft-lift strut remained attached to the airframe; the trailing edge of both portions of that strut contained black

marks consistent with the rubber from the tire. The flaps appeared to be partially down and the fuel selector was in the off position (it could not be confirmed if this was done by first responders).

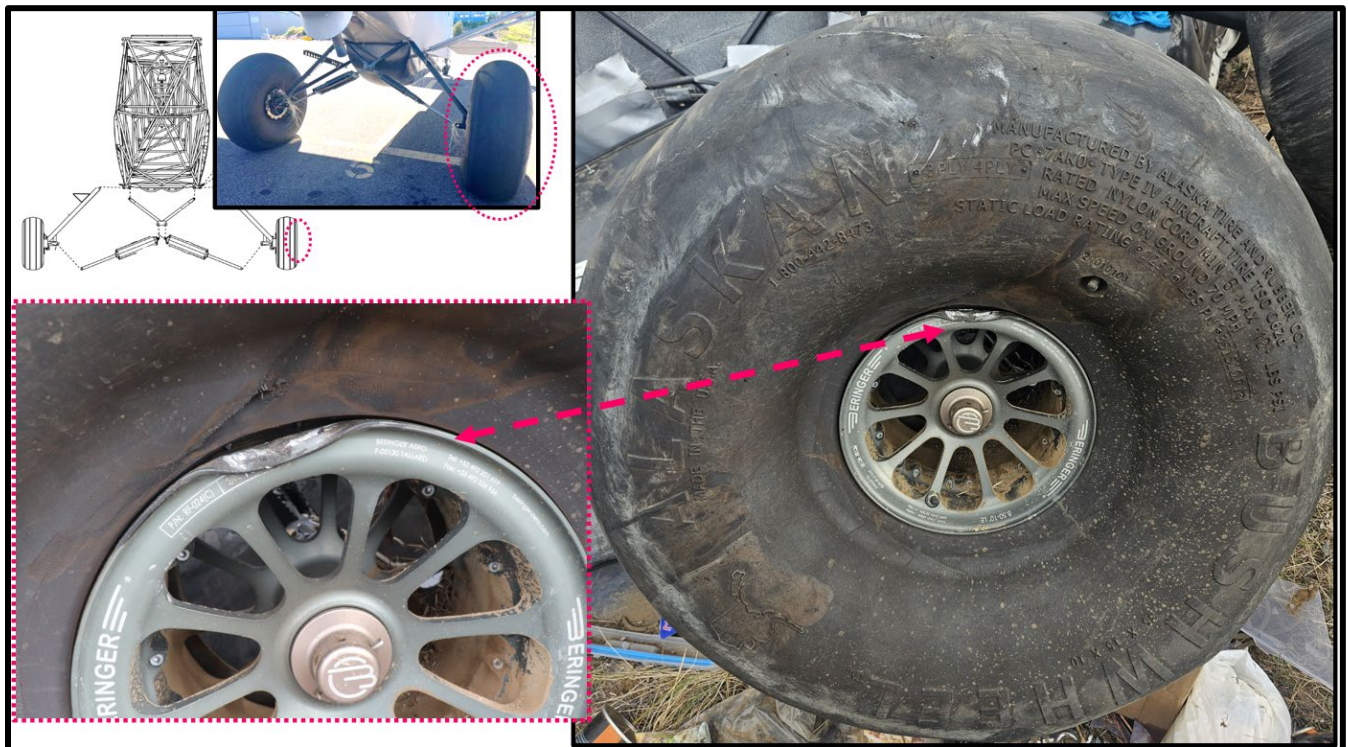
Both tires came to rest on near the belly pod. The left tire was flat and showed several gouges and scrapes on the rubber; the metal hub was bent and folded over itself in one area.

Figure 6: Left wheel

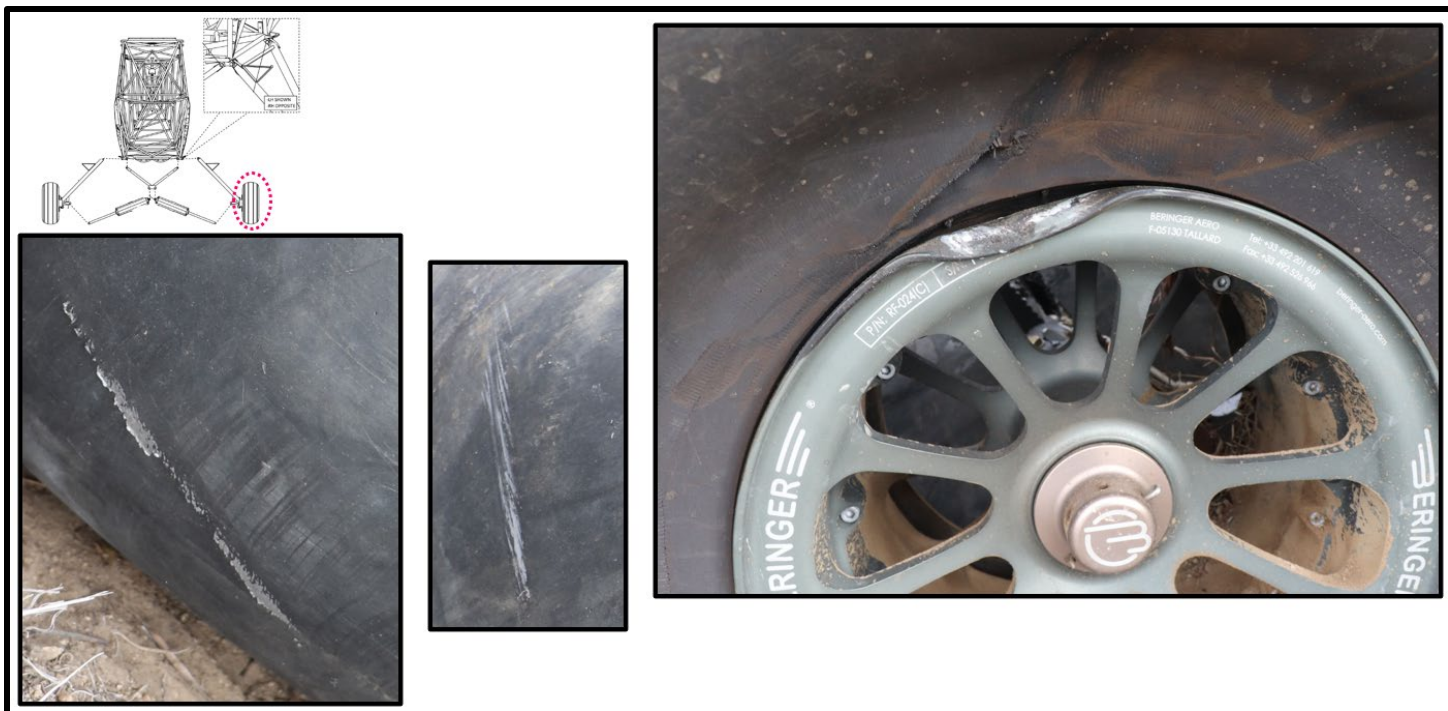
Figure 7: Left main tire

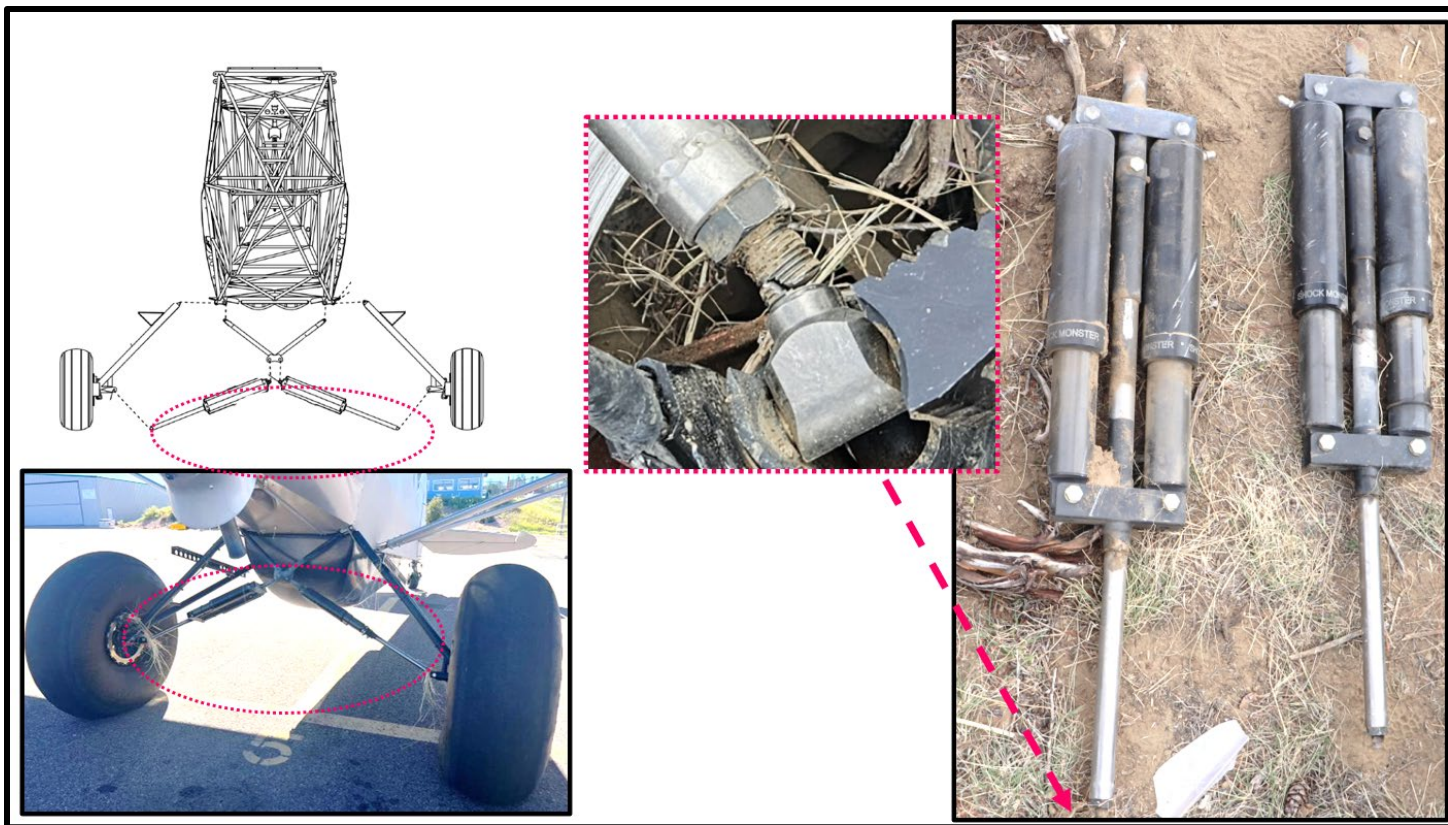
The landing gear struts were collapsed the bottom of the left struts were separated and appeared to have been worn from being dragged across terrain.

Figure 9: Landing gear struts

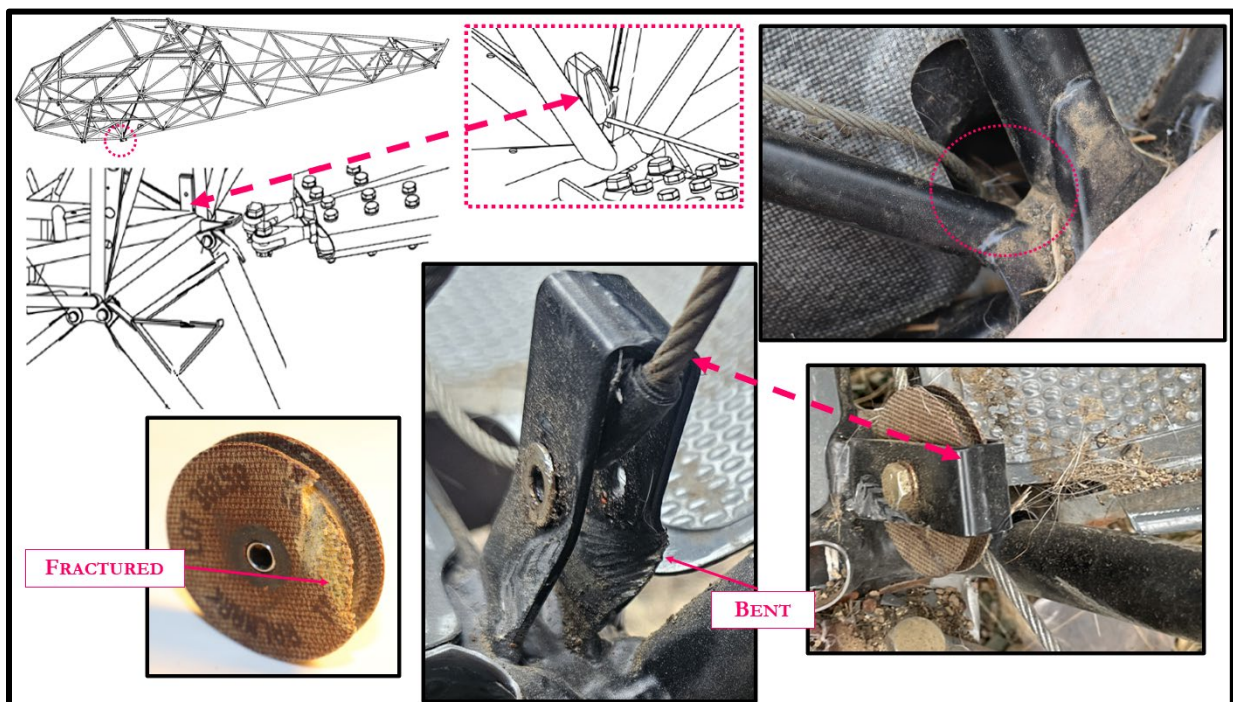
The fuselage frame behind the left lift-strut fork and gear-strut connection fittings was deformed. The left-aileron pulley, located adjacent to the deformed frame, would not move. The aileron cable was trapped between the frame and the pulley and could not move. Removal of the pulley hardware revealed that pulley bracket was bent and there was evidence of the cable rubbing against the bracket and part of the airframe. The phenolic pulley had a groove for the cable that extended around the pulley. The groove contained a peak edge on each side. One side of the peak edge was fractured, consistent with overstress. The side face of the pulley, adjacent to the fractured peak edge) contained a long, imprinted streak consistent to the location where the cable had pulled out/de-railed from the groove.

Figure 12: Internal pulley frame (bent)

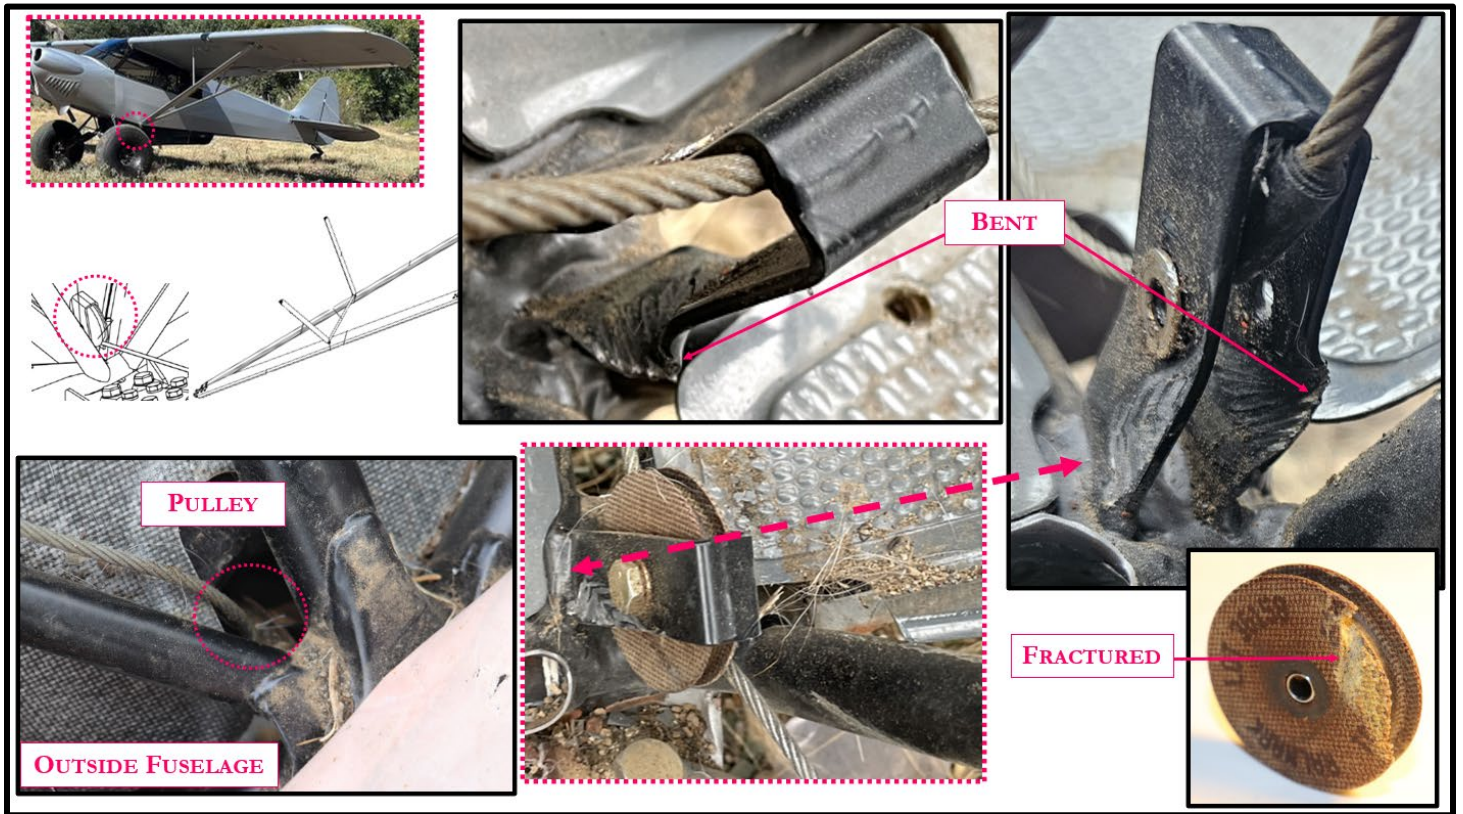
Figure 13: Pulley frame bent

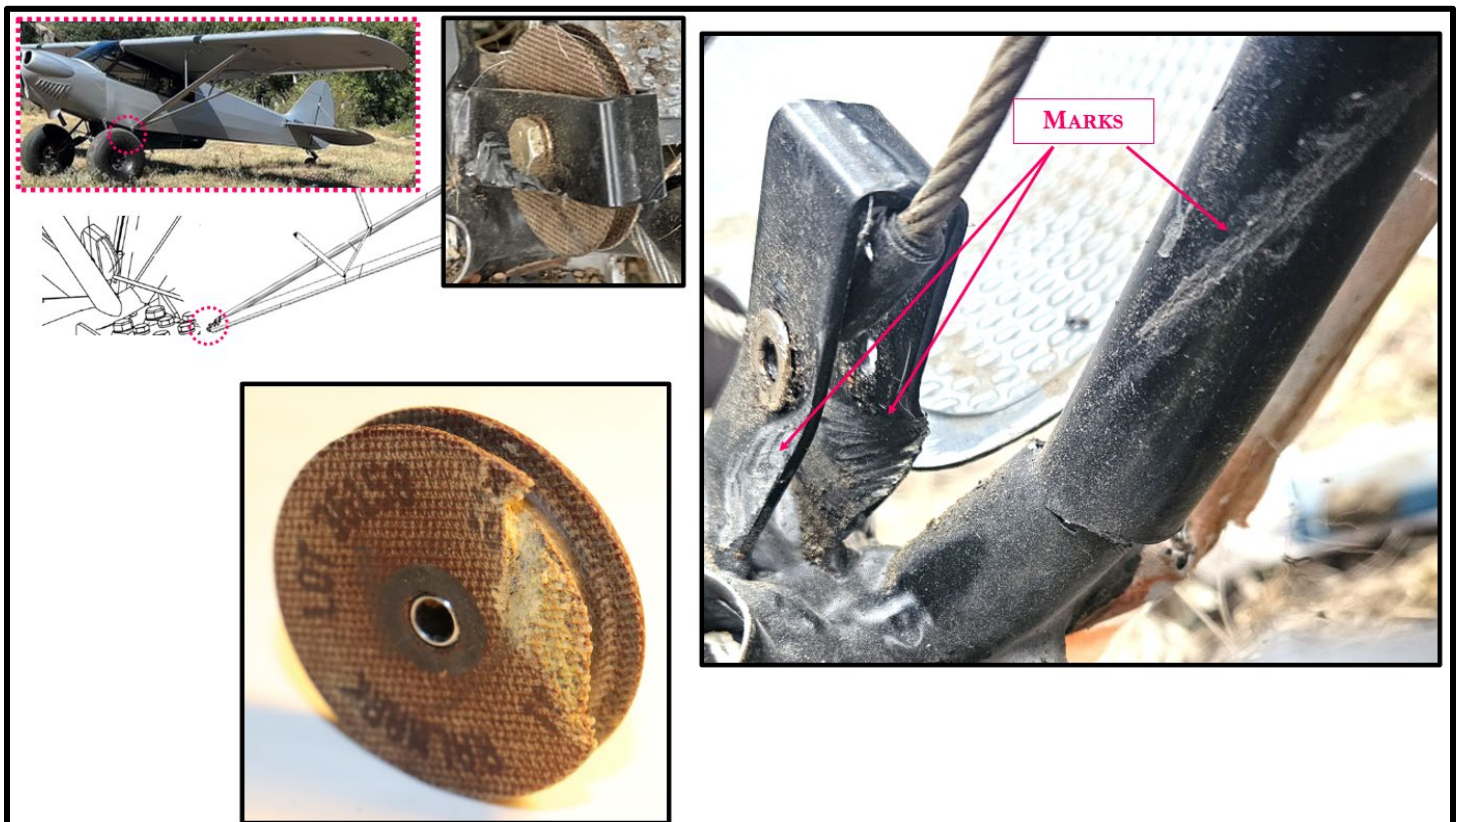
Figure 14: Impact marks on pulley retainer

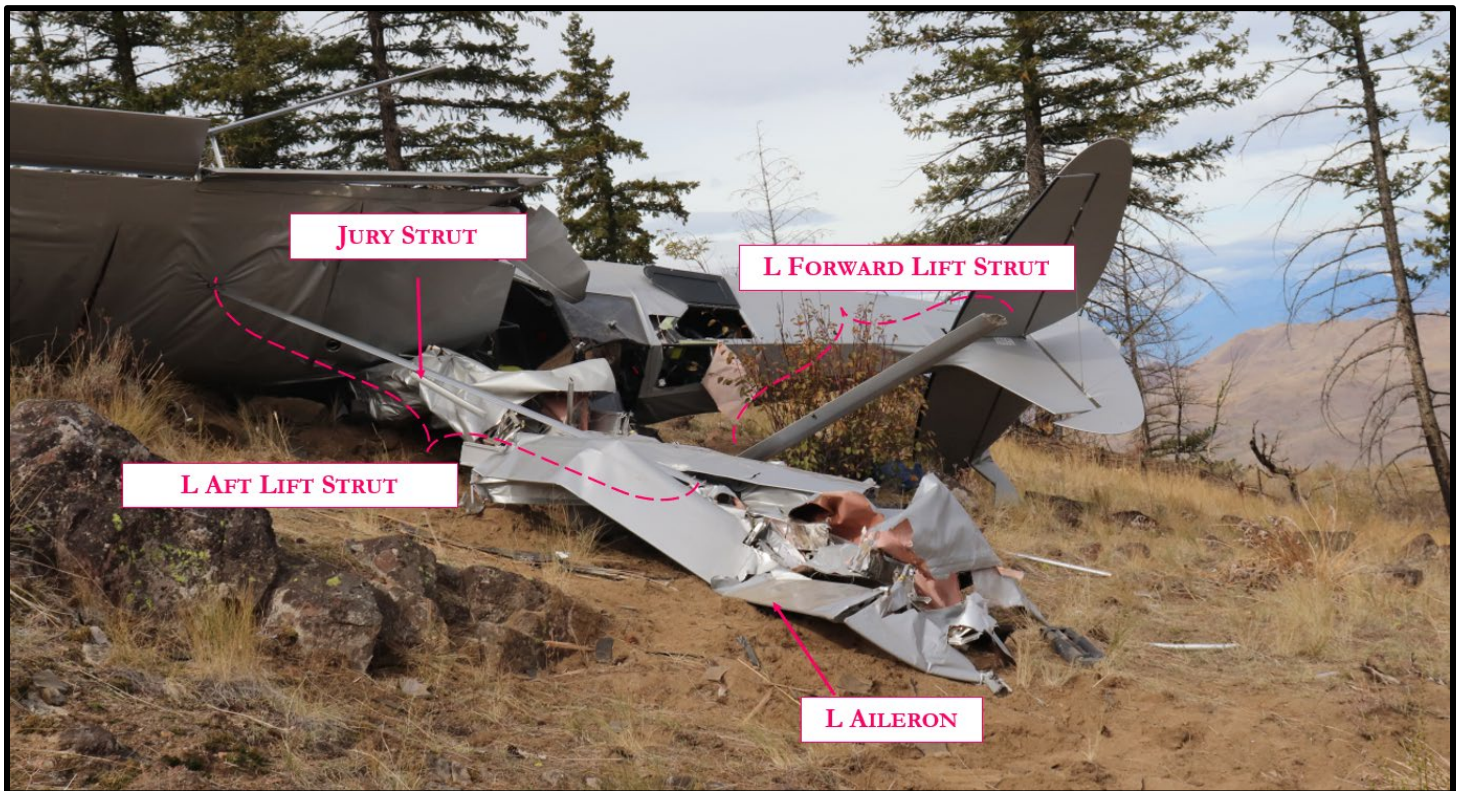
Figure 15: Left wing

The left wing tip was at the far end of the debris field. The left-wing forward lift strut was partially severed and punctured through the right wing. The fracture surface was bent down and contained black marks on the trailing edge. The other piece of the forward lift strut remained attached to the airframe and the fracture surface was deformed downward with the silver paint flaked off. An approximate 1.5 ft piece of the left aft lift strut remained attached to the airframe; the trailing edge contained black marks. The fracture surface had a small paint transfer that was blue and similar in color to the plastic locks of containers found in the wreckage.

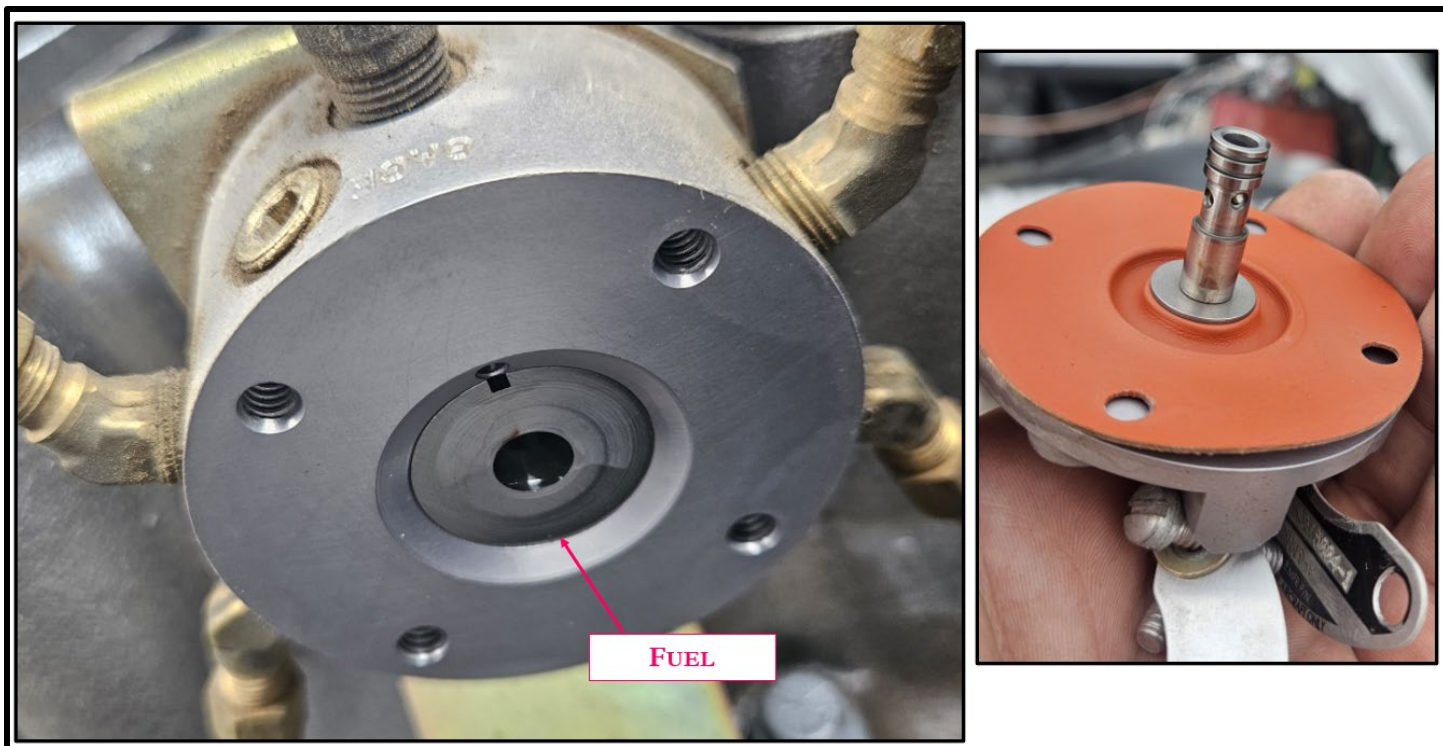
Figure 21: Fuel flow divider (spider)

There was fuel leaking from the right-wing tank and first responders reported smelling fuel when they arrived on scene. The fuel selector was positioned to the "OFF" position. Removal of the gascolator and the fuel flow divider (spider) revealed that there was fluid in both. The fluid was consistent in odor and appearance with that of 100L Avgas.
