# National Transportation Safety Board

WPR24FA010

## EXAMINATION SUMMARY

Location: Centerville, Utah  
Date: October 10, 2023  
Time: 1124 MDT  
1824 UTC  
Airplane: 2015 Vans RV-8

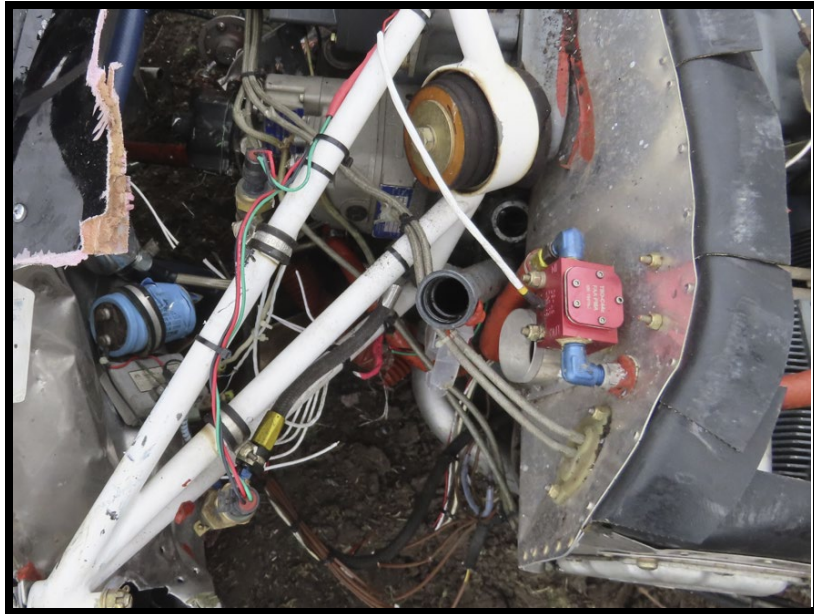
All cylinders and accessories remained attached to the crankcase. The oil filler port sustained impact damage. The oil dip stick was found separated from the filler port and located about 10 ft from the airplane engine, with no anomalies to the filler port neck or threads. The propeller governor and mounting adapter sustained impact damage and had breached the fire wall during the impact sequence. Most of the residual oil found on the engine was concentrated underneath the propeller governor. The top spark plugs were removed, and a light-equipped borescope was introduced to each cylinder, revealing a failure of the No. 2 piston connecting rod. The No. 2 cylinder was removed, and the connecting rod, cap and bearings had failed.

**Figure 1:** View of damaged oil filler neck

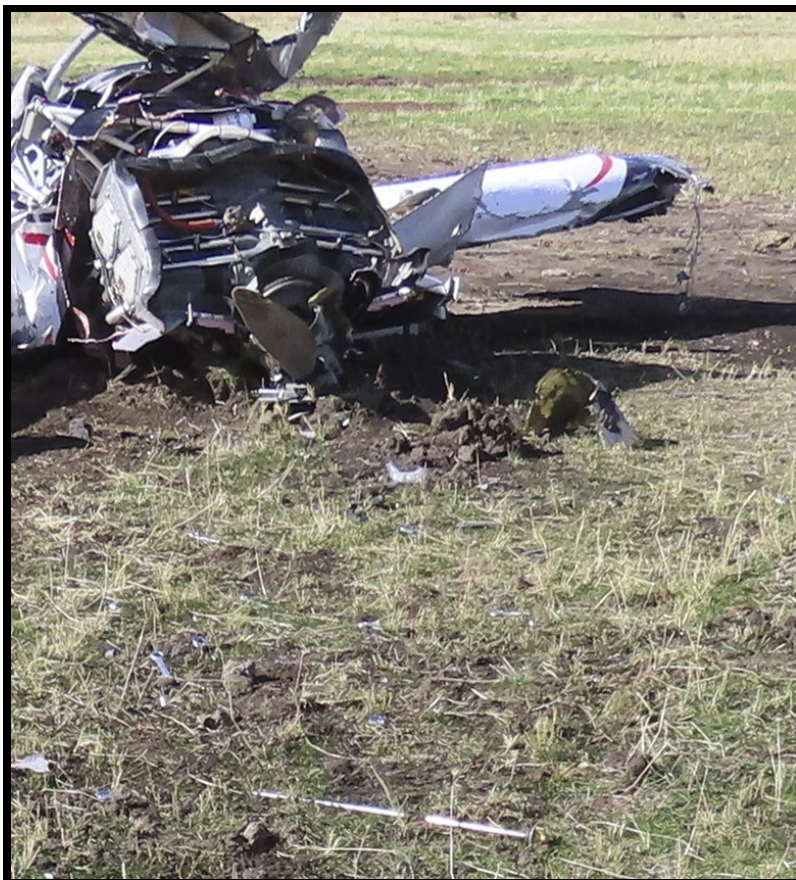
The accident site was contained within a 50 ft X 50 ft grid. The engine oil dip stick was the furthest point from the main wreckage, about 10 ft east. The airplane impacted the ground in a nose down, left wing low profile, and had rotated counterclockwise from an easterly, to a heading oriented generally north about 020°. The initial point of impact was marked by an engine impact crater, red light lens fragments. The left wing leading edge was separated from the fuselage at the wing root with the flap and aileron present, and ground scars from the tail section.

**Figure 2:** View of oil dip stick distance from main wreckage

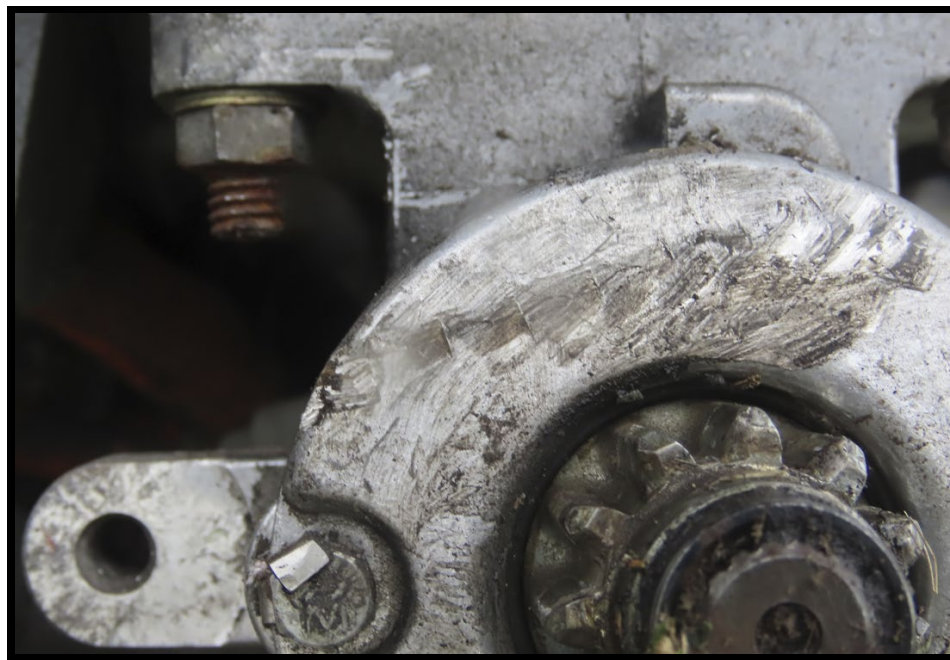
The engine's Skytec starter motor was found attached to the lower side of the engine but was not removed as part of this exam. The starter housing exhibited individual tooth impact marks from the starter ring gear impact commonly associated with slow to no rotation of the engine's propeller.

**Figure 3:** View of witness marks on starter housing

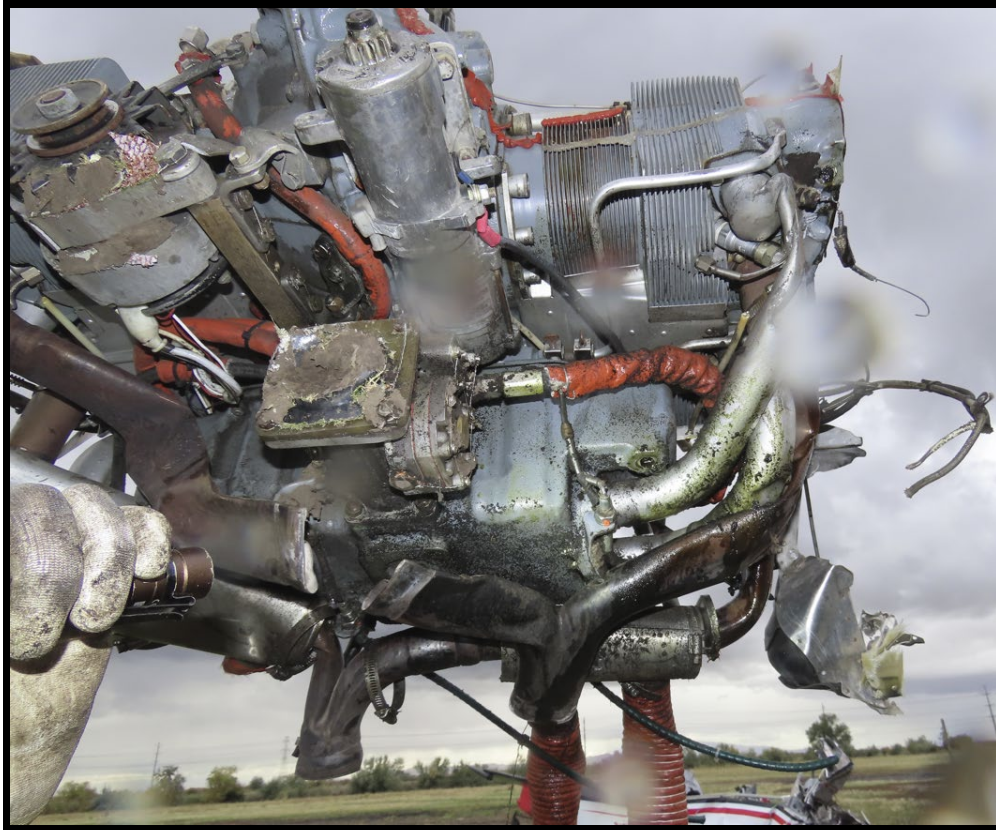
**Figure 4:** Profile view of starter housing

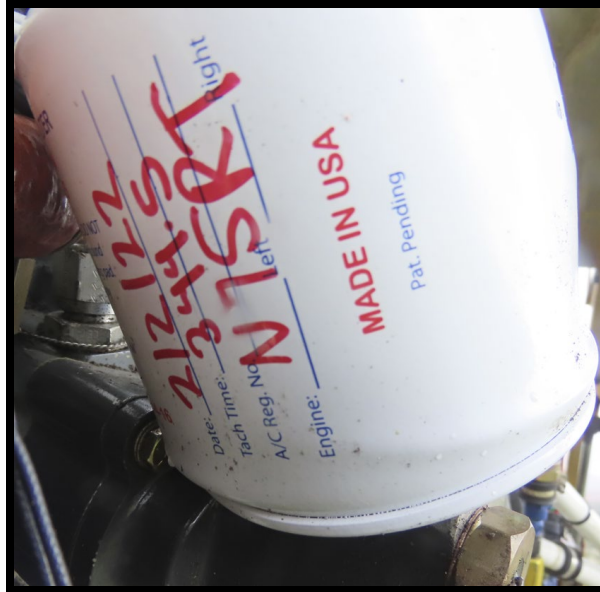
The oil filter was found attached to the rear of the engine but could not be removed due to impact damage. A portion of the can was cut using a saw to reveal a portion of the filter element. The element was removed and examined and was found clean. The date on the oil filter was inconsistent with the tachometer time. The oil suction screen plug was found securely installed to the oil sump and removed. The suction screen was free and clear of any debris at the time of the exam. Both lines to the oil cooler were found secure and tightly mounted to their respective fittings. The oil filler port sustained impact damage and fracture separated from the crankcase at the base of the filler port. Oil sump bolts attaching the sump to the engine case were found to be loose when light pressure to an offset wrench was applied, a sump gasket was observed between the mating surfaces.

**Figure 5:** Date/Hour discrepancy inscription on oil filter

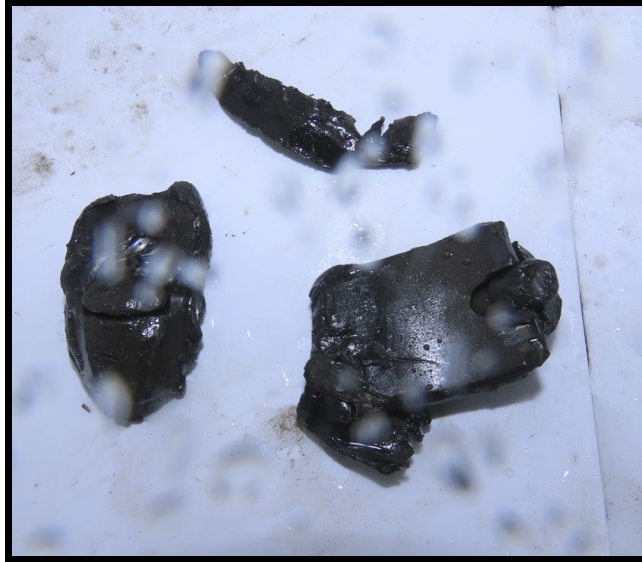
A lighted borescope examination of each cylinder was conducted through each top spark plug hole and through a series of holes drilled into the engine case near the engine's camshaft. The inspection revealed metal within the engine predominately around cylinder No. 2. The cylinder was removed revealing that the No. 2 connecting rod and cap were separated and sustained extraordinary damage within the engine. Portions of the cap and bearing material were found within the engine case and oil sump. The mating surface of the No. 2 piston connecting rod to crankshaft, exhibited a deep blue color throughout the journal, with variations of black and grey colors emanating from the journal area. The remaining portion of rod and piston could not be removed from the No. 2 cylinder barrel due to the amount of damage. The engine could not be rotated due to the damage observed to barrel and piston skirt on cylinder No. 1, likely caused during catastrophic failure of the No. 2 connecting rod during engine operation.

**Figure 6:** View of connecting rod and cap pieces found in oil sump

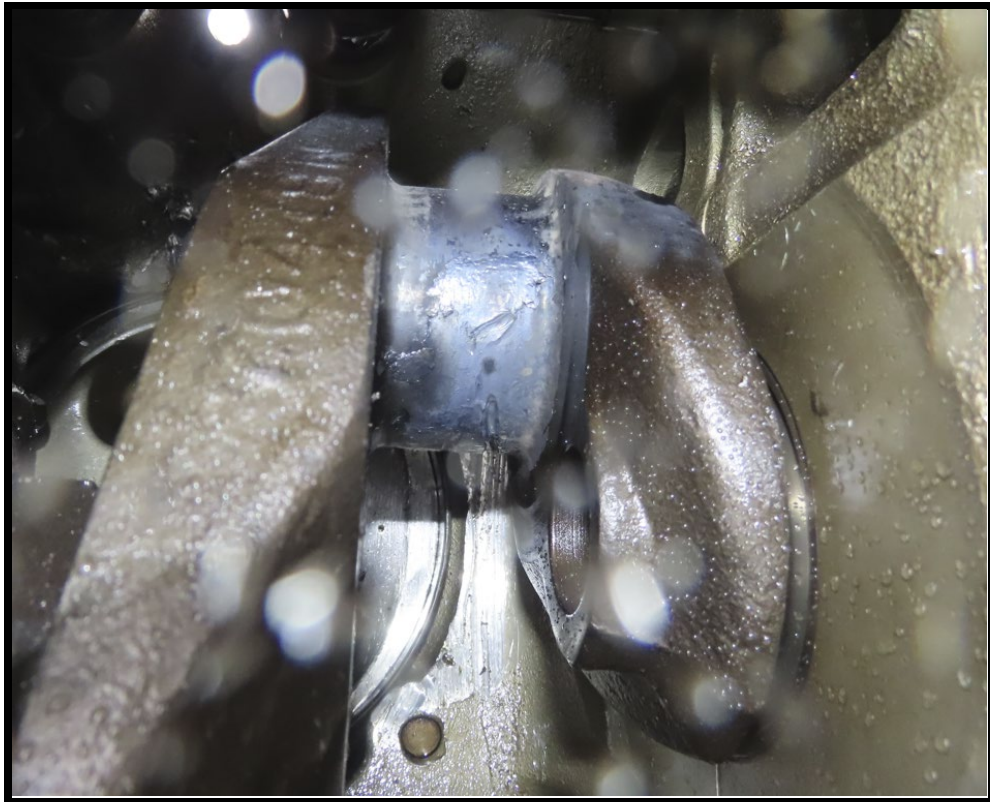
**Figure 7:** View of oil starvation signatures on crankshaft journal

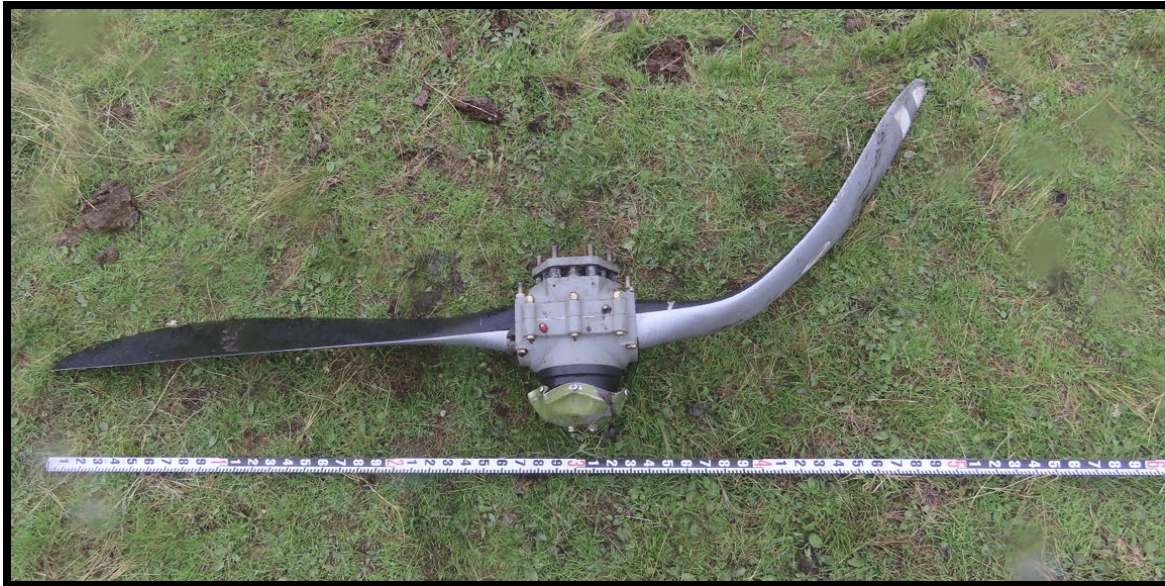
One propeller blade was visible while the other blade was underneath the engine and embedded into soft dirt. The propeller was removed from the engine at the flange. The propeller blades did not reveal chordwise scratches, leading edge gouges, or S-bending. Both blades remained attached to the hub. The two-blade propeller was marked by the IIC as blade A and blade B. Blade A was unremarkable, but blade B was bent aft, about 45°. The engine flange was fractured and deformed about 30° down into the soft ground. The engine would not rotate through.

**Figure 8:** View of propeller blade damage

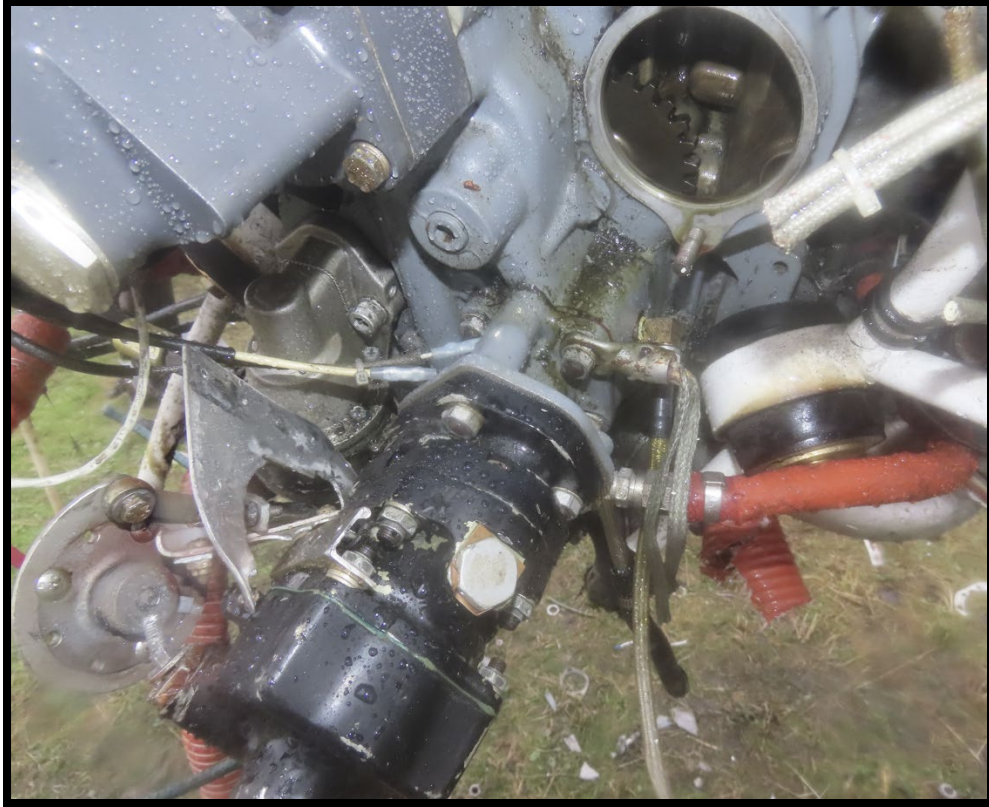
The prop governor was found mounted to the accessory case with its control arm and cable impact fractured from the unit. The mounting adapter was found to have numerous fractures, and damage was observed to the oil fitting. The propeller governor was firmly secured to the mounting adapter and tightly affixed to the accessory case. The propeller governor screen was present and found to be free and clear of any debris. The governor rotated freely by hand and pumped oil during rotation.

**Figure 9:** View of propeller governor and mounting adapter

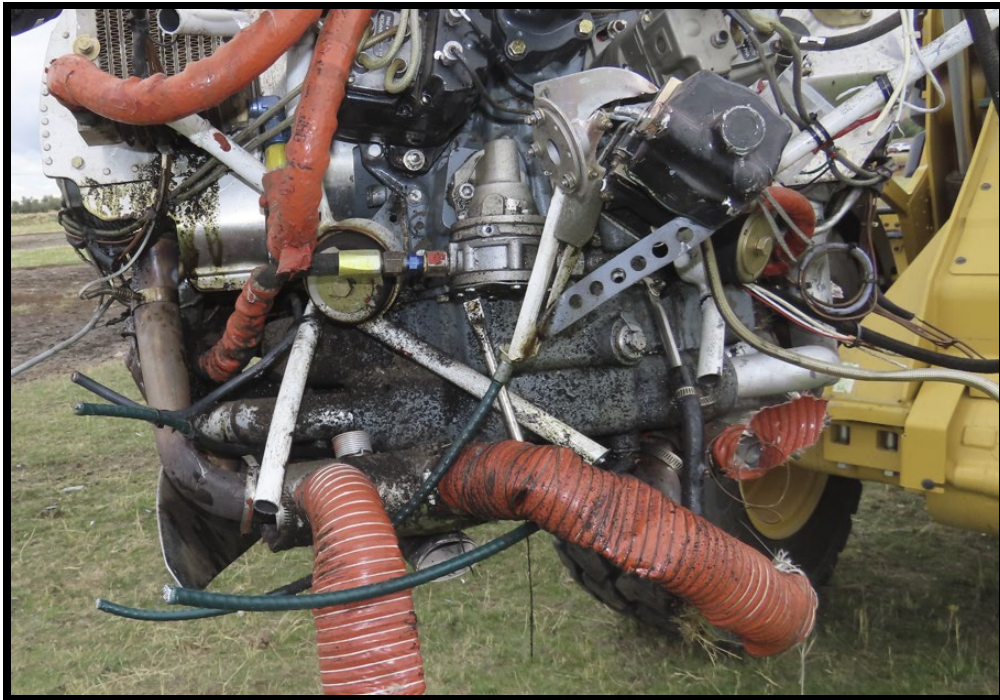
**Figure 10:** View of residual oil and dirt accumulation on the engine

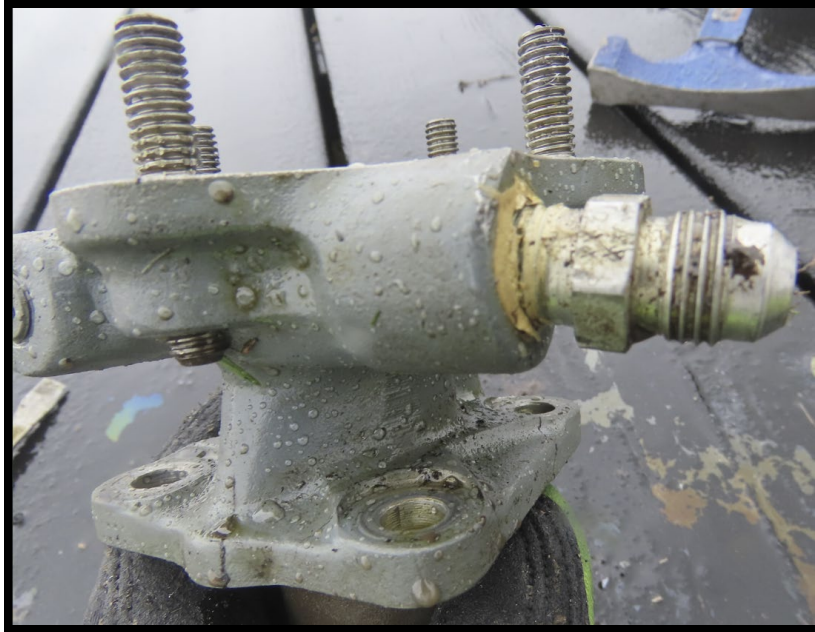
**Figure 11:** View of hairline cracks throughout the propeller governor mounting adapter

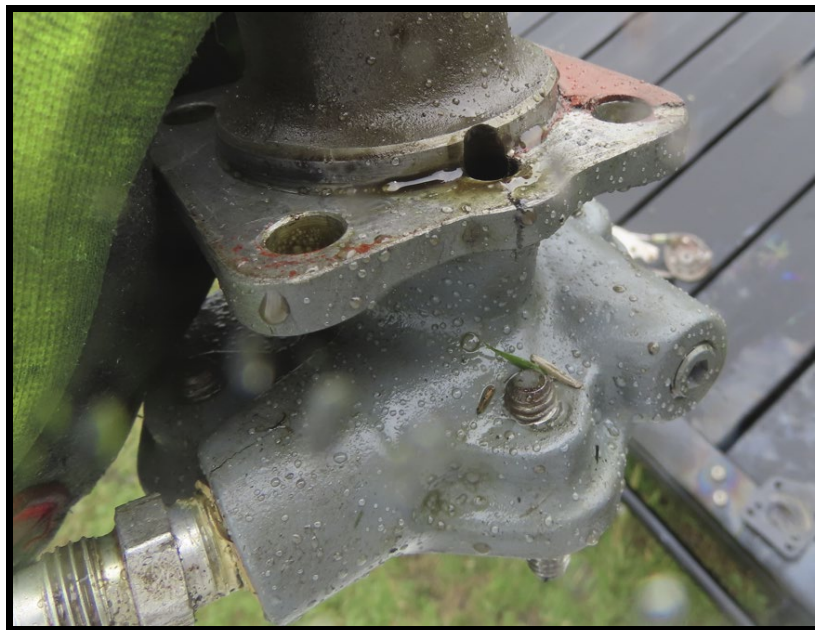
**Figure 12:** View of hairline cracks throughout the propeller governor
