WPR24FA010

## INVESTIGATION PHOTOGRAPHS

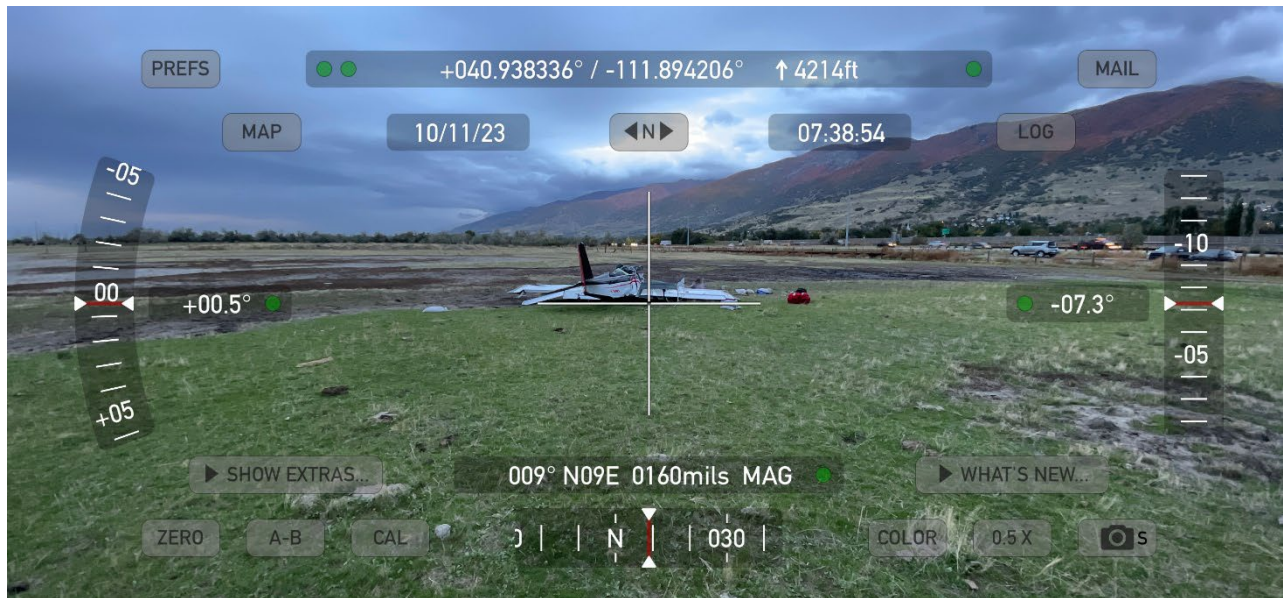
**Photograph 1 - Post impact view of the airplane's nose oriented on a northerly heading**

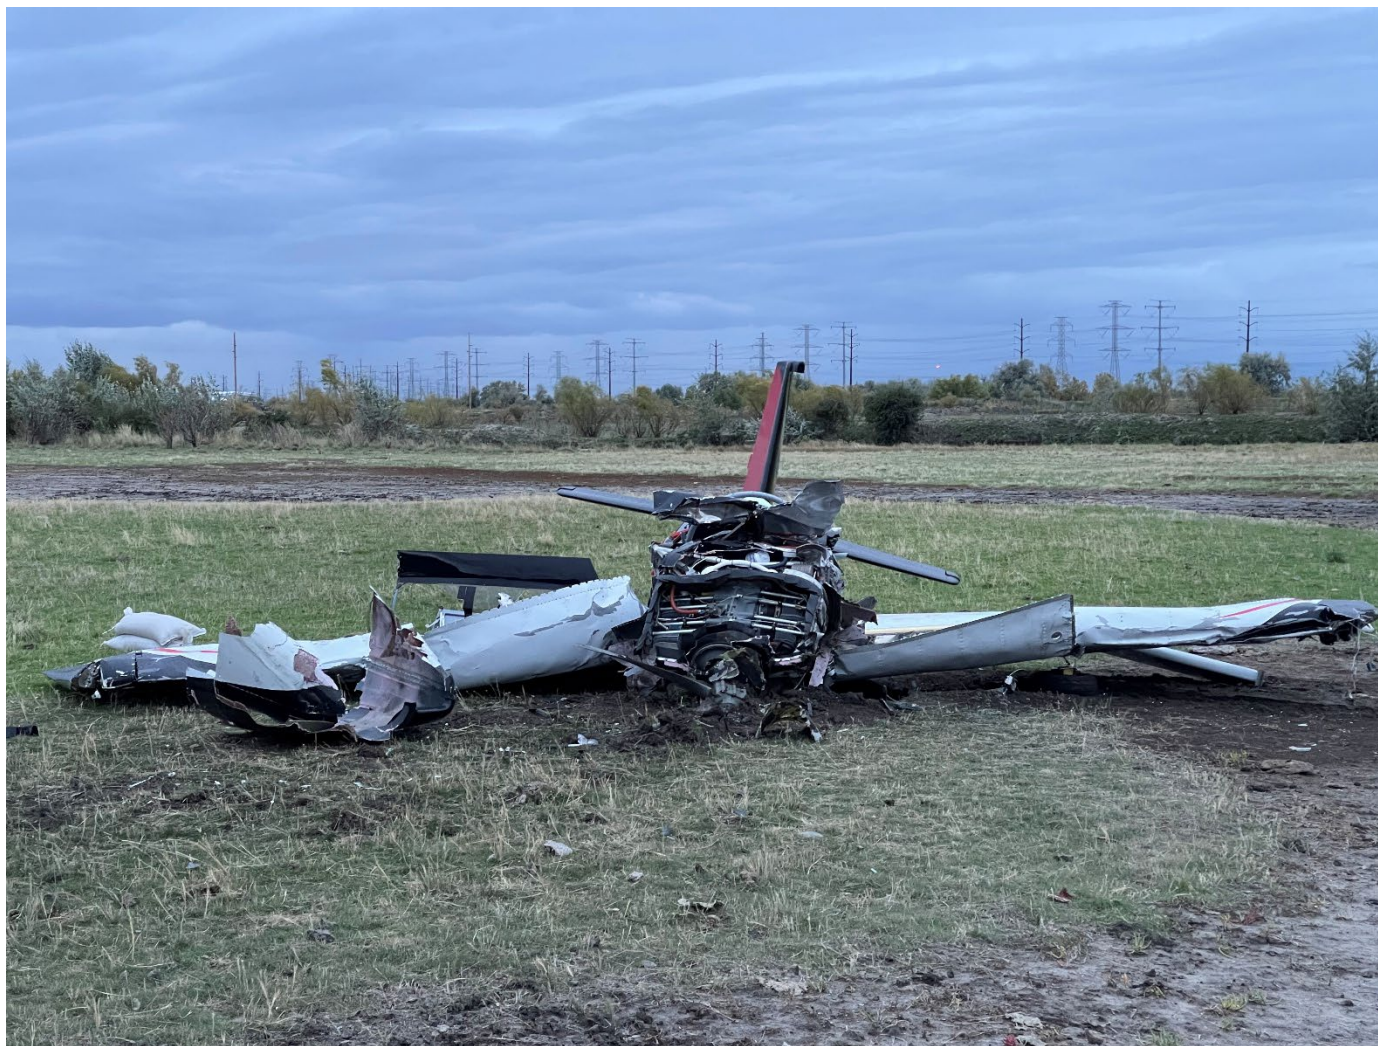
**Photograph 2 - Forward to aft view of the airplane**

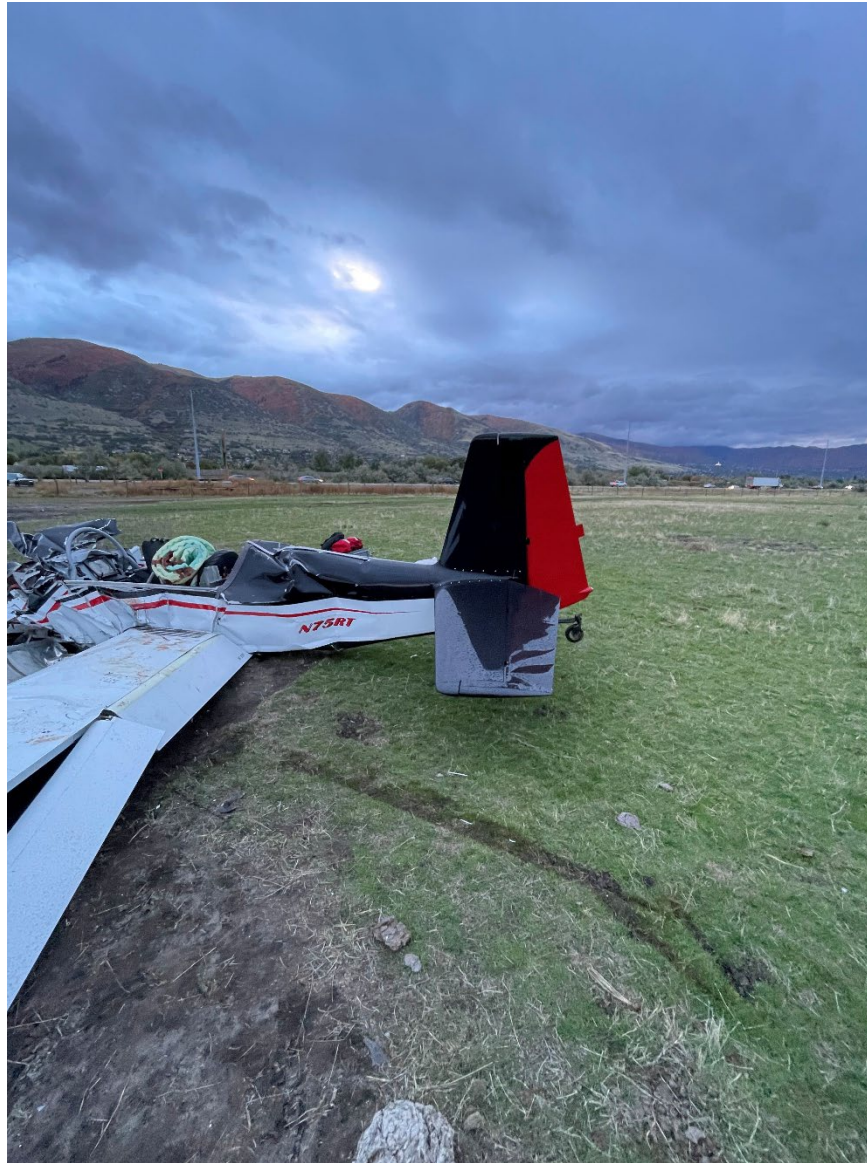
**Photograph 3 - View of ground scars and resting position of the airplane**

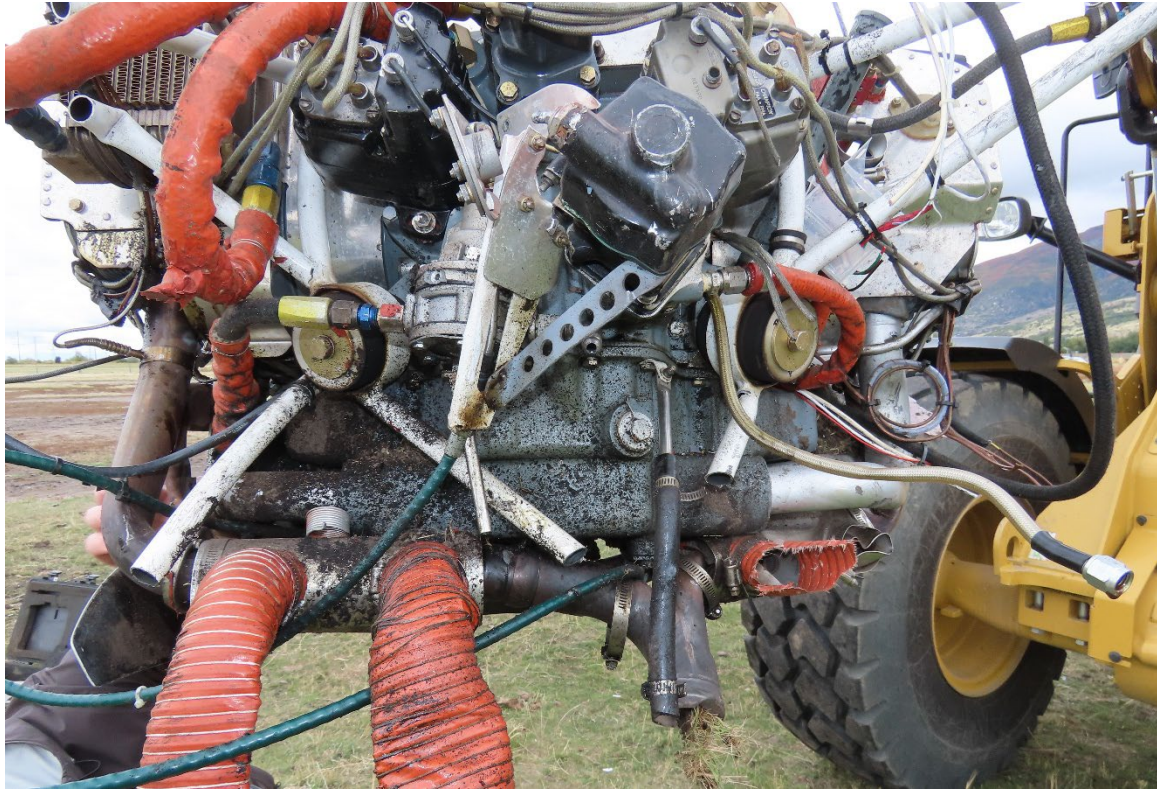
**Photograph 4 -Engine oil saturation throughout lower accessory case**

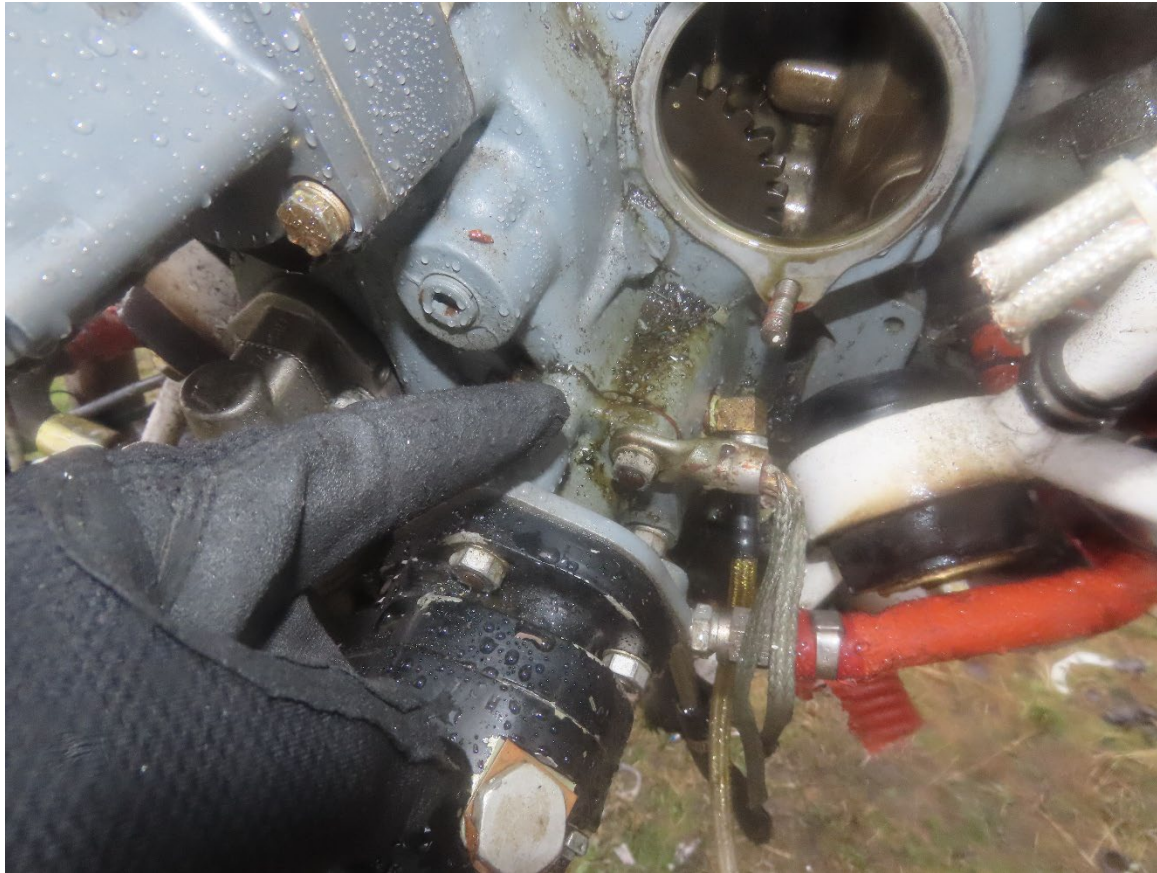
**Photograph 5 - Engine oil pooling above and adjacent to propeller governor adapter and air/oil separator oil return line**
