# National Transportation Safety Board

WPR24FA014

## **PERSONAL ELECTRONIC DEVICES**

Specialist's Factual Report

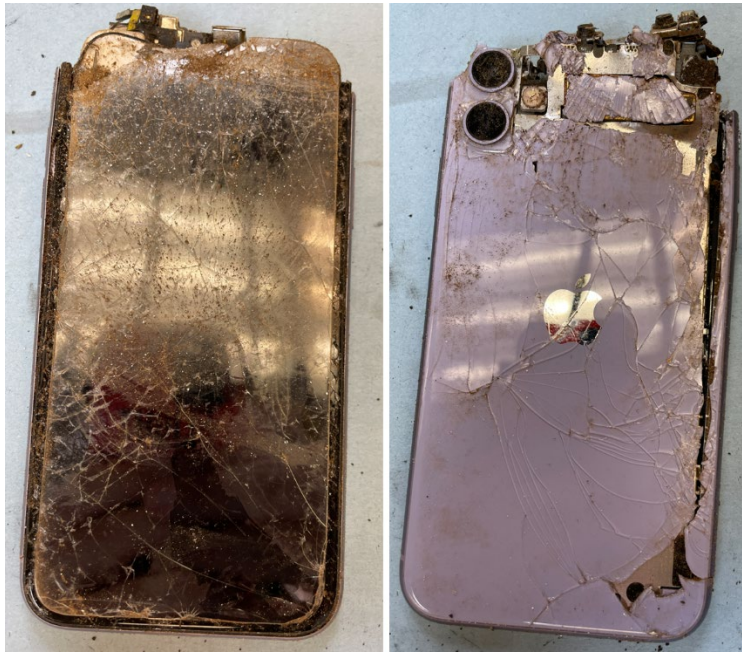
Figures 1 to 4 show the condition of the four PEDs received by the Vehicle Recorder Division. All PEDs except the Apple iPhone 11 powered on normally after being cleaned externally. The motherboard of the Apple iPhone 11 was removed from the device and placed into a surrogate device, and the device powered on. All four PEDs were unlocked with provided passcodes.

**Figure 1.** Front and back of the Apple iPhone 11 as Received.

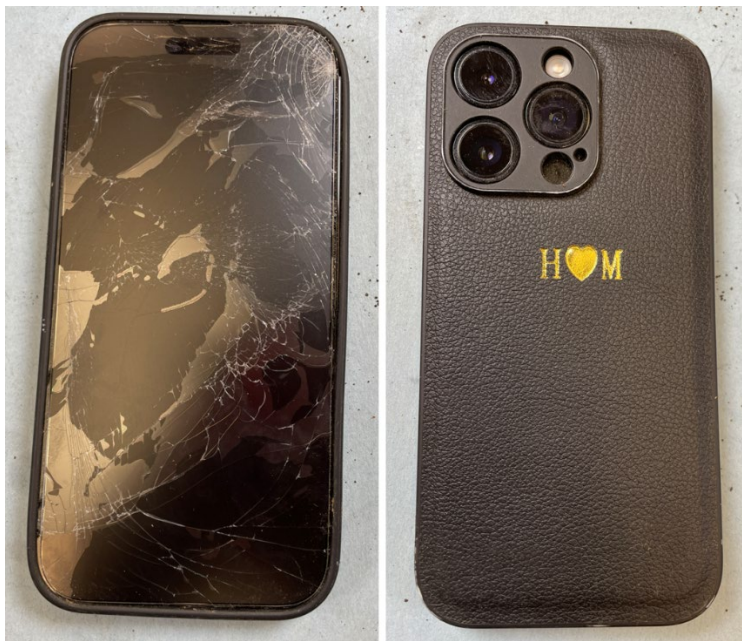
**Figure 2.** Front and back of the Apple iPhone 14 Pro as Received.

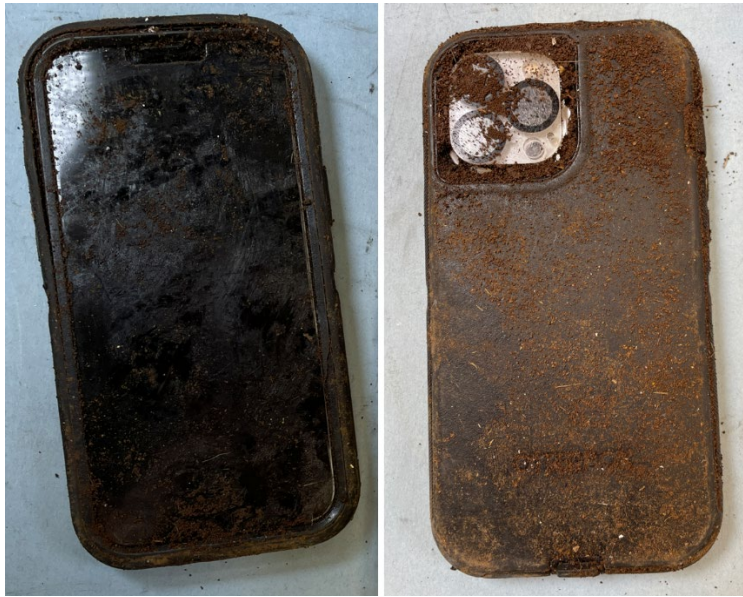
**Figure 3.** Front and back of the Apple iPhone 13 Pro Max as Received.

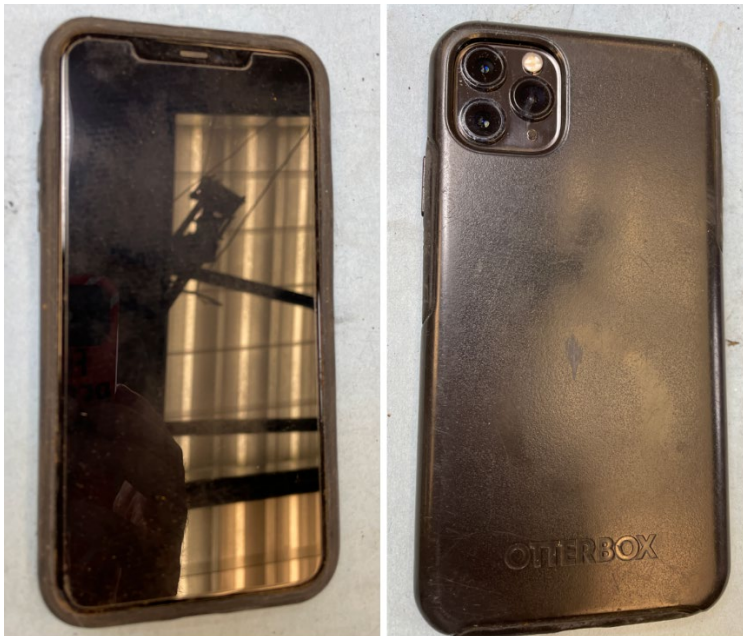
**Figure 4.** Front and back of the Apple iPhone 11 Pro Max as Received.

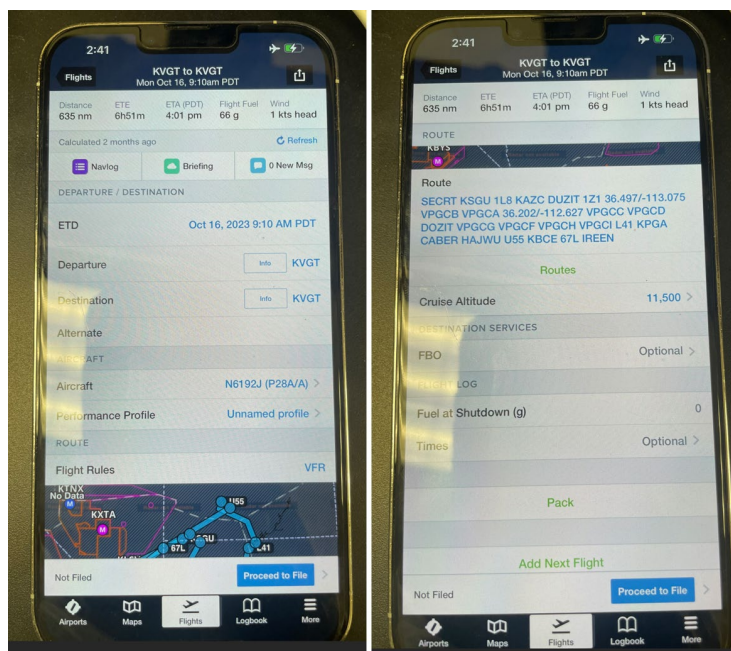
ForeFlight was running in the background of the copilot's phone, but it did not have the accident flight track log recorded. The last track log recorded was a flight associated with a different aircraft on October 14, 2023. There was a flight plan entered in ForeFlight for previous flights on October 16, 2023. Figure 5 shows the details of this flight plan. No other data pertinent to the investigation were found.

**Figure 5.** ForeFlight flight plan for previous flights on October 16, 2023.
