# National Transportation Safety Board

WPR24FA014

## **ACCIDENT SITE SUMMARY**

Location: Williams, AZ  
Date: 10/17/2023  
Time: 1219 MST  
1919 UTC  
Airplane: N6192J, PA-28-140

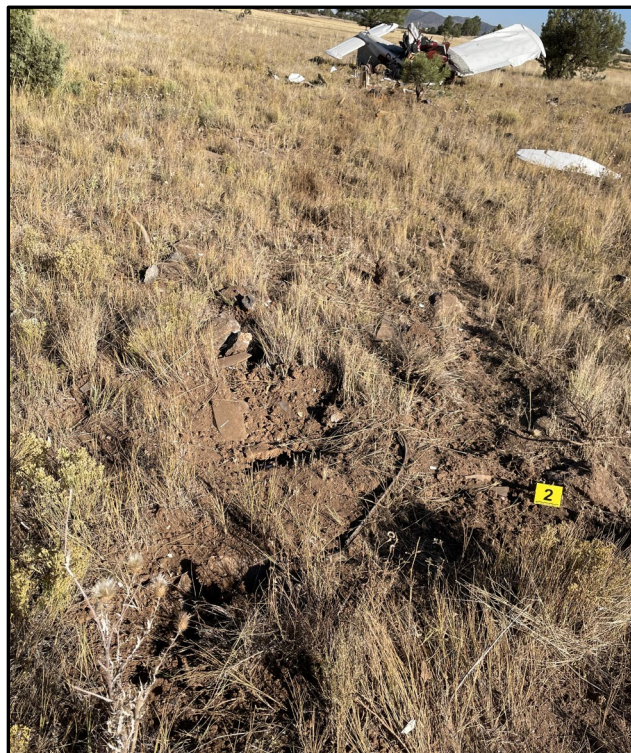
Examination of the accident site revealed that the airplane impacted terrain, about 1/2 mile short of the runway 36 threshold at CMR, about 2,499 ft and 146° heading off the extended runway centerline. The terrain was flat, rocky, and heavily populated with sage brush, about 1 ft in height. The ground disturbance at the initial impact point was about 6 inches in width and about 1 ft length. Fragments of red lenses, consistent with the left-wing position light were located in the disturbance. A mark in the ground lead to another ground disturbance about 25 ft further. The second ground disturbance was about 6 ft in width, 10 ft in length, and 6 inches in depth. A couple of propeller strikes were observed in the ground. The first propeller strike was near the beginning of the disturbance, and the second propeller strike was about in the middle of the disturbance and indicated that the airplane had deviated slightly to the right. Several fragments of broken rocks were noted in the disturbance. The initial direction of the debris field was about 171°.

**Figure 1: Ground disturbance that leads to the main wreckage.**

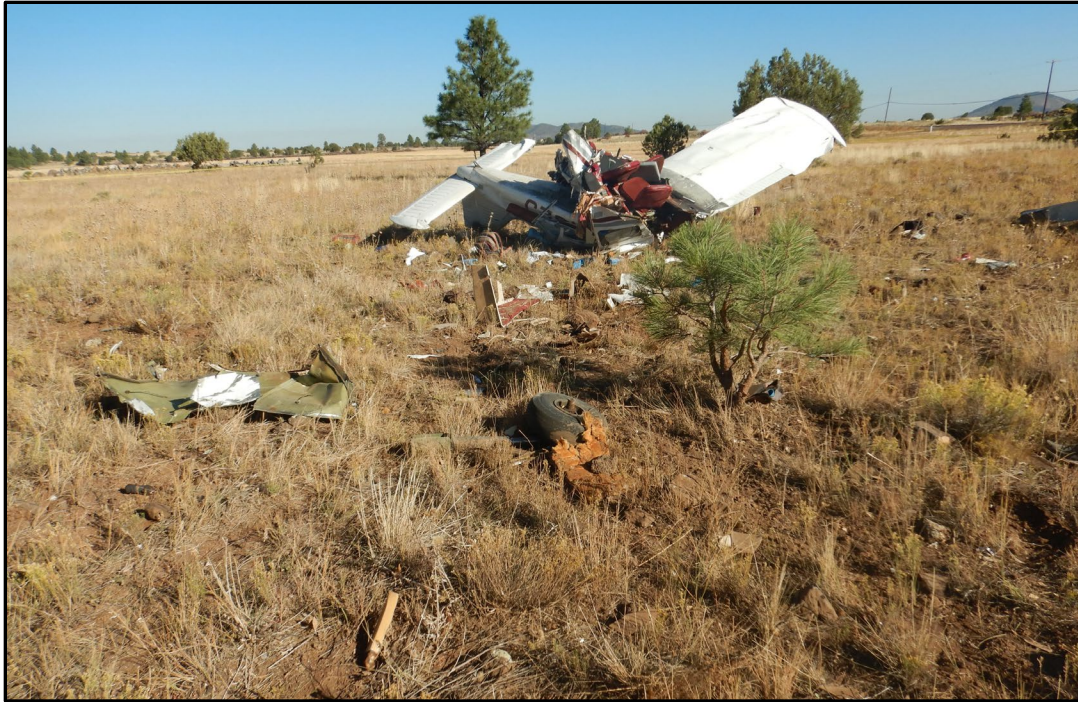
The wreckage site was located at an elevation of about 6,670 ft. The airplane came to rest inverted on a heading of about 129° magnetic and was about 90 ft from the initial point of impact. All major components of the airplane were contained within the main wreckage site. There was no post-crash fire.

**Figure 2: Airplane wreckage in the field.**

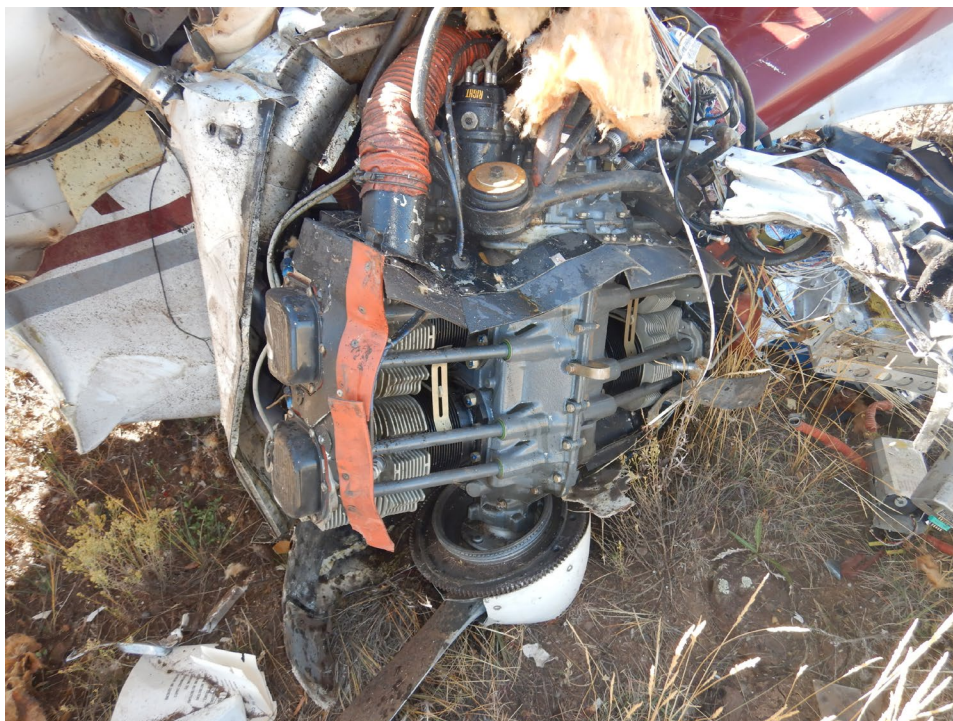
**Figure 3: Engine facing downwards toward the ground.**

The engine was located on the right side of the fuselage behind the cabin area pointing downward towards the ground. The engine was partially attached, and the two-bladed propeller was attached to the propeller crankshaft. The propeller crankshaft was bent to the left.
