National Transportation Safety Board

WPR24FA024

**INVESTIGATIVE SUPPLEMENTAL MATERIALS**

Location: Orangeville, UT  
Date: 10.27.2023  
Time: 1345 mountain daylight time  
Airplane: Cessna T206H

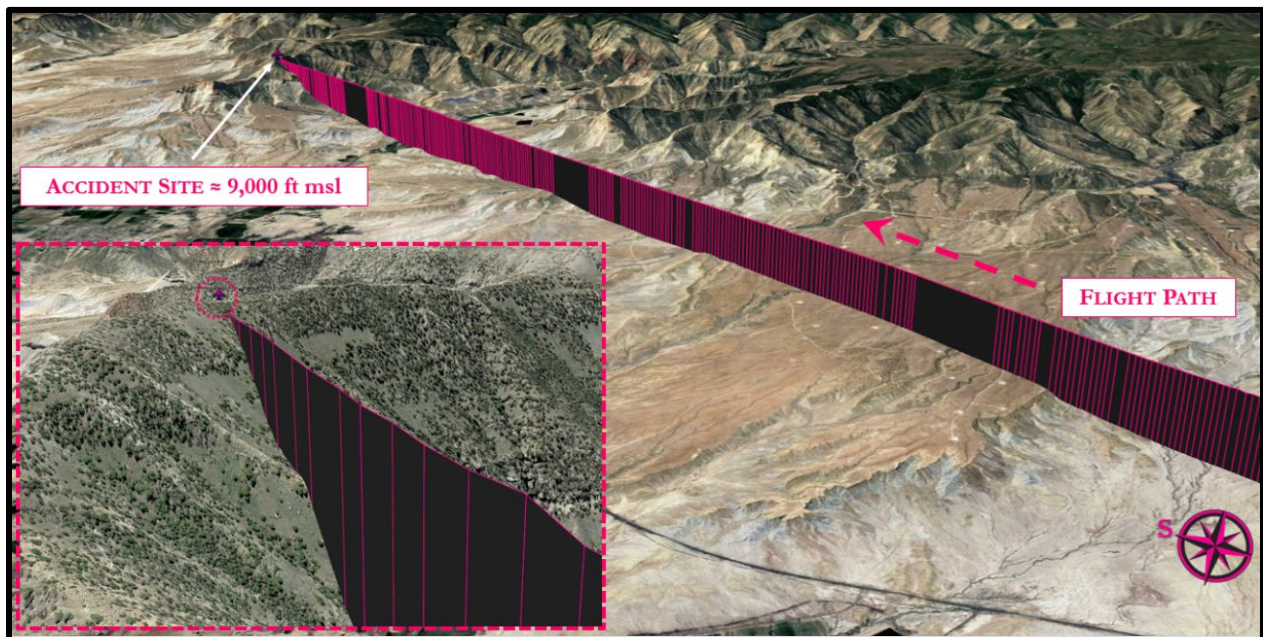
Figure 1: Airplane's Flight Path

Investigators reviewed Federal Aviation Administration (FAA) provided Automatic Dependent Surveillance-Broadcast (ADS-B) data for the accident flight. The data disclosed that at about 1300 the airplane departed Vernal to the southwest and then proceeded west to Bottle Hollow Reservoir. Thereafter, at about 1310, the airplane headed on a southwest course and climbed to about 8,300 ft mean sea level (msl). At 1318, the airplane climbed to about 8,800 ft and remained at that altitude and on a constant southerly heading until the data ended at 1345. The last ADS-B data point was located adjacent to where the wreckage was located, near the peak of a hill (see Figure 1).

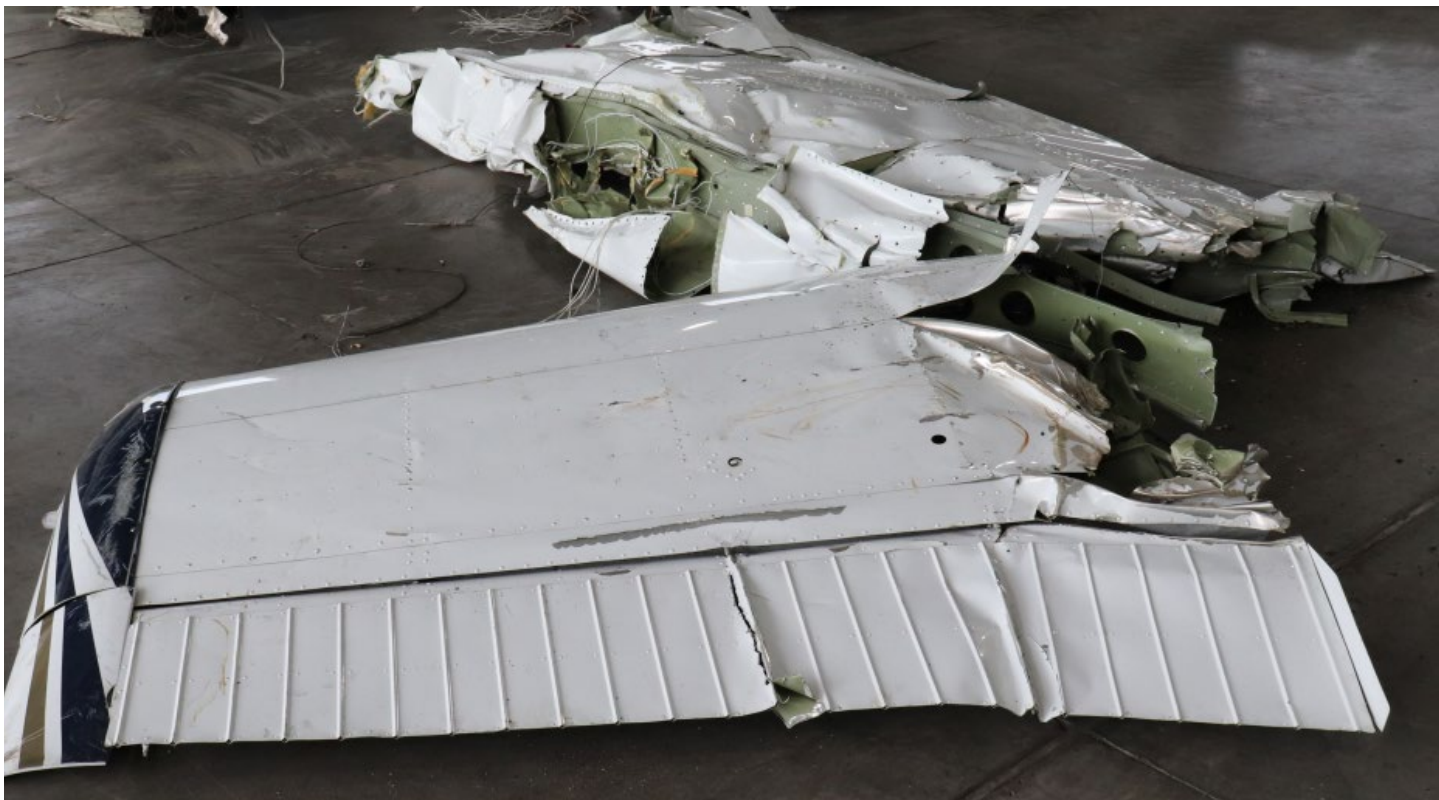
*Figure 3: Left wing*

Site photographs showed that the left wing had separated from the fuselage and was located separately in the wreckage. The wing was separated into inboard and outboard sections at the junction of the flap and aileron. The fuselage and empennage sustained extensive thermal damage.

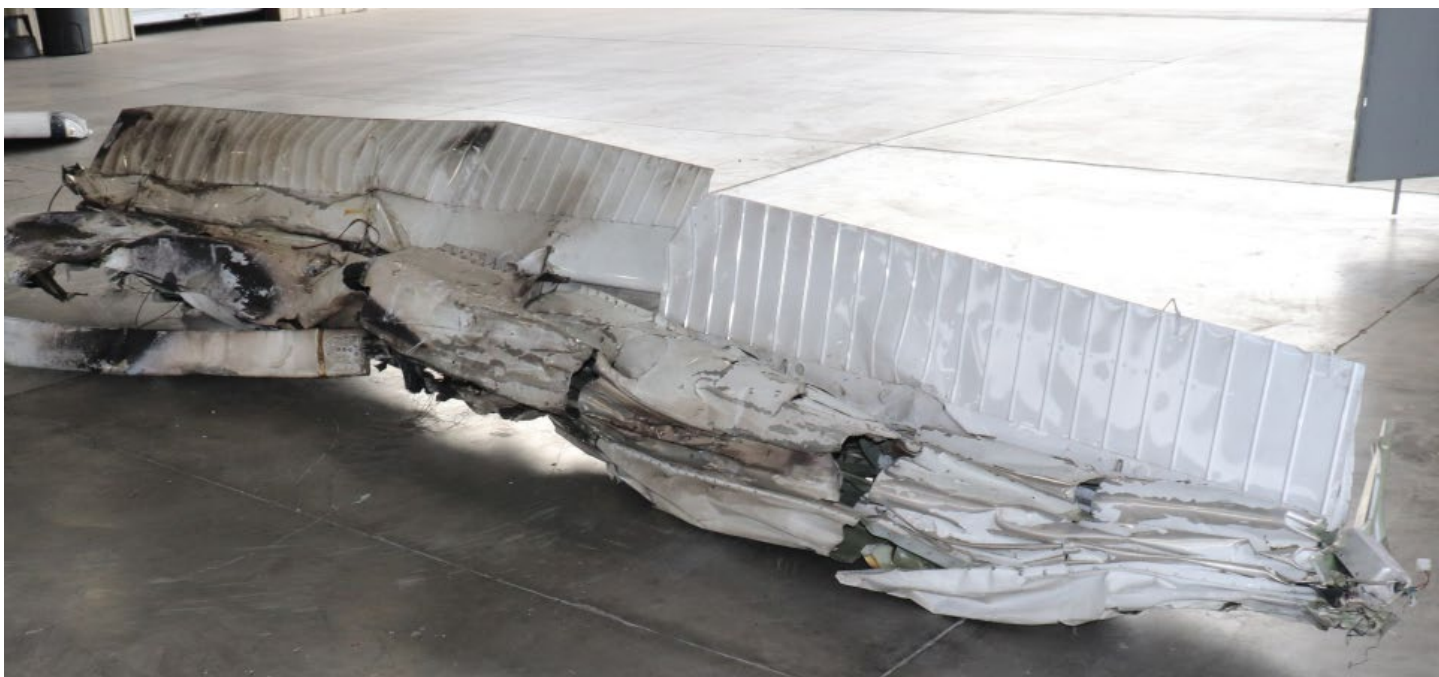
*Figure 4 :Right wing*

The right wing exhibited substantial leading edge crush damage and thermal damage near the fuel tank.

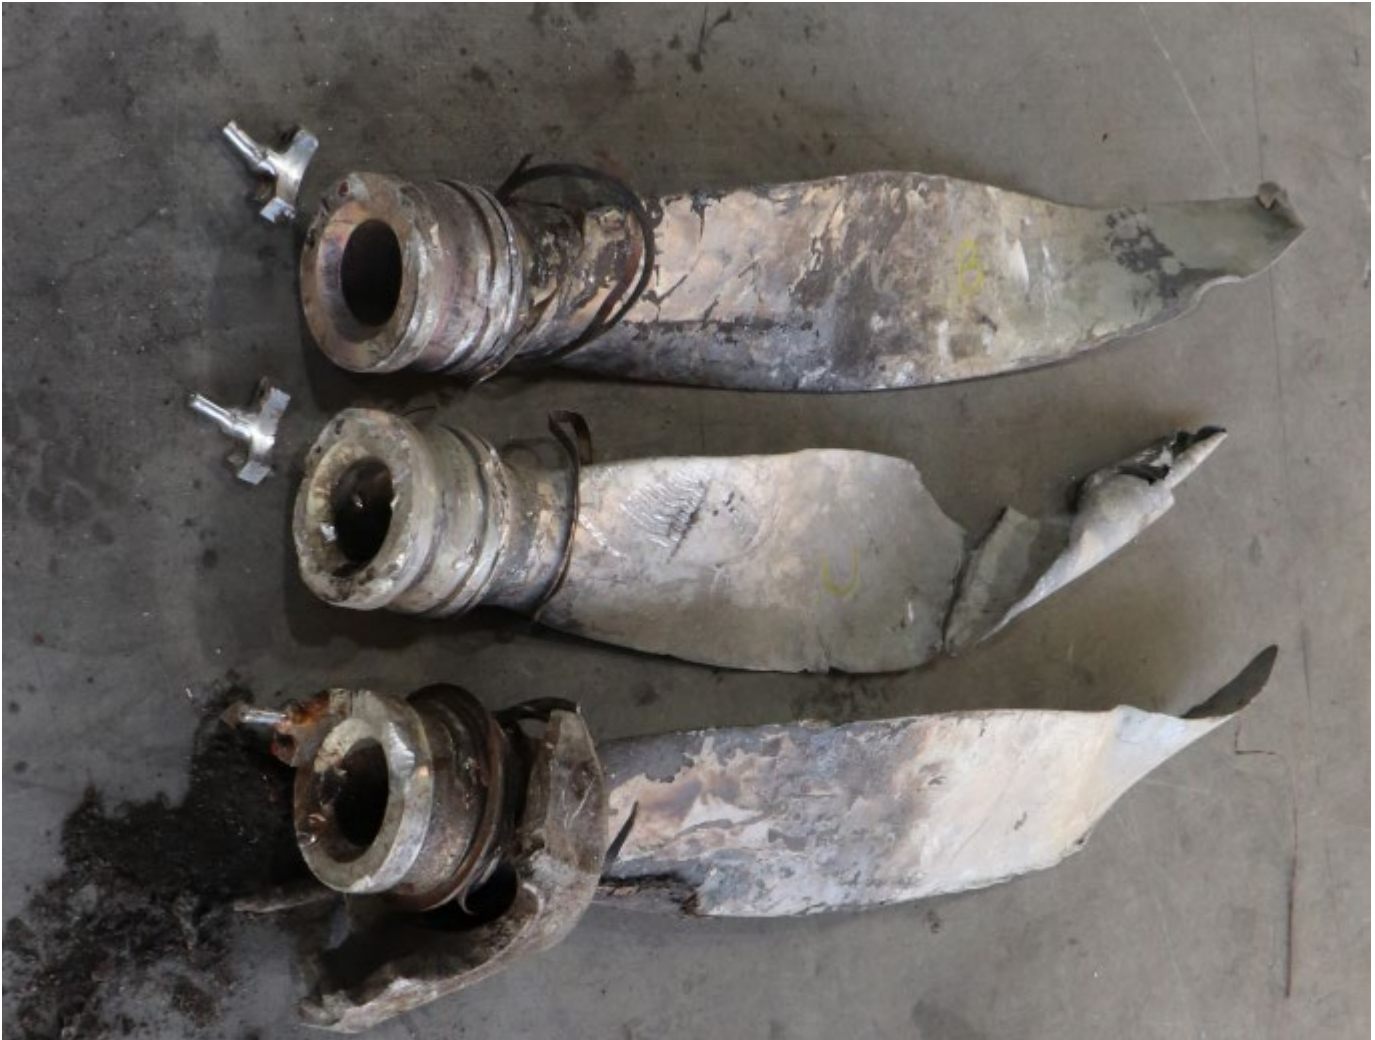
*Figure 5: Propeller blades*

The propeller hub was fractured with a fragment of the hub remaining securely attached to the crankshaft flange. All three metal propeller blades had separated from the hub. Each blade exhibited varying degrees of leading-edge damage, torsional twisting, chordwise striations, and trailing-edge S-bending. The condition of the blades was consistent with damage resulting from the absorption of rotational forces.
