# National Transportation Safety Board

WPR24FA035

## **FIELD NOTES SUMMARY**

Location: Provo, Utah  
Date: November 14, 2023  
Time: 1008 Mountain standard time (MST)  
1708 Coordinated Universal Time (UTC)  
Airplane: N3971L

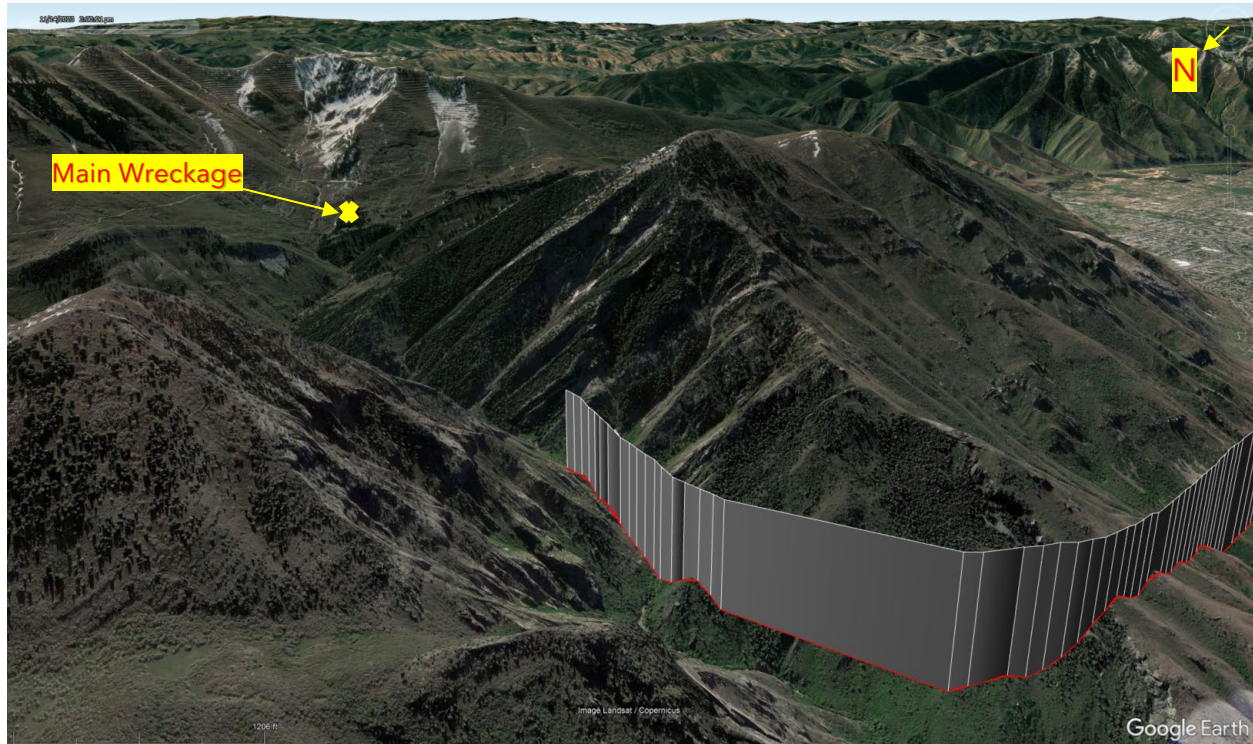
The Civil Air Patrol received an emergency locator transmission the day of the accident, about 1117 MST. A search by a local law enforcement agency ensued and the airplane wreckage was discovered on a rising face of Slate Canyon about 2,000 ft below the summit, about 6 nm northeast of Spanish Fork Municipal Airport/Woodhouse Field (KSPK), Spanish Fork, Utah.

**Figure 1. View of location of main wreckage in relation to ADS-B data track in Google Earth.**

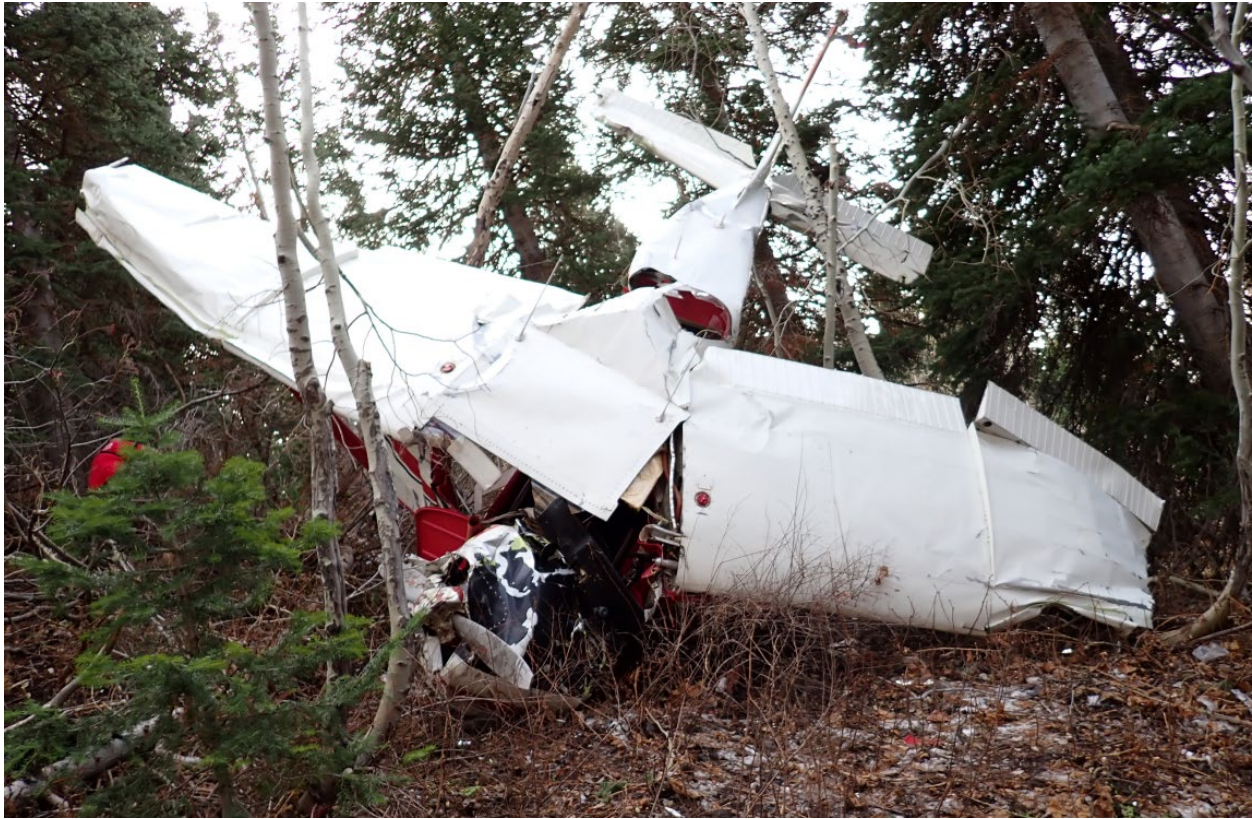
The wreckage was located on a mountain side at a field elevation of about 7,900 ft mean sea level (msl). The airplane came to rest on a slope (figure 2) and was oriented on a heading of 050° magnetic. The first identified point of contact (FIPC) was identified by a severed branch of 70-foot-tall aspen trees and several broken tree branches. A debris path was marked with subsequent tree strikes that began about 80 ft forward of the FPI and oriented on a heading of 280° magnetic. The main wreckage marked the end of the debris path and was located about 170 ft beyond

**Figure 2. View of accident airplane which came to rest nose down.**

The fuselage came to rest nose down against aspen trees. The windscreen was damaged and both forward door posts were separated from the forward section of the cabin roof. The cabin roof remained attached to the upper aft section of the fuselage. The aft fuselage remained attached and sustained heavy compression damage consistent with impact. Flight control cable continuity was established to the cockpit to all surfaces.
