# National Transportation Safety Board

WPR24FA037

## **ACCIDENT SITE SUMMARY**

Location: La Jolla, CA  
Date: 11/15/2023  
Time: 2120 PST  
0520 UTC  
Airplane: N1400, Cessna P210N

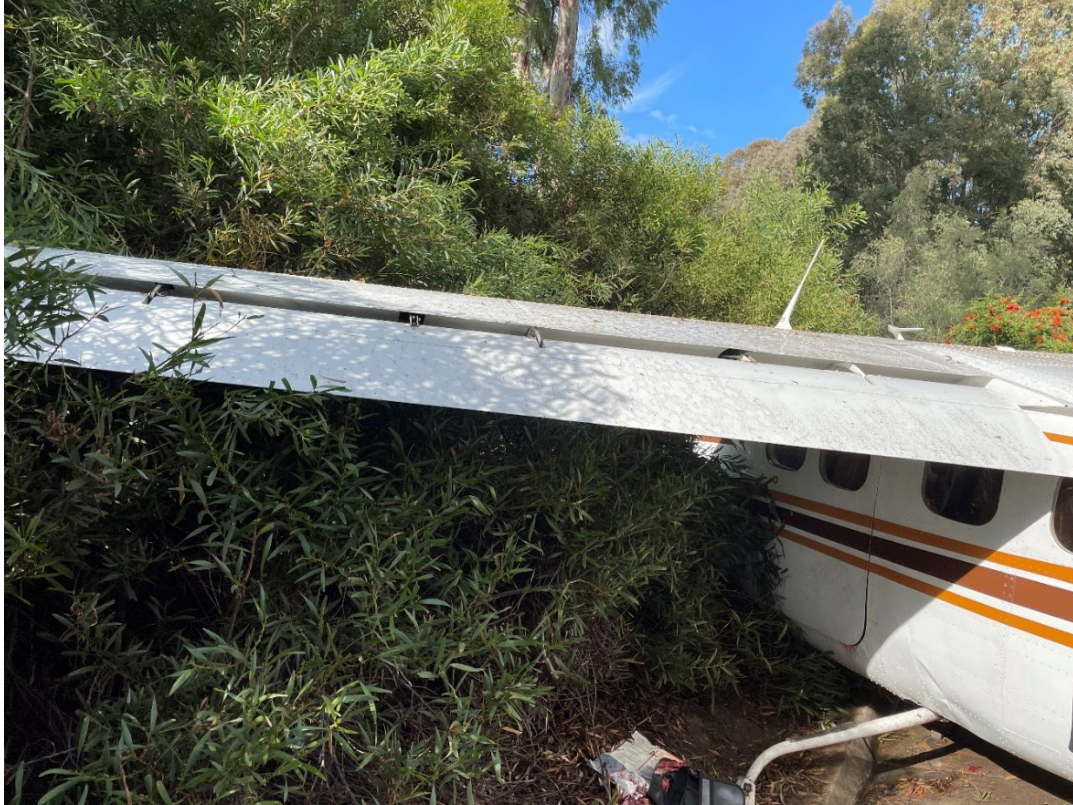
Examination of the accident site revealed that the airplane impacted terrain, on the side of the hill about 40 ft from the hilltop. A road was at the base of the hill, and the private homes were located on the top of the hill. The terrain slope was about 70° was populated with tall trees (75-100 ft tall) and vegetation. The ground disturbance just about a foot forward of the front of the airplane was the initial impact point.

**Figure 1: Airplane as viewed from the left rear.**

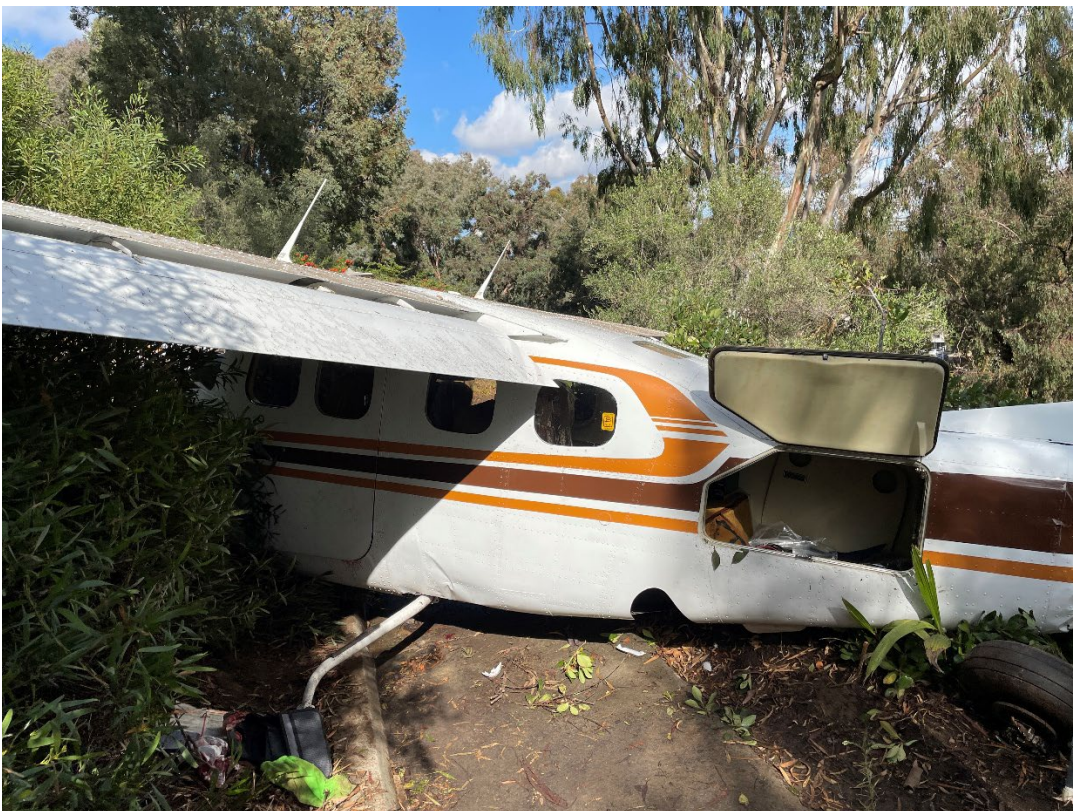
**Figure 2: Airplane as viewed from the left side.**
