# National Transportation Safety Board

WPR24FA037

## **AIRFRAME AND ENGINE EXAMINATION SUMMARY**

Location: La Jolla, CA  
Date: 10/15/2023  
Time: 2120 MST  
0520 UTC  
Airplane: N1400, Cessna P210N

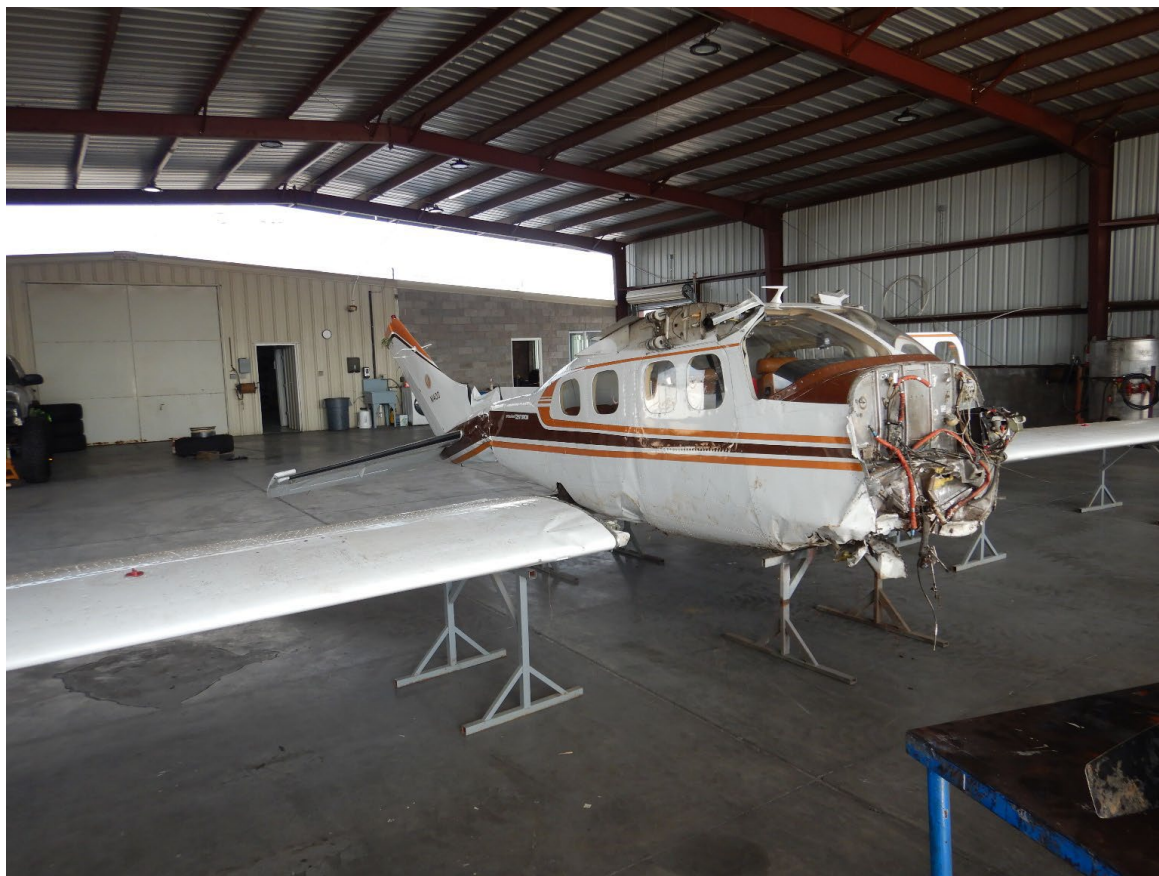
**Figure 1: Airplane as viewed from the right front during the examination.**

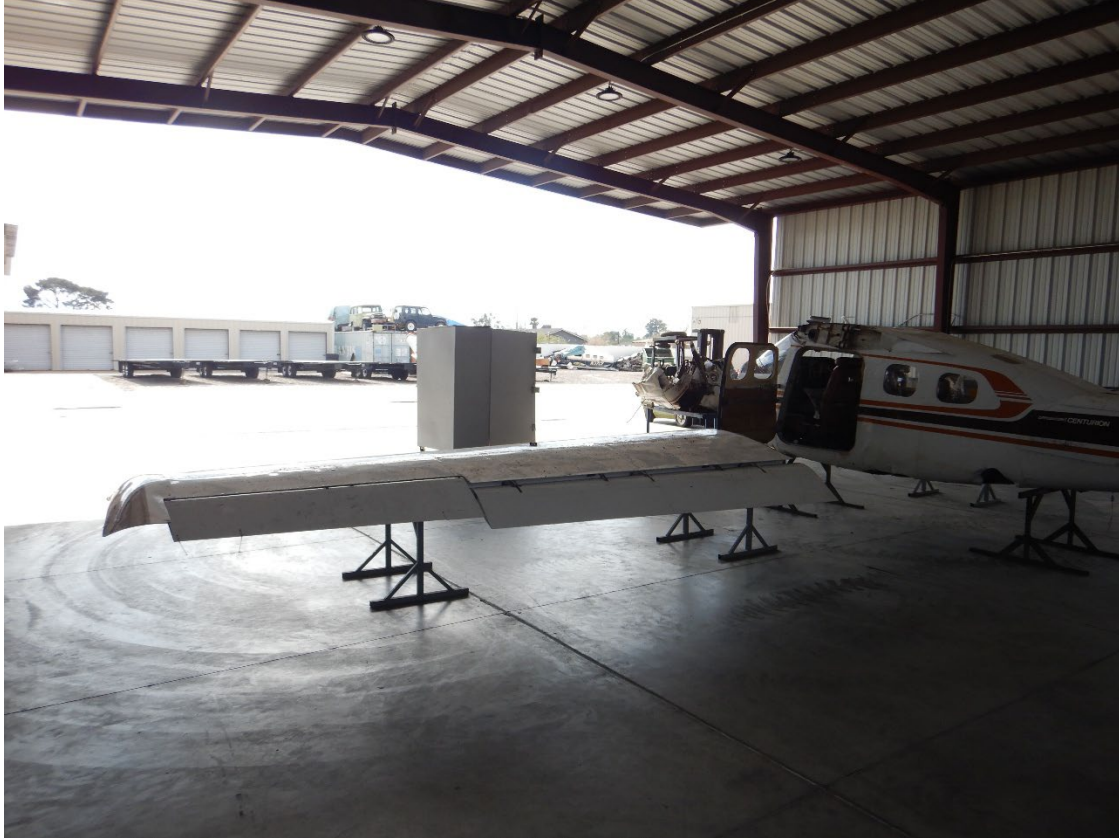
**Figure 2: Airplane as viewed from the left side.**

The empennage portion of the airplane was bent downward. The vertical stabilizer and rudder were attached and relatively intact. The horizontal stabilizers and elevators were attached and intact.

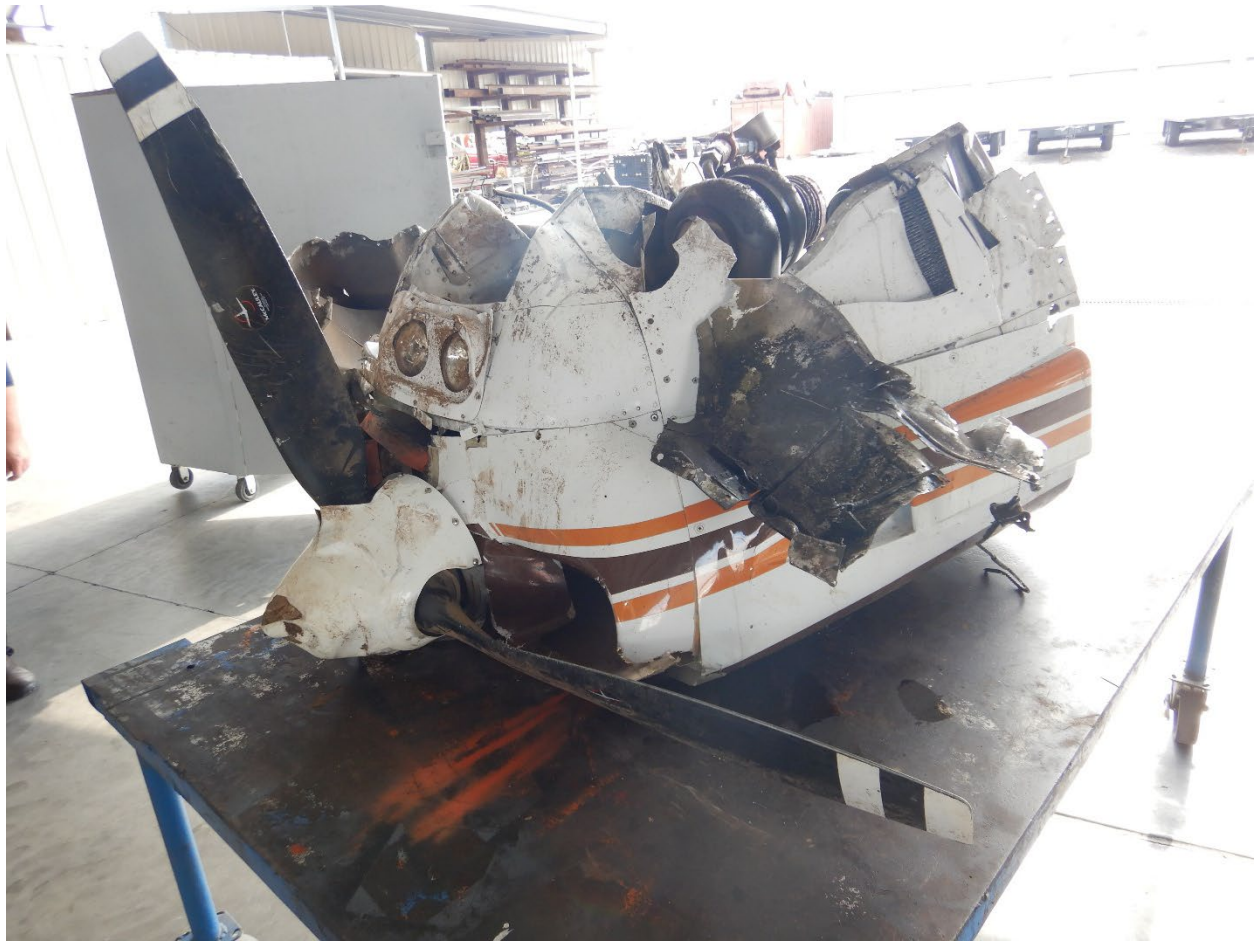
**Figure 3: Engine as viewed from the front right side (inverted).**

The engine was not attached to the fuselage. The turbo charger turned freely by hand. The air induction system was free of obstructions. Engine control cable continuity was confirmed.

The propeller remained attached to the crankshaft propeller flange. Two blades were relatively intact and did not exhibit leading edge gouging or scoring. The third blade was separated from the hub and was bent slightly aft about midspan. The spinner was attached and exhibited impact markings.
