## WPR24FA037 Meteorological Information

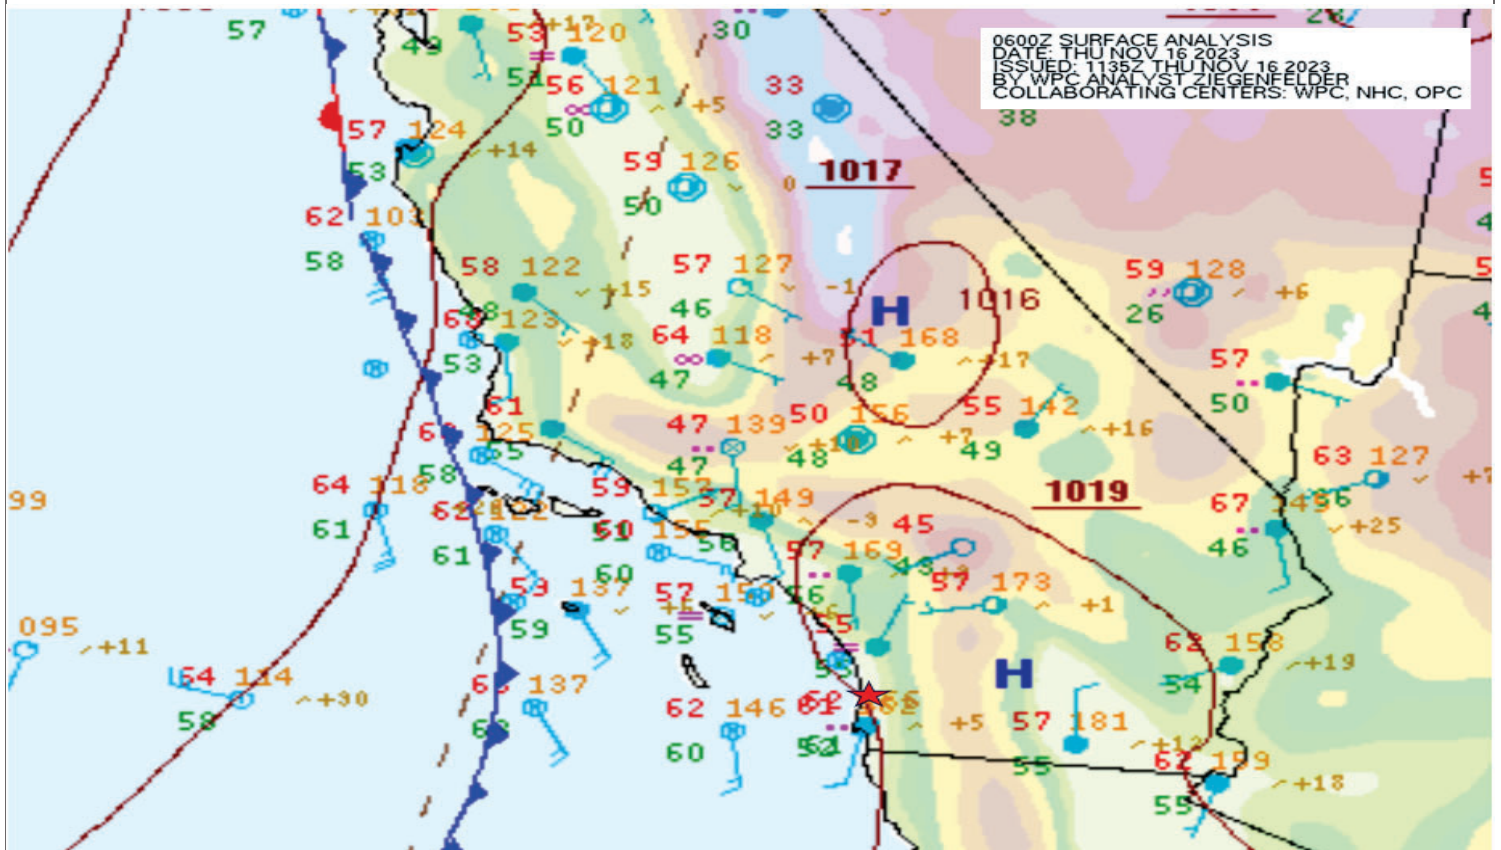
Figure 1

**Synoptic Conditions:** The southwest regional NWS Surface Analysis Chart for 2200 PST with the approximate accident site marked by a red star is included as figure 1. The chart depicted a cold front extending along the California coast with two high pressure centers of 1017- and 1019-hectopascals (hPa) respectively over southeast and southern California. The station models depicted generally southerly winds of 10 knots or less along the southern California coast with visibilities restricted in light rain and mist, with overcast clouds.

NWS Surface Analysis for 2200 PST with the approximate accident site marked by the red star.

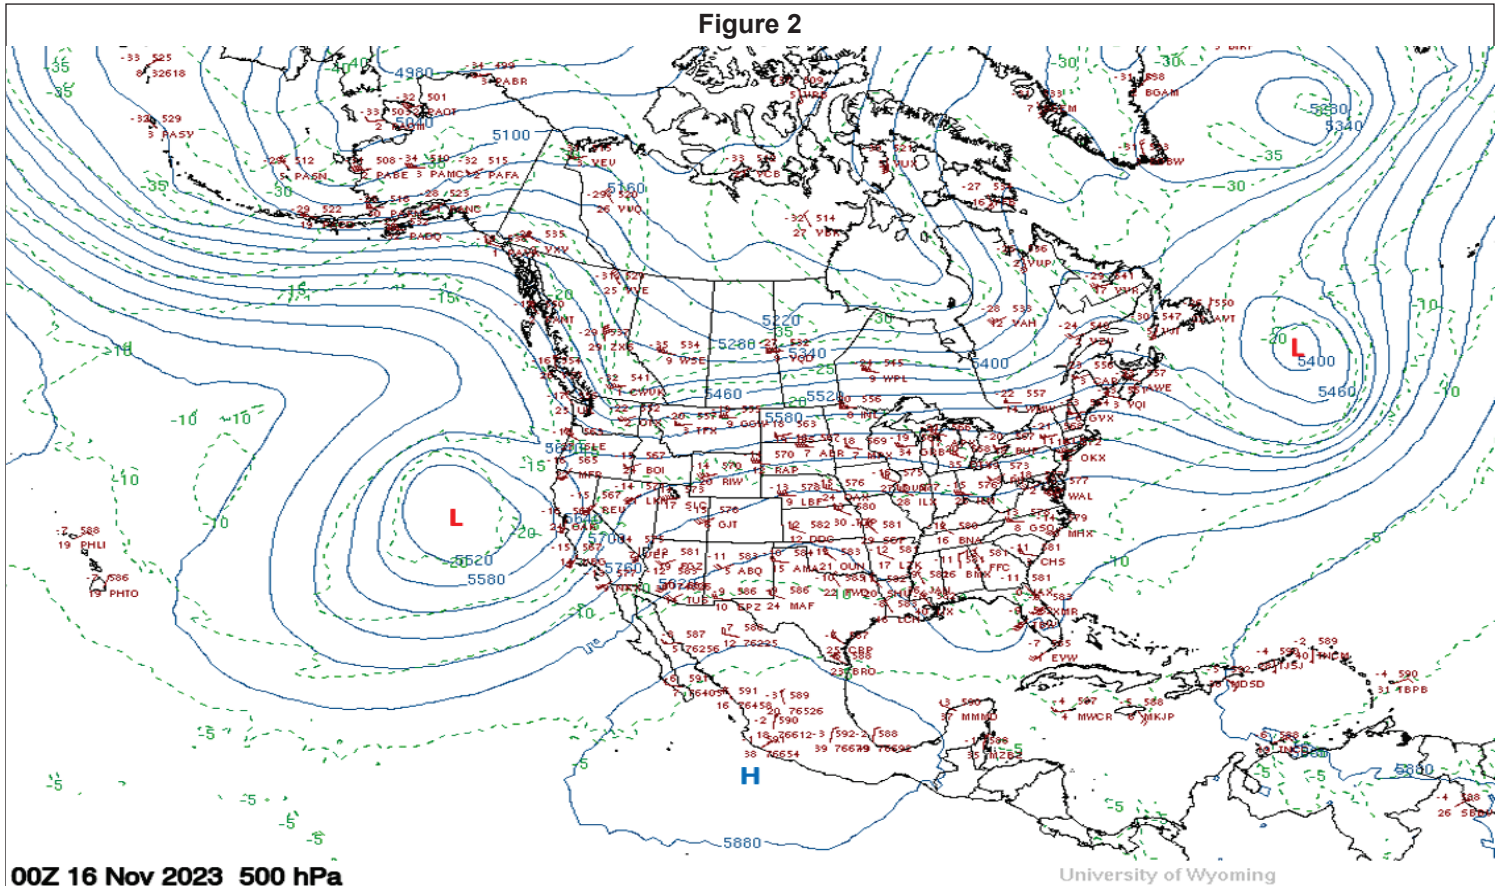
Figure 2

The NWS 500-hPa constant pressure chart for 1600 PST (0000Z 16NOV2023) is included as figure 2 and depicted a cut off upper level low-pressure system off the California Pacific coast, which resulted in funneling southwest flow of moisture into the area. The upper level low and associated trough of low pressure also supported diffluent flow over the area and favorable upper-level divergence for clouds and precipitation over the region.

NWS 500-hPa constant pressure chart for 1600 PST depicting an upper level low and trough off the California Pacific coast providing support for southwesterly flow of moisture over the area.

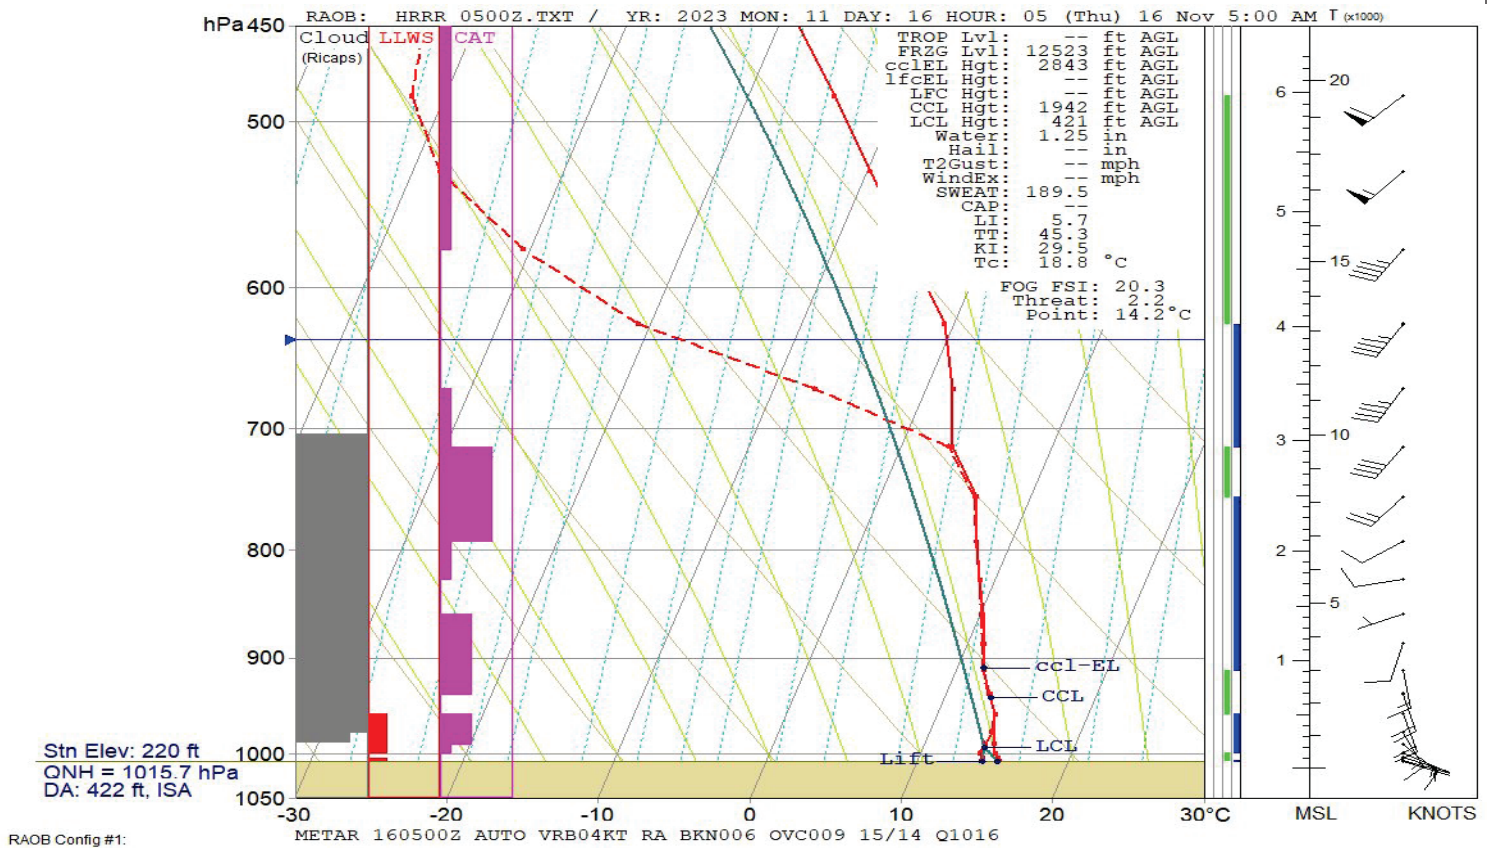
**Sounding** - A High-Resolution Rapid Refresh (HRRR) numerical model data was obtained from the NOAA Air Resources Laboratory for the closest grid point of the accident site for 2100 PST, the data was then plotted on a standard skew T log P diagram using the RAOB Analyst software. Figure 3 is the HRRR model sounding from the surface to 450-hPa or approximately 22,000 ft. The sounding depicted an elevation of 220 ft over the grid point with a near surface temperature of 15.3°C (59.5°F), a dew point temperature of 14.3°C (57.7°F), and a relative humidity of 94%. The lifted condensation level (LCL) was identified at 421 ft agl, and the convective condensation level (CCL) at 1,942 ft agl, with the precipitable water content of 1.25 inches. The freezing level was identified at 12,743 ft, above the accident airplanes cruising level. The RAOB Analysis supported nimbostratus type clouds with bases near 400 ft agl and tops near 10,000 ft.

High-Resolution Rapid Refresh (HRRR) numerical model over the accident site for 2100 PST. Clouds depicted in gray on left axis.

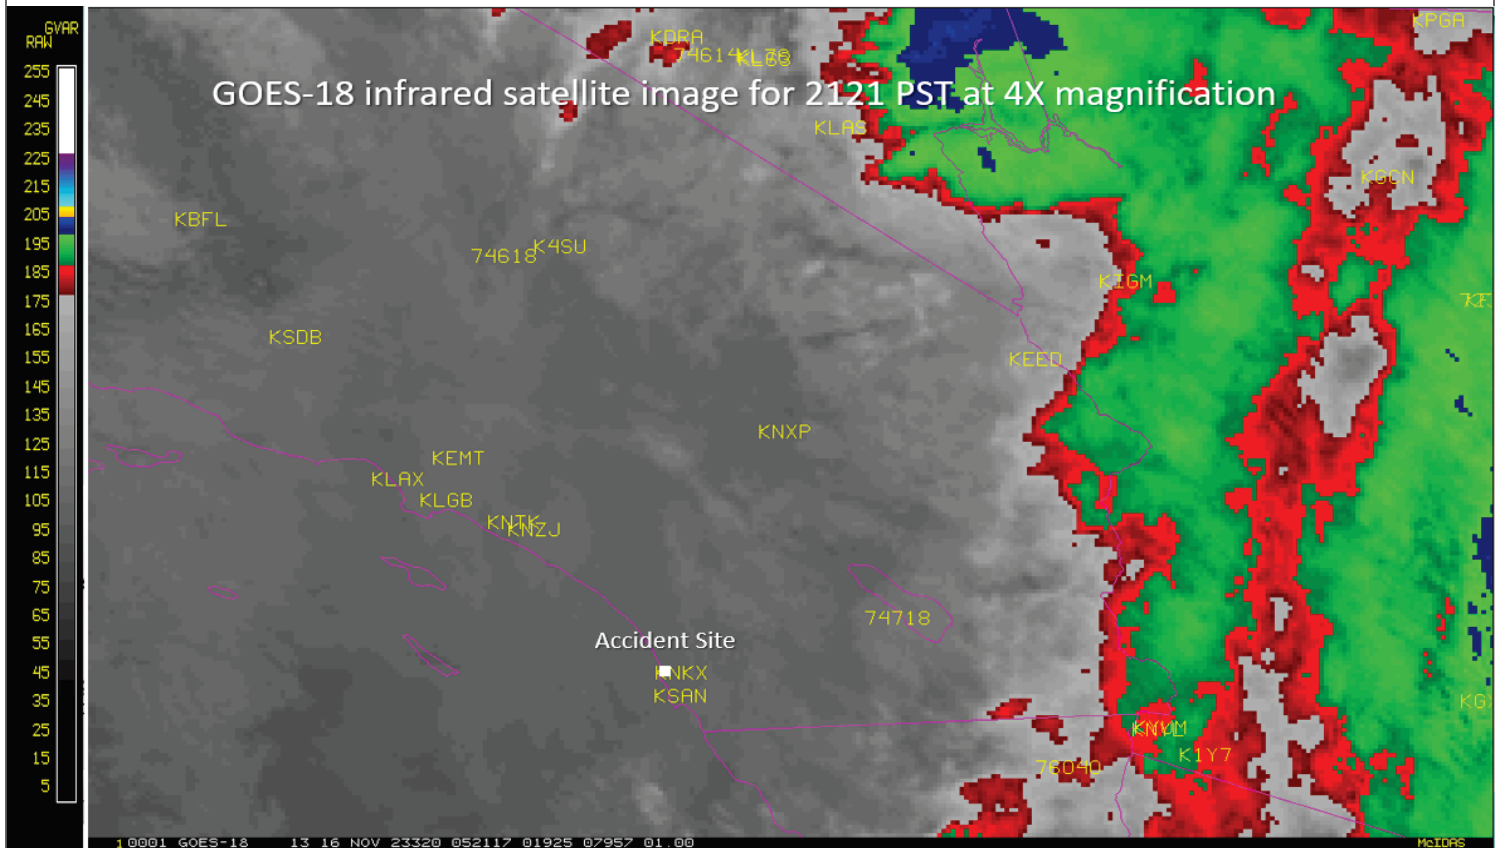
**Satellite Imagery** - The Geostationary Operational Environmental Satellite number 18 (GOES-18) imagery were obtained from an archive at the Space Science Engineering Center (SSEC) at the University of Wisconsin-Madison in Madison, Wisconsin, and processed using the Man-computer Interactive Data Access System (McIDAS) software. The infrared band 13 at a wavelength of 10.3 microns (µm) provided a resolution of 2 kilometers (km) with radiative cloud top temperatures. Figure 4 is the GOES-18 infrared image at 2121 PST at 4X magnification with a standard MB temperature enhancement curve applied to highlight the higher and often colder clouds associated with deep convection. The image depicted an area of low clouds over the accident site with a radiative cloud top temperature of 282 Kelvin or 8.8C which corresponded to cloud tops near 6,000 ft

GOES-18 infrared satellite imagery for 2121 PST depicting low clouds over the area.

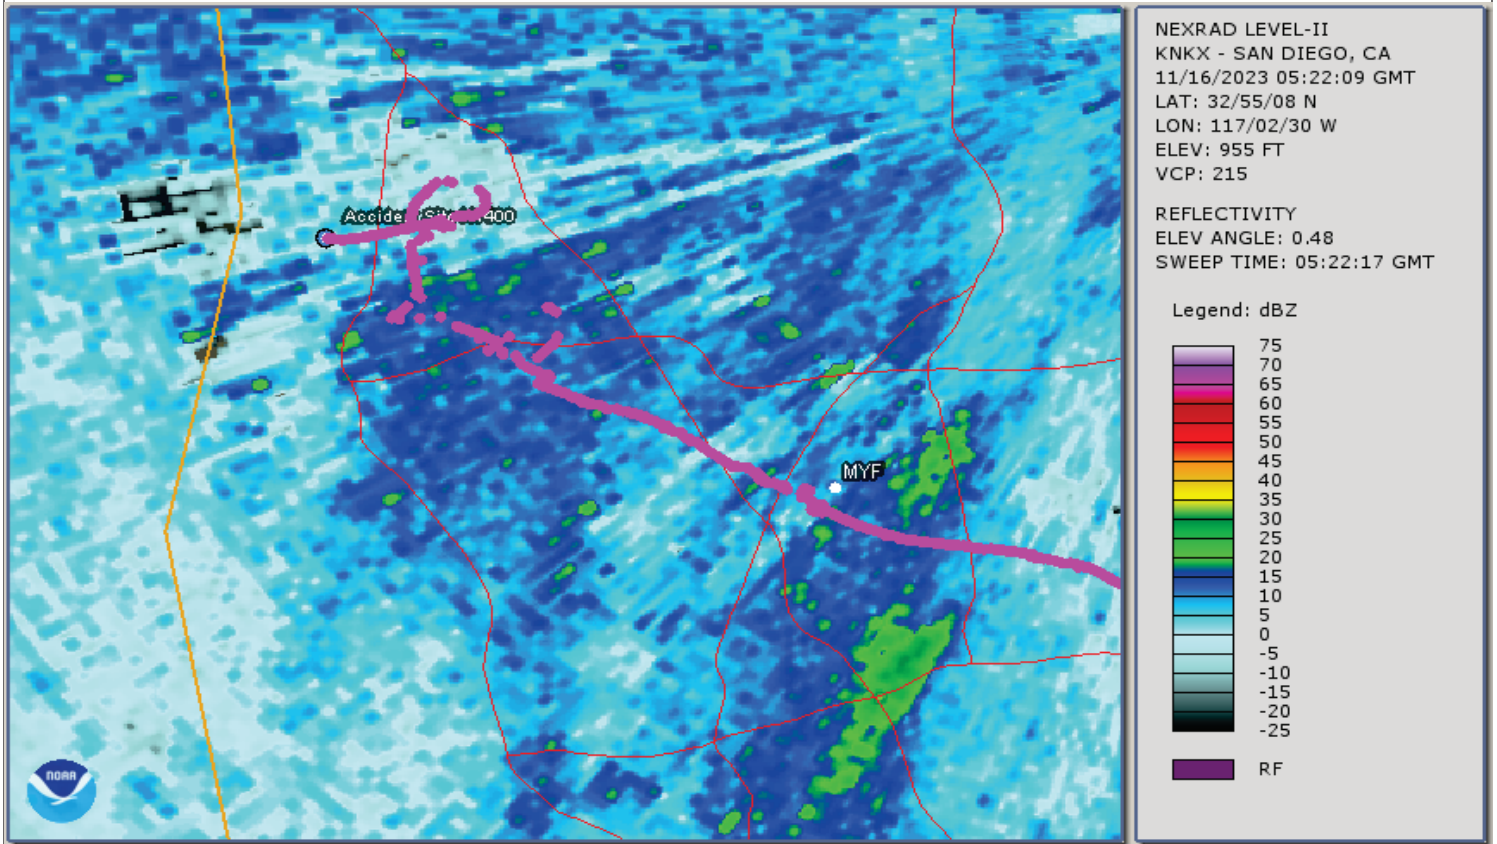
Figure 5

**Weather Radar Imagery** - The NWS San Diego (KNKX) Weather Surveillance Radar 1988 Doppler (WSR-88D) was located about 10 miles east of the accident site with an antenna elevation of 1,052 ft. The KNKX WSR-88D 0.5° base reflectivity image for 2122 PST with the flight track of N1400 overlaid in magenta is included as figure 5. The image depicted the flight track in echoes of 5 to 20 dBZ or very light intensity echoes during the period. associated with very light intensity.

NWS San Diego WSR-88D 0.5 degree base reflectivity image for 2122 PST with the accident airplane's flight track in magenta.
