WPR24FA040

## **ACCIDENT SITE SURVEY**

Location: Mertzon, Texas  
Date: November 25, 2023  
Time: 18:35  
Airplane: Piper Aircraft 28-180 / N7763W

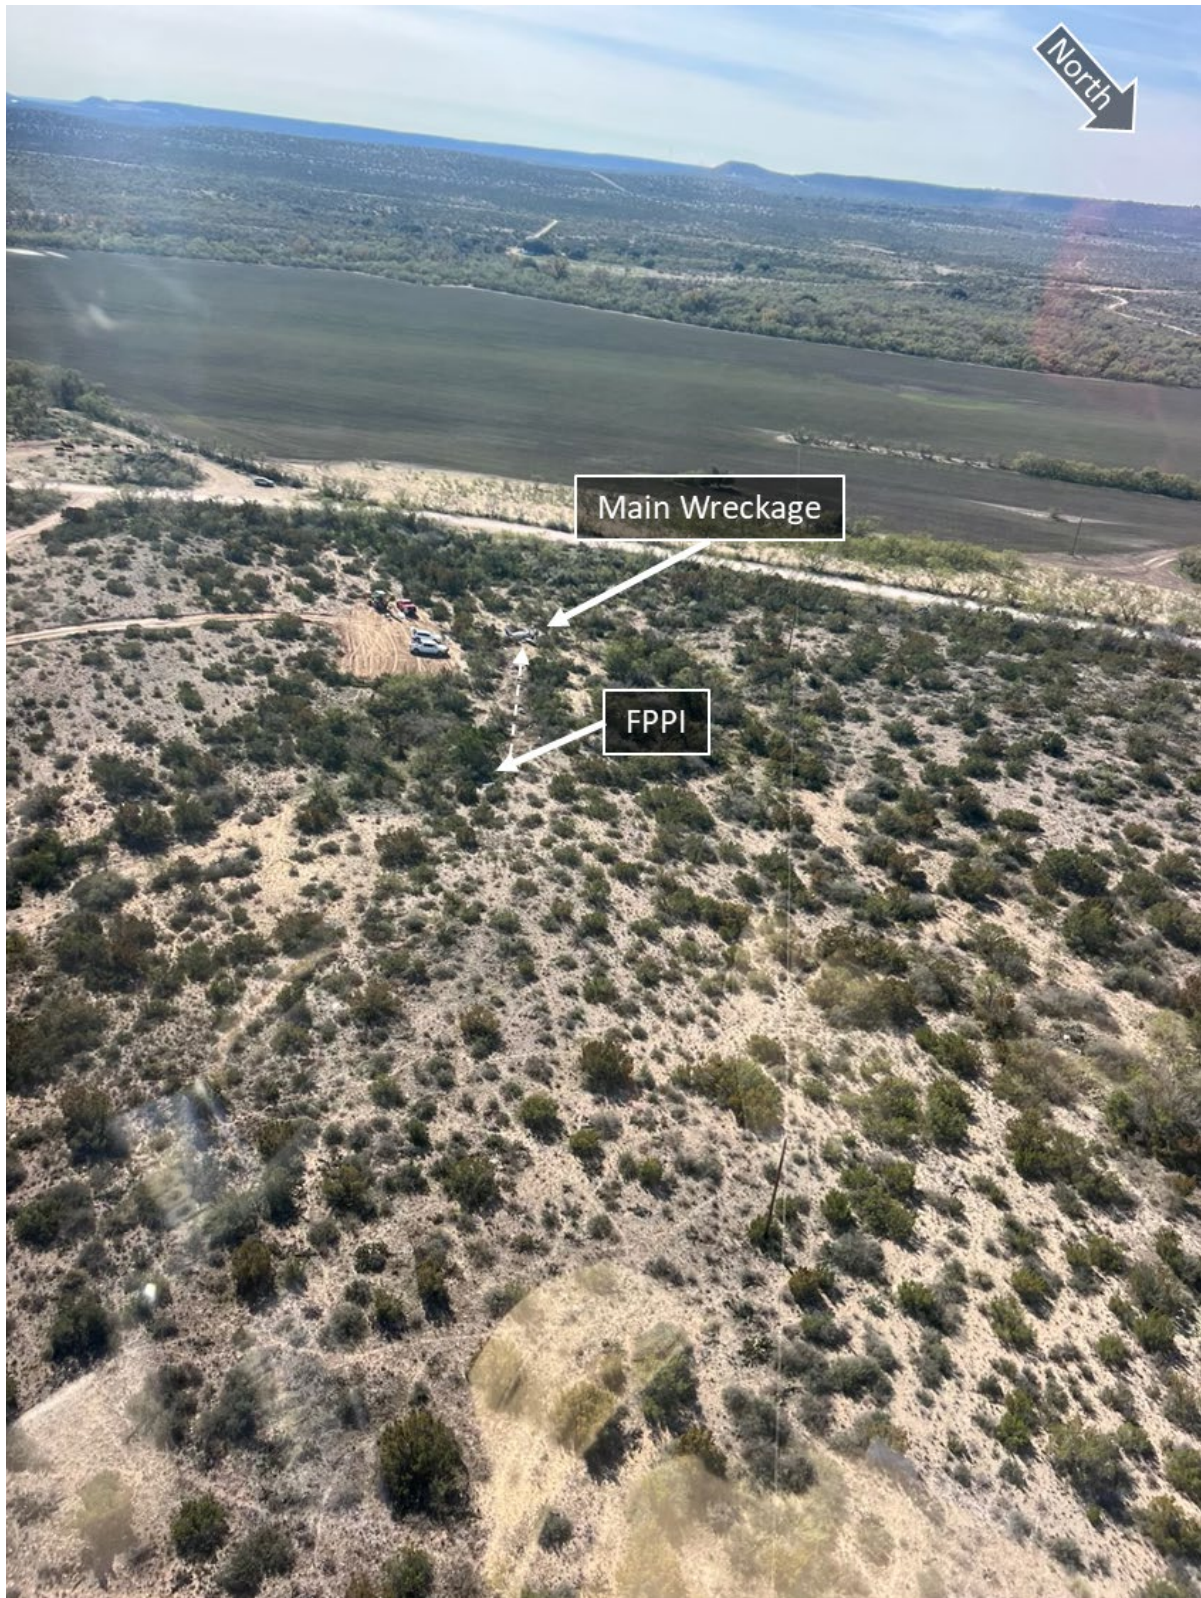
The accident scene was in an open, hilly, and unpopulated terrain covered with cactus and scrub oak of about 2 ft to 15 ft tall. The ground was hard and rocky. Power distribution lines were located about 830 ft northeast of the accident site; however, there was no damage to the power lines or poles. Figure 2 shows the location of the main wreckage, and the first point of probable impact (FPPI). The dashed white arrow indicates the estimated direction of travel.

Figure 2. Overhead image showing the main wreckage and the FPPI. Photograph courtesy of the Sheriff's Department.

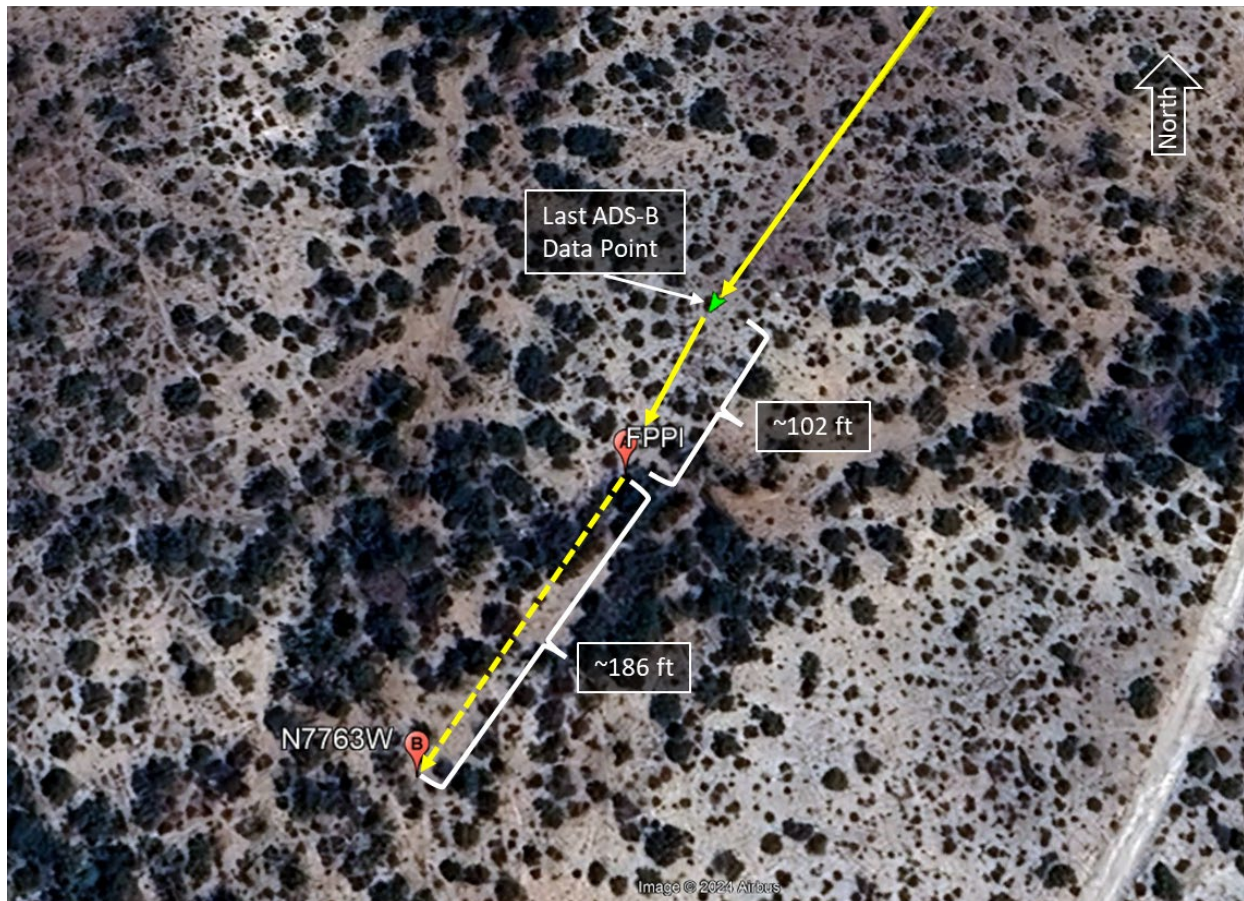
The airplane came to rest inverted at 31°22'47.40" N 101°0'5.44" W at an elevation of about 2,227 ft mean sea level (msl), on a heading of about 299° magnetic. Figure 3.

The last ADS-B data point recorded the airplane, about 2,200 ft msl or about 0 ft agl, about 288 ft northeast of the accident site.

Figure 3. Google Earth image showing the location of the last ADS-B data point, the FPPI, and the airplane wreckage.

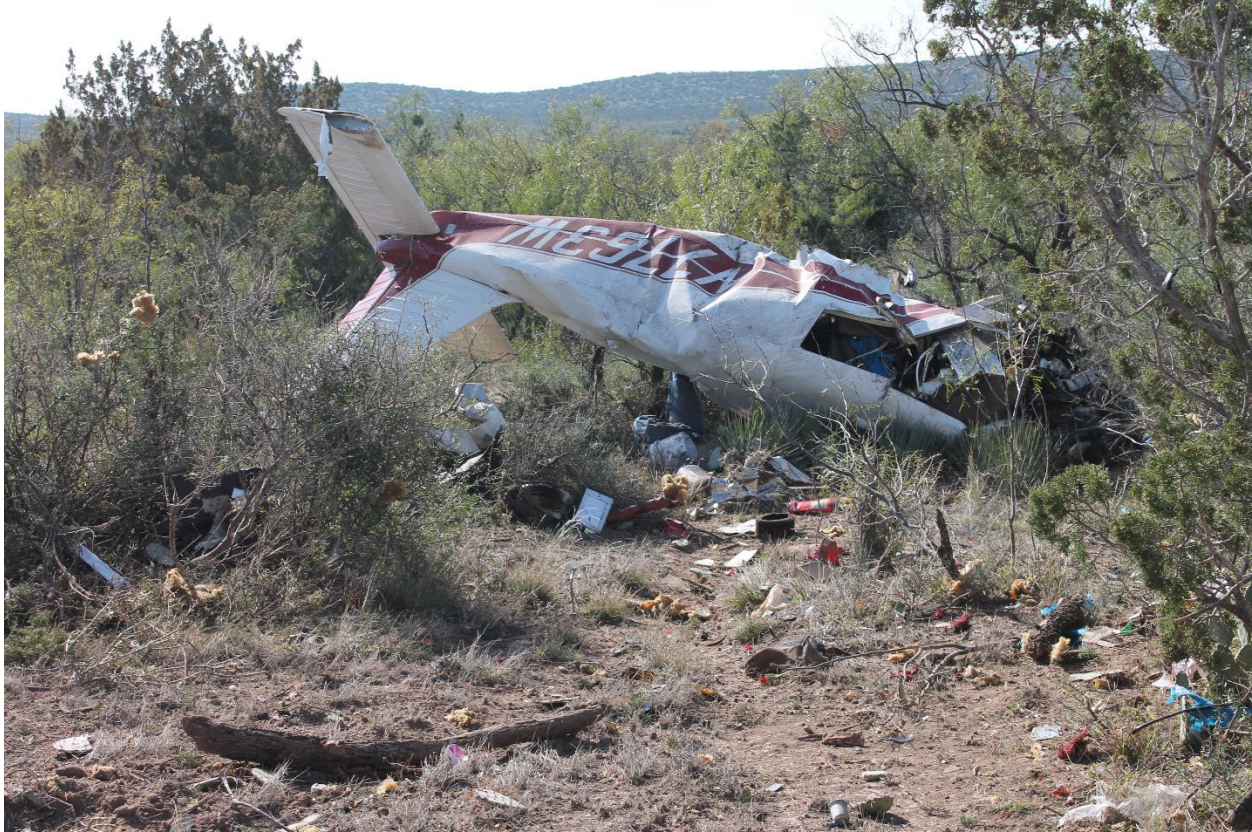
Figure 4. Image of the accident airplane.

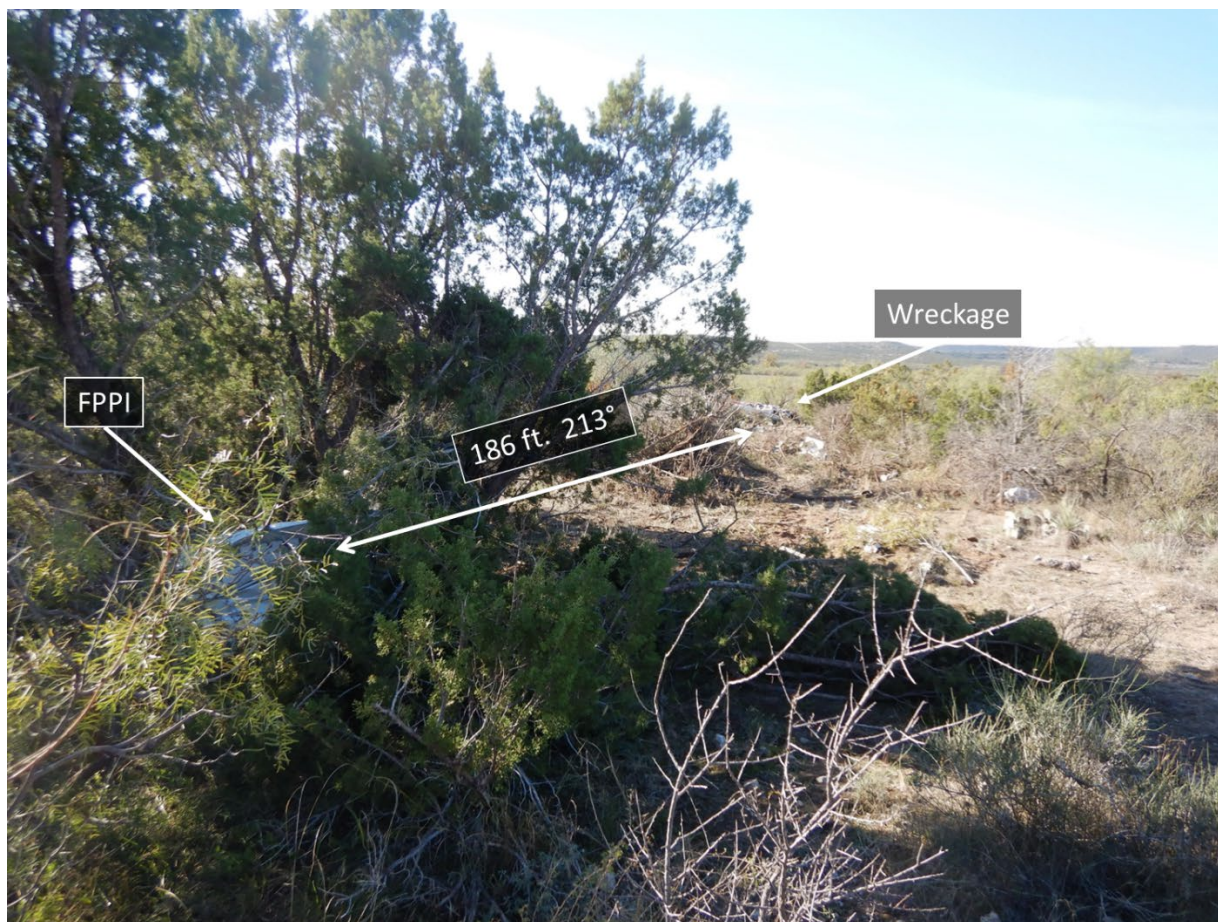
A line of disturbed vegetation extended back from the wreckage by about 186 ft on a bearing of about 033° magnetic (213° from FPPI to wreckage). Fragments of the airplane including the wings and propeller were strewn about the area. The FPPI was a scrub oak tree located at 31°22'48.93" N 101°0'4.25" W at an elevation of about 2,234 ft msl. A section of the left wing remained lodged in the scrub oak tree.

Figure 5. Image showing the FPPI and the wreckage in the background.
