# National Transportation Safety Board

WPR24FA040

## **AIRFRAME AND ENGINE EXAMINATION REPORT**

Location: Mertzson, Texas  
Date: November 25, 2023  
Time: 1835 Central Standard Time  
Airplane: Piper PA-28-180

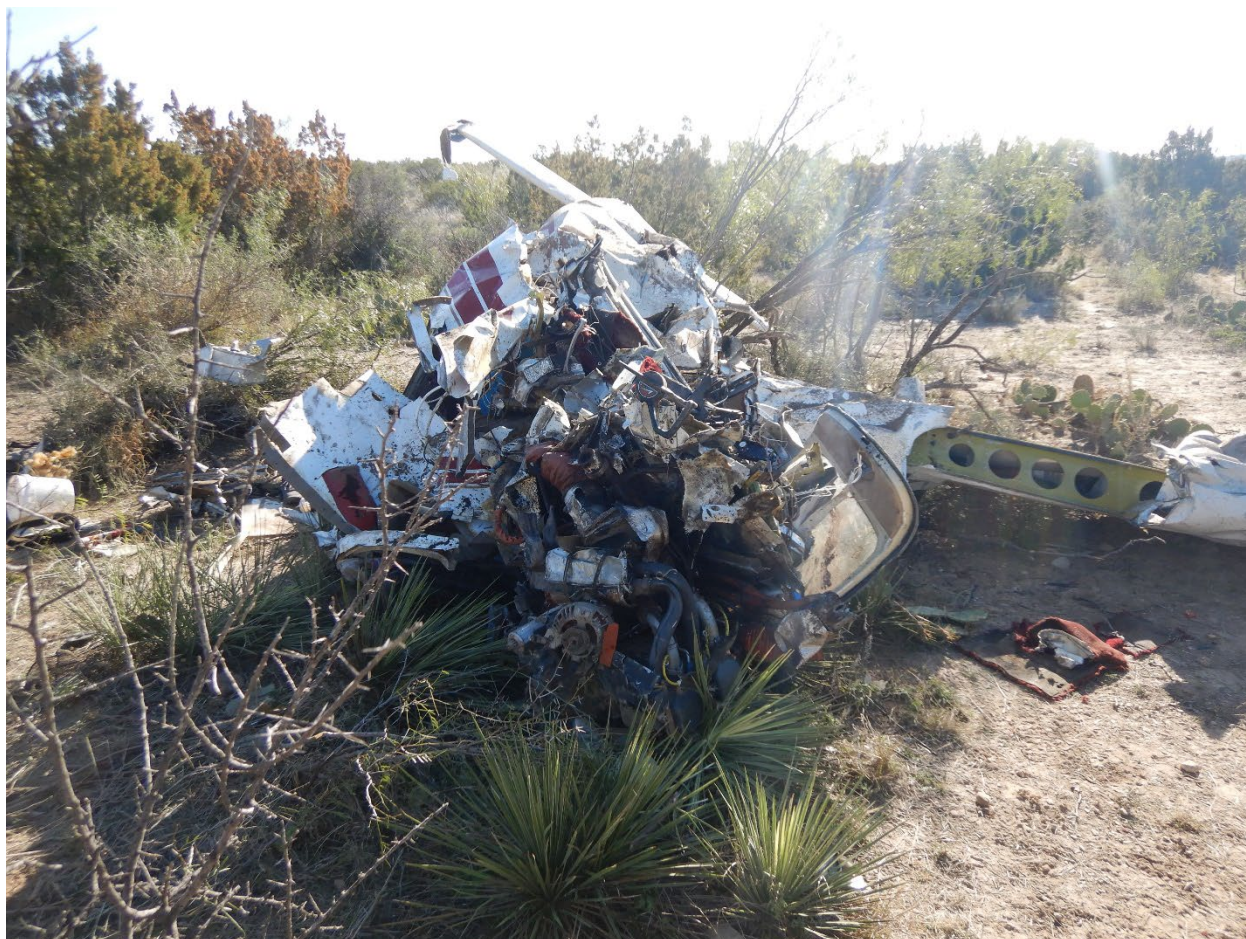
Figure 1. N7763W, Front view.

The engine cowling area was destroyed to the firewall. The right side of the fuselage exhibited aft crushing damage from the firewall to the empennage, with crushed sheet metal and supporting structures underneath the sheet metal. The right door had separated from the fuselage and remained latched. The top of the fuselage was crushed downward. The windscreen was shattered.

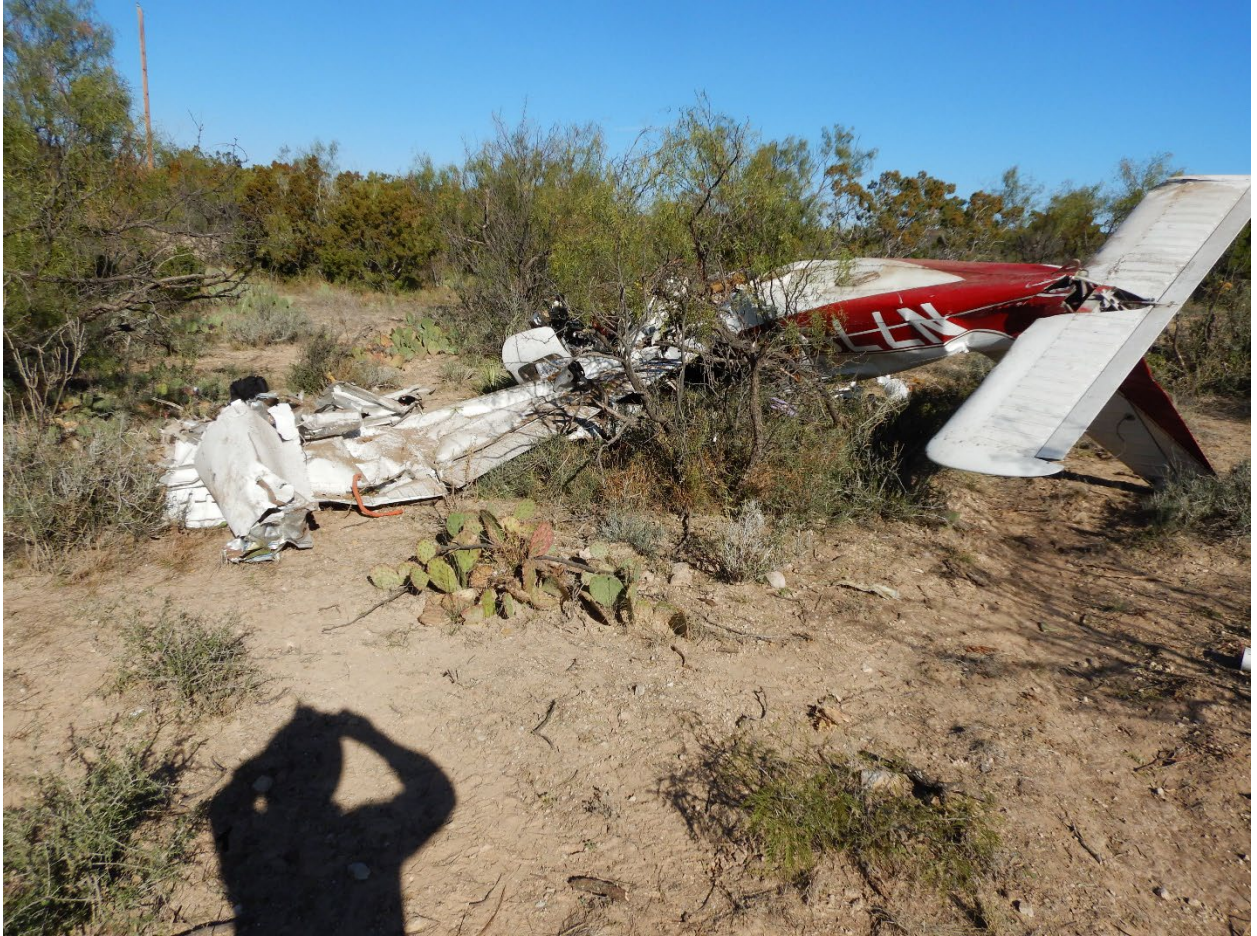
Figure 3. Empennage right-side view.

The empennage remained attached to the fuselage and exhibited minor damage to the stabilator and stabilator trim. The vertical stabilizer remained secured to the fuselage and exhibited minor damage. The rudder exhibited substantial damage with bending of the metal.

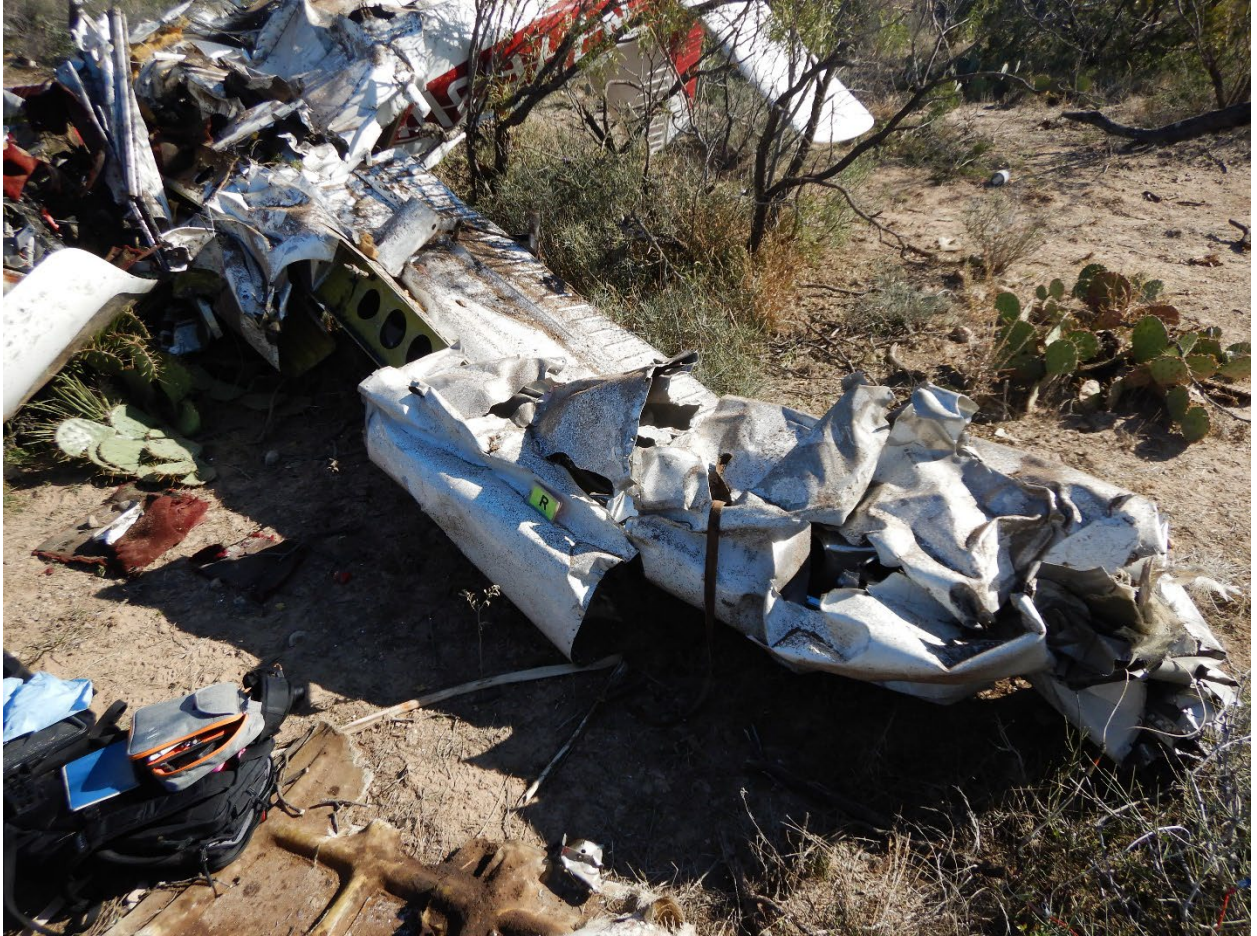
Figure 5. Right wing, underside view.

The right wing remained attached to the fuselage and exhibited aft crushing to the spar. The right flap remained secured at the hinges and exhibited substantial damage. The right flap remained attached to the wing, exhibited damage, and was positioned full up. The right-wing tip had been deposited in the debris field along with a long (about 5 ft) imprint of white paint transfer on rocks, consistent with the lower section of the right-wing contact. A section of the right wing, including the fuel tank area separated. The fuel cap remained secured and exhibited a good seal.

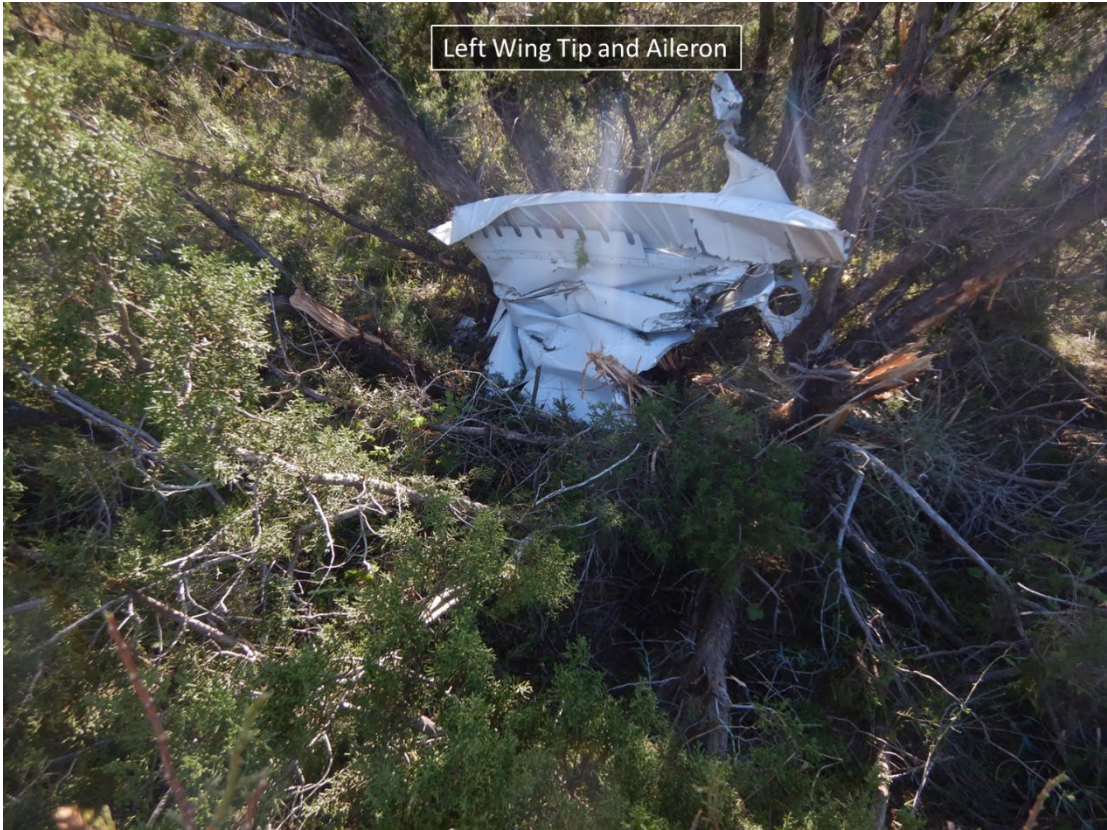
The left wing separated from the fuselage at the root and fractured into several sections. The wing tip and aileron were deposited at the first point of probable impact, a juniper tree. Two sections of mid-wing were deposited in the debris field and made up the remainder of the wing. The root section was substantially damaged, and the fuel tank was breached.

Figure 7. Left wing tip and aileron.

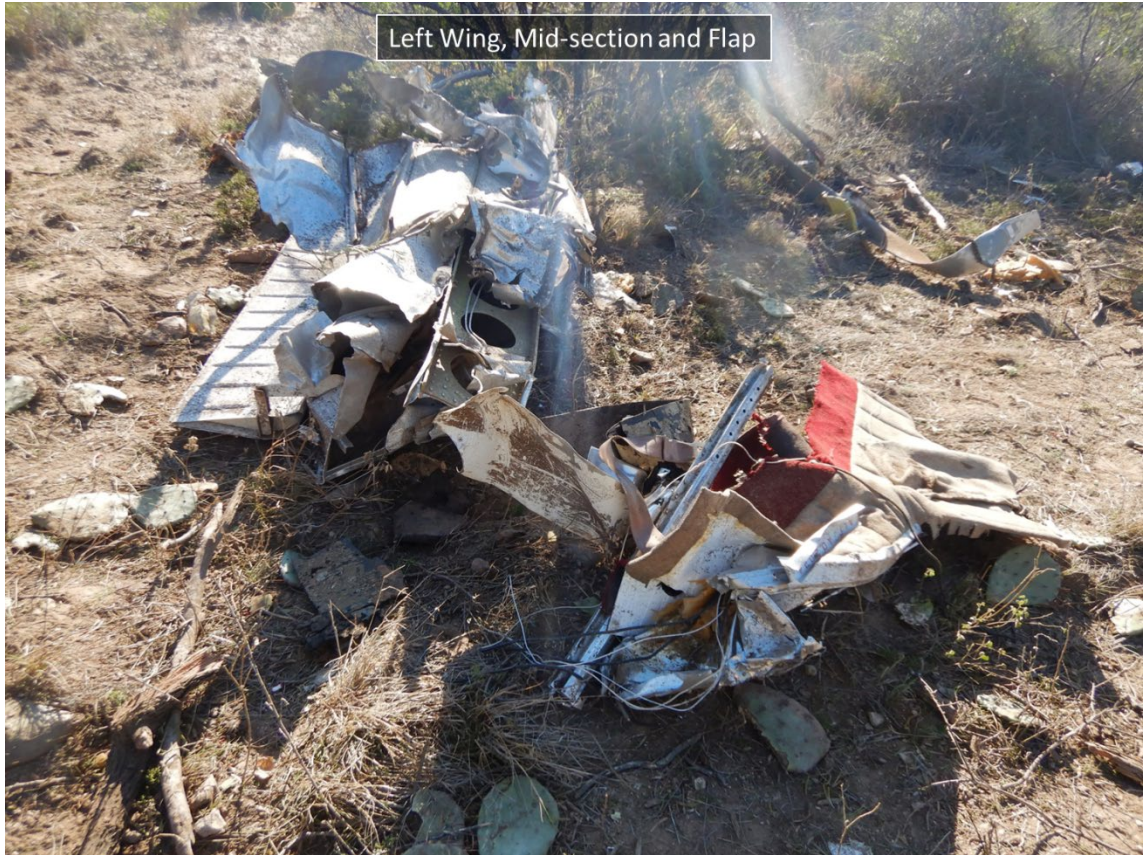
Figure 8. Left wing, root section and flap.

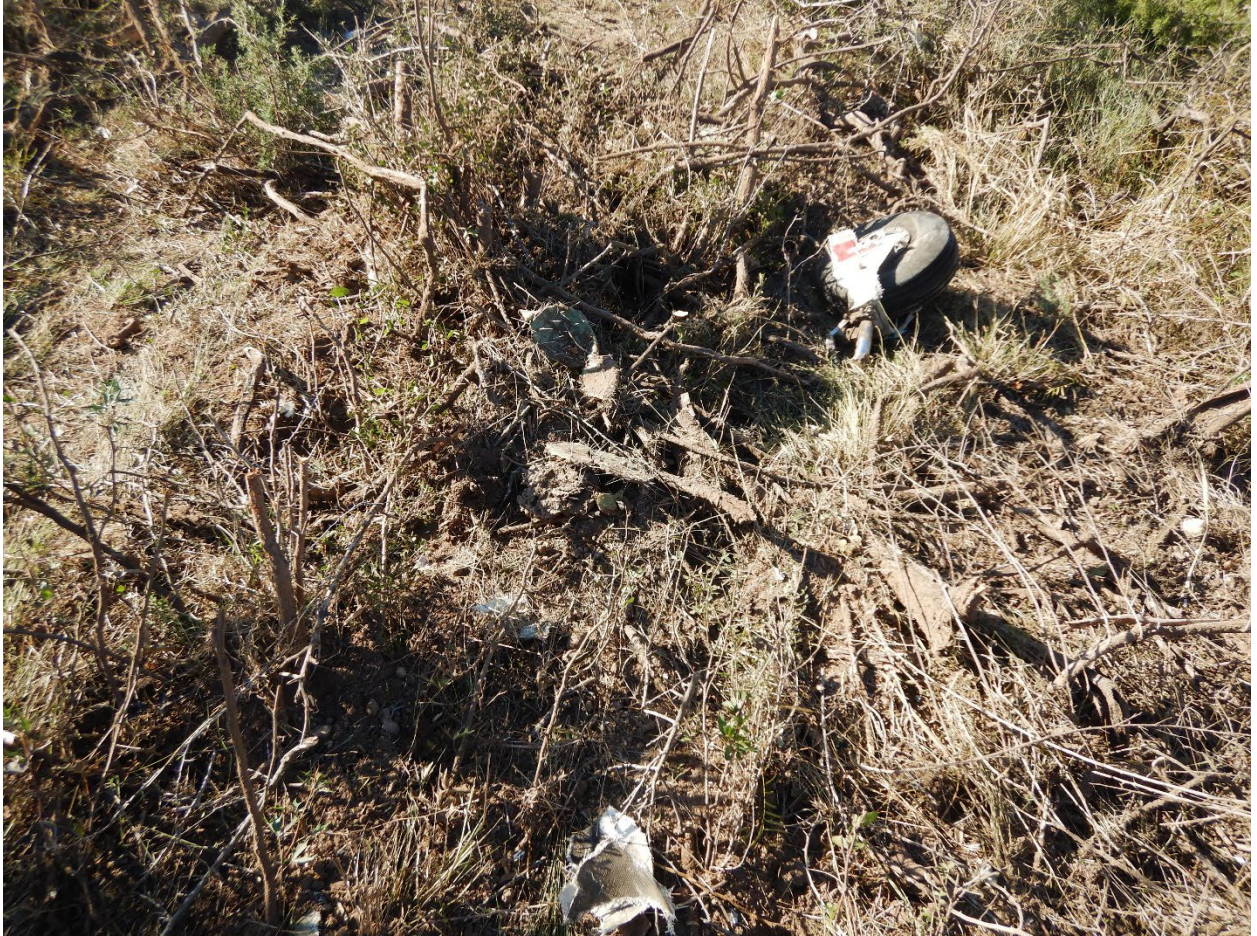
Figure 9. Nose wheel.

The nose gear separated from the lower fuselage at the oleo strut and was deposited in the debris area. The right main landing gear separated from the underside of the wing but remained attached via the brake line. The Left main landing gear separated from the underside of the left wing and was located near the wing root section. Both left and right wheel covers were in the debris area.

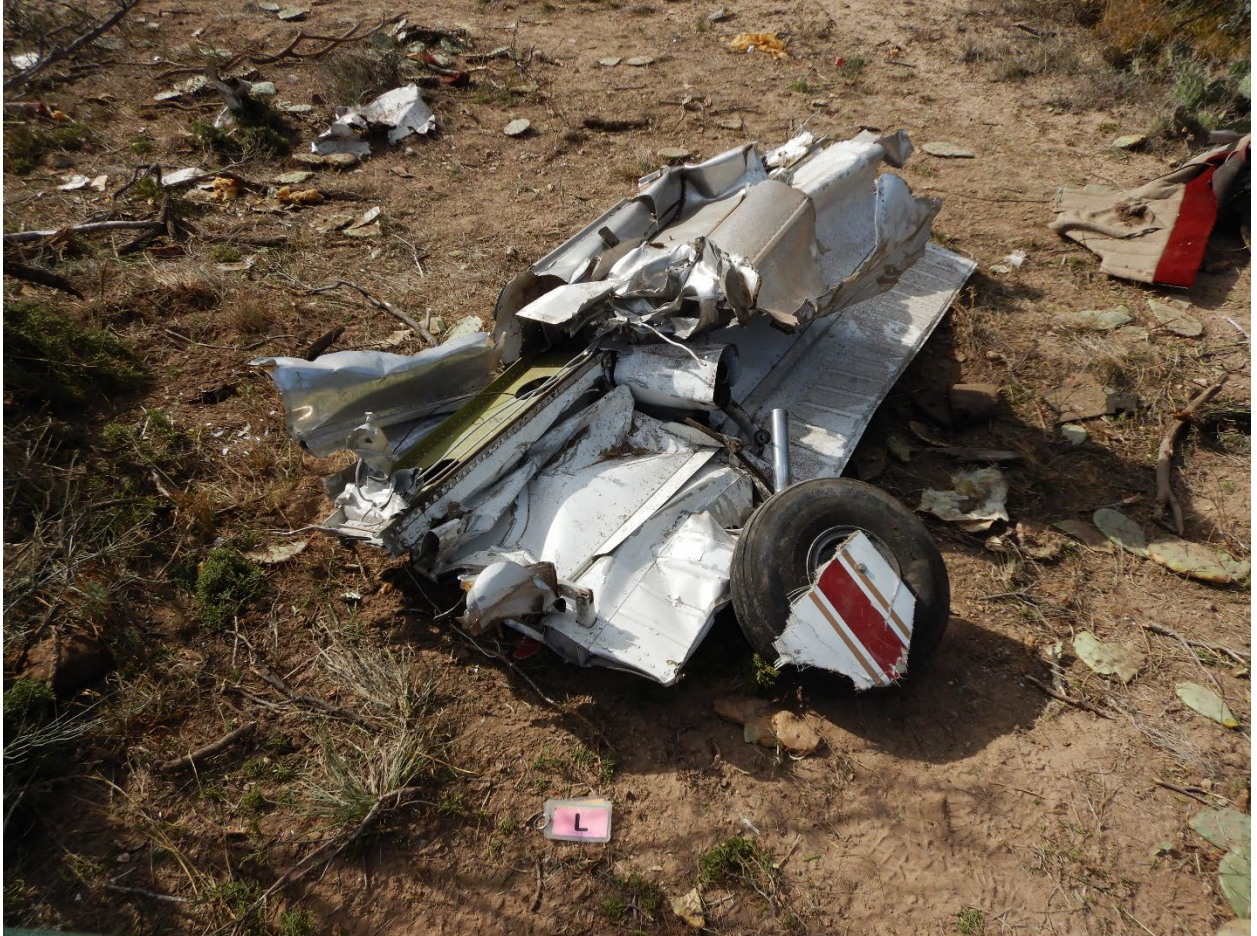
Figure 11. Left wing Root section, with flap and left main landing gear.

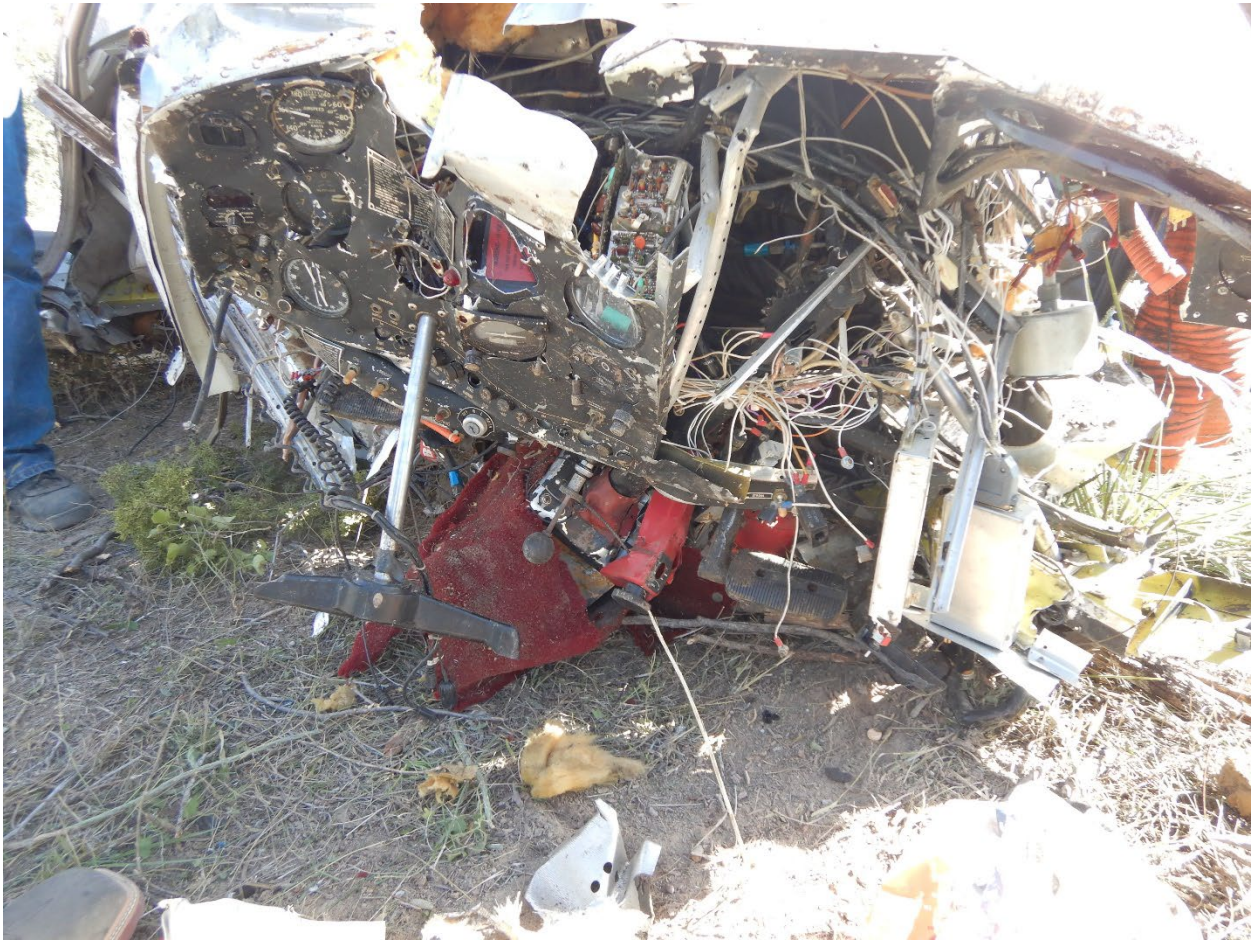
Figure 12. Instrument Panel.

The cockpit area was destroyed. Both pilot and front passenger seats were separated from their seat rails. One seat rail was deposited in an impact gouge in the ground. The instrument panel was fractured into several pieces. Many of the instruments were separated from the instrument panel.

Attitude Indicator: Left bank, about 60°, Nose low, about 9°. Instrument was separated from instrument panel.

Airspeed: 160 knots indicated

Tachometer: 1380 RPM: Hours: 3372.8X

Altimeter: 32,080 ft

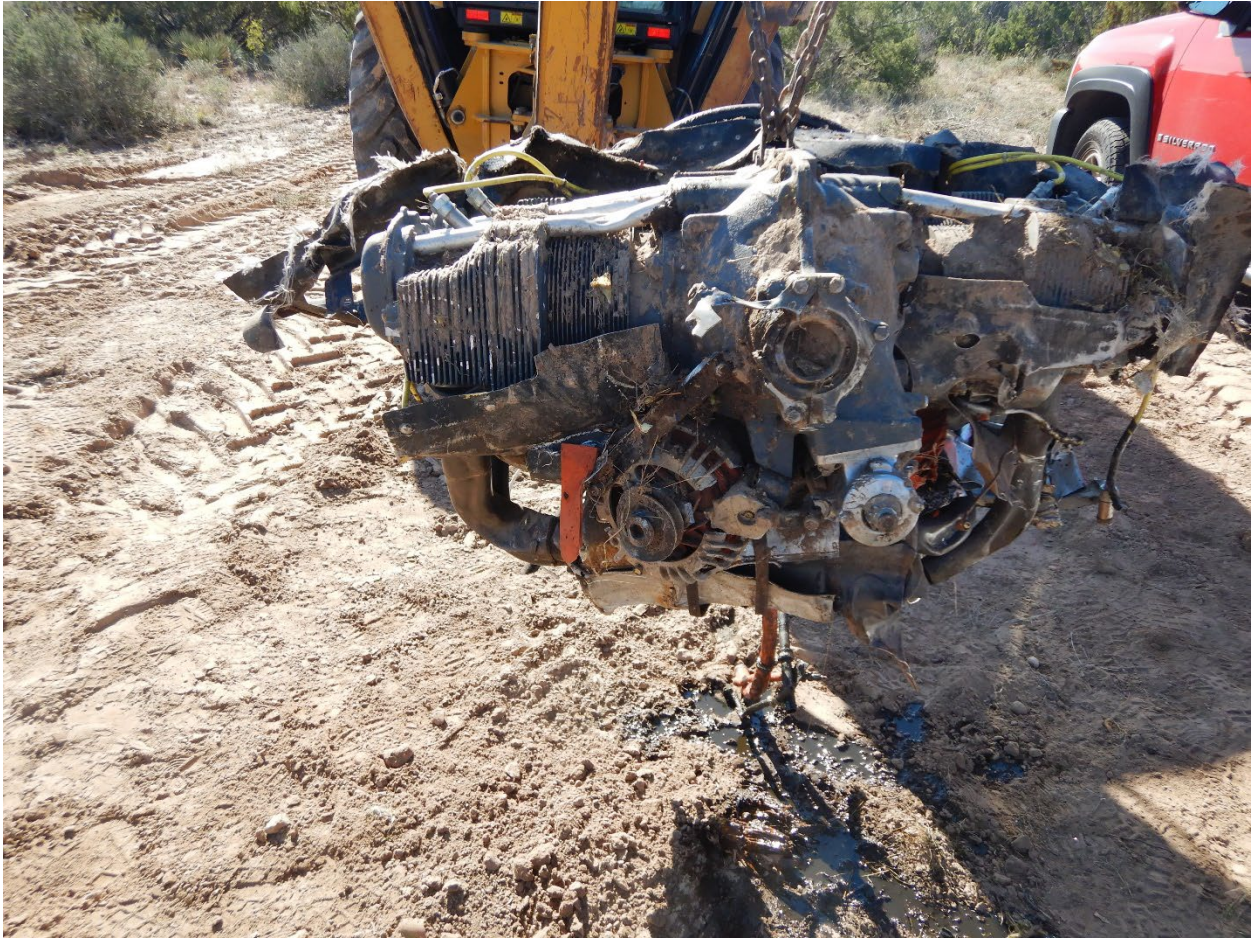
Figure 14. Engine, Front view.

The engine was examined by a Party Member from Lycoming Engines. The engine remained attached to the damaged firewall. The engine rotated and held compression at all four cylinders. The lower spark plugs were removed and exhibited normal electrode appearance when compared to the Champion Check-A-Plug chart. Valve-train continuity was confirmed. Both magnetos exhibited spark at all leads. The

starter ring gear was separated and prevented timing of the engine. The oil strainer was free of debris.

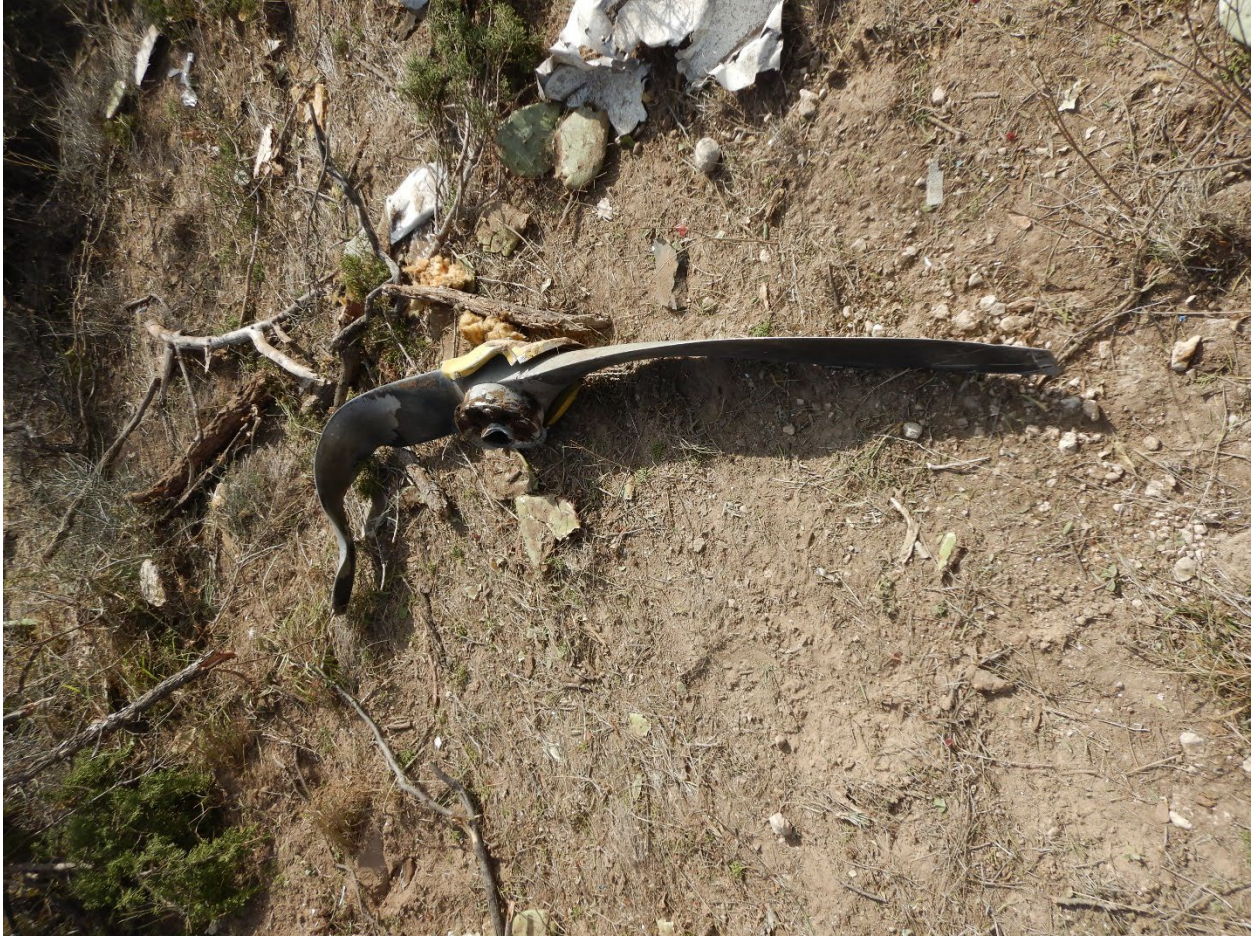
Figure 19. Propeller, rear view.

The two-bladed fixed pitch aluminum propeller separated from the engine at the propeller flange. One blade exhibited slight aft bending but remained generally straight. The tip exhibited red paint transfer, consistent with the red paint of the fuselage. This blade exhibited some spanwise scoring near the tip. The other blade exhibited a near-90° bend near the tip that extended inward about 12 inches. This blade exhibited chordwise scoring and S-bending.
