# National Transportation Safety Board

WPR24FA052

## **ACCIDENT SITE AND FOLLOW-UP WRECKAGE EXAMINATION SUMMARY REPORT**

Location: Taylor Airport (TYL), Taylor, Arizona  
Date: 12/06/2023  
Time: 0744 Local (Apple watch notification)  
Airplane: REMOS Aircraft GMBH, Remos GX (N449RA)

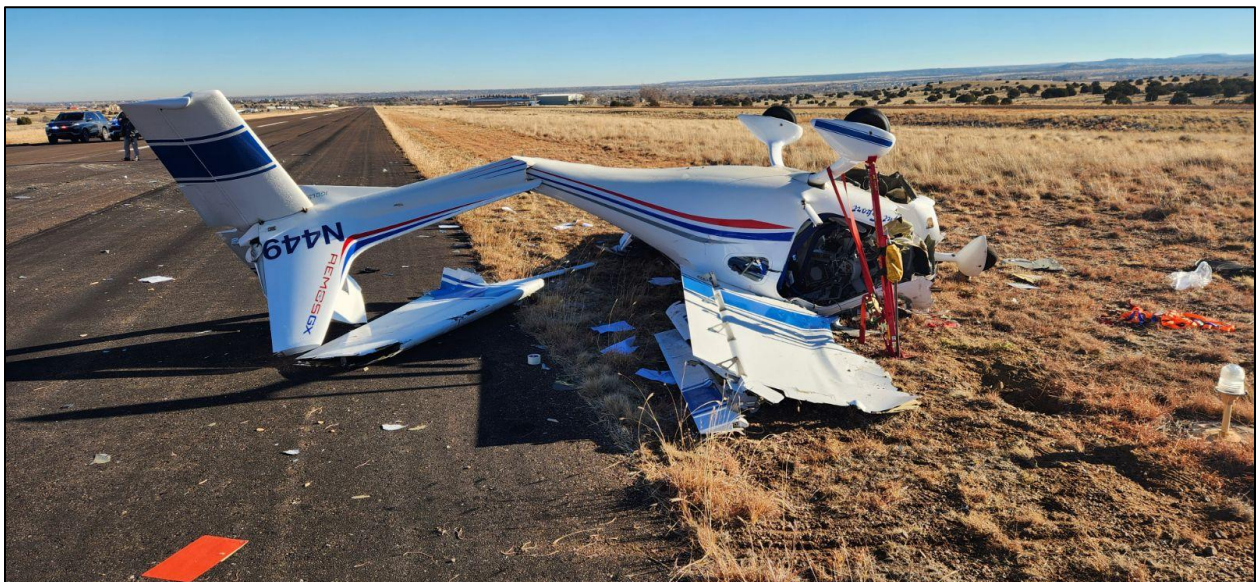
The airport manager took a photo of the inverted airplane about 20 minutes after the accident and the pilot has not been removed from the airplane cabin area. The photo shows a dark cabin area, and the damaged tail section shows frost on the upper surface of the horizontal stabilizers that are facing downward.

Figure 1-Accident site, photo taken minutes after the accident. (Courtesy of the Airport Manager)

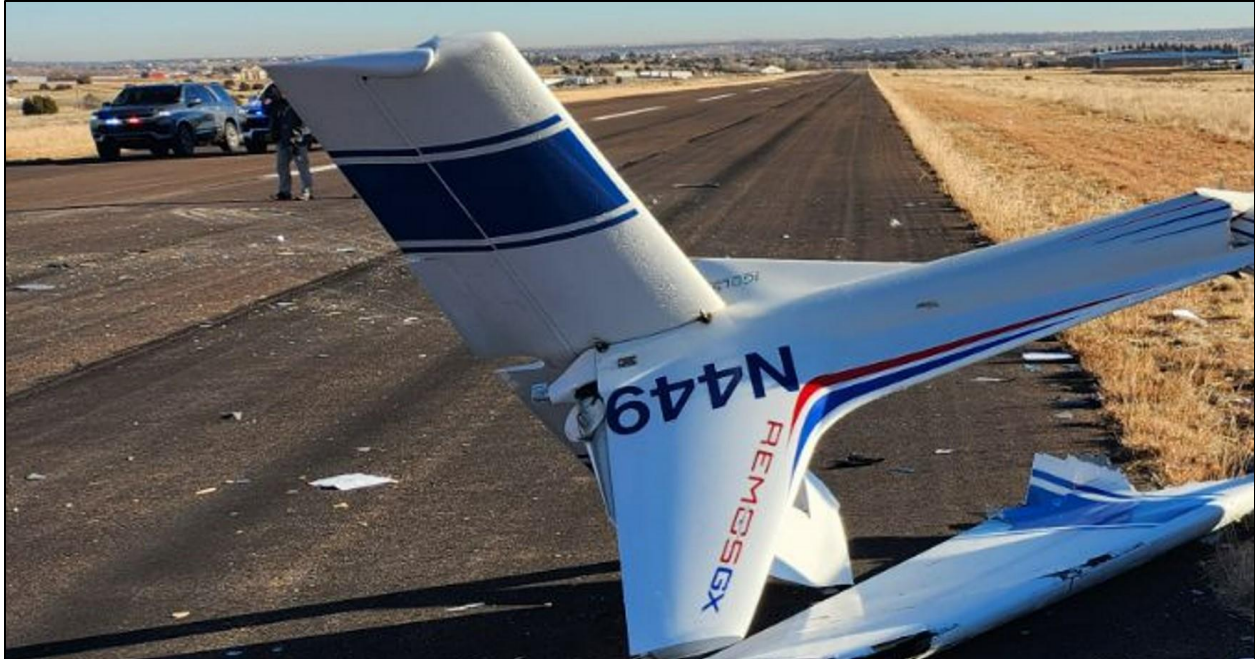
Figure 2-Accident site, photo zoomed in to show frost covering the top side of the horizontal stabilizers. (Courtesy of the Airport Manager)

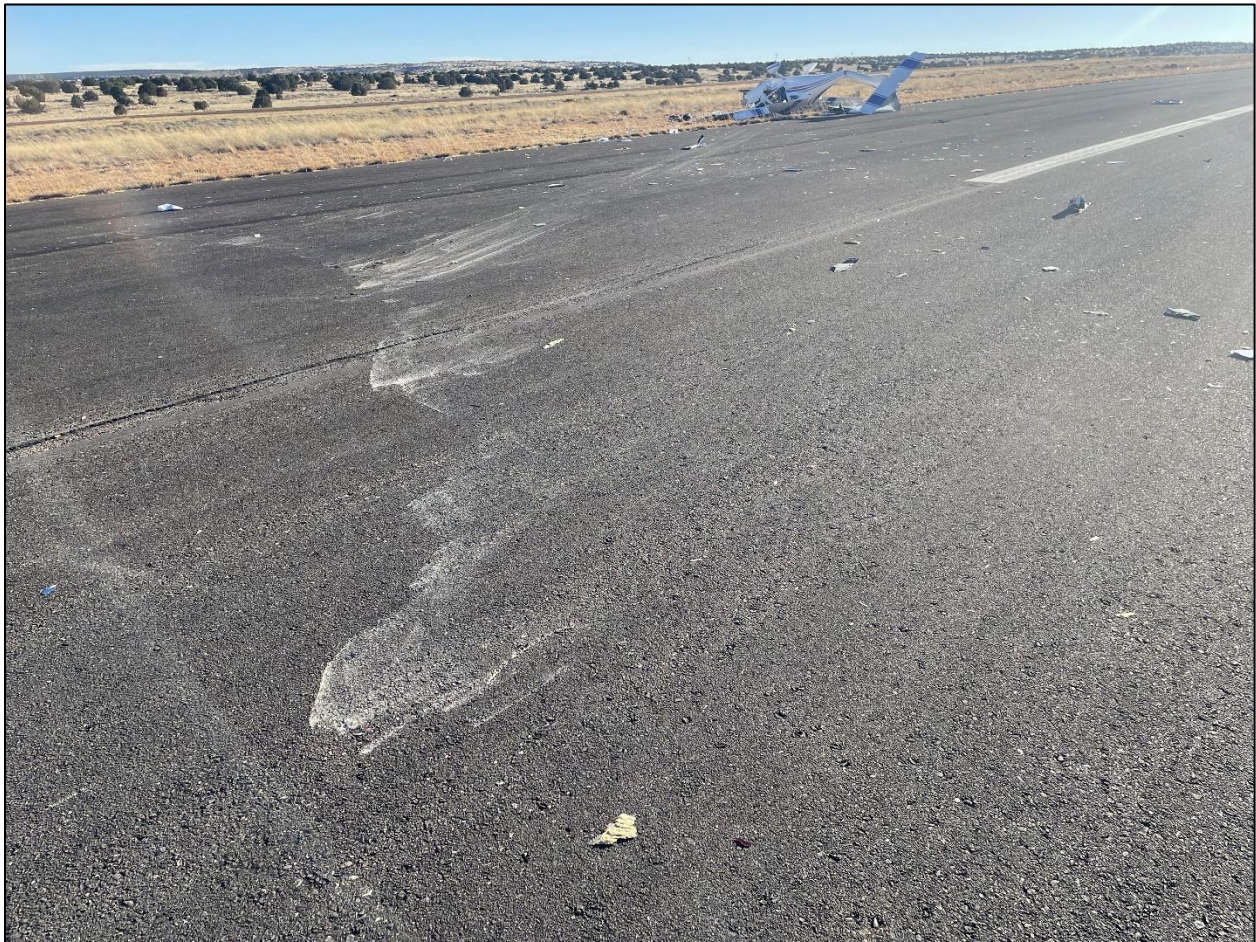
The white transfer marks were spread along diagonally about 40 ft on the left side of the runway. In the middle of the white transfer marks were 3 propeller strike marks and a propeller hub mark in the runway surface. A propeller blade was found on the left side of the debris field near the left side of the white transfer marks. The propeller blade separated from the hub near the shank end and had missing material near the blade tip. The debris field continued for another 110 ft, which contained broken plexiglass and carbon fiber material. The left wing tip fairing was found on the

right side of the debris field about 30 ft from the FIPC. Red plexiglass shards were found near the fairing. The green plexiglass was found along the left side of the debris field. The outboard section of the right aileron was found about 60 ft into the debris field. The left entry door separated and was found on the right side of the debris field. The right entry door separated and was found off the left side of the runway. Both doors were found in the locked position and both locking pins were in the engaged position.

Figure 4-Accident site, first identified point of contact with the runway.

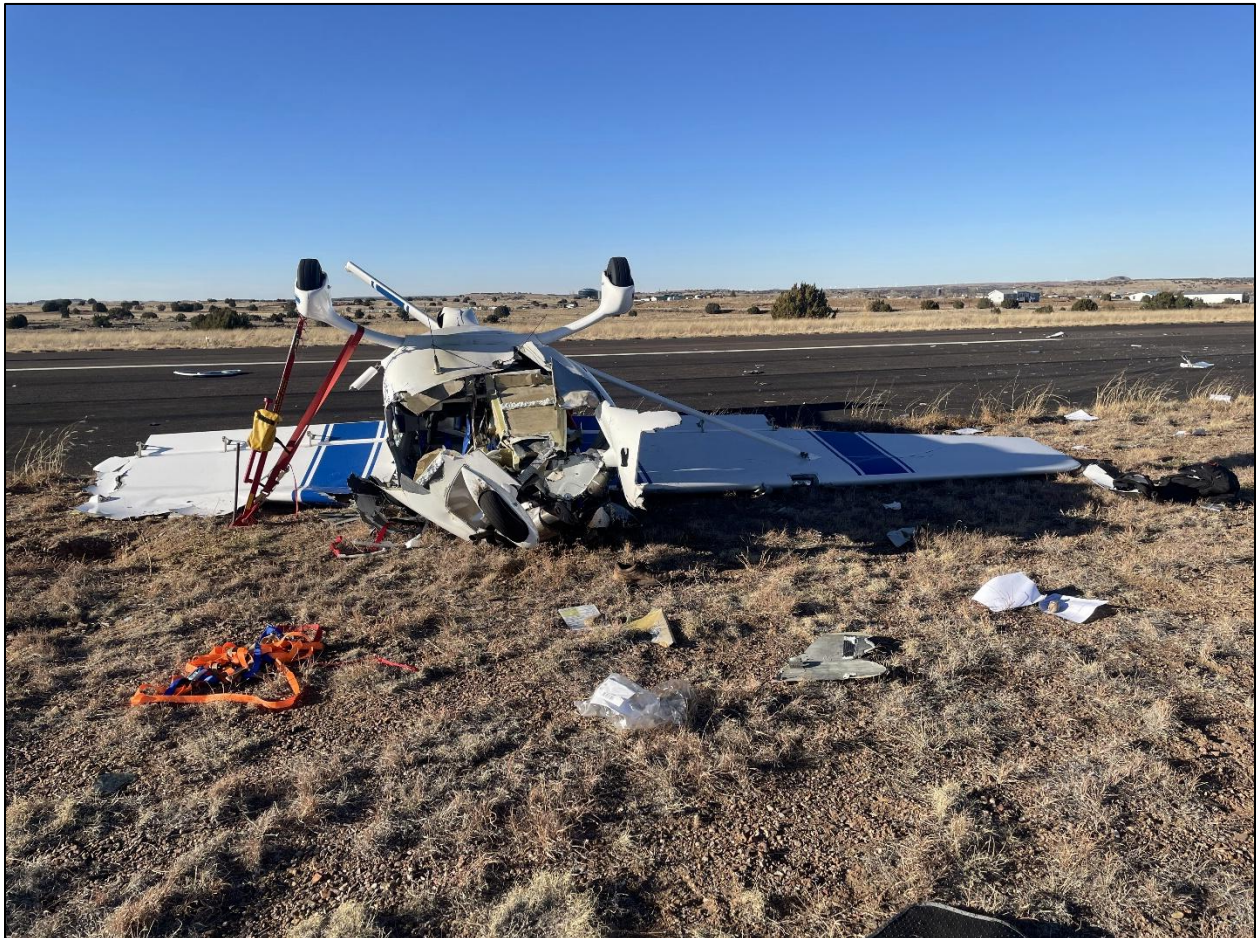
The main wreckage was found inverted with impact damage to the fuselage and wings. The main landing gear was undamaged, and the nose landing gear was bent downward with impact damage to its supporting structure. The empennage was damaged forward of the empennage and twisted to the right. The rudder had impact damage and was partially separated. The left outboard wing and side strut separated and was found near the empennage. The left aileron had impact damage and remained connected to its control rod. The left flap remained attached to the wing and appeared to be in the up position. The right wing remained mostly intact with impact damage to the aileron and wingtip fairing. The forward fuselage structure was cut by first responders to facilitate the removal of the pilot. During the recovery

The right seat control stick boot area had a tight wad of tie down straps wedged between the control stick and the side of the boot. The control stick was found in the [aileron up, elevator up position] aft left position. The wad was removed and the control stick moved freely by hand. The control stick linkage located in the lower fuselage felt broken and loose when operated by hand.

The engine and propeller remained partially attached with excessive impact damage.

Figure 5-Accident site, main wreckage.

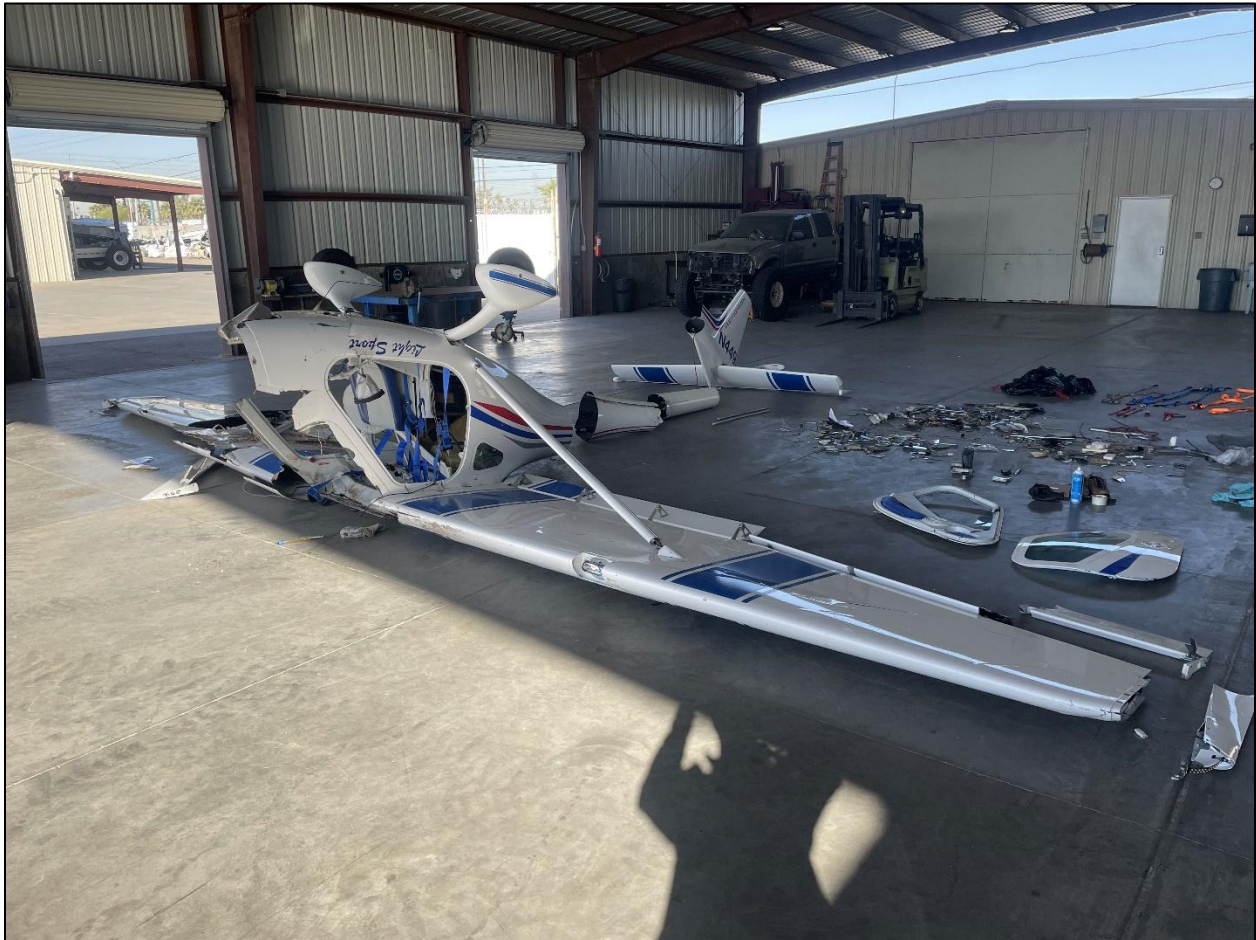
The wreckage was transported to Air Transport in Phoenix, Arizona, where an examination of the wreckage was conducted on December 8, 2023. The empennage was cut in multiple areas by the recovery crew to facilitate its transport. The rudder cables were cut during this process. The wreckage was displayed on the examination floor.

Figure 6-Wreckage examination, main wreckage layout.

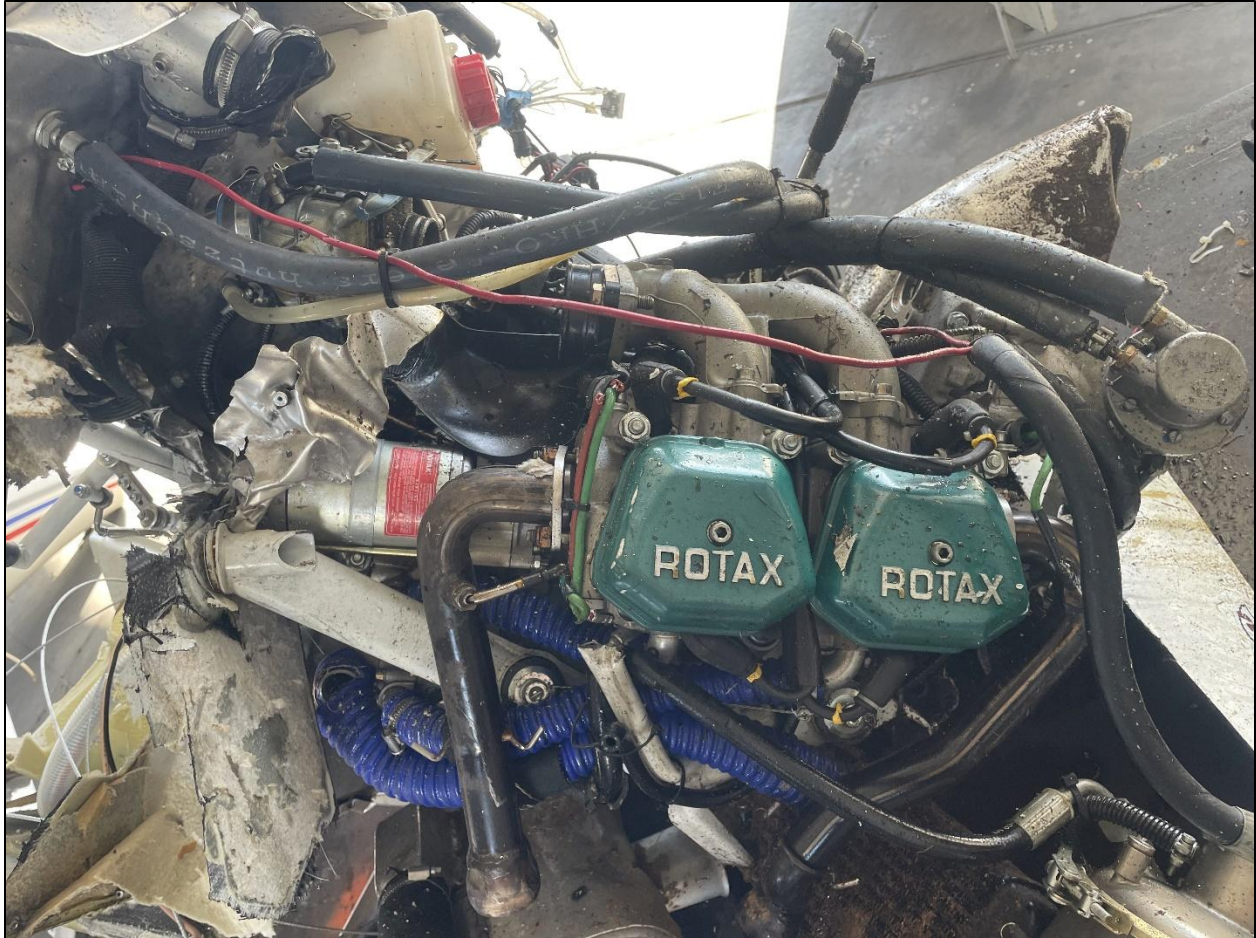
The engine, firewall, nose landing gear, rudder pedals and linkage, and instrument panel remained intact. The engine had impact damage to the left cylinder bank. Multiple lines, tubes and cables had impact damage. The propeller assembly including one blade had impact damage and remained attached to a portion of the reduction gear shaft. The propeller and the reduction gear shaft separated from the engine. An NVM instrument was removed in an attempt to download. No accident flight data was recovered from the instrument. Engine control cables remained intact.

Figure 7-Wreckage examination, engine and firewall.

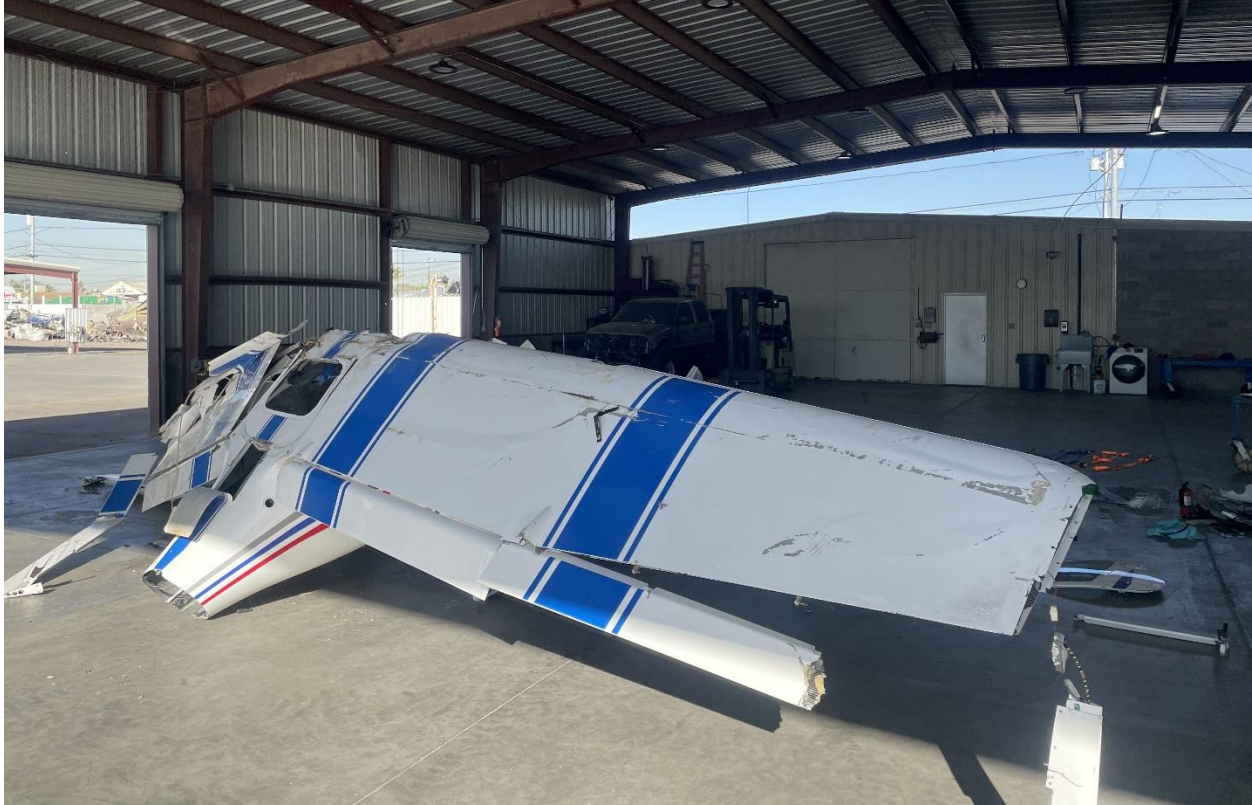
The right wing and side strut remained attached to the fuselage. The top side of the leading edge of the wing had crush damage. The wing tip fairing separated and was found in the debris field. The aileron outboard 1/3 separated at the linkage and was found in the debris field.

Figure 8-Wreckage examination, airplane positioned upright.

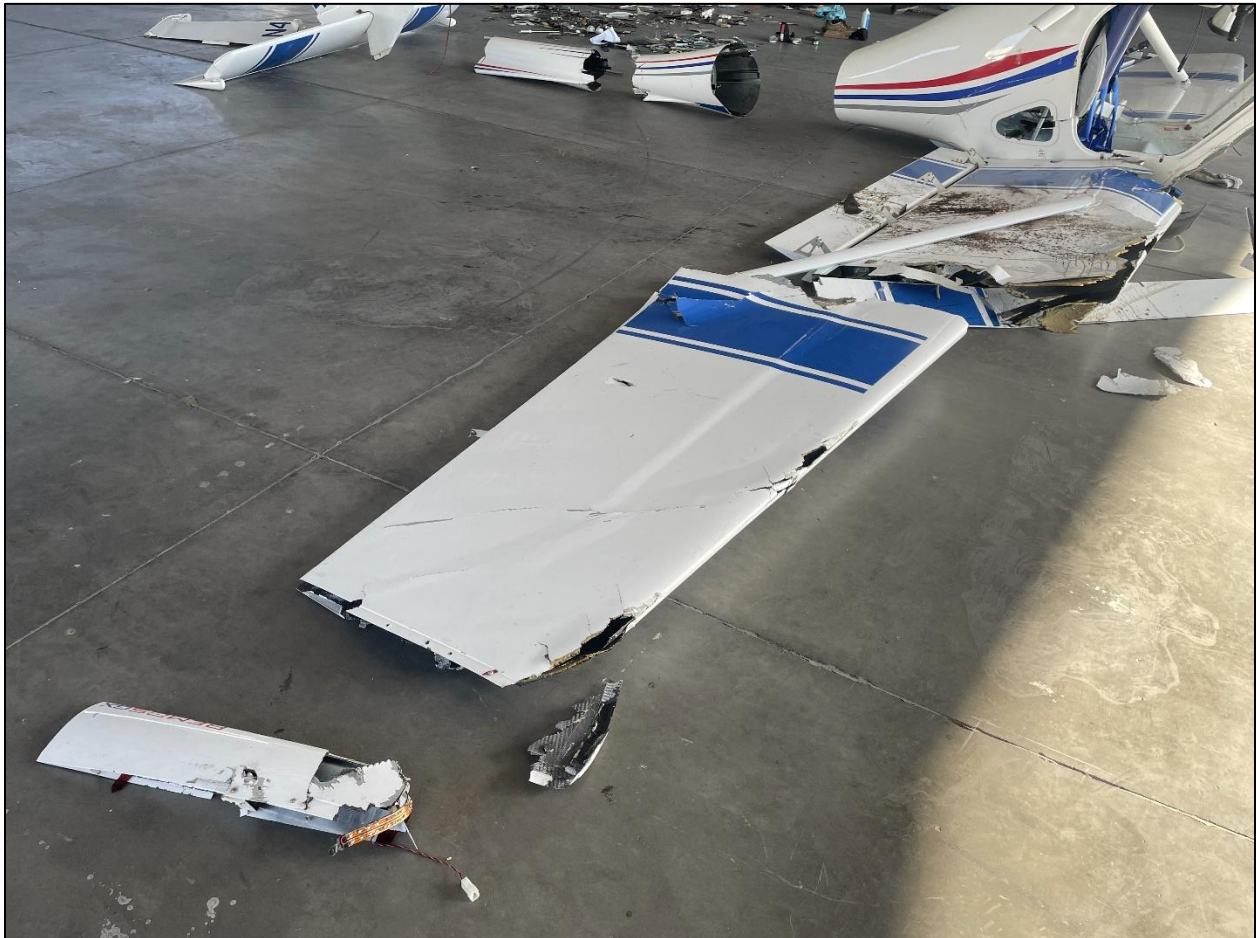
The left wing was found in multiple sections. The outboard section of the wing separated near the wing strut attachment. The side strut remained attached to the damaged spar and separated near the fuselage attachment. The top side of the leading edge of the wing had crush damage. The aileron separated from its wing attachments and remained attached to the aileron control tube and linkage. The wing tip fairing separated and was found in the debris field.

Figure 9-Wreckage examination, left wing.
