# National Transportation Safety Board

WPR24FA053

## COMPUTED TOMOGRAPHY

Specialist's Factual Report

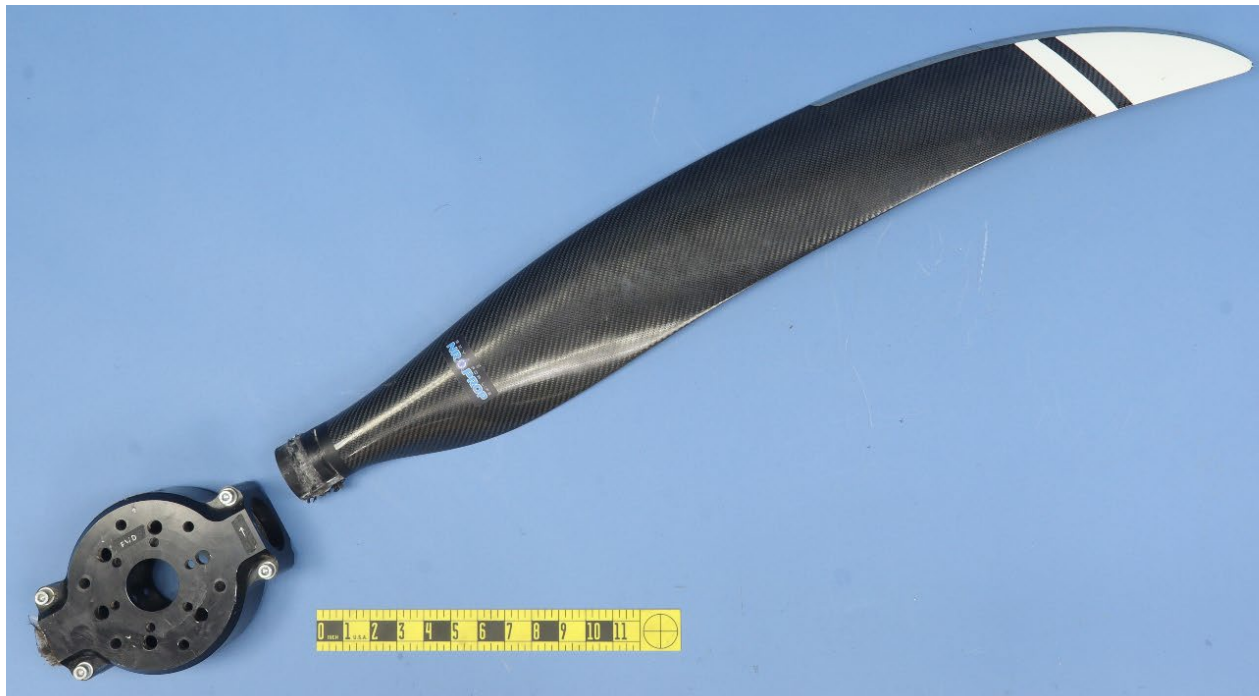
A single intact propeller blade (see figure 1) along with assorted items of cabin contents, an iPad, and clear plexiglass fragments were located about ½ mile north of the accident site, underneath the airplanes flight path. All remaining airframe primary structure, flight control surfaces, and engine components along with the second propeller blade, which had detached on impact, were accounted for in the main wreckage. The propeller hub remained attached to the engine crankshaft.

**Figure 1.** Photo of the accident propeller blade (one found ½ mile from accident site) and the propeller hub.

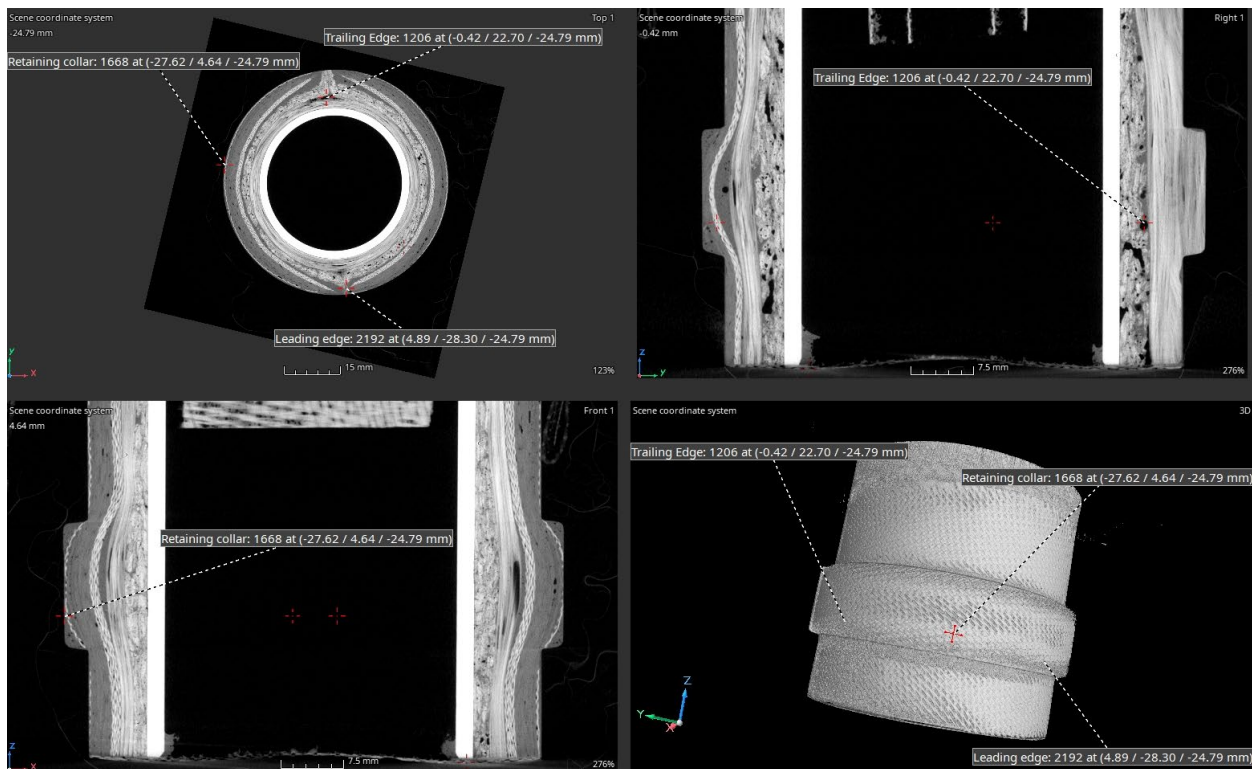
- 1) The retaining collar is present (see figures 3 and 4).
- 2) The serial number (SN) of the exemplar propeller was 6409 (see figure 5).
- 3) The root area of the exemplar propeller blade consists of the following cross section: 1) an aluminum (AL) insert; 2) layers of unidirectional carbon wrapped circularly (circ) around the insert; 3) layers of unidirectional carbon and glass oriented longitudinally (long) along the blade; 4) layers of woven glass; and 5) layers of carbon fiber. (See figure 6)

**Figure 3.** CT images of the exemplar propeller blade root area - overview.

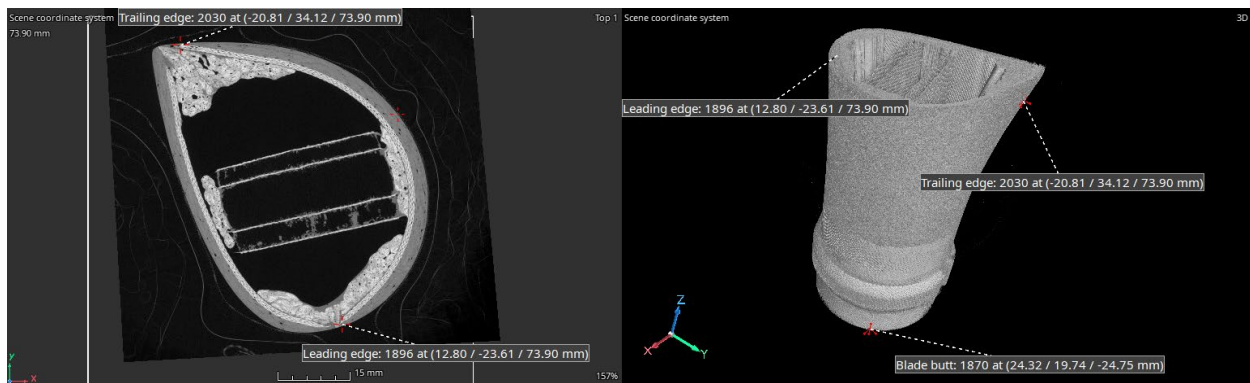
**Figure 4.** CT images of the exemplar propeller blade root - showing the leading and trailing edges.

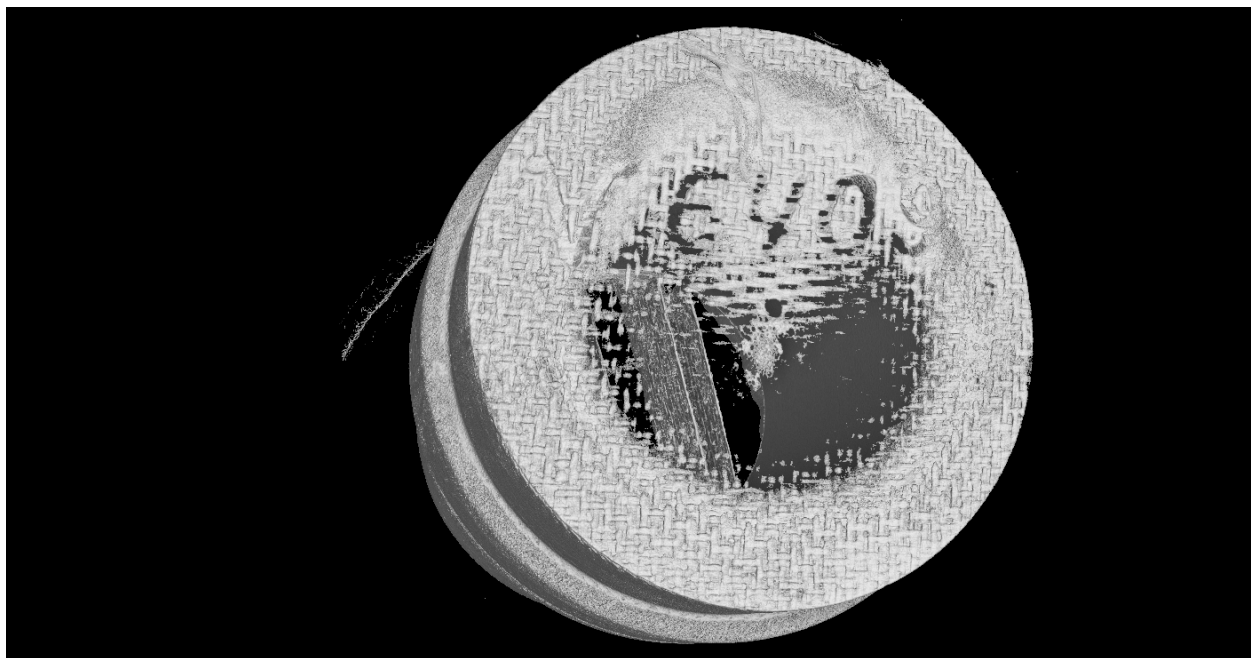
**Figure 5.** CT image of the exemplar propeller blade root showing SN 6409 at the blade butt.

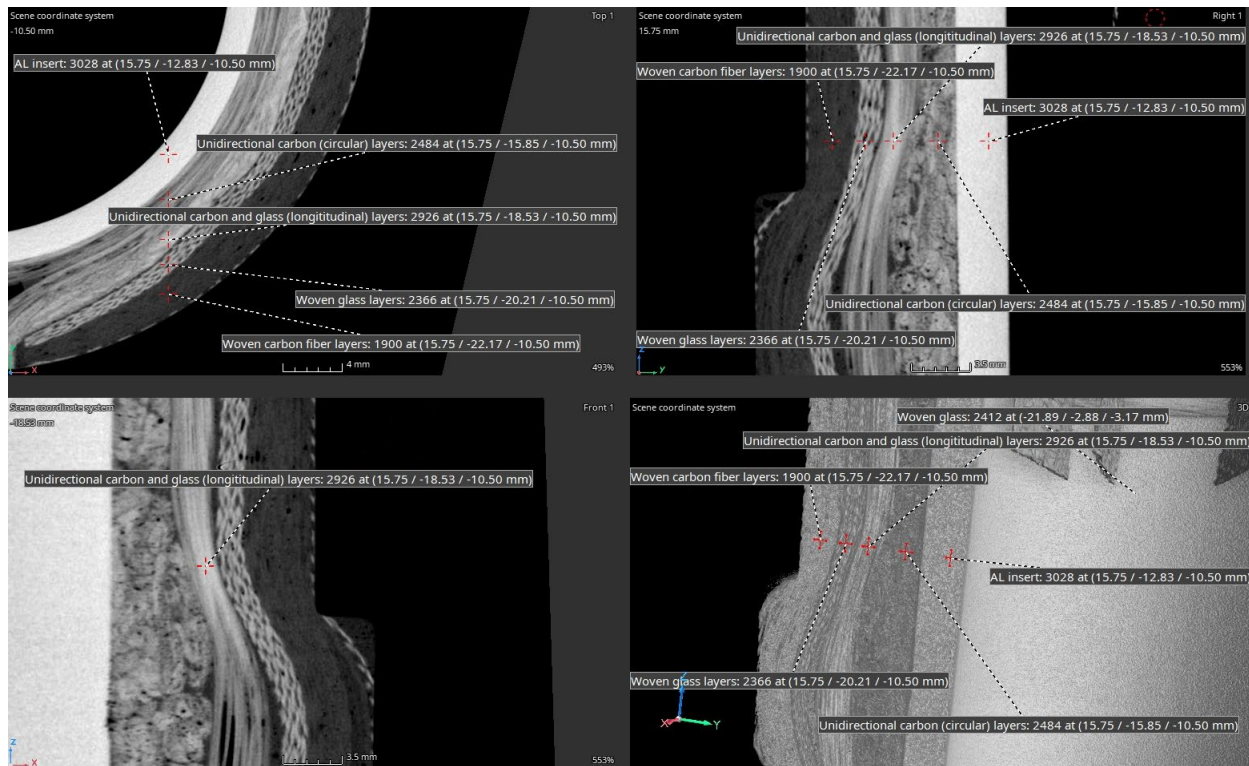
**Figure 6.** CT images of the exemplar propeller blade root - cross section.

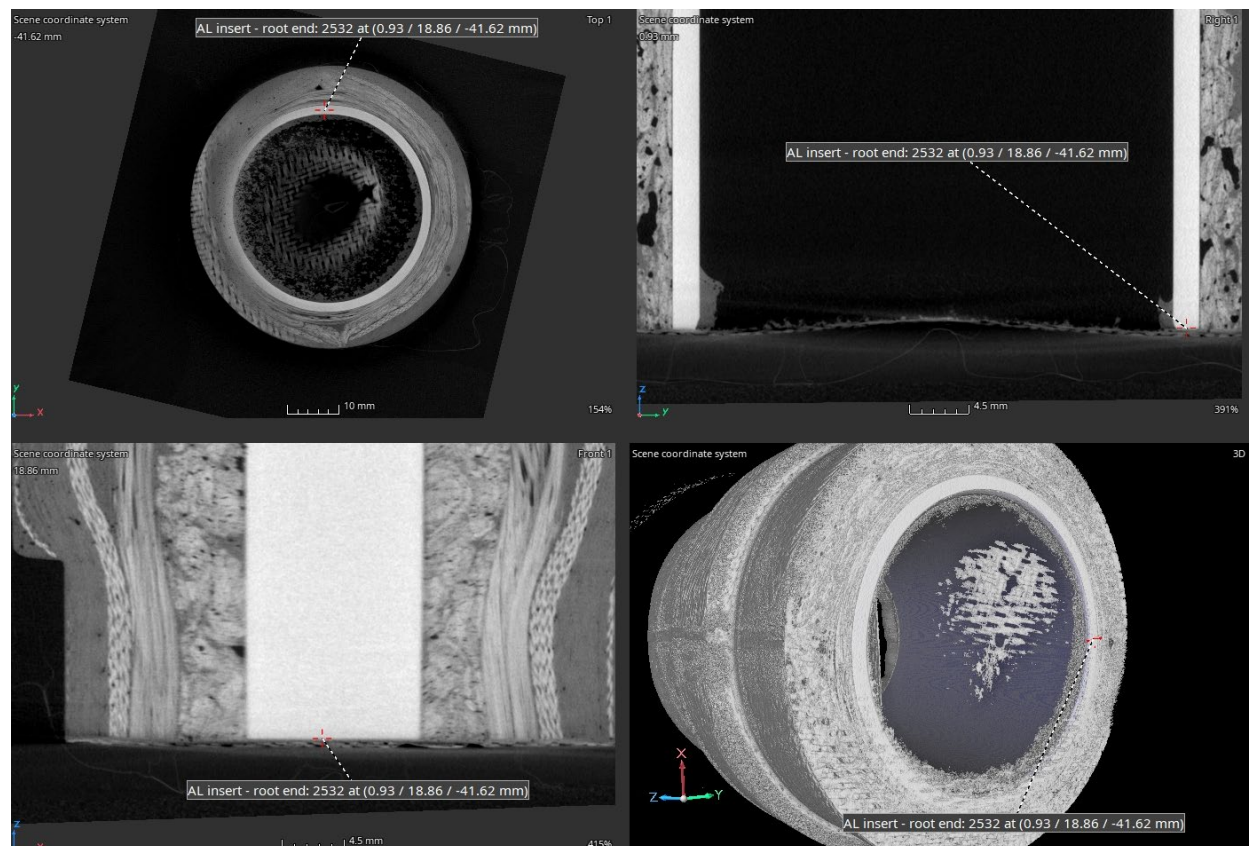
- 4) The aluminum insert starts at the root area of the propeller blade and is just under a layer of carbon fiber (see figure 7). On the exemplar blade, the top of the aluminum insert was approximately 3 - 4 mm below the cross support (see figures 8 and 9).

**Figure 7.** CT images of the exemplar propeller blade root - showing aluminum insert.

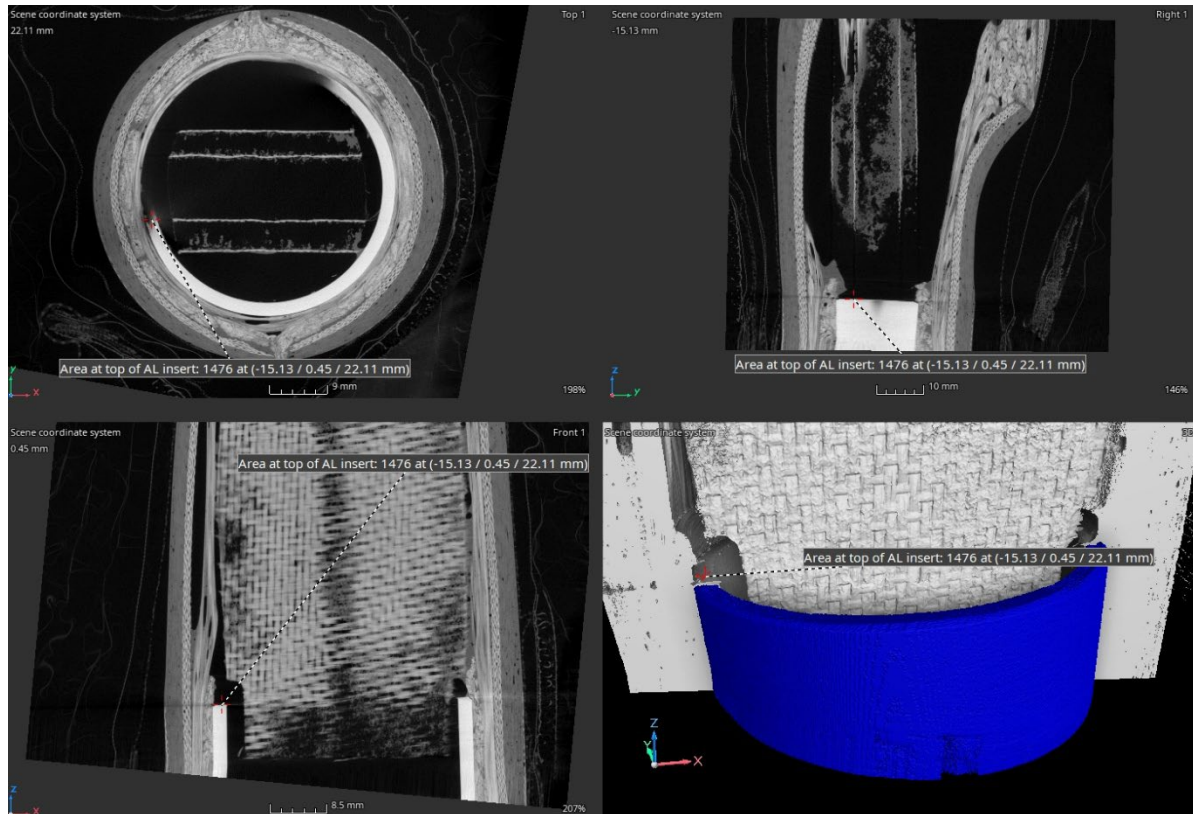
**Figure 8.** CT images of the exemplar propeller blade root - aluminum insert inside blade.

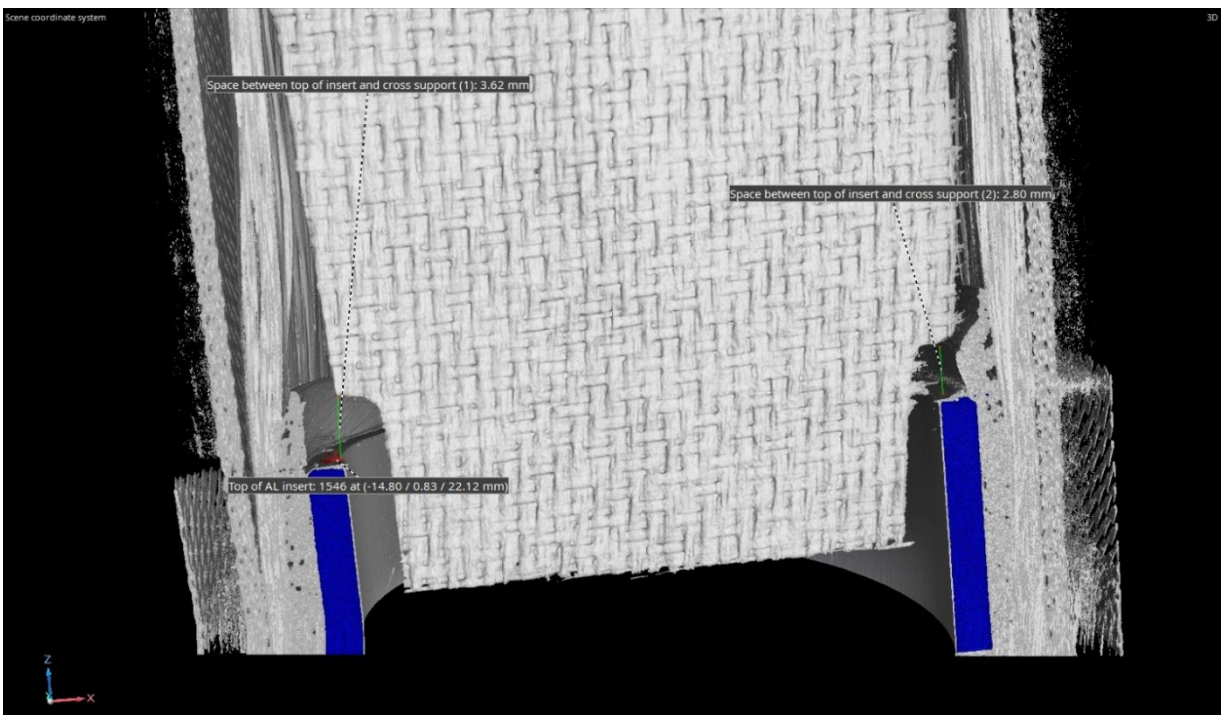
**Figure 9.** CT image of the exemplar propeller blade root - aluminum insert inside blade showing the gap between the cross support and the top of the insert.

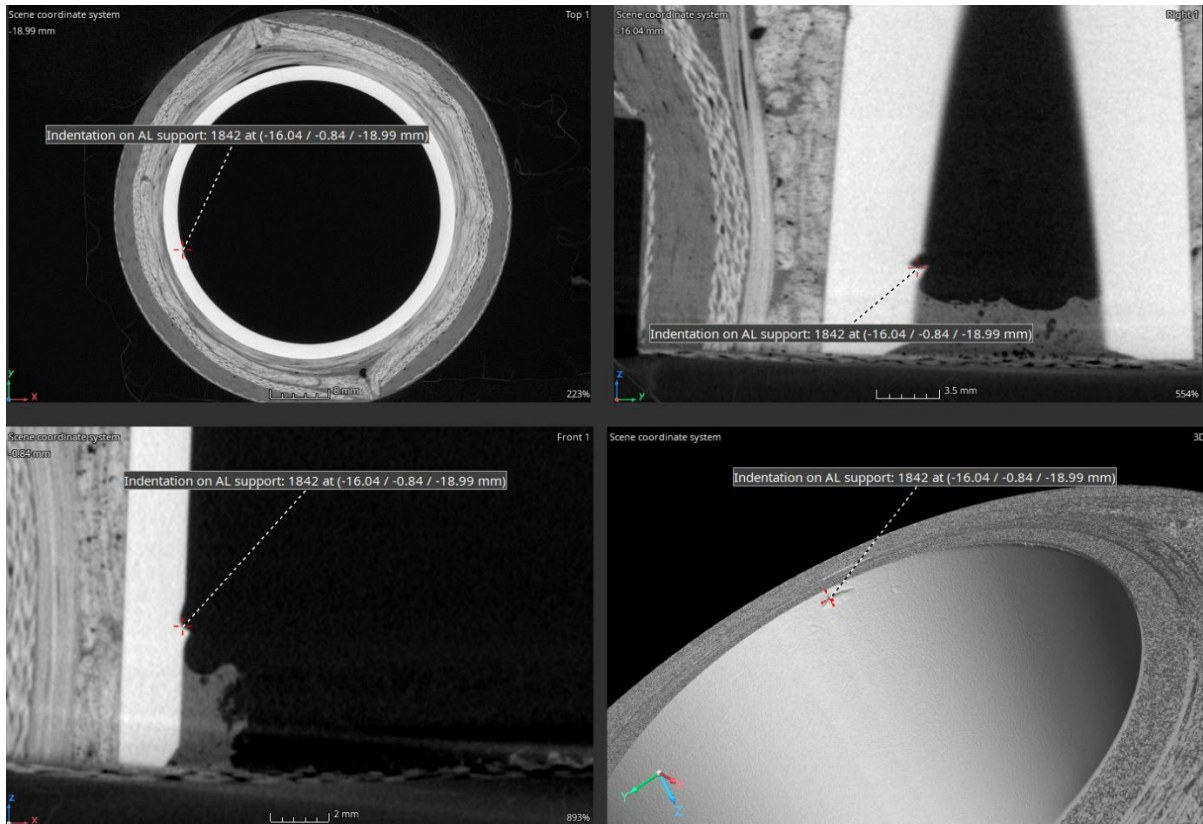
- 5) There was an indentation on the aluminum insert.
- 6) Several ring artifacts were observed in the CT images and an example is shown in figure 11. A ring artifact appears as a circular or arc-shaped streak or ring on the CT scan image, often near the center of the scan. The ring artifact can be due to a defective or miscalibrated detector or detector misalignment.

**Figure 10.** CT images of the exemplar propeller blade root - indentation in aluminum insert.

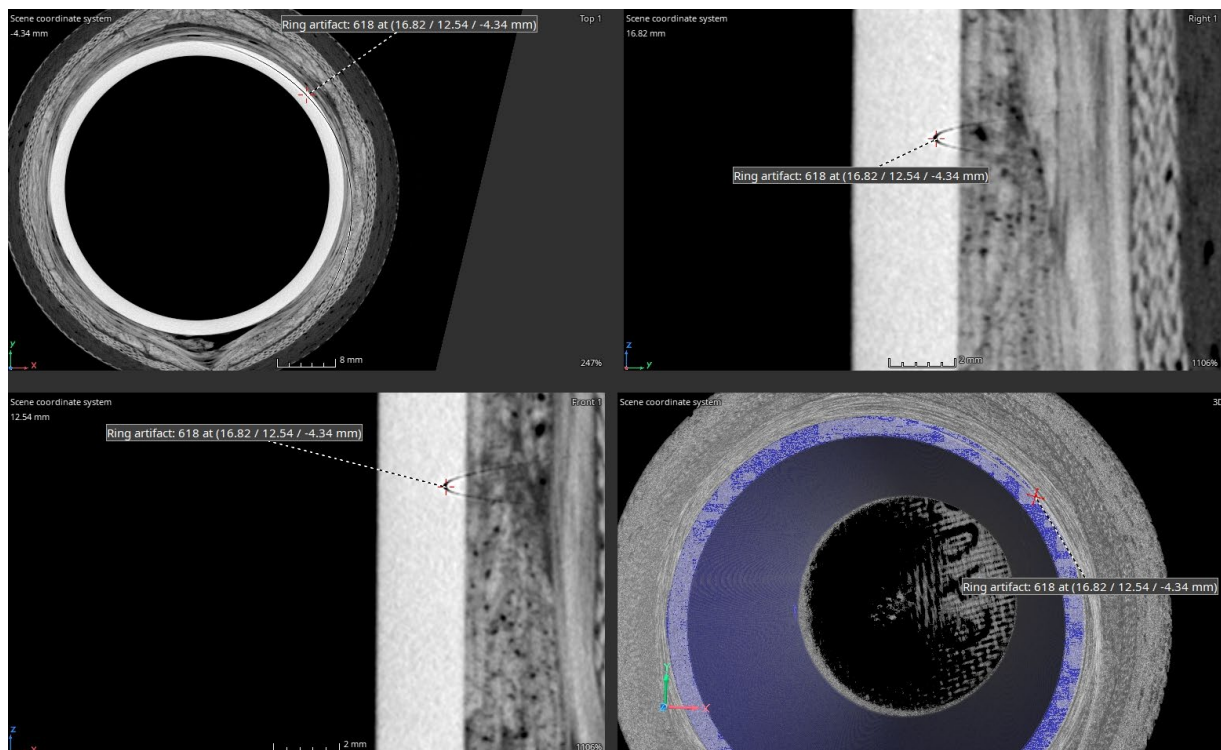
**Figure 11.** CT images of the exemplar propeller blade root - ring artifact.

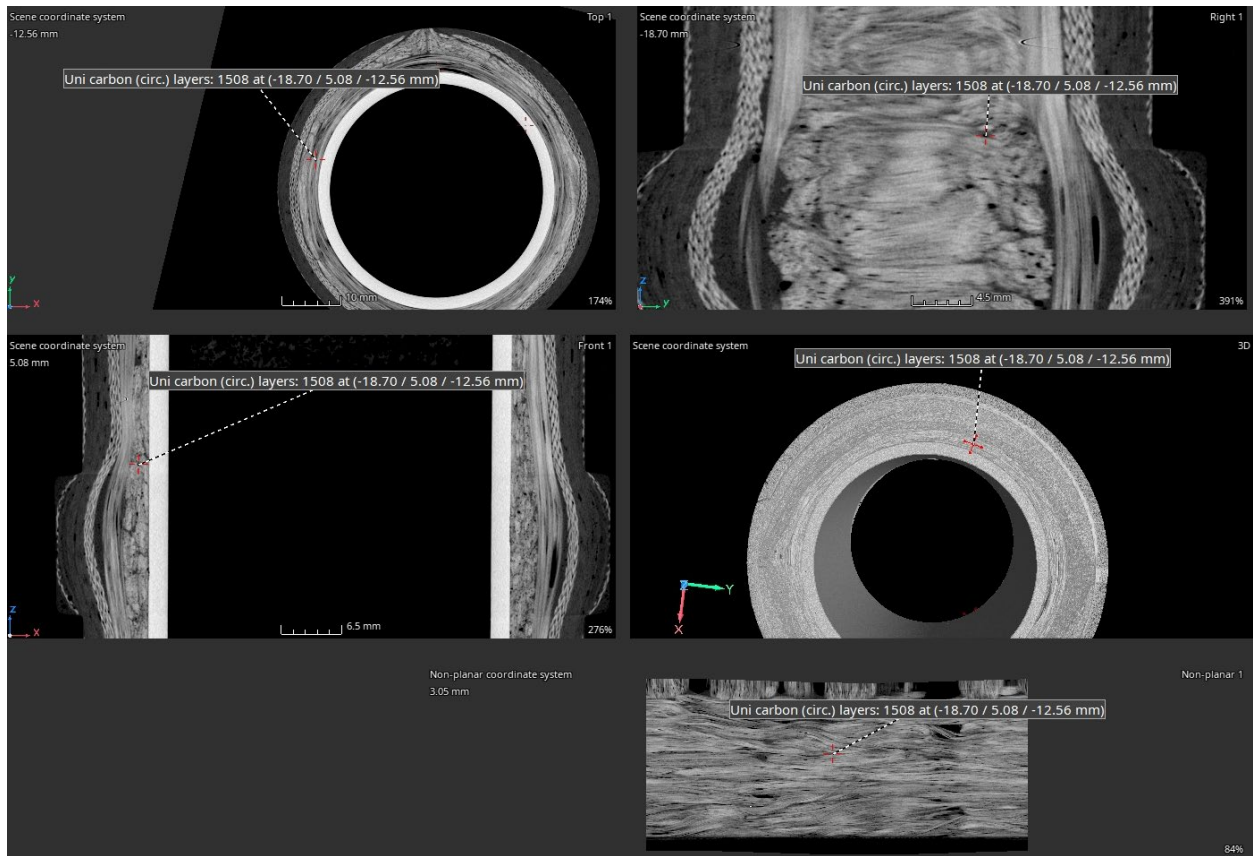
- 7) For the unidirectional carbon (circ) layers, there were some small voids or low density areas visible between the carbon fibers (see figures 12 thru 14).

**Figure 12.** CT images of the exemplar propeller blade root- unidirectional carbon (circ) layers.

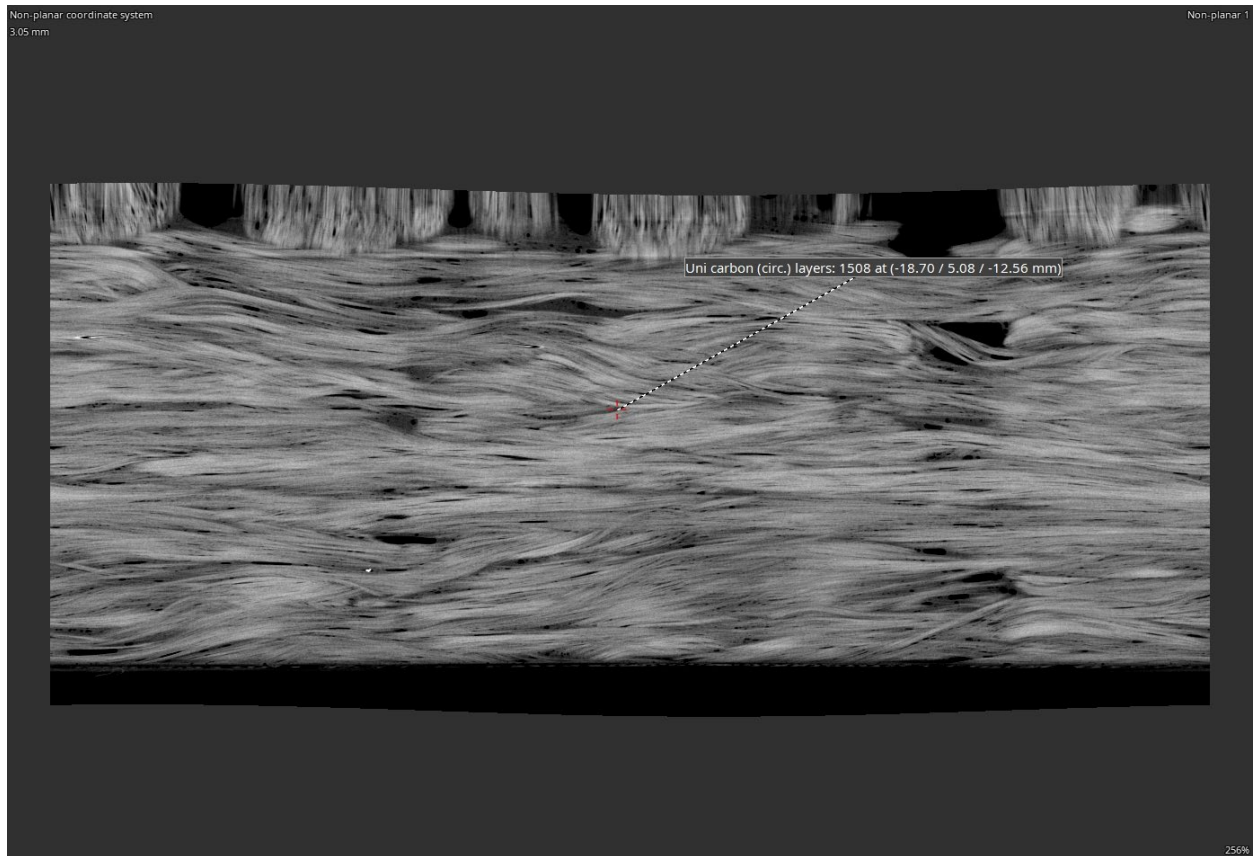
**Figure 13.** CT image of the exemplar propeller blade root - unidirectional carbon (circ) layers unrolled.

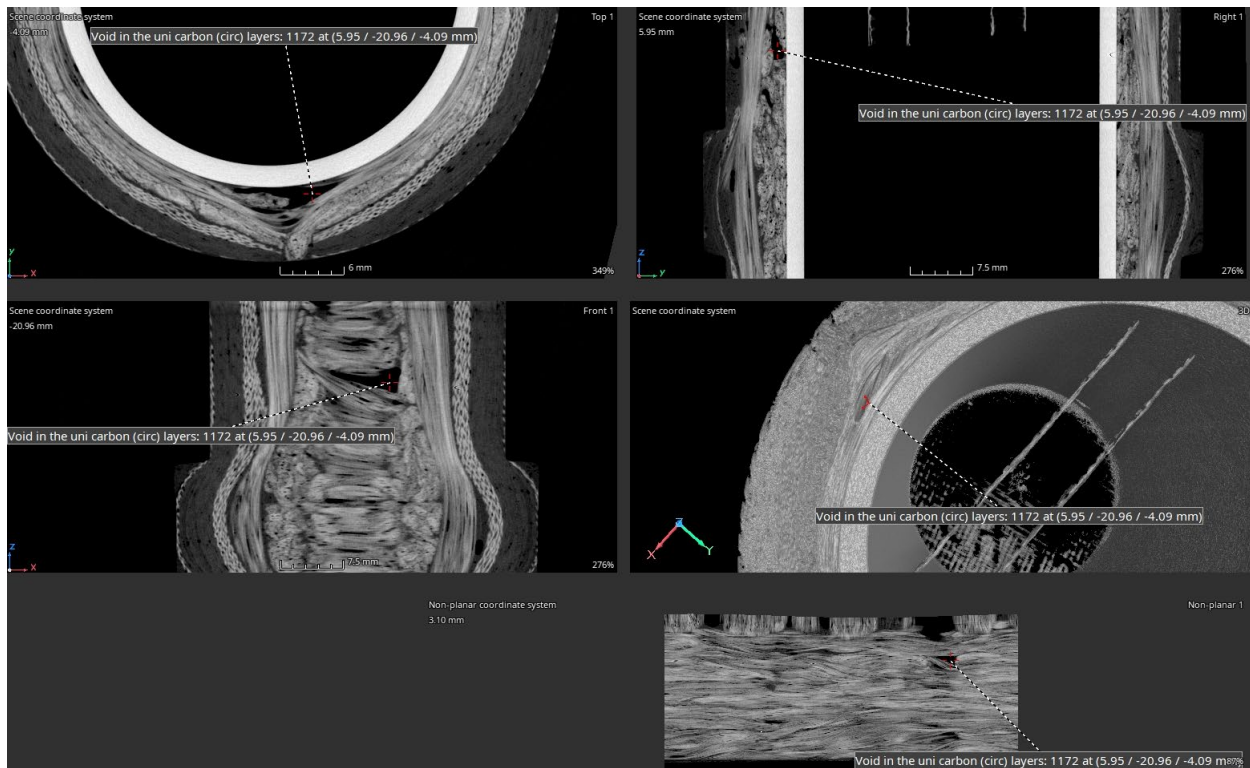
**Figure 14.** CT images of the exemplar propeller blade root - void in the unidirectional carbon (circ) layers.

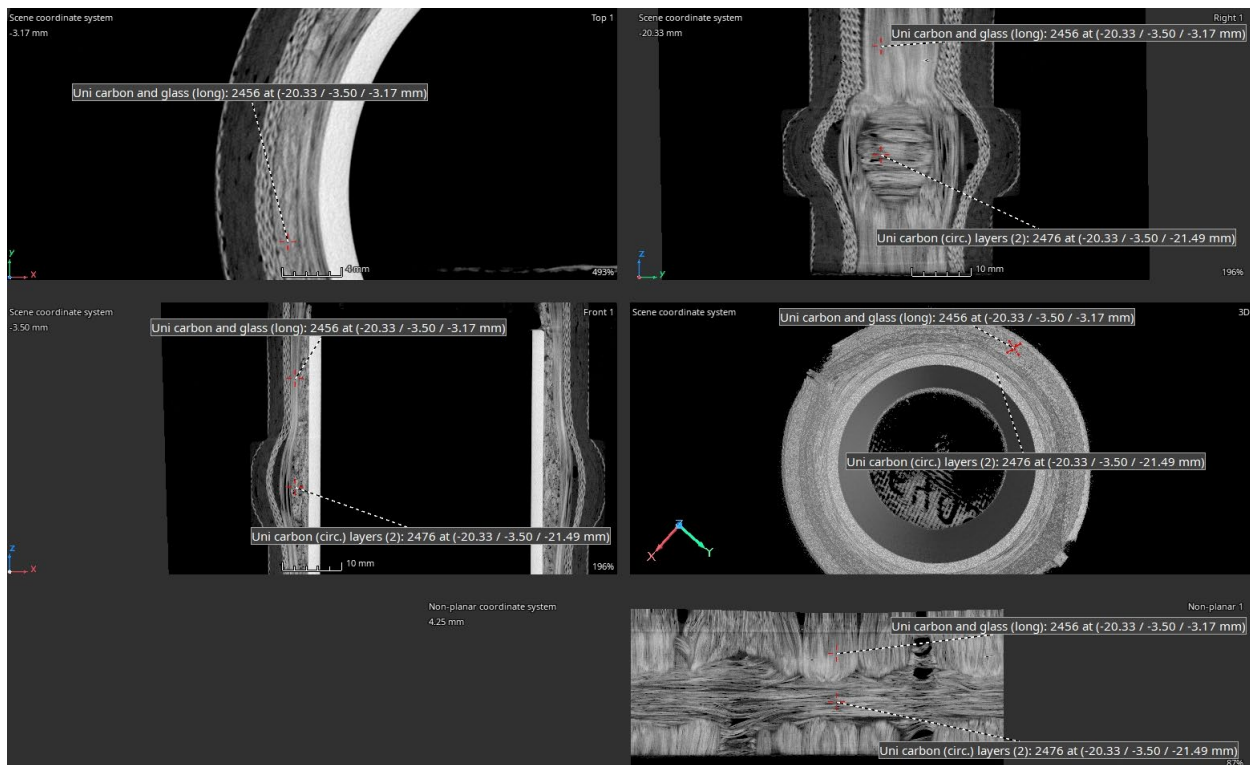
- 8) For the unidirectional carbon and glass (long) layers, there were some small voids or low density areas visible between the carbon fibers (see figures 15 thru 17).

**Figure 15.** CT images of the exemplar propeller blade root - unidirectional carbon and glass (long) layers.

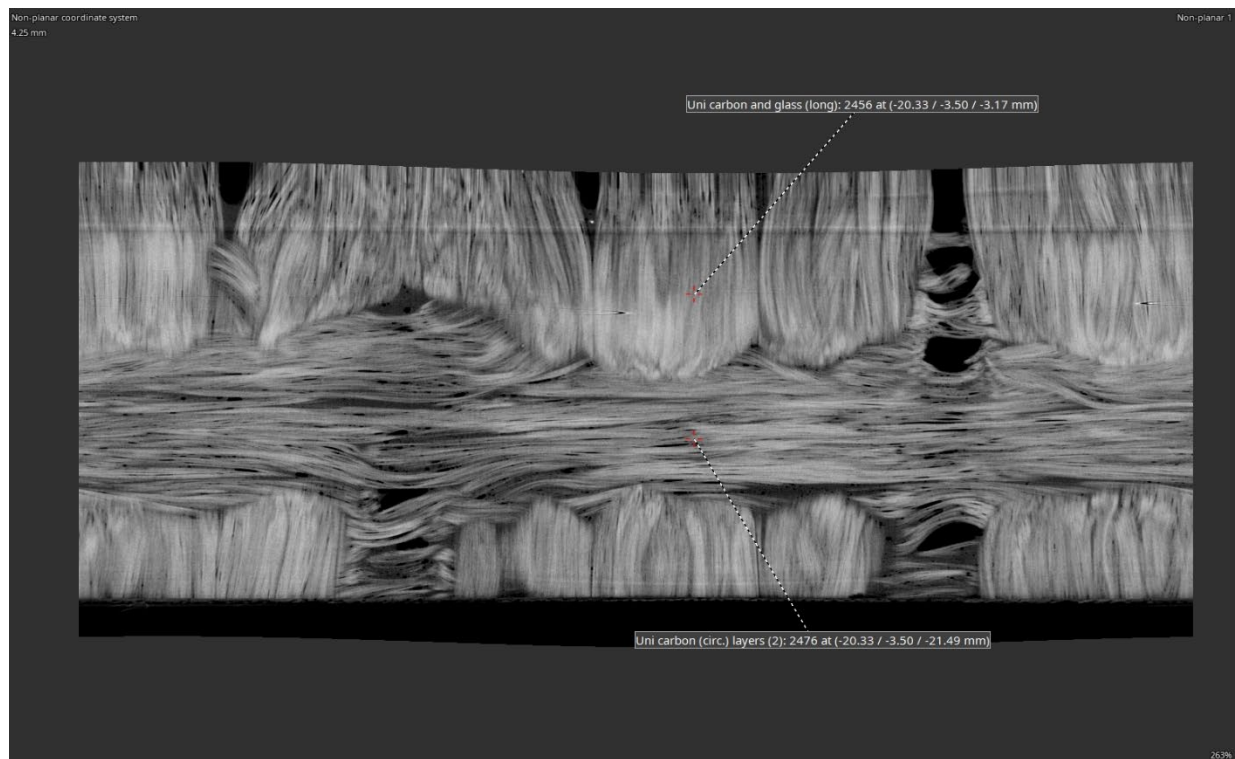
**Figure 16.** CT image of the exemplar propeller blade root - unidirectional carbon and glass (long) layers unrolled.

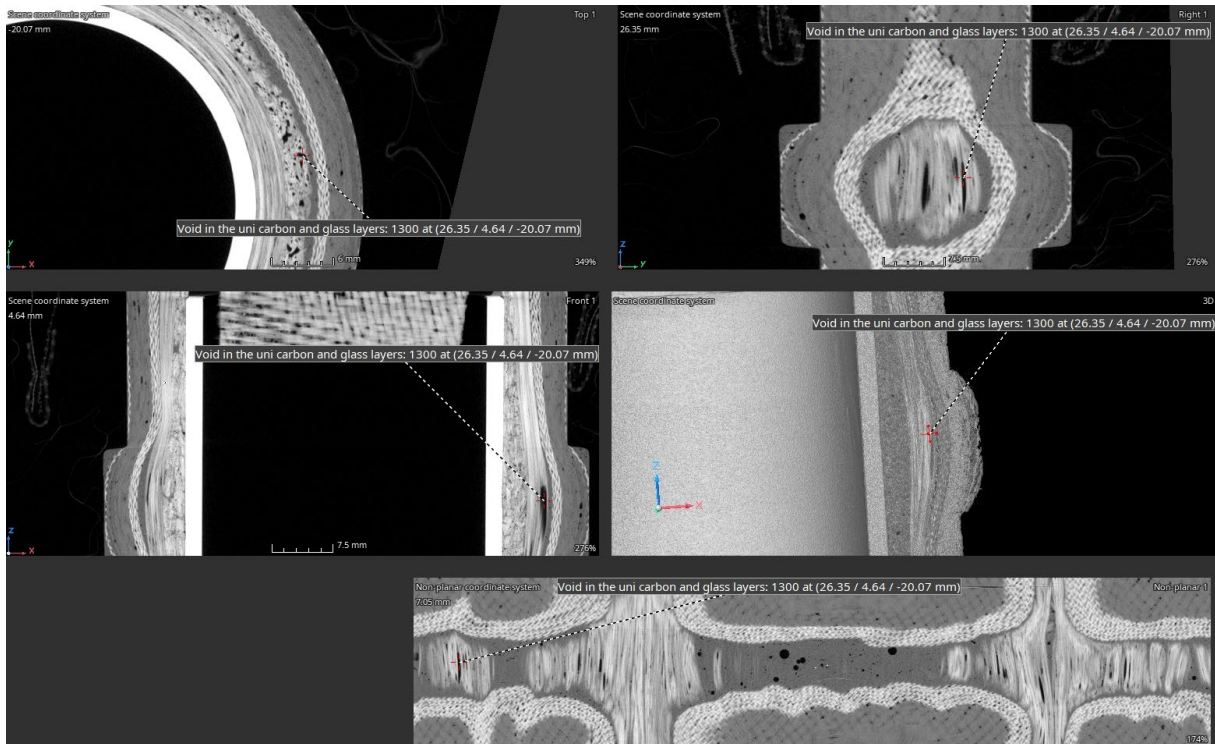
**Figure 17.** CT images of the exemplar propeller blade root - void in unidirectional carbon and glass (long) layers.

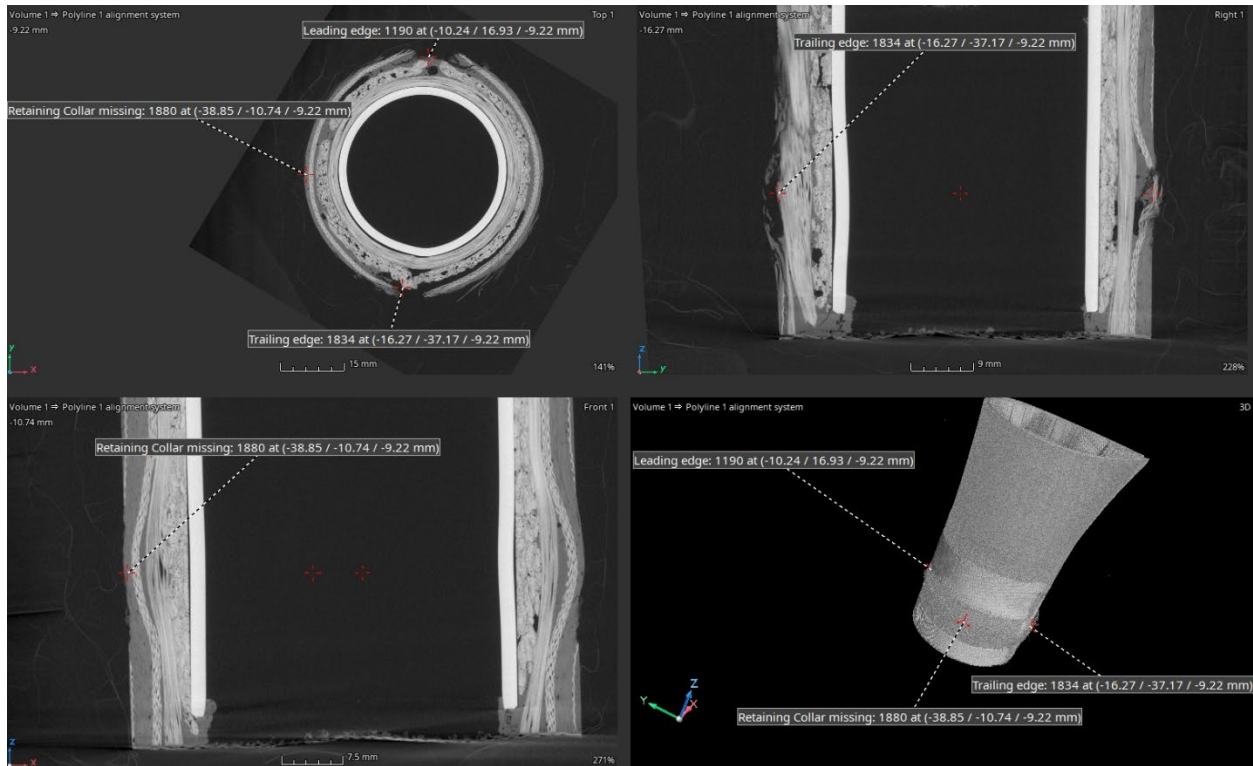
- 1) The retaining collar is not present on the accident propeller blade (see figures 22, 23 and 24). (The retaining collar is shown on the exemplar propeller blade in figure 3.)
- 2) The accident propeller blade was SN 6410 (see figure 24).
- 3) The root area of the accident propeller blade consists of the following cross section: 1) an AL insert; 2) layers of unidirectional carbon wrapped circularly around the insert; 3) layers of unidirectional carbon and glass oriented longitudinally along the blade; 4) layers of woven glass; and 5) layers of carbon fiber. (See figure 25)
- 4) For the accident propeller, the AL insert was recessed approximately 3.69 to 3.82 millimeters into the blade (see figure 26). On the accident blade,

**Figure 22.** CT images of the accident propeller blade root - overview.

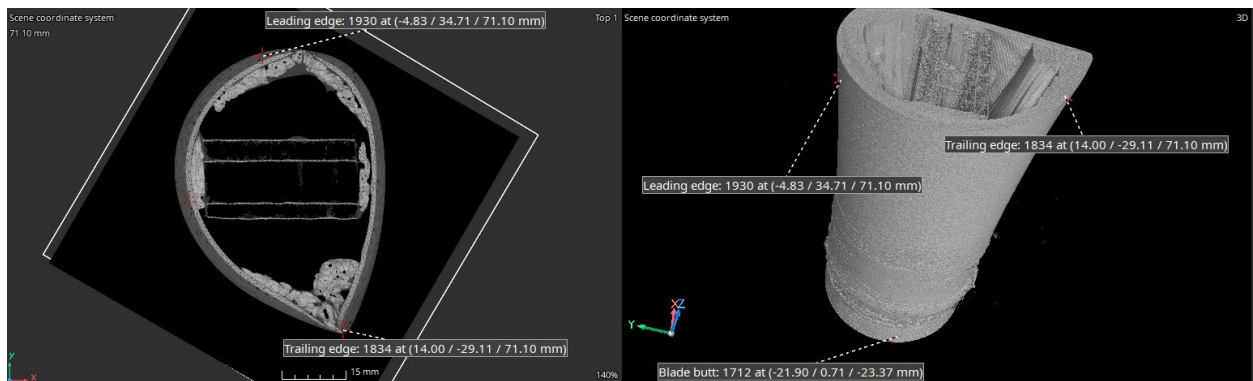
**Figure 23.** CT images of the accident propeller blade root - showing the leading and trailing edges.

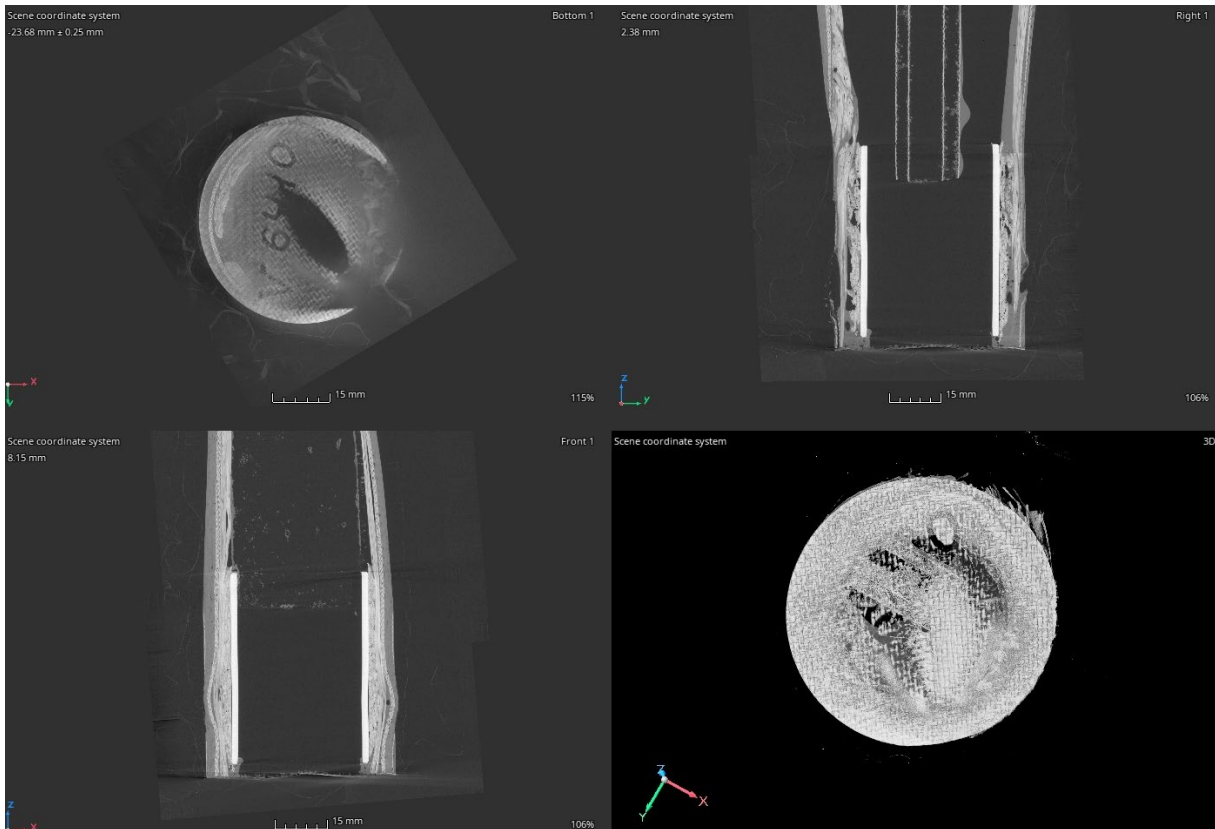
**Figure 24.** CT images of the accident propeller blade root showing SN 6410 at the blade butt.

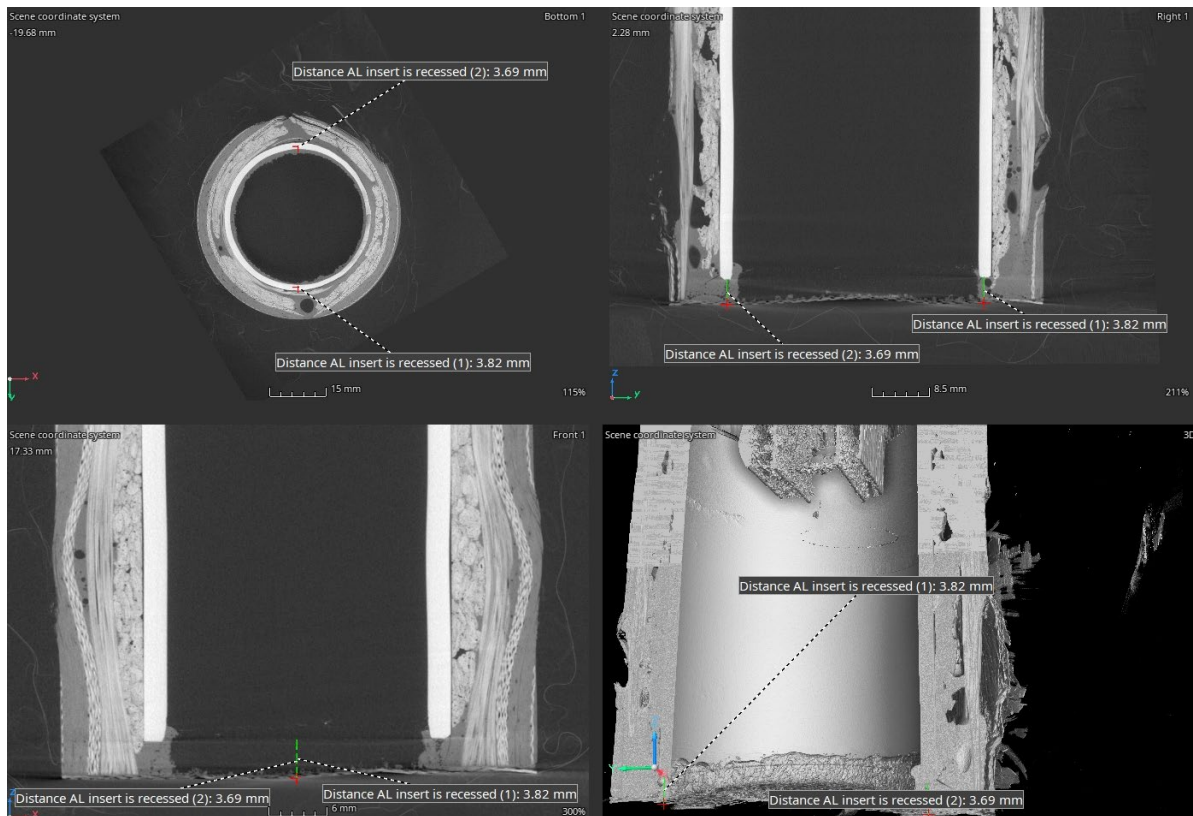
**Figure 26.** CT images of the accident propeller blade root - aluminum insert at blade butt.

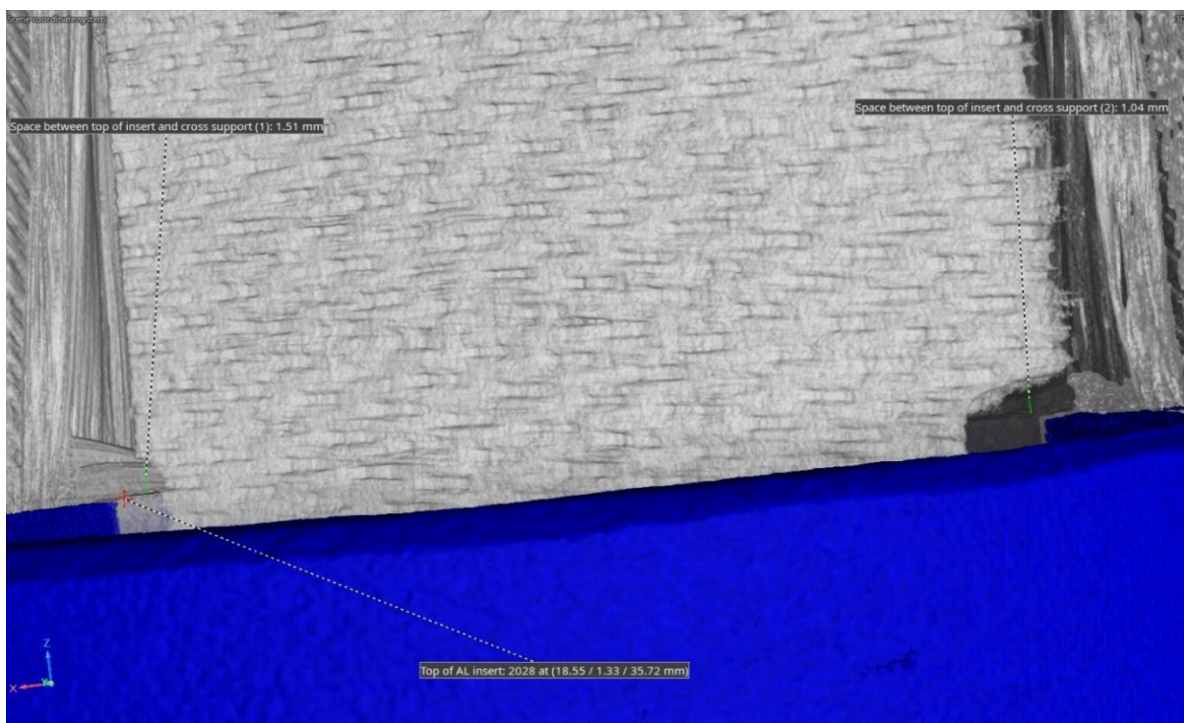
- the top of the AL insert was approximately 1-1.5 mm below the cross support (see figure 27). The AL insert was bowed inward (see figure 28).
- 5) There was a gap between the AL insert and the unidirectional carbon (circ) layers (see figures 28 and 29). There was an anomaly between the AL insert and the unidirectional carbon (circ) layers (see figure 29). There appear to be tears in the unidirectional carbon (circ) material (see figures 30 and 31). The unidirectional carbon (circ) layers do not go all the way to the blade root (see figure 31).

**Figure 27.** CT image of the accident propeller blade root - aluminum insert inside blade showing the gap between the cross support and the top of the insert.

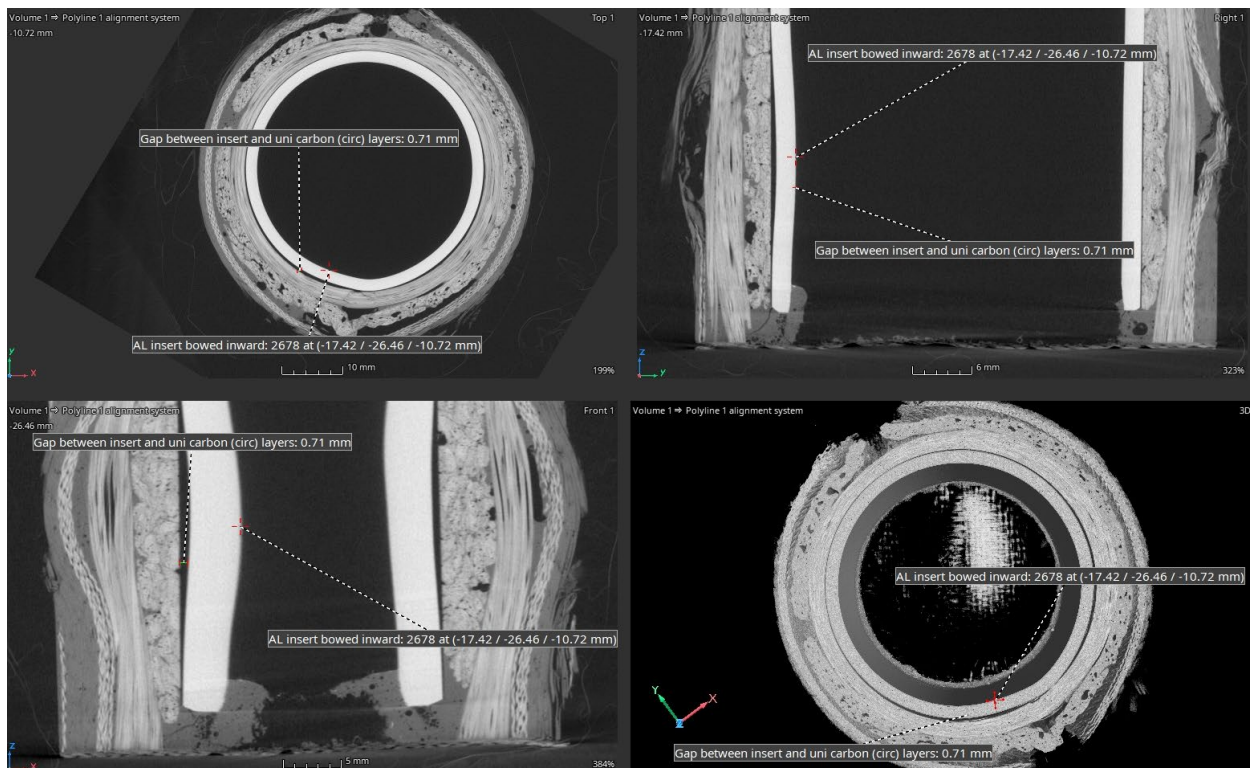
**Figure 28.** CT images of the exemplar propeller blade root - aluminum insert bowed inward.

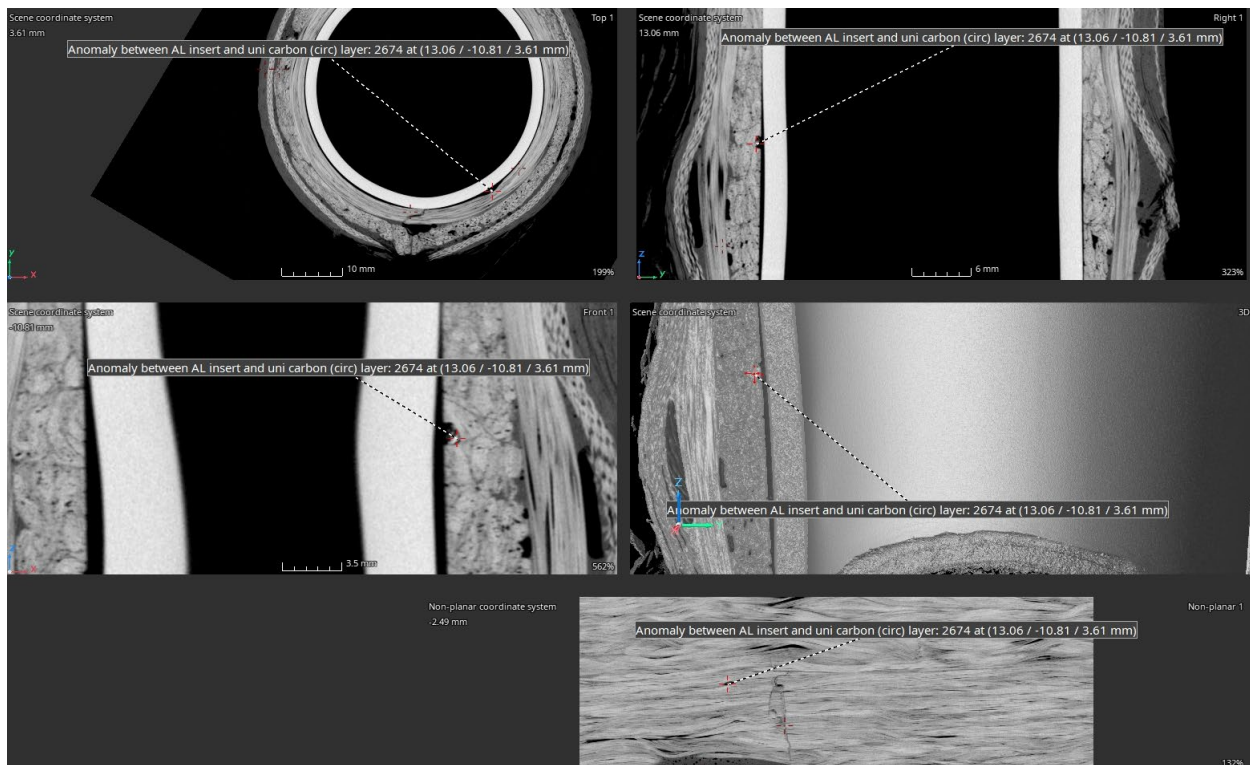
**Figure 29.** CT images of the accident propeller blade root - anomaly between unidirectional carbon layers (circ) and aluminum insert.
