# National Transportation Safety Board

WPR24FA053

## COMPUTED TOMOGRAPHY

Specialist's Factual Report

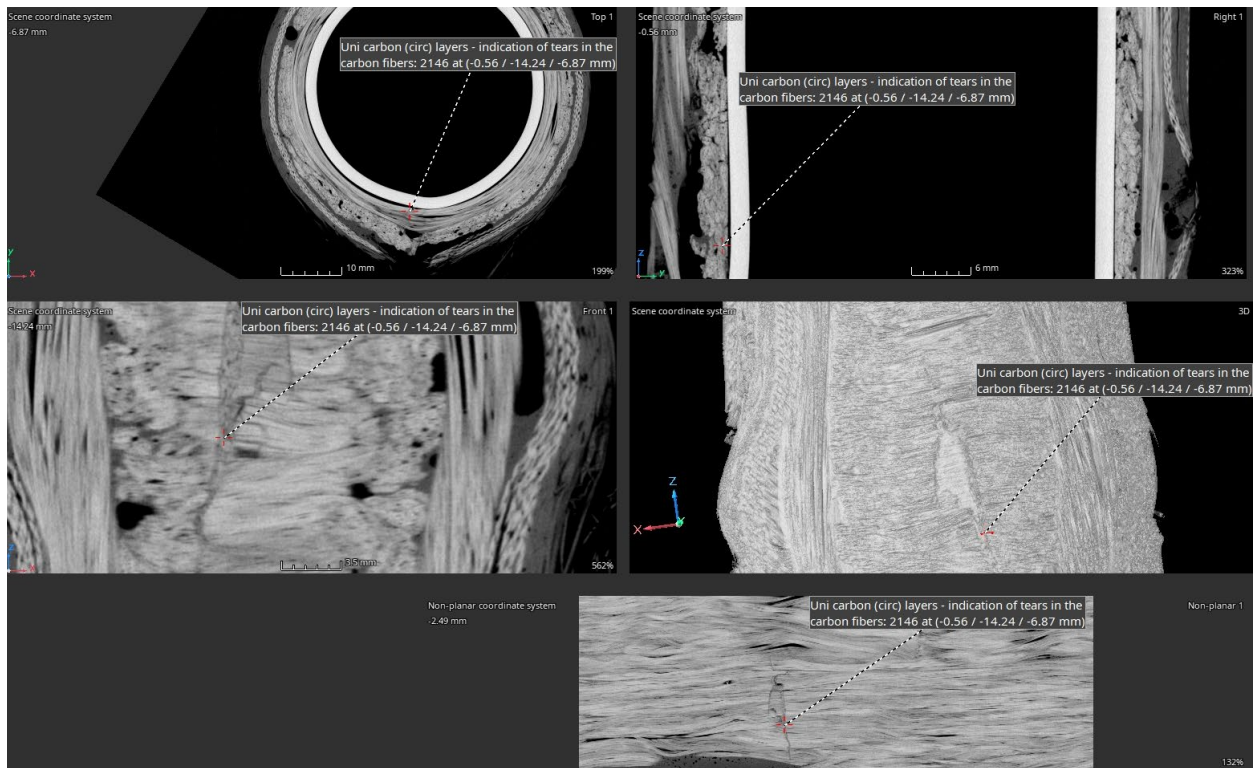
- the top of the AL insert was approximately 1-1.5 mm below the cross support (see figure 27). The AL insert was bowed inward (see figure 28).
- 5) There was a gap between the AL insert and the unidirectional carbon (circ) layers (see figures 28 and 29). There was an anomaly between the AL insert and the unidirectional carbon (circ) layers (see figure 29). There appear to be tears in the unidirectional carbon (circ) material (see figures 30 and 31). The unidirectional carbon (circ) layers do not go all the way to the blade root (see figure 31).

**Figure 30.** CT images of the accident propeller blade root - indications of tears in the unidirectional carbon (circ) material.

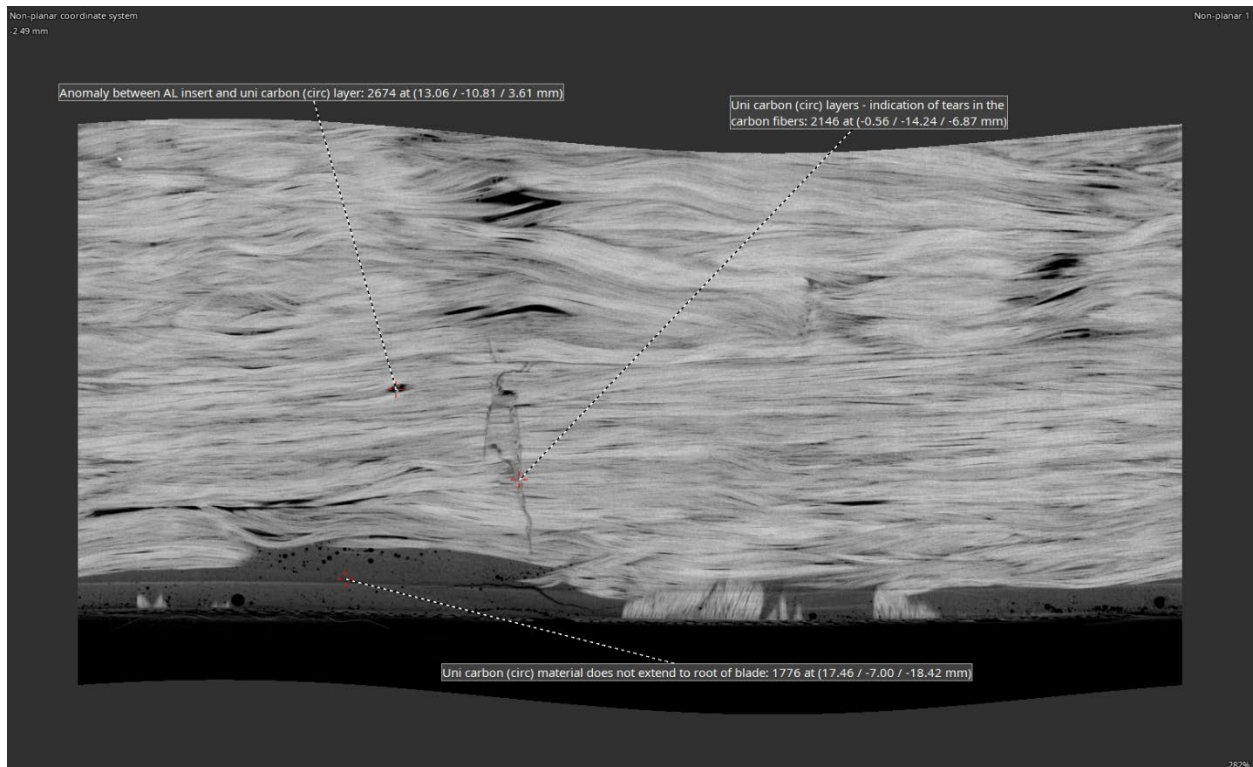
**Figure 31.** CT image of the accident propeller blade root -unidirectional carbon (circ) layers unrolled.

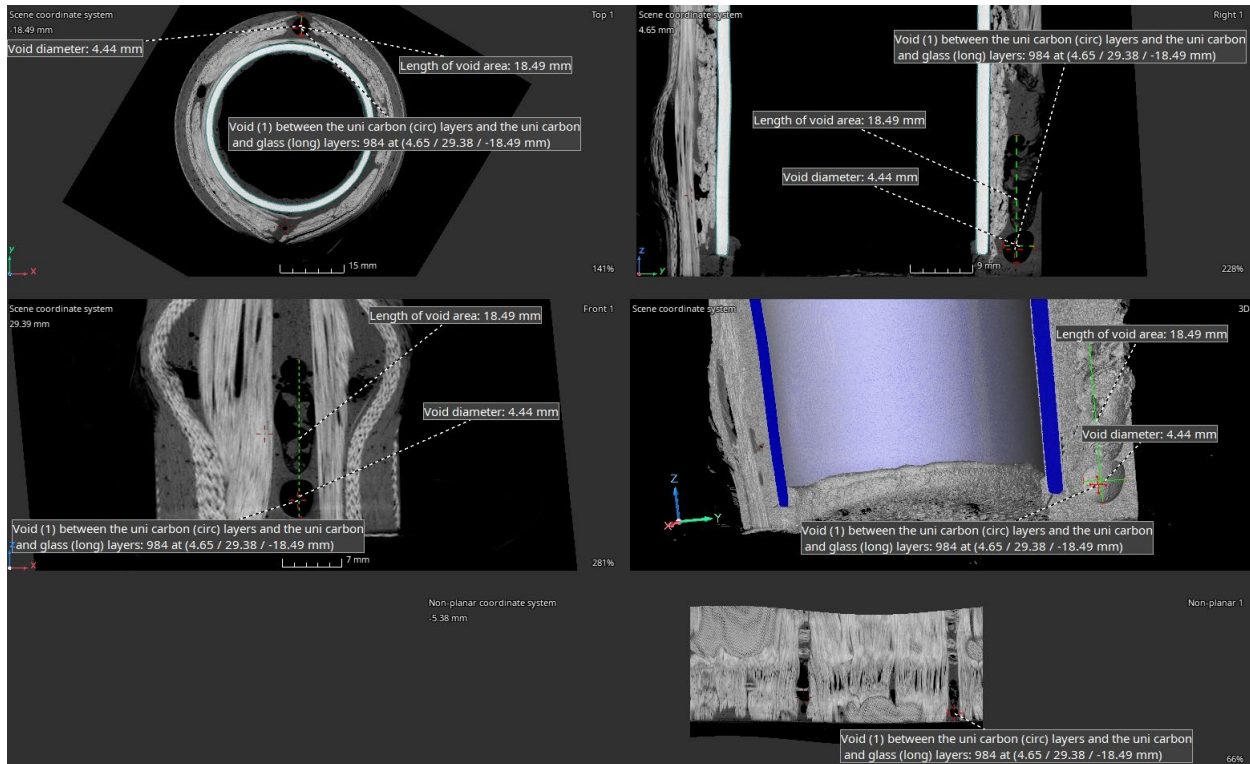
- 6) There are three large areas of voids in and between the unidirectional carbon (circ) layers and unidirectional carbon and glass (long) layers. Void area 1 is approximately 4.44 mm by 18.49 mm (see figures 32 and 35). Void area 2 is approximately 2.95 mm by 23.62 mm (see figures 33 and 35). Void area 3 consists of several voids of varying size (1.50 mm by 7.82 mm to 2.09 mm by 1.58 mm and mostly occupy the unidirectional carbon and glass (long) layers (see figures 34 and 35).

**Figure 32.** CT images of the accident propeller blade root - void area 1 in unidirectional carbon (circ) layers and unidirectional carbon and glass (long) layers.

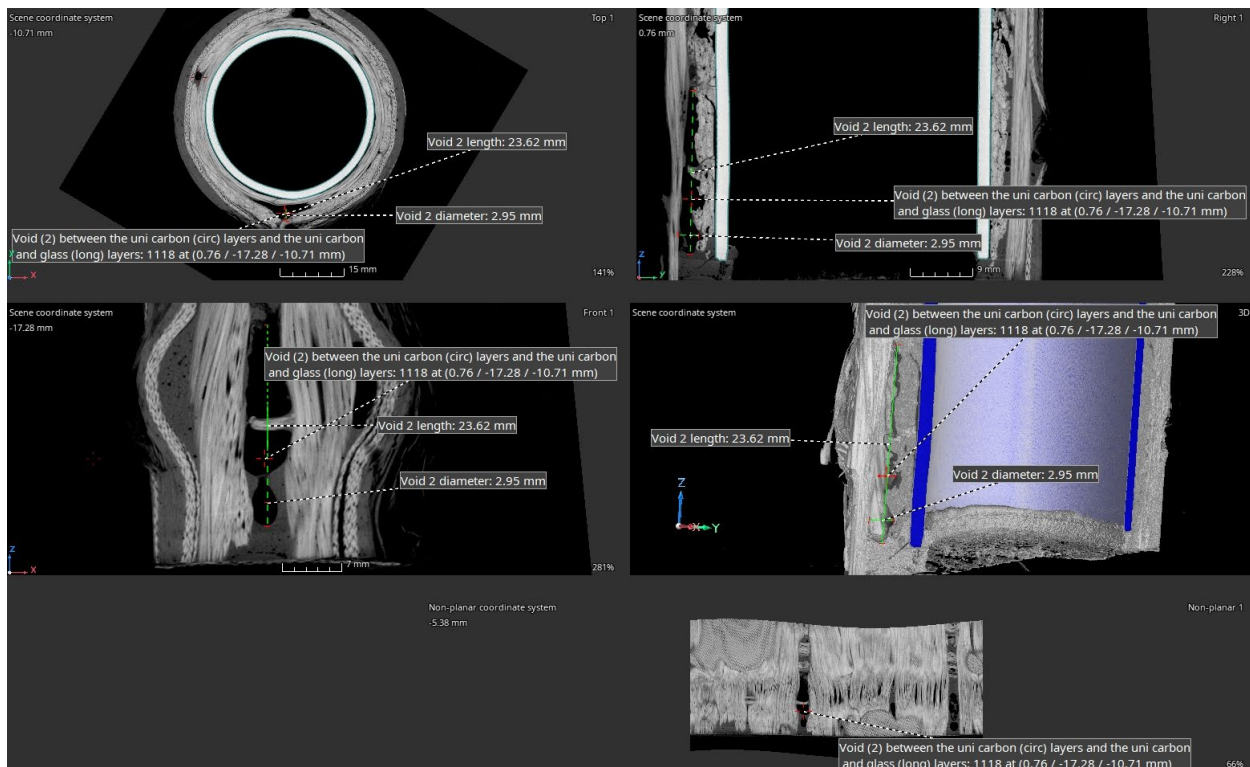
**Figure 33.** CT images of the accident propeller blade root - void area 2 in unidirectional carbon (circ) layers and unidirectional carbon and glass (long) layers.

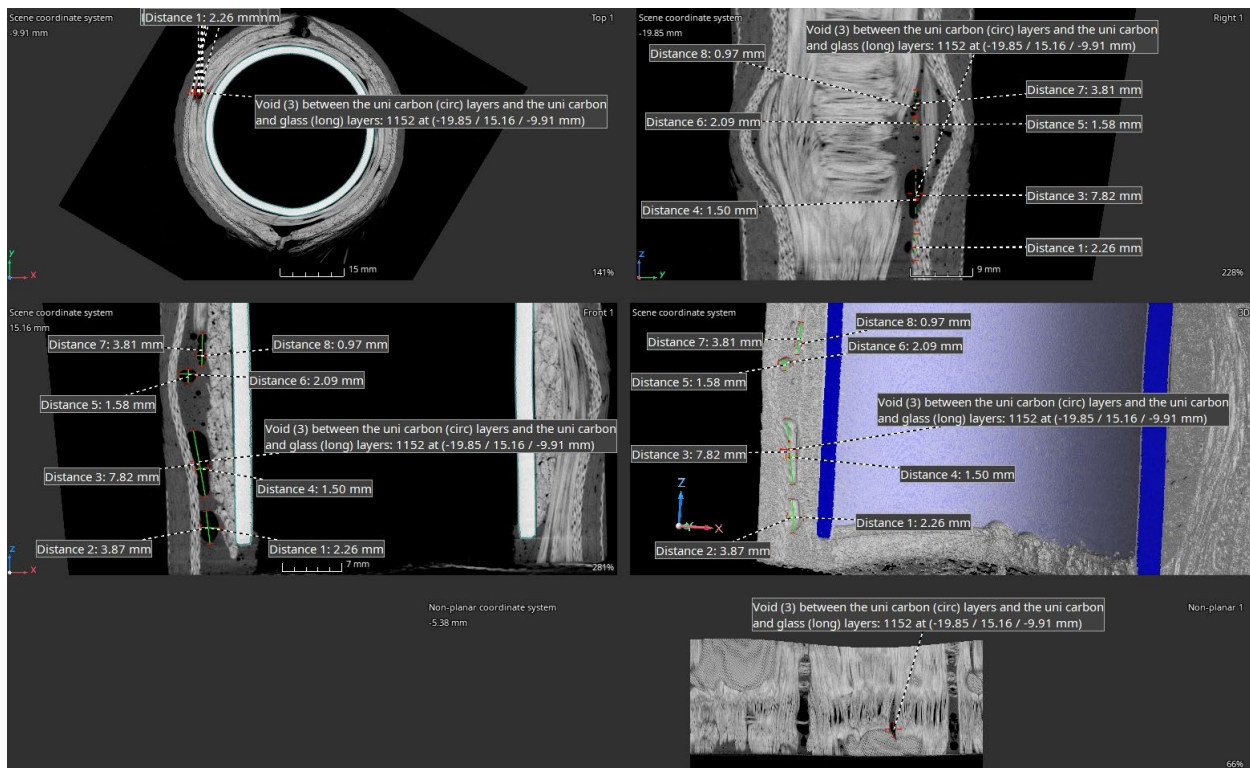
**Figure 34.** CT images of the accident propeller blade root - void area 3 in unidirectional carbon (circ) layers and unidirectional carbon and glass (long) layers.

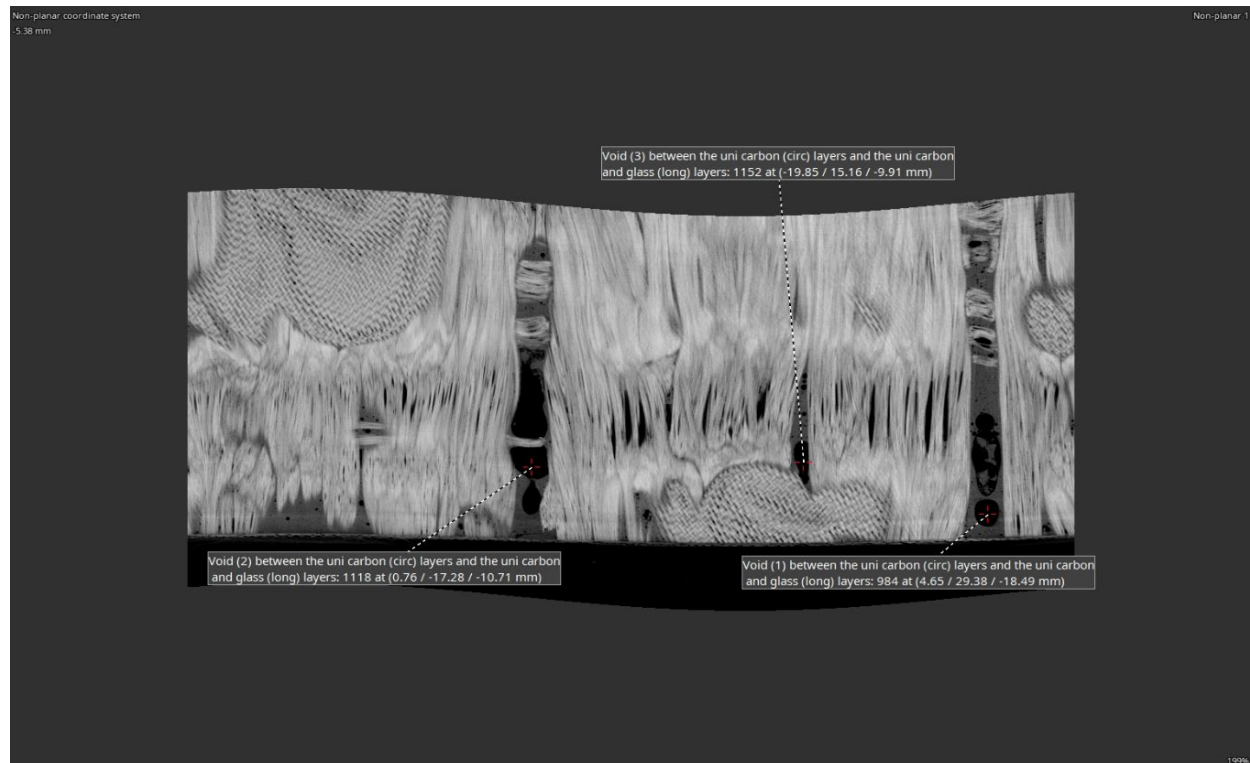
**Figure 35.** CT image of the accident propeller blade root - unidirectional carbon (circ) layers and unidirectional carbon and glass (long) layers unrolled.

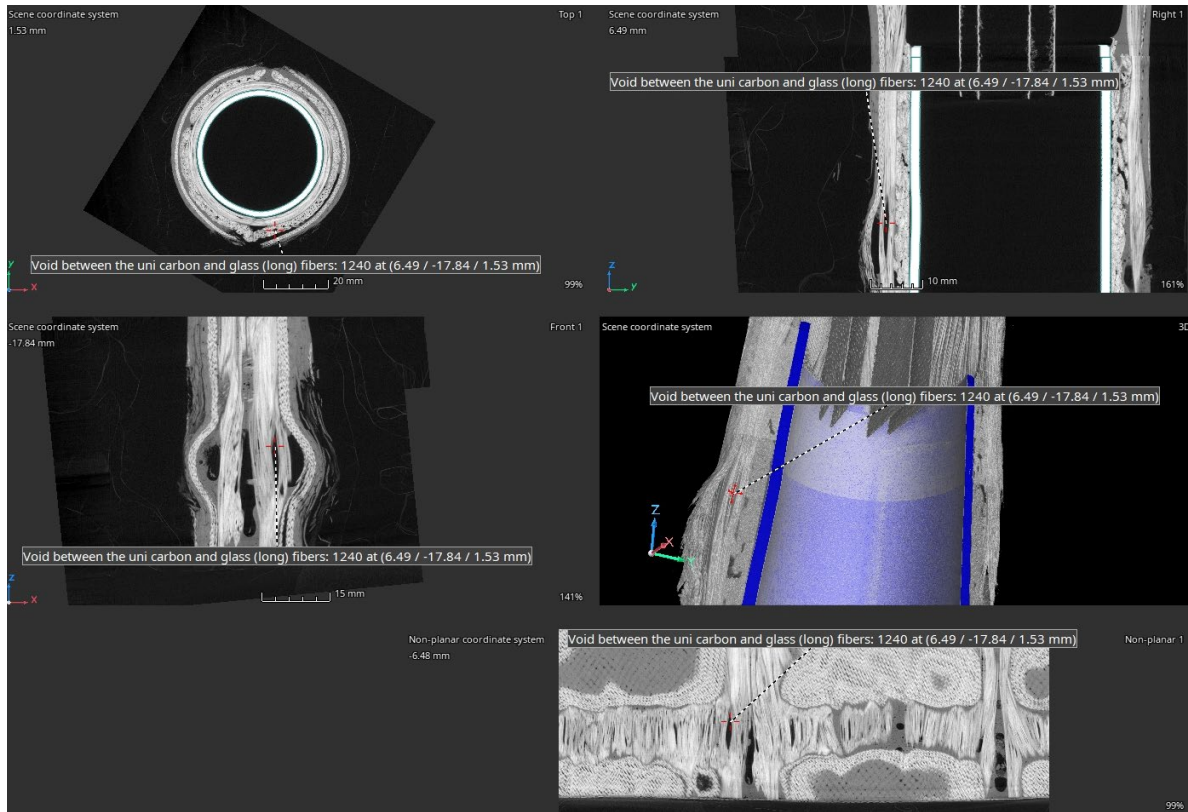
- 7) For the unidirectional carbon and glass (long) layers, there were some voids or low density areas visible between the carbon fibers (see figures 36 and 37).

**Figure 36.** CT images of the accident propeller blade root - void between unidirectional carbon and glass (long) layers.

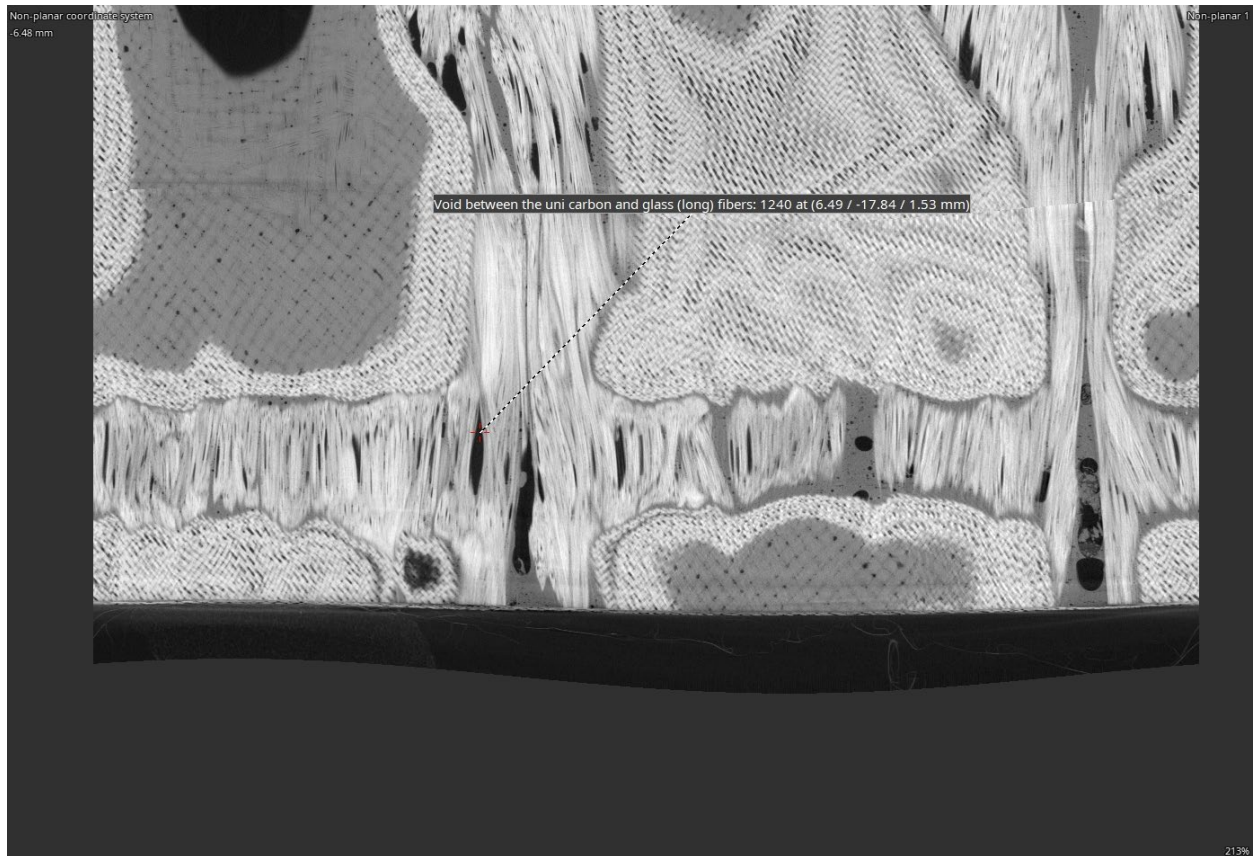
**Figure 37.** CT image of the accident propeller blade root - void between the unidirectional carbon and glass (long) layers unrolled.

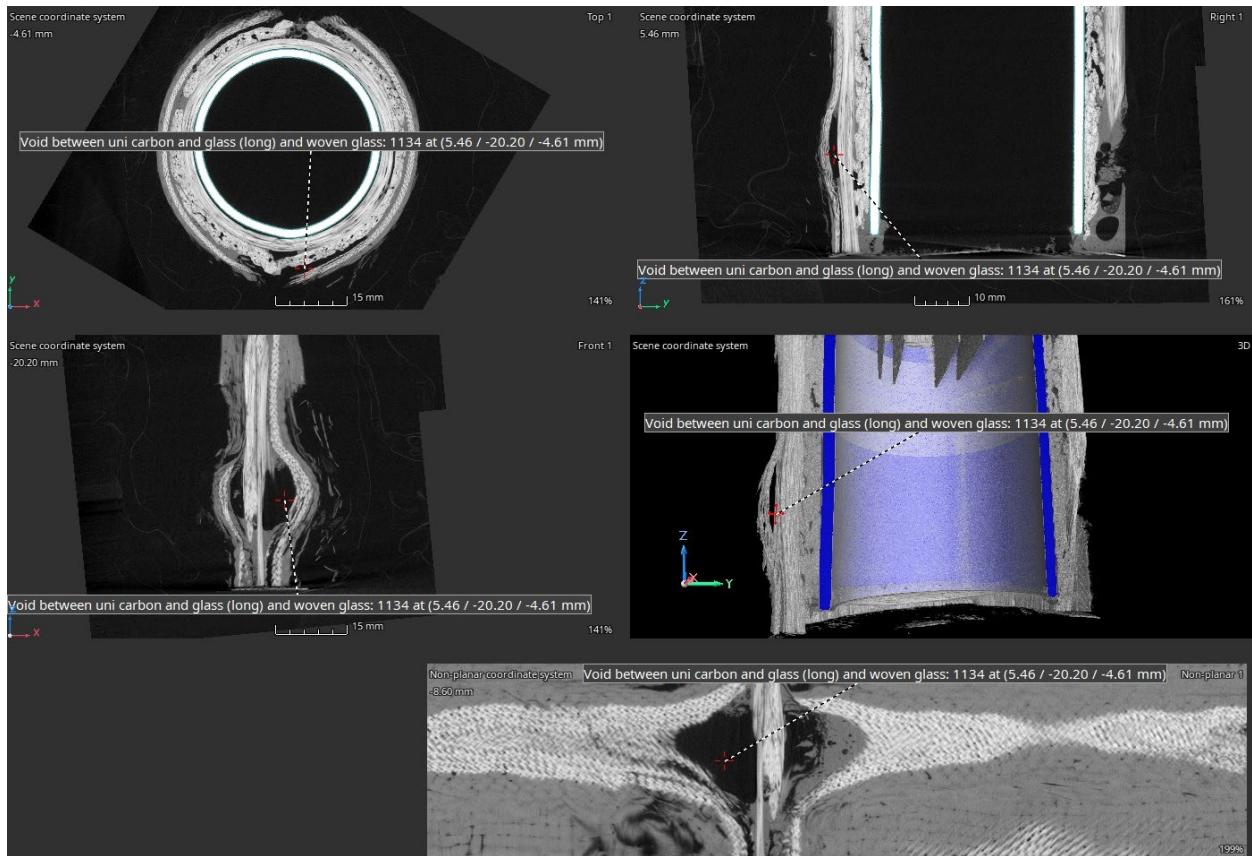
- 8) There were two significant voids noted between the unidirectional carbon and glass (long) layers and the woven glass layers (see figures 38 thru 40).

**Figure 38.** CT images of the accident propeller blade root - void 1 between unidirectional carbon and glass (long) layers and the woven glass layers.

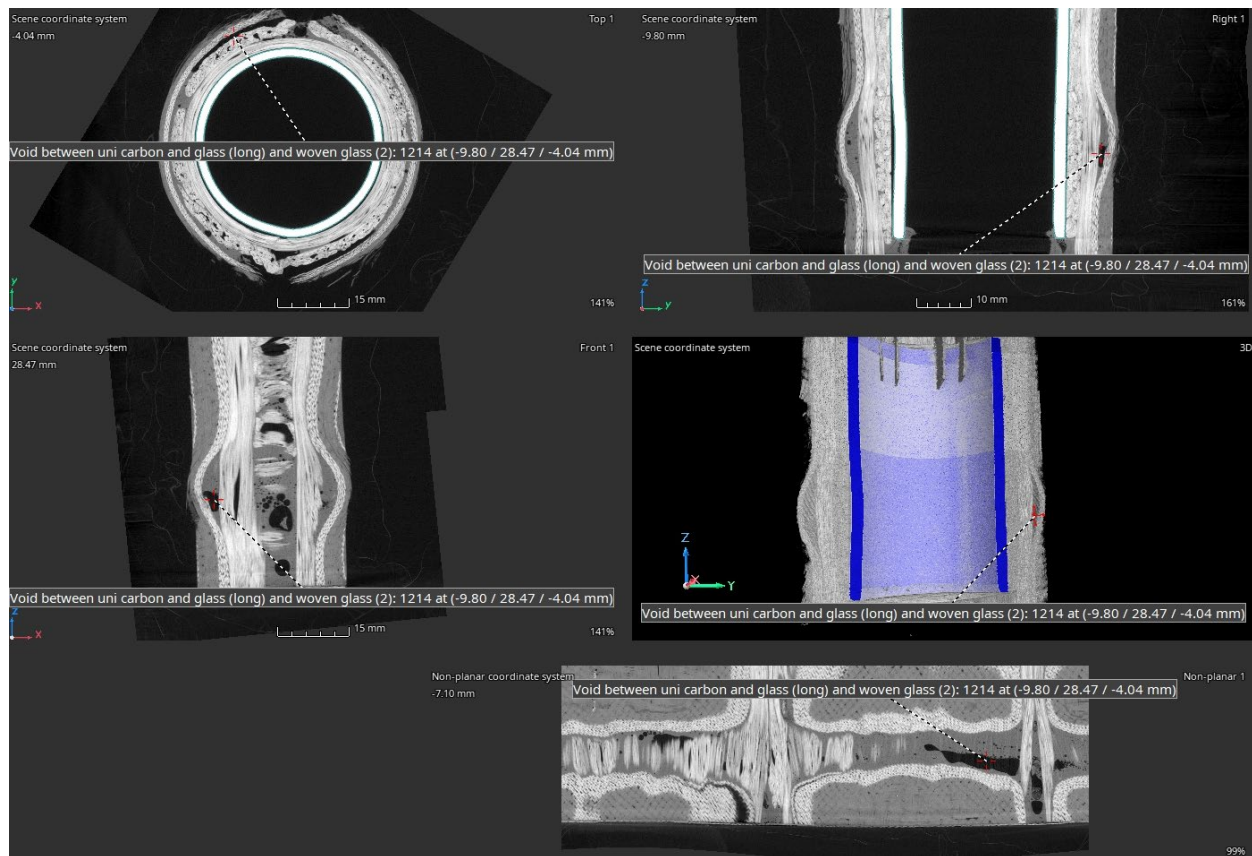
**Figure 39.** CT images of the accident propeller blade root - void 2 between unidirectional carbon and glass (long) layers and woven glass layers.

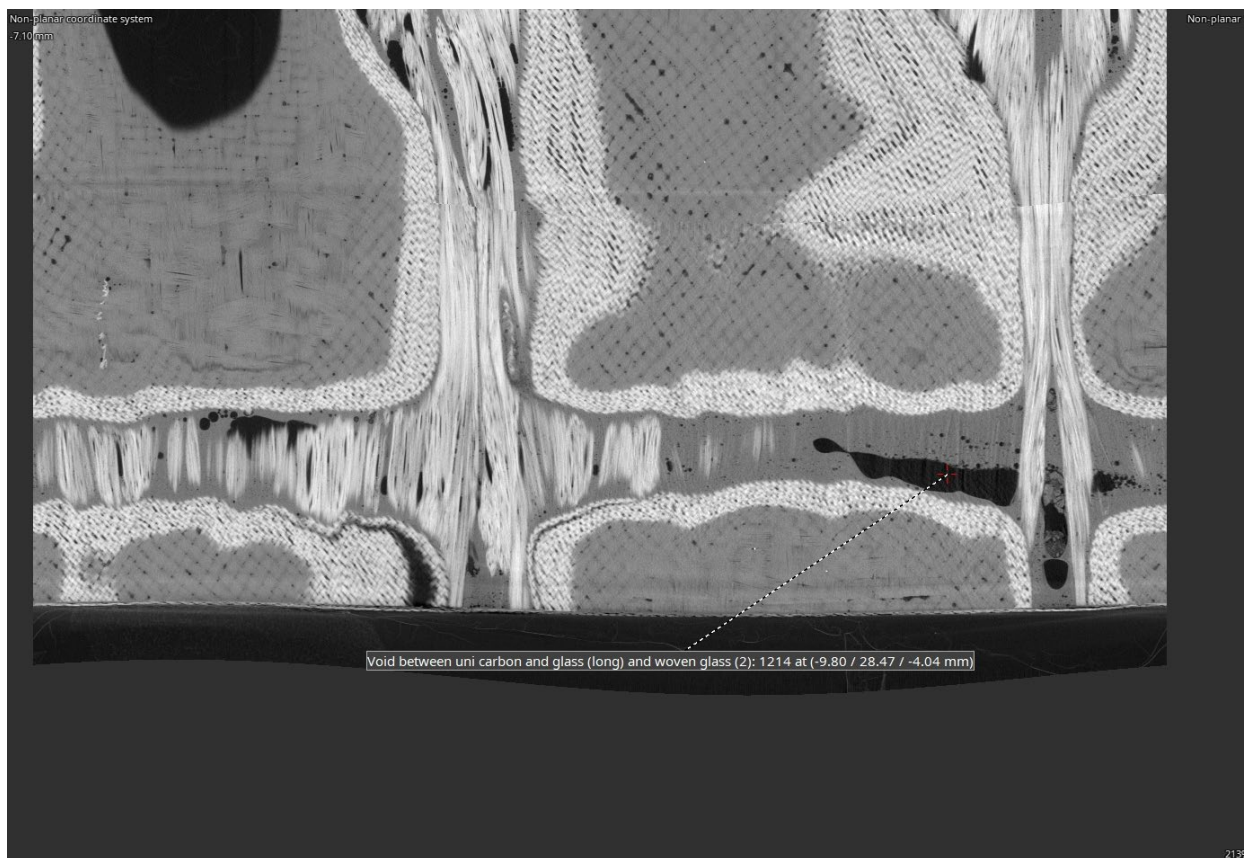
**Figure 40.** CT image of the accident propeller blade root - void 2 between unidirectional carbon and glass (long) layers and woven glass layers unrolled.

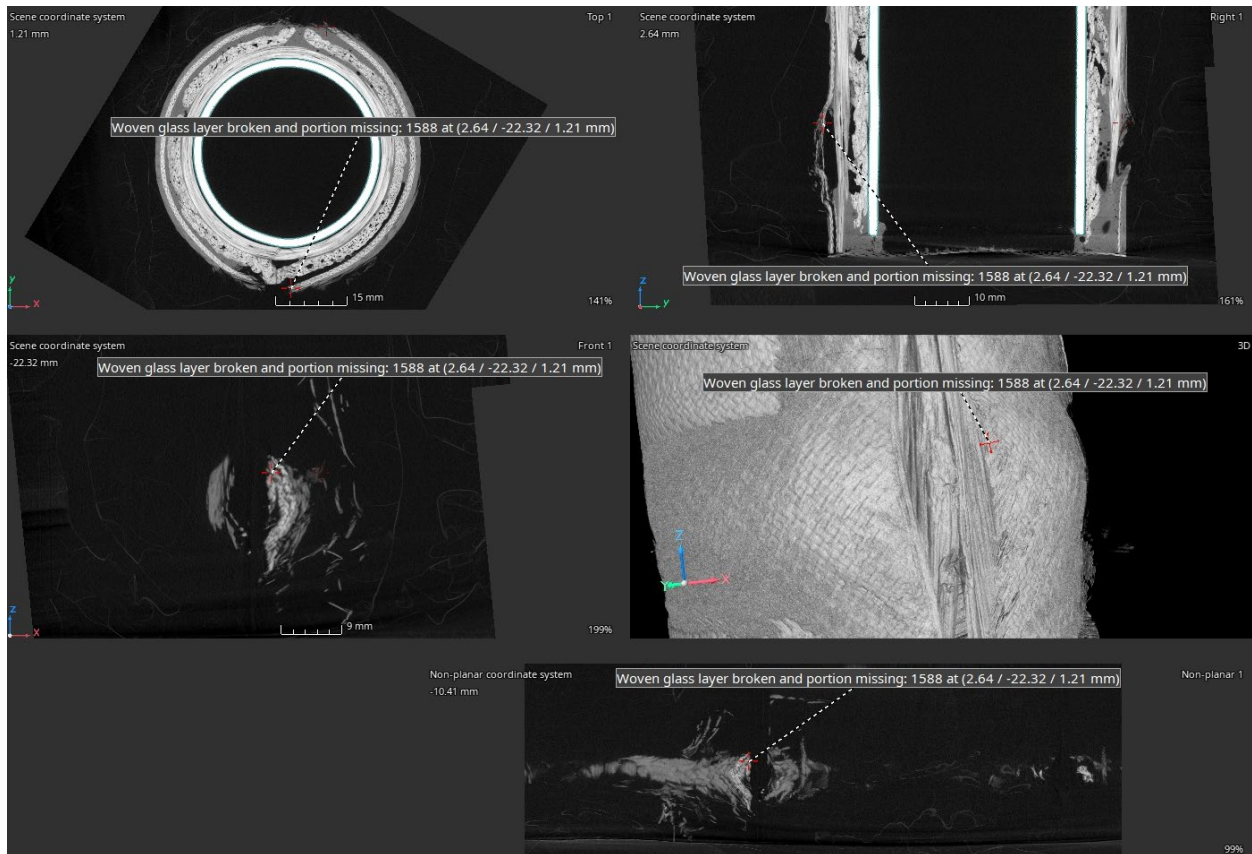
- 9) The woven glass layers are broken and portions missing on opposite sides of the propeller (see figures 41 and 42).
  - 10) The woven carbon fiber layers are broken and portions missing on opposite sides of the propeller. (see figures 43 and 44).

**Figure 41.** CT images of the accident propeller blade root - area 1 of broken woven glass layers.

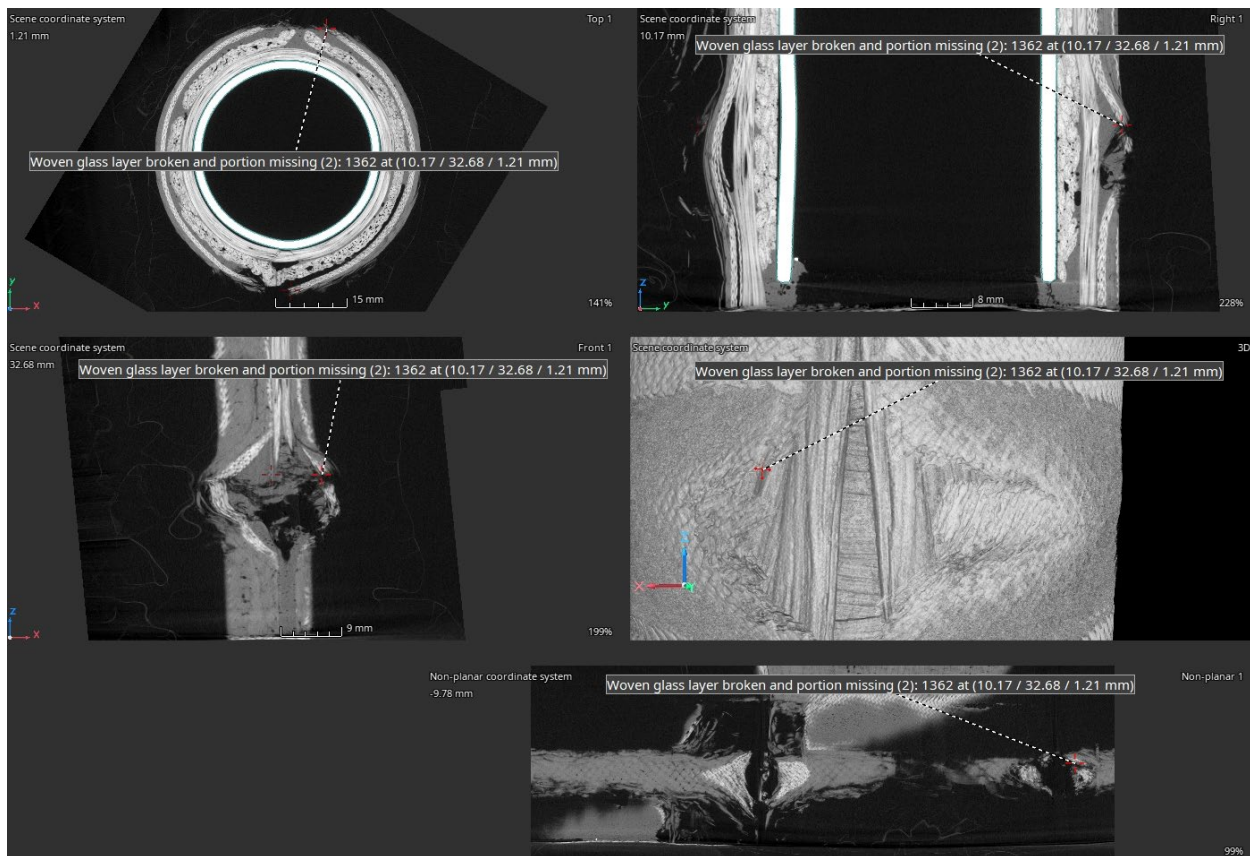
**Figure 42.** CT images of the accident propeller blade root - area 2 of broken woven glass layers.

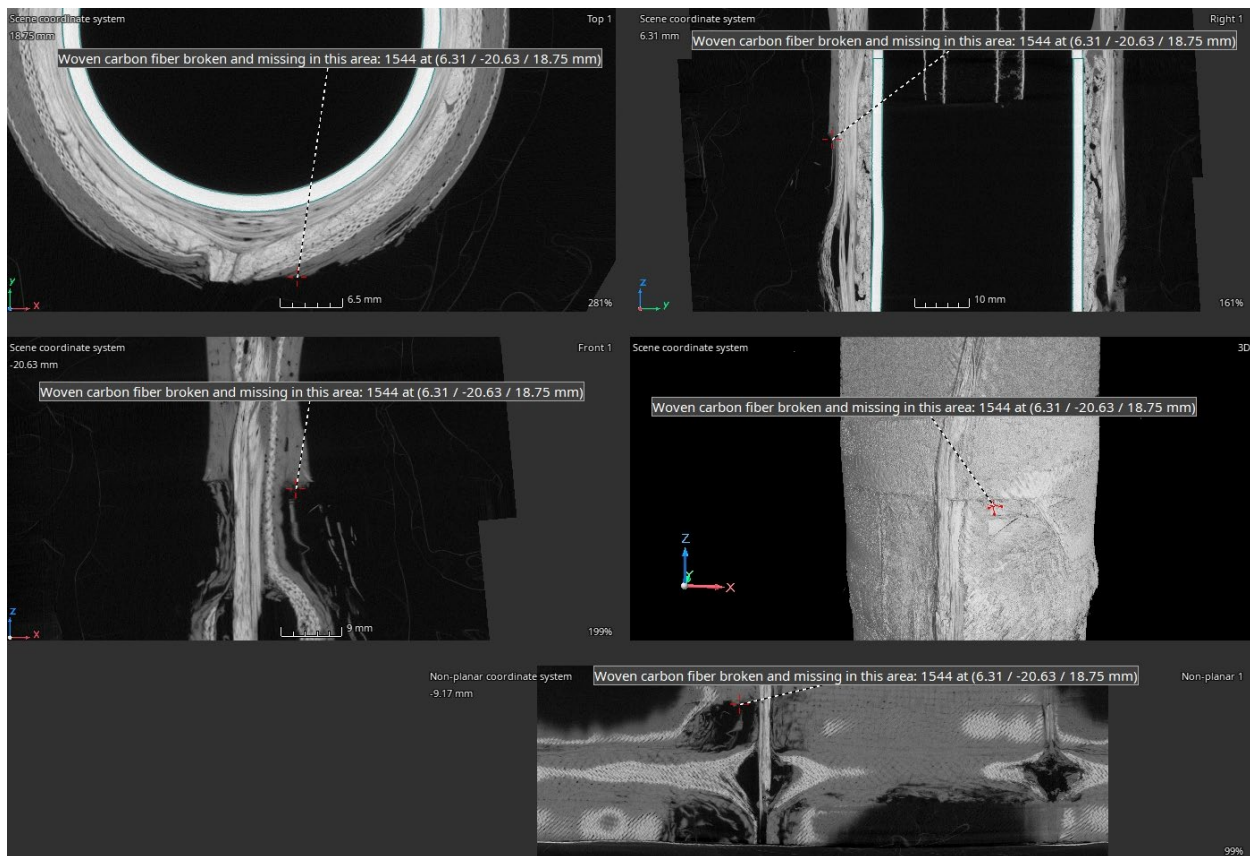
**Figure 43.** CT images of the accident propeller blade root - area 1 of broken and missing woven carbon fiber layers.

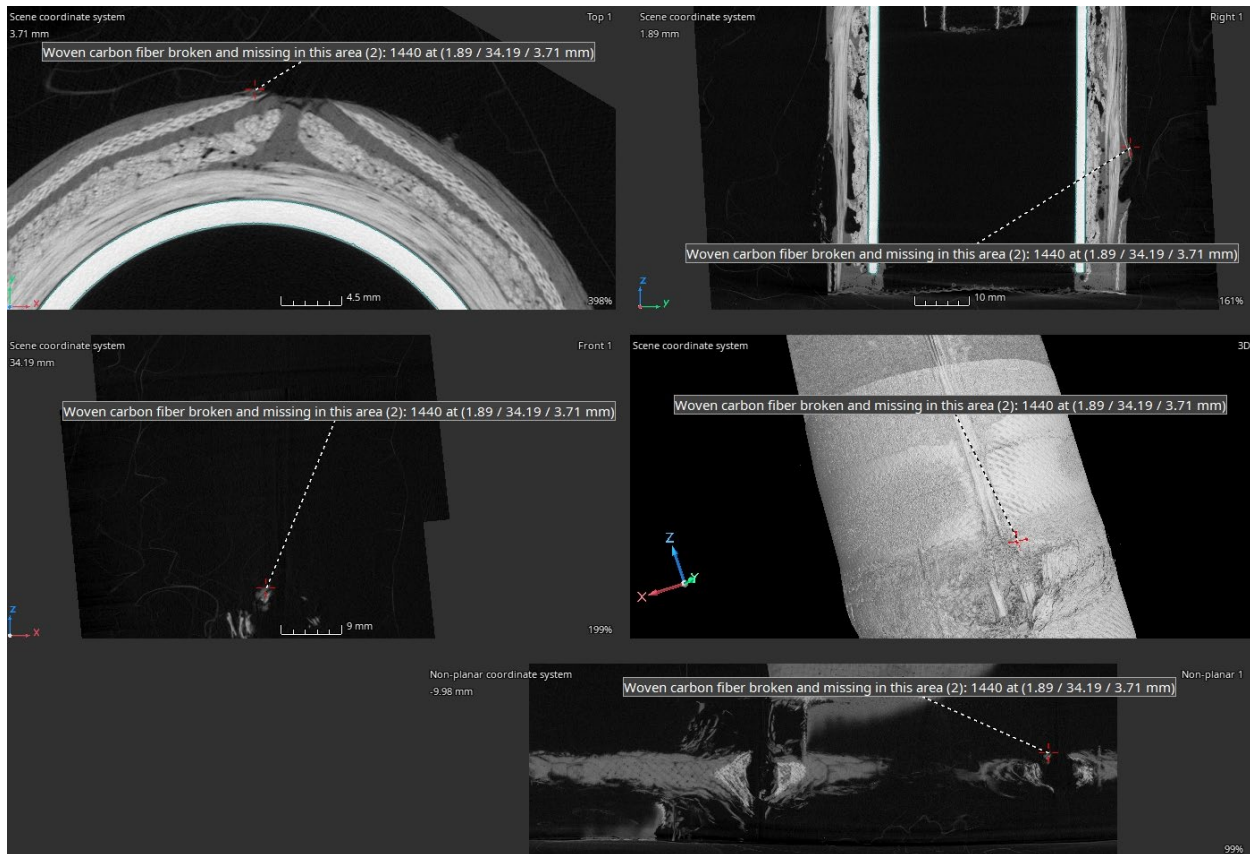
**Figure 44.** CT images of the accident propeller blade root - area 2 of broken and missing woven carbon fiber layers.
