# National Transportation Safety Board

WPR24FA053

## **MATERIALS LABORATORY**

Location: Eloy, Arizona  
Date: December 8, 2023  
Vehicle: Series 5 Kitfox, N66180  
Investigator: Elliott Simpson, AS-WPR

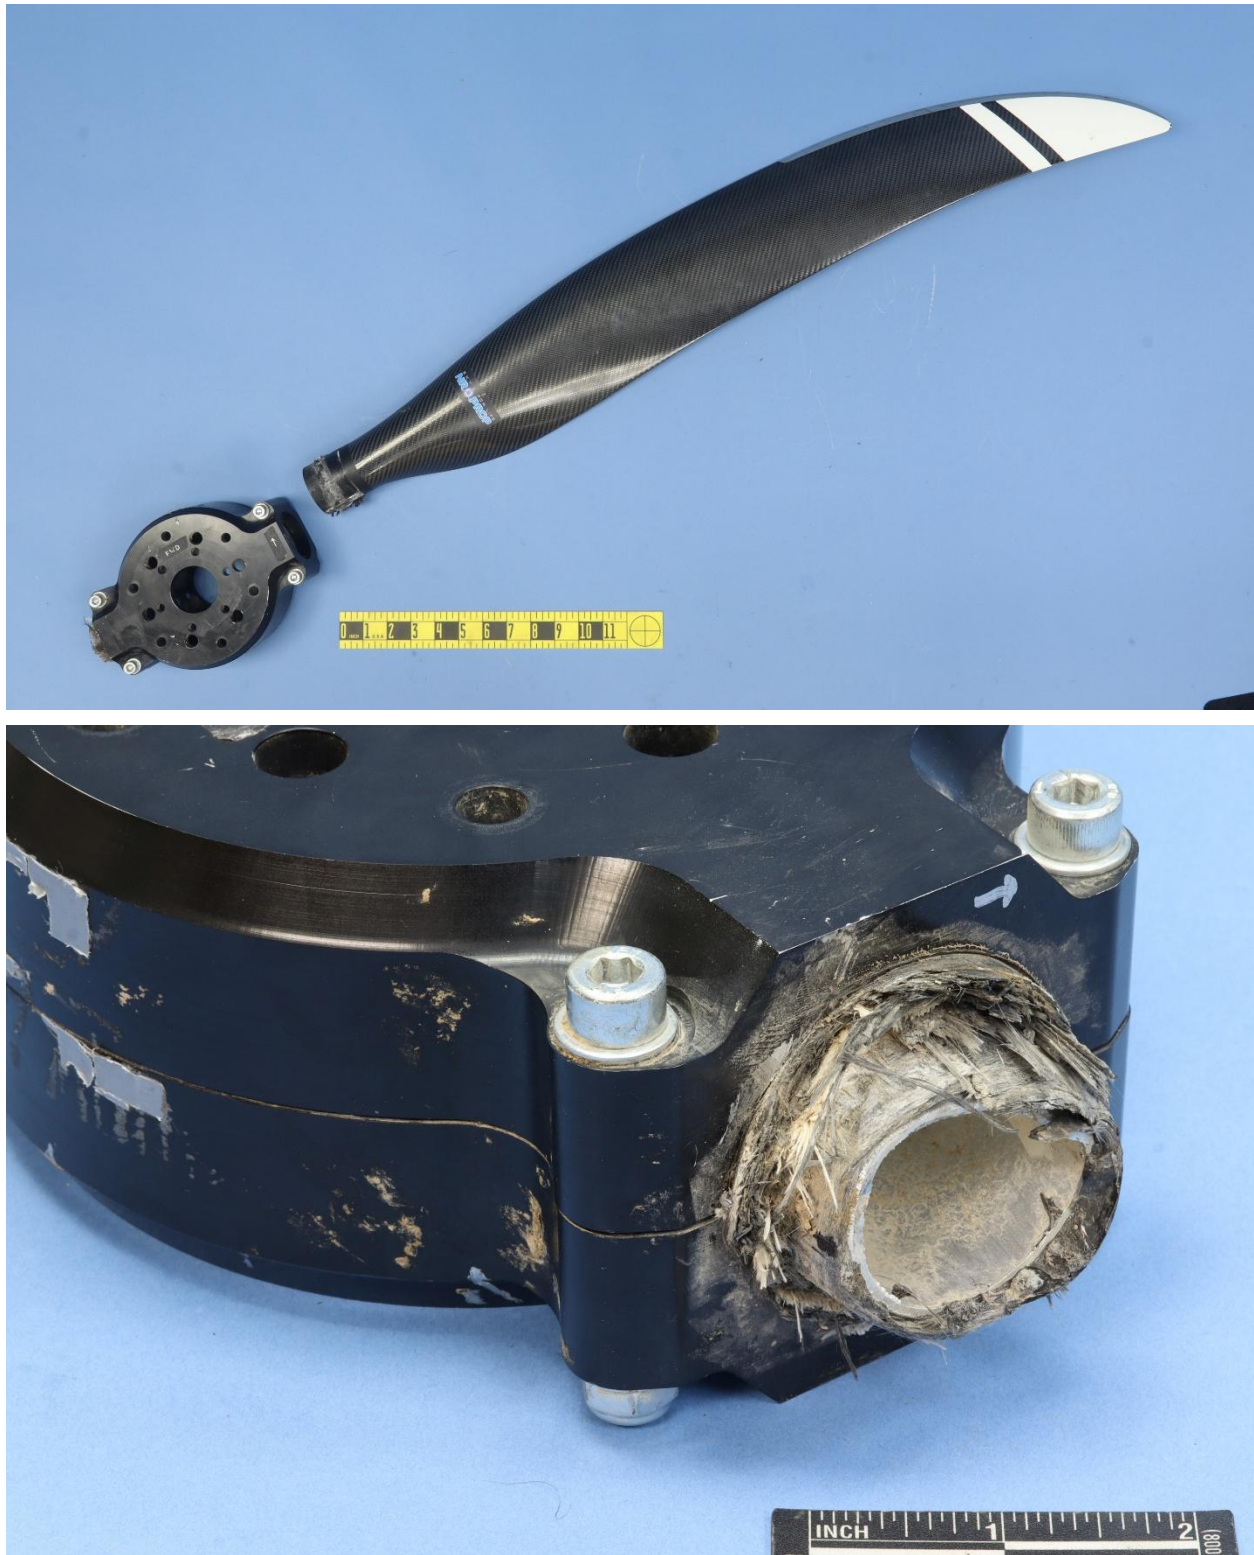
Pieces of a ground adjustable pitch propeller assembly were submitted to the NTSB Materials Laboratory for examination (figure 1). One of the blades had pulled free of the hub. The other blade had fractured just above the root and the root was still retained within the hub. An exemplar blade was also submitted for examination (figure 2a).

**Figure 1.** Top image: Overview of propeller hub with retained blade root and separated blade. Bottom image: The retained root of the separated blade.

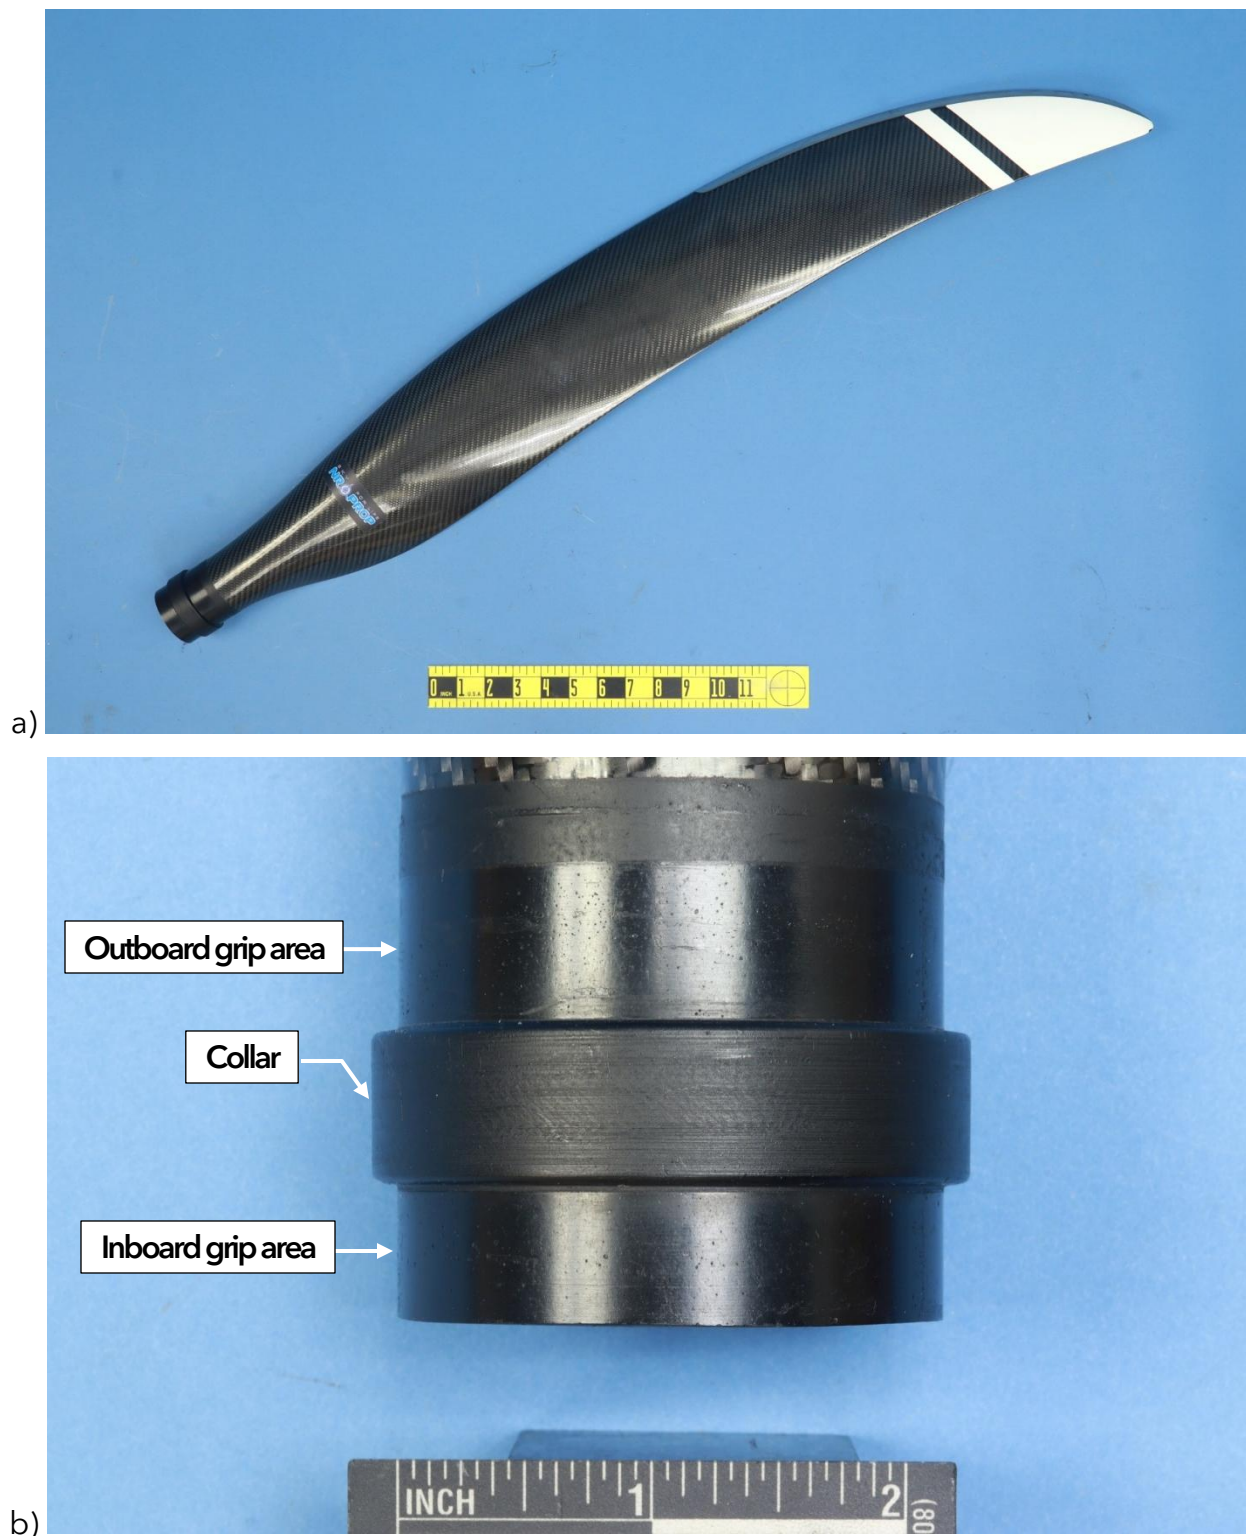
The assembly, as originally installed, consisted of two composite propeller blades and a two-piece hub, clamped together by bolts. Blade retention was achieved by friction between the outer cylindrical surface of the blade and an inner clamping surface on the hub along spanwise inboard and outboard grip areas (figure 2b). A collar in the middle of the blade retention area slotted into a groove on the hub (see below).

**Figure 2.** Exemplar propeller blade: a) Overview image and b) blade root.

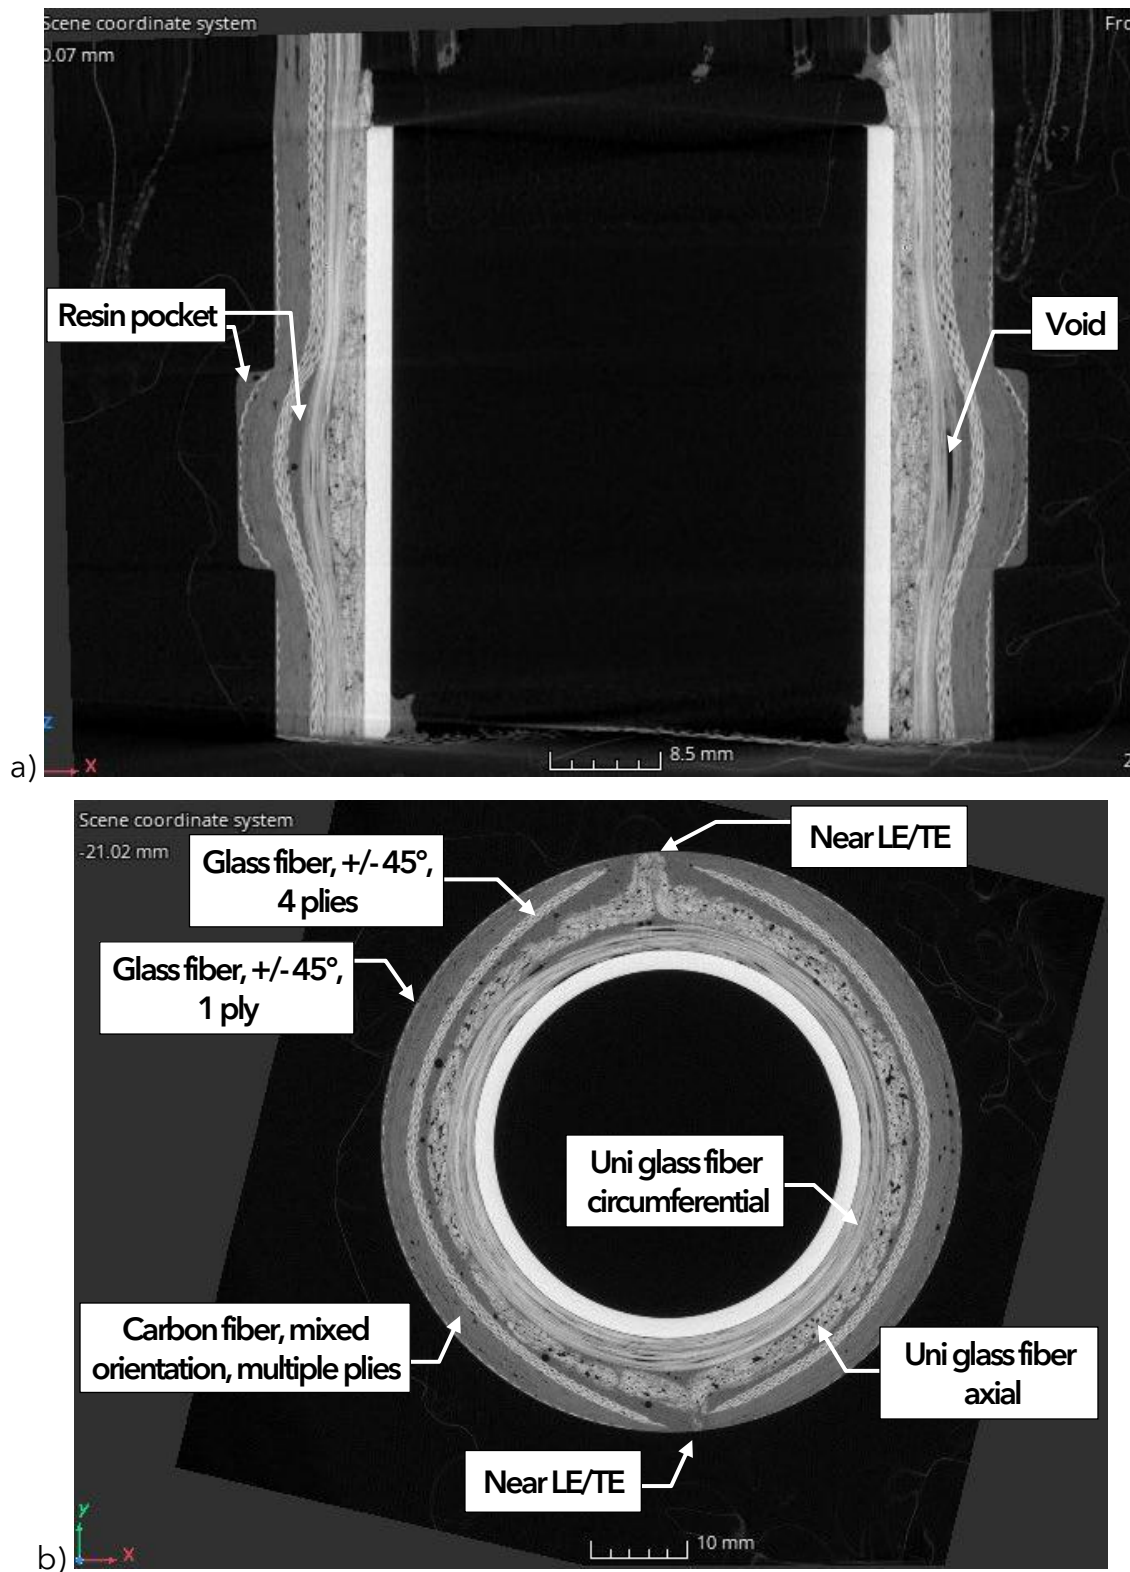
The root sections of the exemplar blade and separated blade were examined by X-ray computed tomography (X-ray CT). Longitudinal and transverse sections of the exemplar blade are shown in figures 3a and 3b, respectively. The retained blade root was also cut in the longitudinal direction after it was removed from the hub and the layers were examined in cross section by optical microscope and scanning electron microscope (see below).

The root construction consisted of multiple composite fiber polymer matrix layers built around an aluminum tube. The innermost layer consisted of unidirectional (uni) glass fiber wound circumferentially around the tube. The next layer consisted of uni glass fibers oriented along the axial direction of the blade. The next layer comprised four plies of plain-woven glass fiber fabric with warp and weft at  $\pm 45^\circ$ . The next layer comprised multiple plies of carbon fiber fabric. Plies that could be clearly distinguished included three  $0^\circ/90^\circ$  plies, a  $\pm 45^\circ$  ply, and three additional  $0^\circ/90^\circ$  plies. The final outermost layer consisted of a  $\pm 45^\circ$  glass fiber fabric ply. The axial unidirectional fiber layer thickness was built up near the leading and trailing edges of the blade. As such the woven fabric layers did not wrap completely around the root of blade but rather came to tapered ends as they approached the leading and trailing edges (figure 3b).

**Figure 3.** X-ray CT scans of the exemplar blade root: a) axial section and b) transverse section. The unidirectional fibers in the axial direction were built up near the leading edge (LE) / trailing edge (TE) of the blade root.

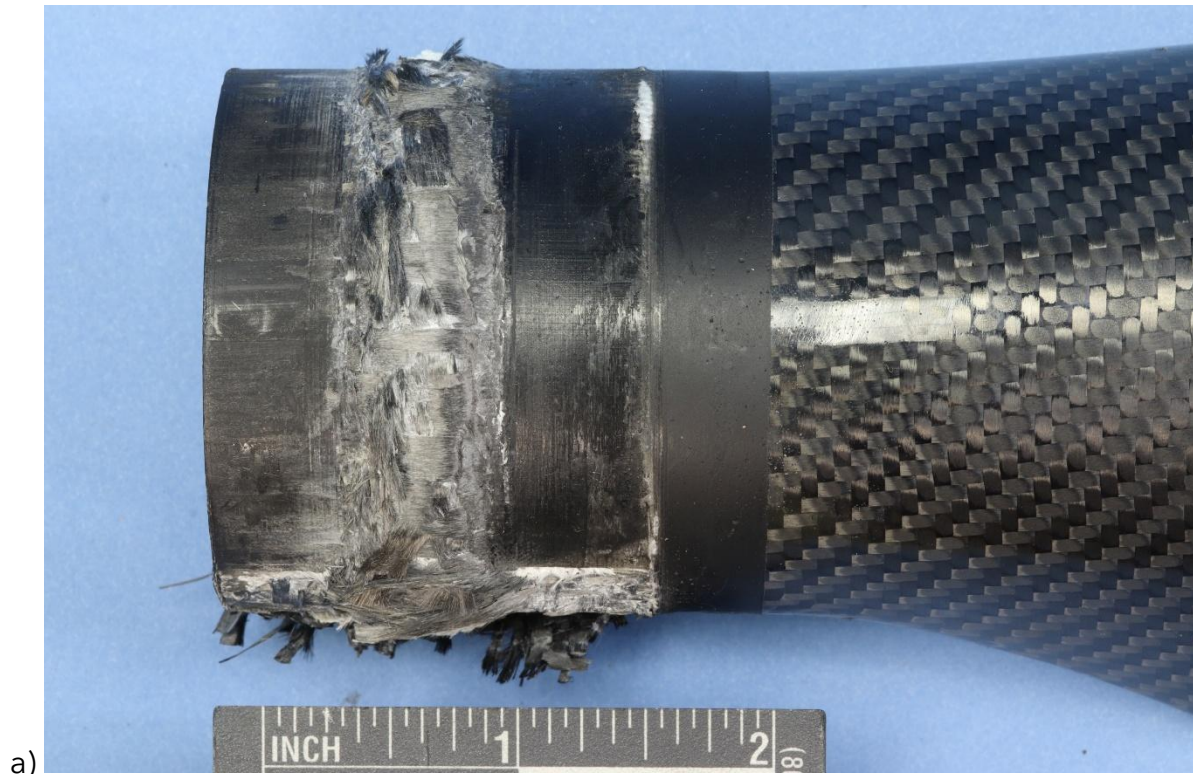
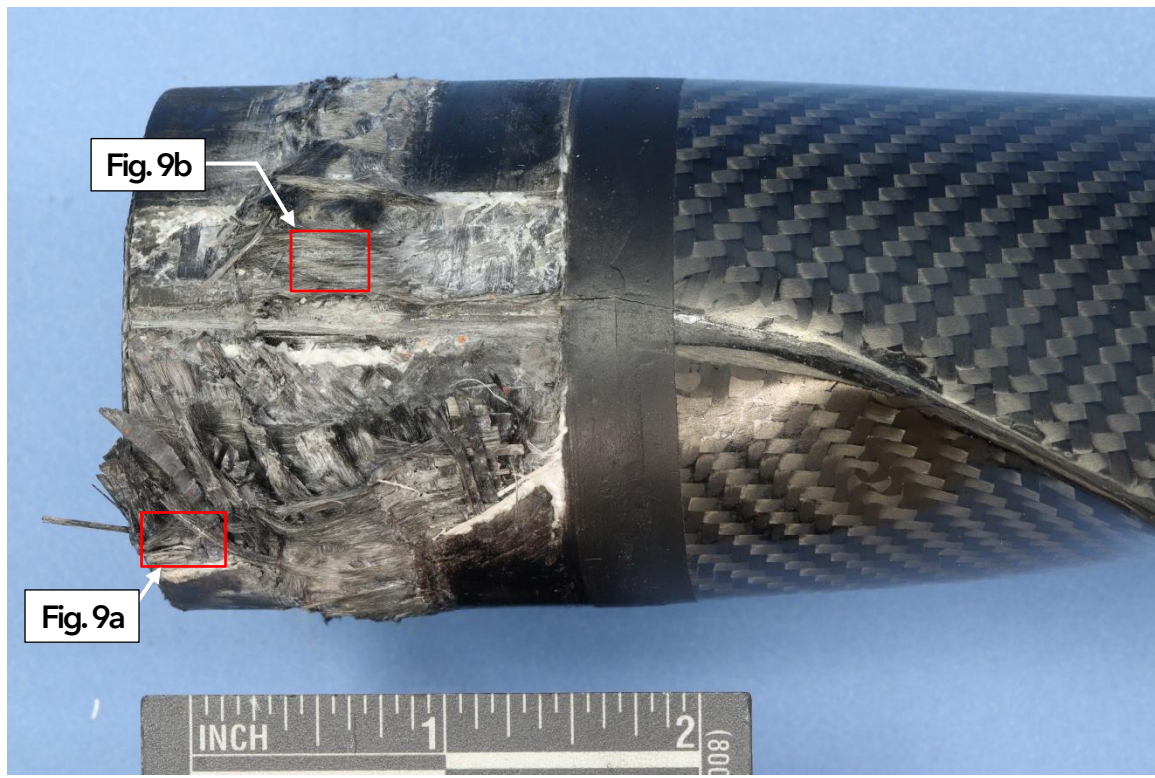
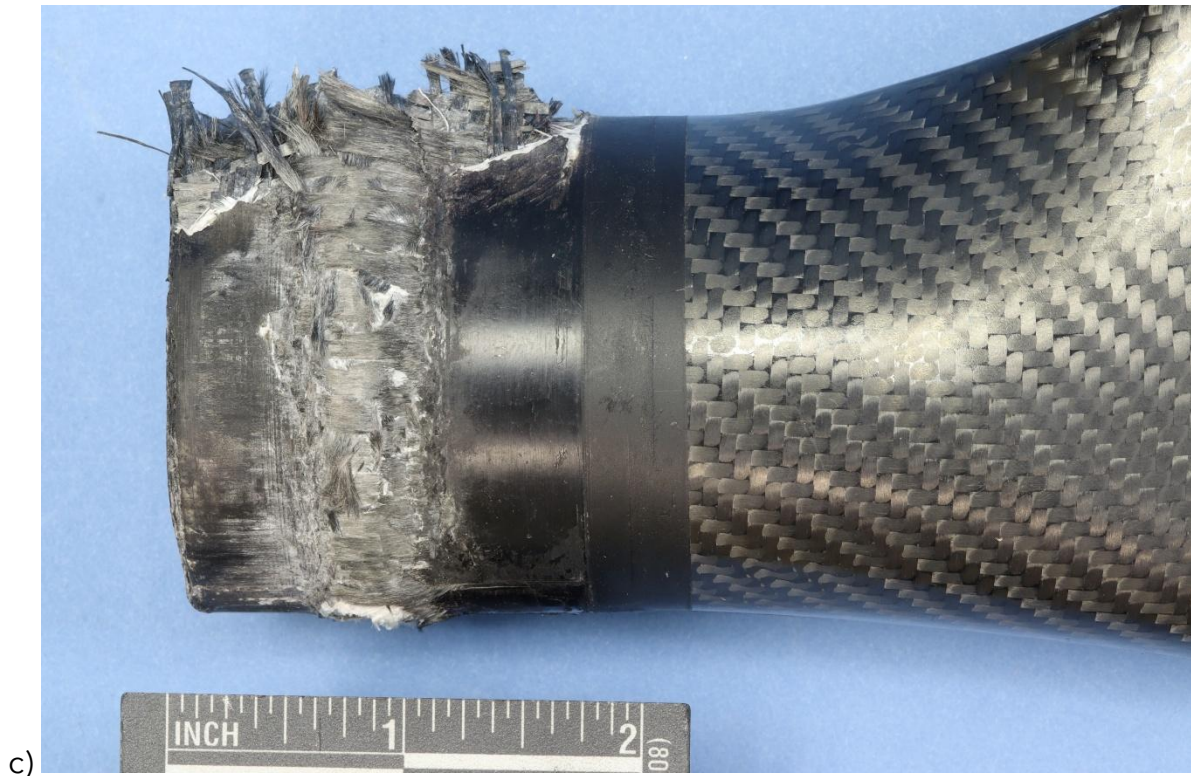
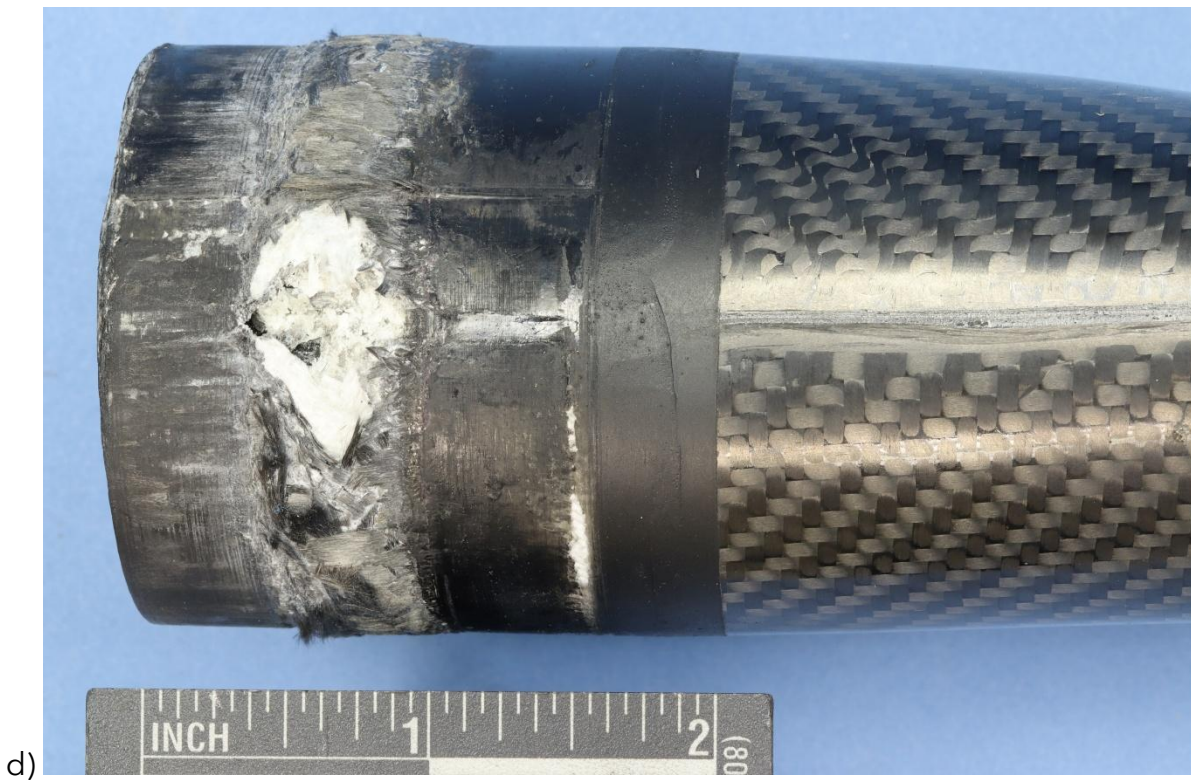
The separated blade exhibited fracture and wear features at its root end (figures 4a – 4d). There were axial (spanwise) rub marks on the grip section at the base of the blade root and on the clamping faces of the hub (figures 5a, 5b). The collar had separated from the blade and was retained inside the groove in the hub (figures 5a, 5b). The outer resin and glass fiber layers were worn away on either side of the built up unidirectional axial fiber layer close to the blade trailing edge (figure 4b). On the opposite side of the blade, an elliptical wear region had exposed the  $\pm 45^\circ$  glass fiber layers in the collar region (figure 4d).

**Figure 4.** Images of separated blade root: a) approximately in-line with blade back; b) approximately in-line with trailing edge;

**Figure 4 (cont.).** c) approximately in-line with blade face; and d) approximately in-line with leading edge.

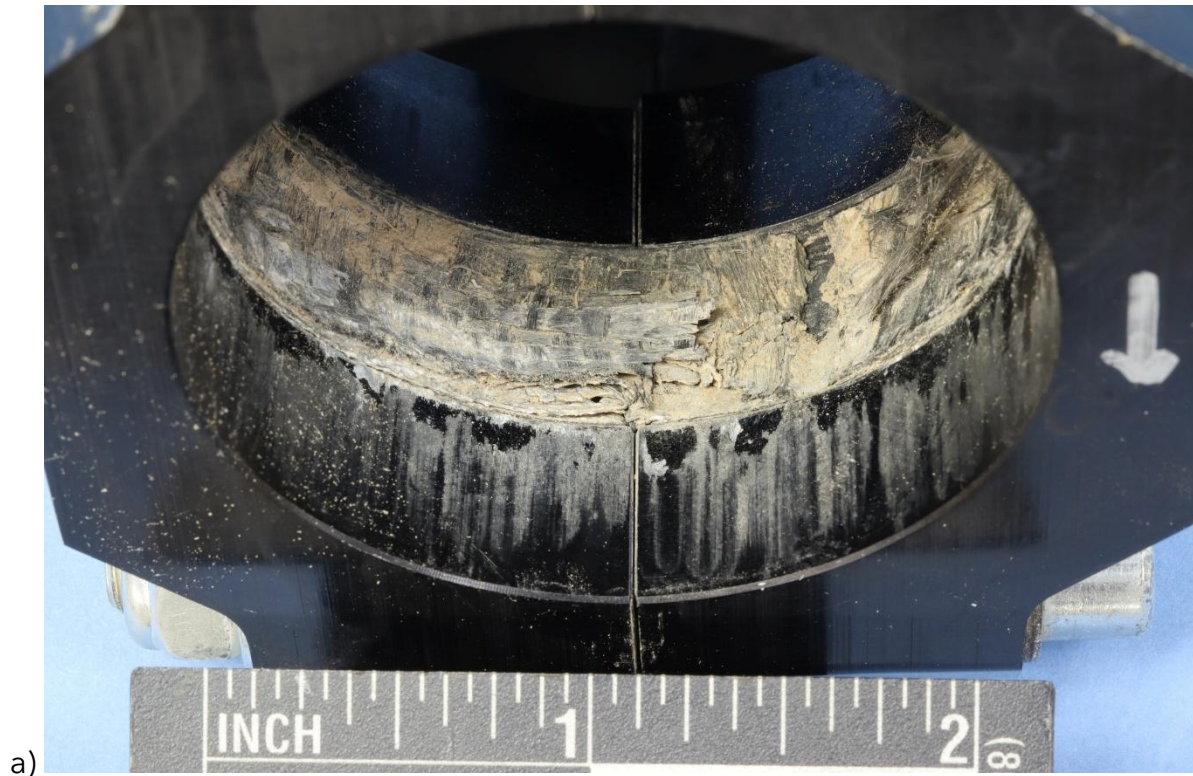
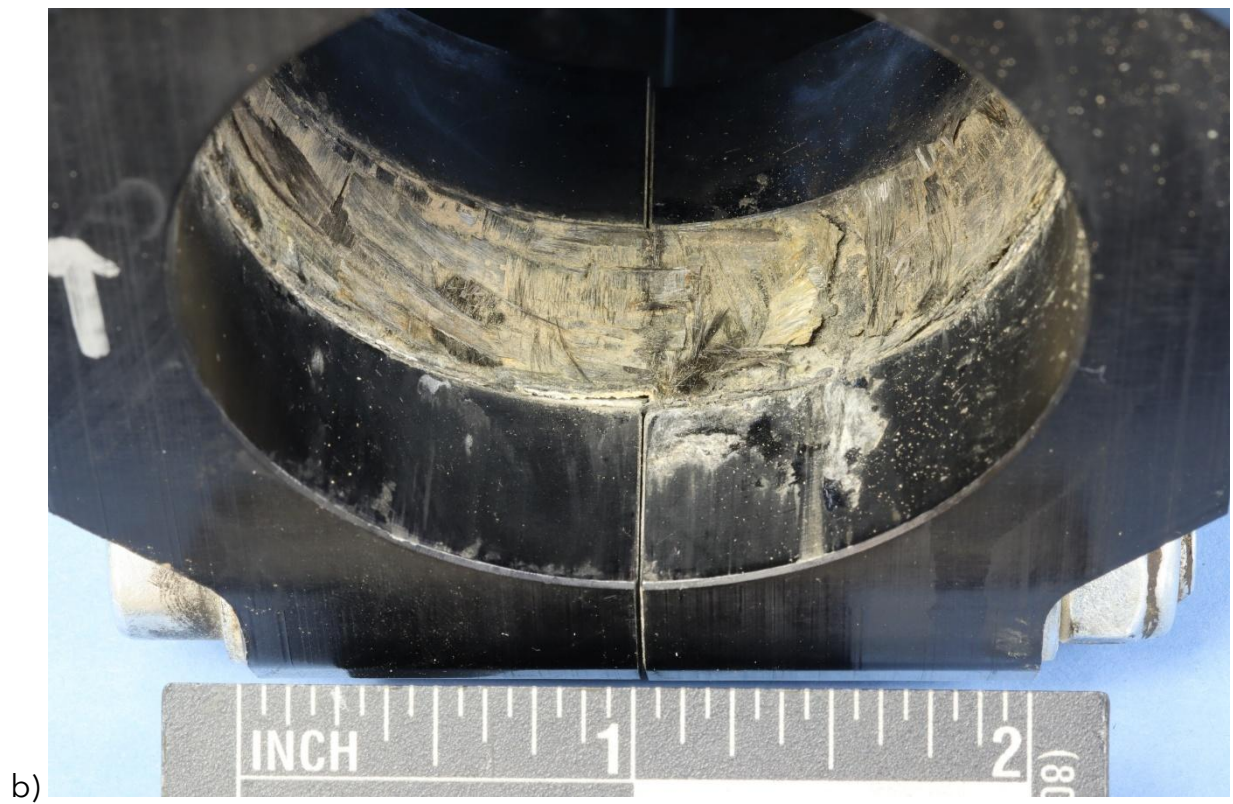
**Figure 5.** a) and b) Images of the blade collar remnant left inside the hub groove.

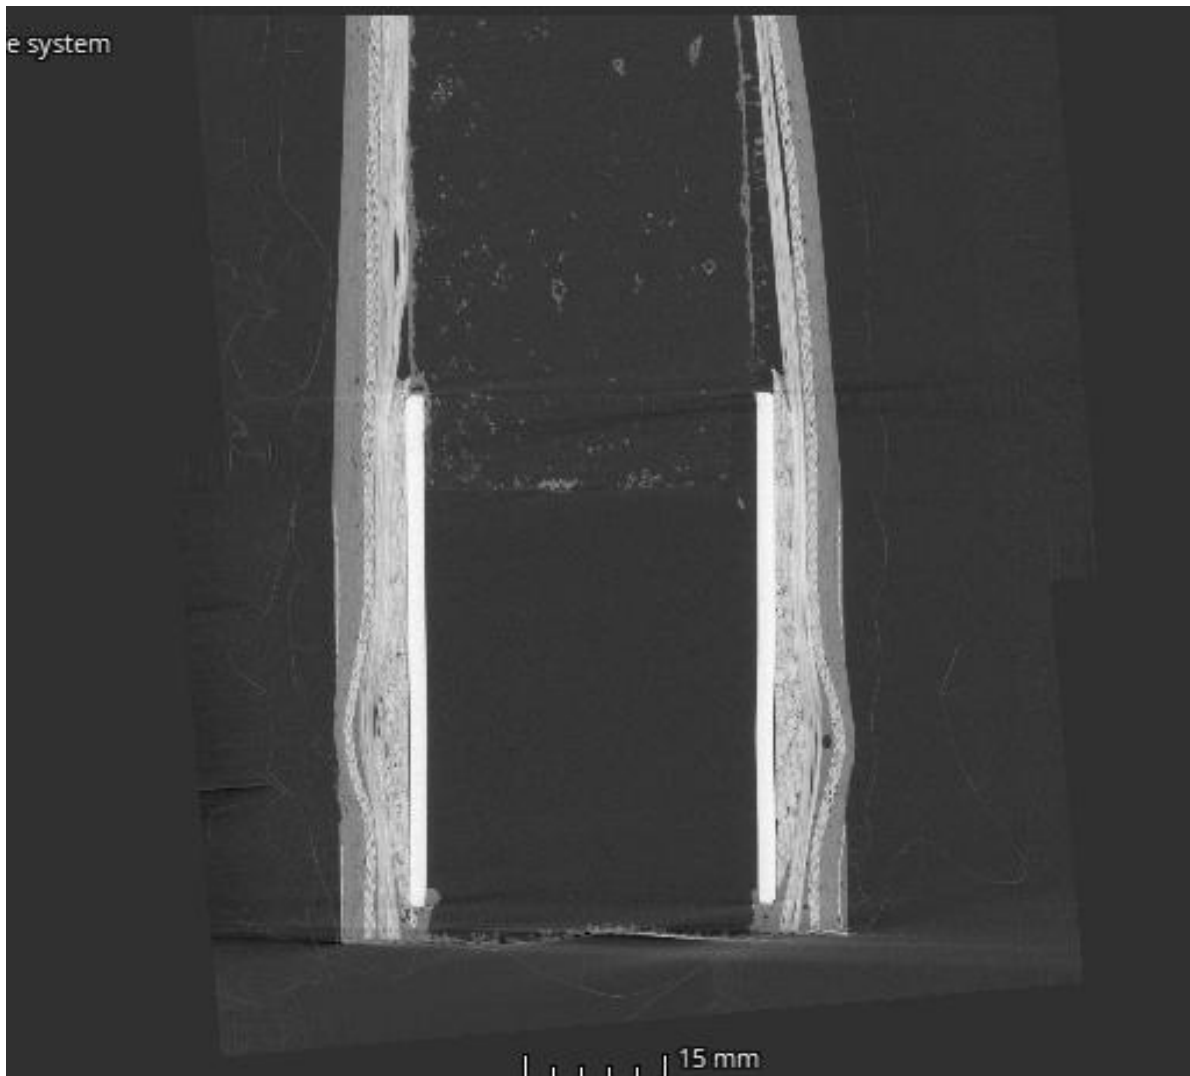
As seen in X-ray CT scans, the aluminum backing tube was not positioned against the base of the blade root (figure 6). Measurements on axial/radial images indicated that the tube was recessed from the base of the blade approximately 3.7 to 3.8 mm (approximately 0.15 inch).

**Figure 6.** X-ray CT scan showing the recessed aluminum tube on the separated blade.

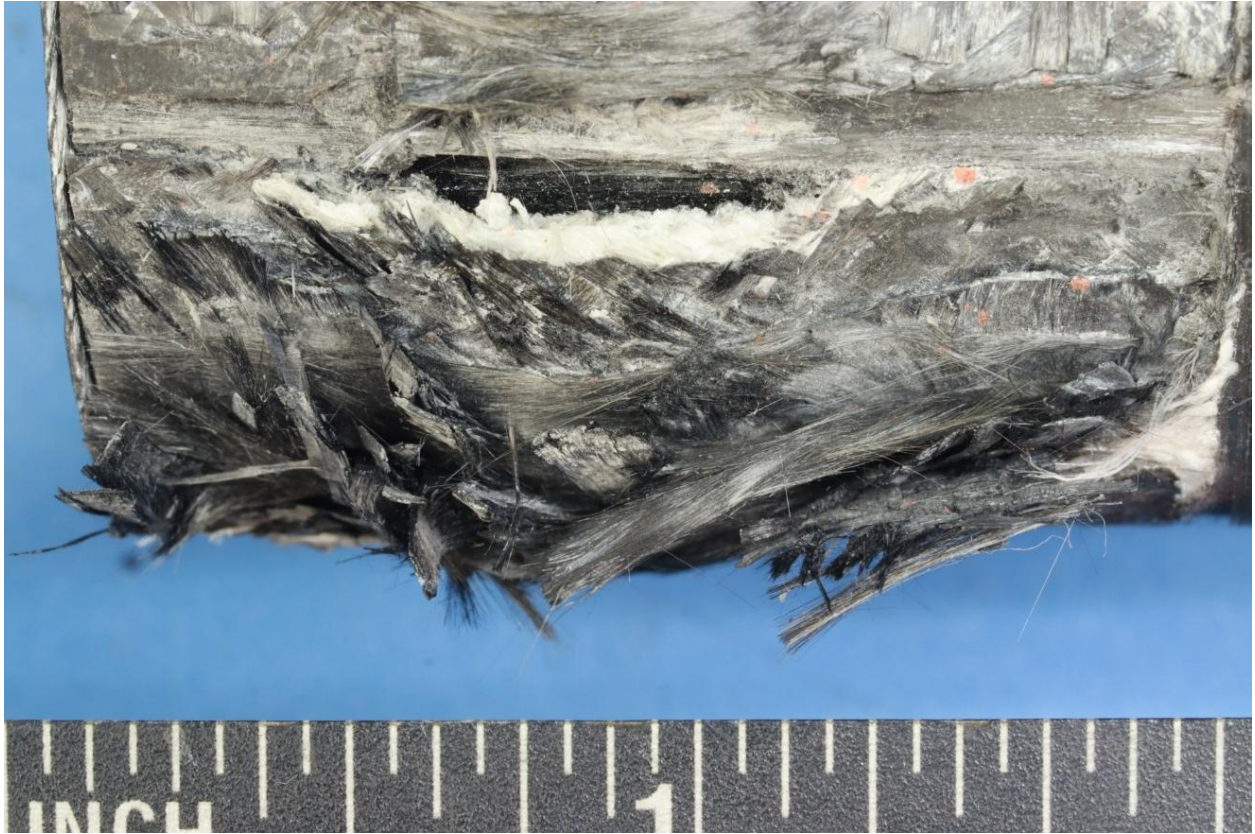
The blade exhibited multiple voids. Several of these voids were visible from the outside where the collar had separated. One void was located near the trailing edge between the  $\pm 45^\circ$  glass fiber layers and the underlying unidirectional axial fiber layer, within the collar region (figure 7). The void measured approximately 15 mm by 2.5 mm (about 0.6 inch x 0.1 inch). A second void was visible on the opposite side of the blade, near the leading edge position (figure 8a). The void opening was located within the collar region and was round with an approximate diameter of 8 mm (0.32 inch). X-ray CT scan images through this region indicated that the opening connected to a network of sub-surface voids that extended approximately 18.5 mm along the axial direction starting near the base of the blade root (figure 8b). Additional void regions were visible on other scan images. See the X-ray CT scan report for additional details.

**Figure 7.** Void between the +/- 45° glass fiber layers and the underlying unidirectional axial glass fiber layer. The void measured approximately 0.6 inch by 0.1 inch. See also figure 4b.

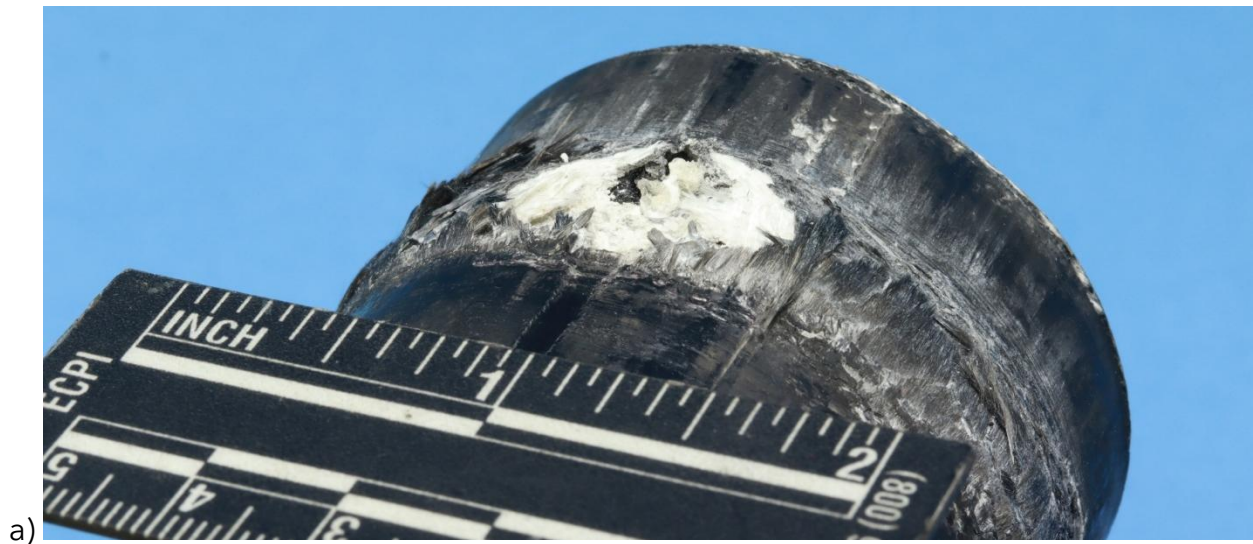
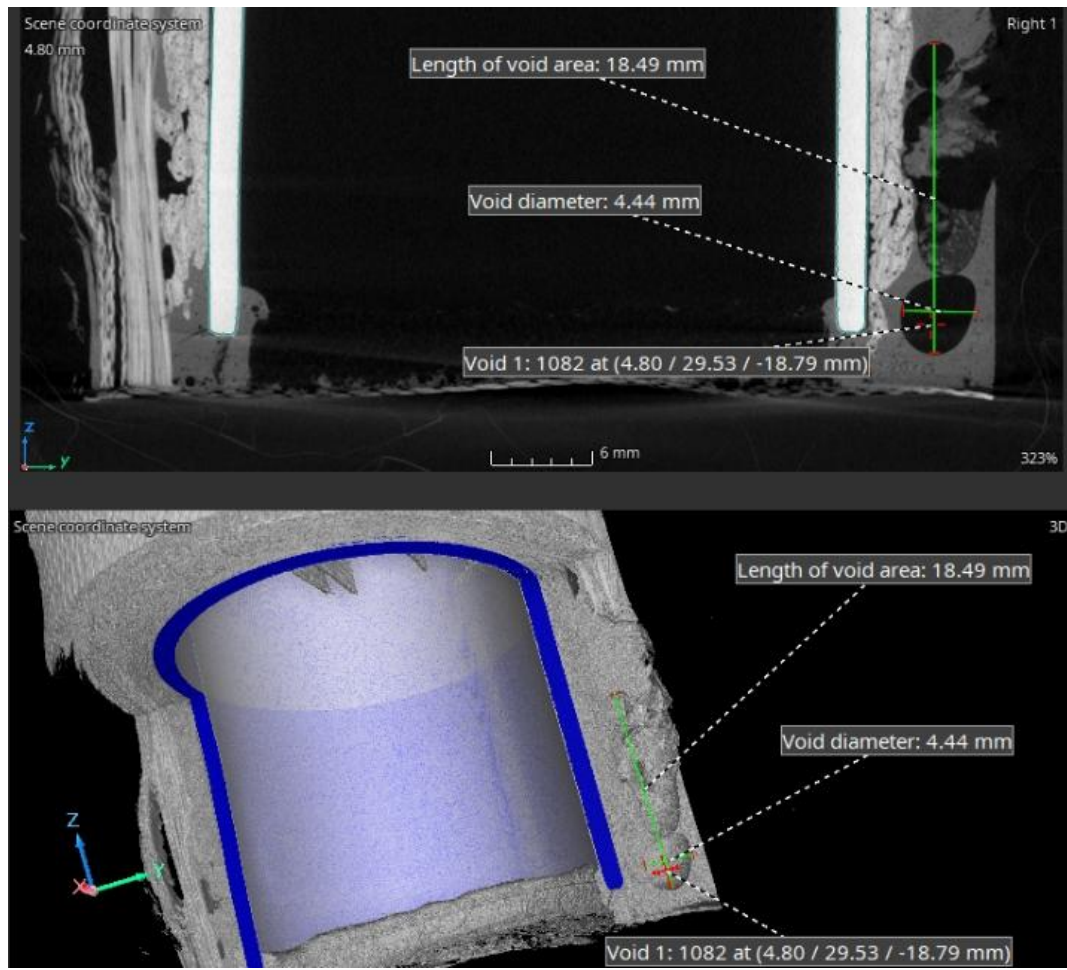
**Figure 8.** a) Image of blade root near leading edge location showing exposure of void after separation from the blade collar and b) X-ray CT scans through void showing subsurface structure.

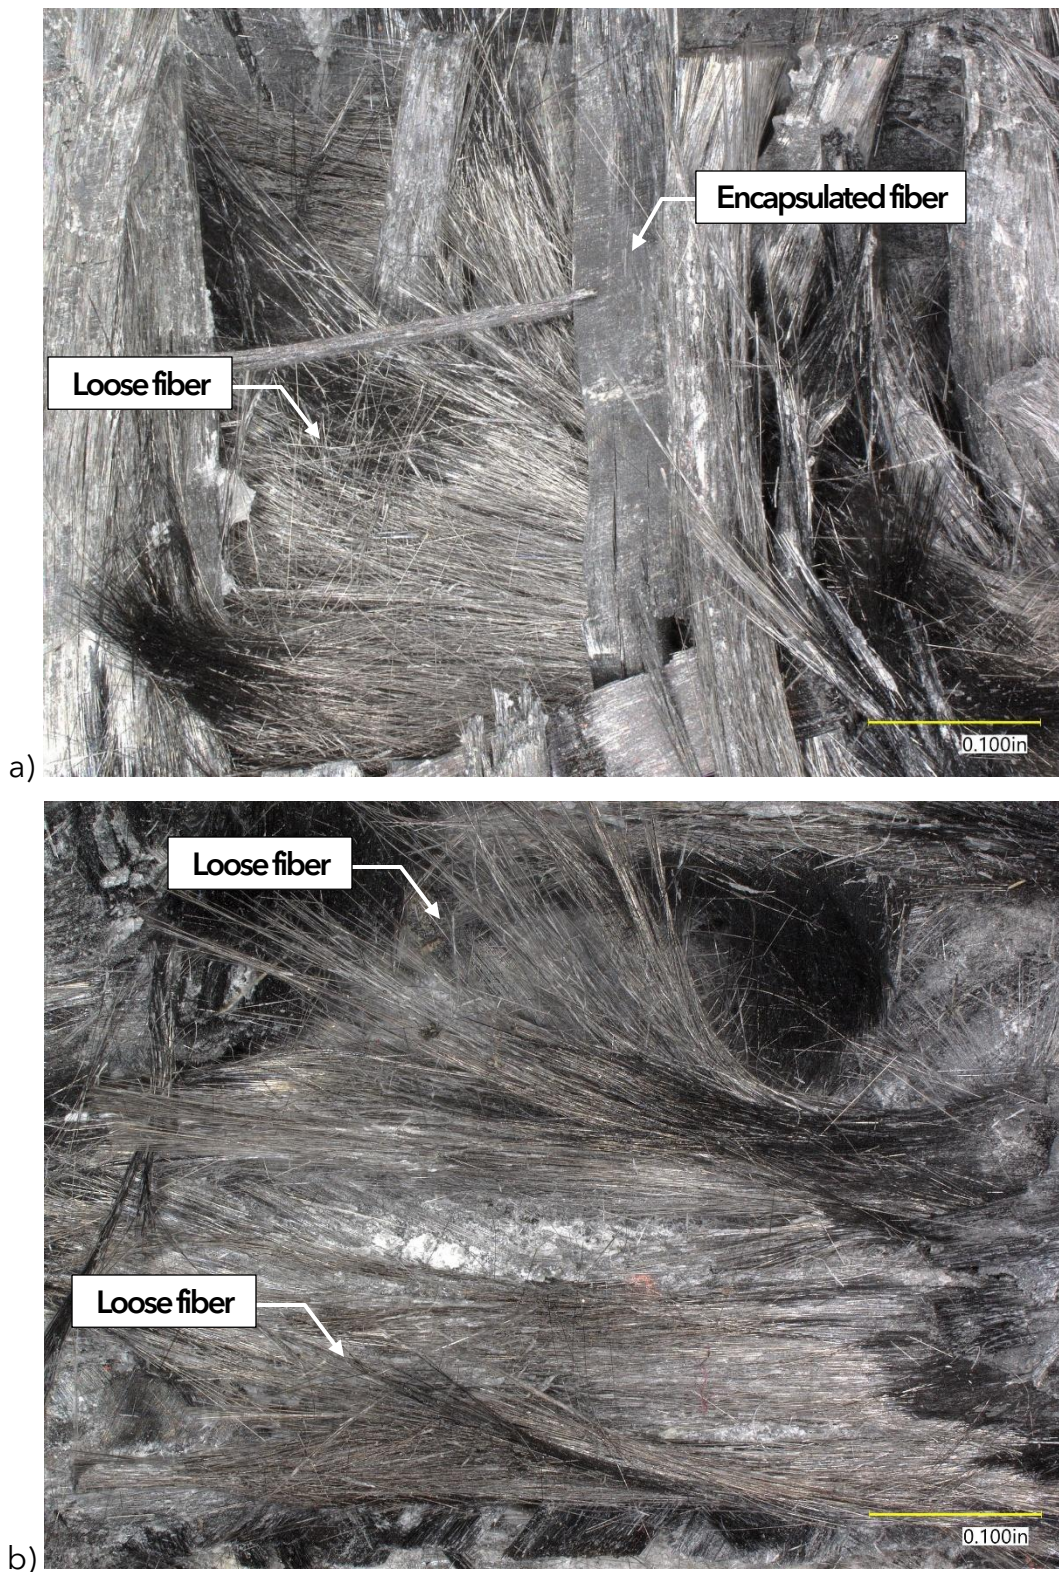
Loose fiber regions were visible on the exposed fiber surfaces at the blade root. Typical images are shown in figures 9a and 9b at the locations indicated in figure 4b. The appearance was consistent with incomplete or absent resin encapsulation (resin starvation).

**Figure 9.** a) and b) Images of loose fiber regions on the separated blade at the locations indicated in figure 4b.

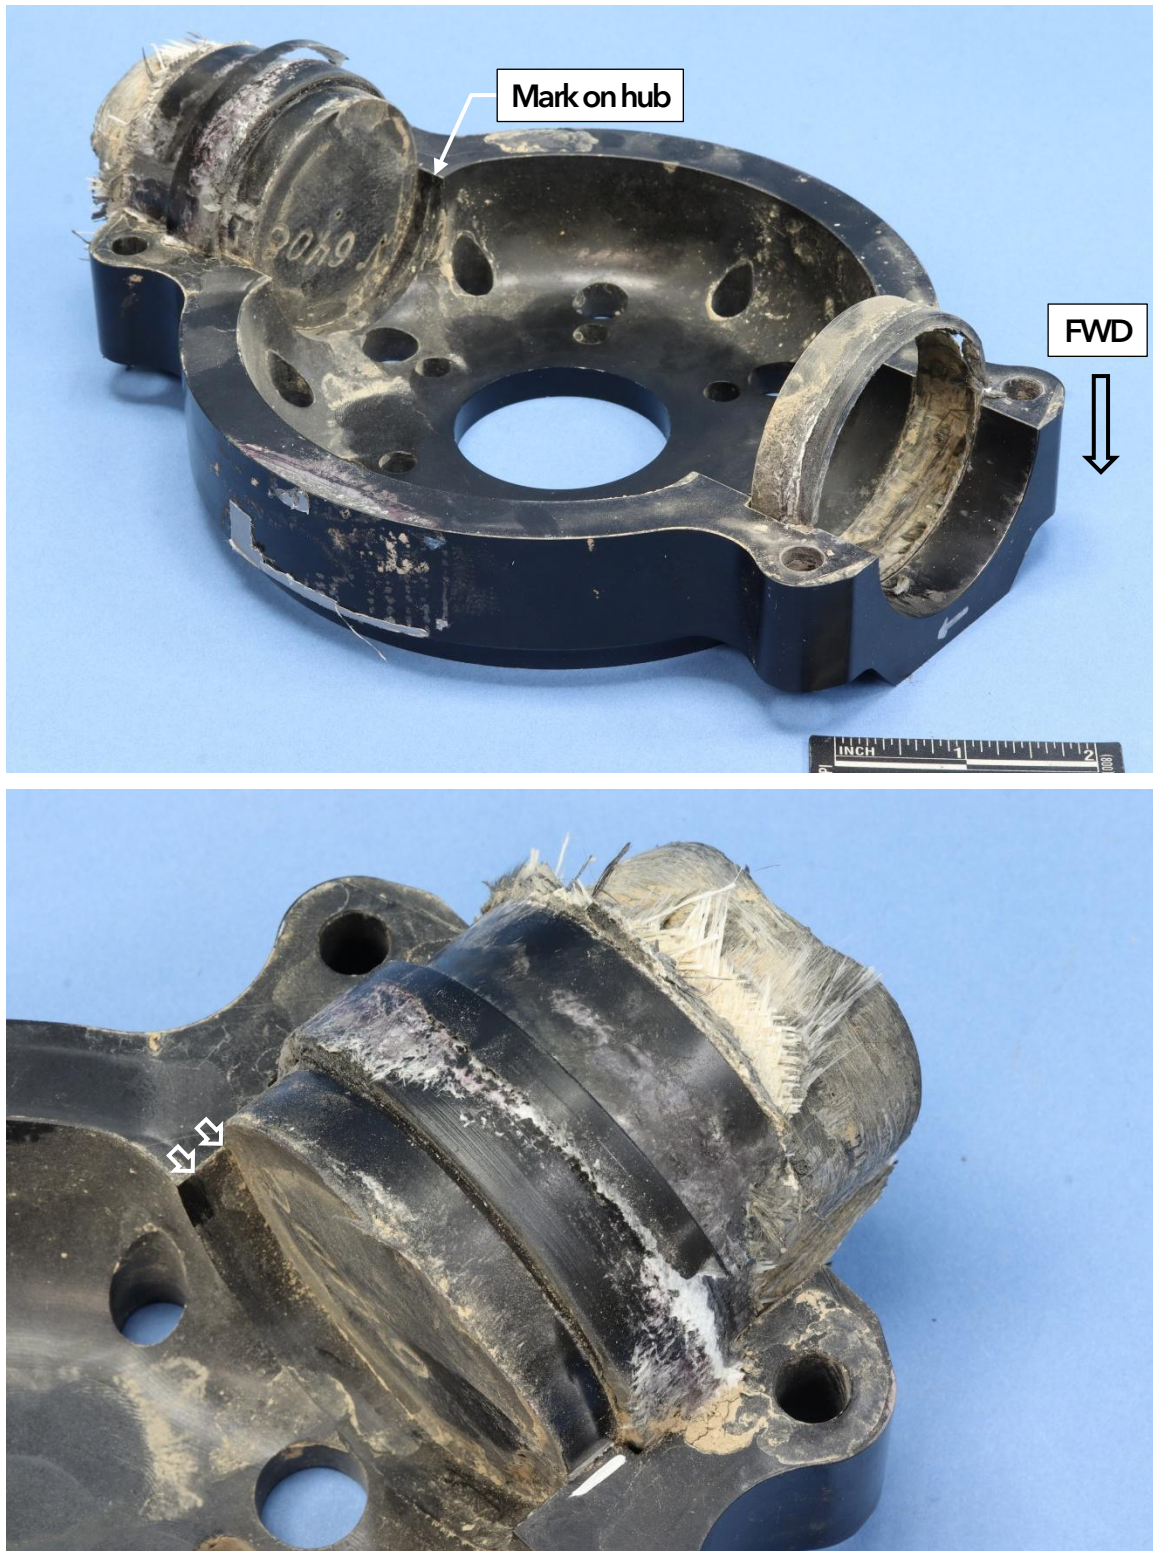
The hub was examined in its as-received state prior to disassembly and attributes related to blade retention were measured. On the side with the separated blade, within the blade clamping area, the distance between the inner clamping surfaces, measured  $90^\circ$  to the parting plane, was 54.23 mm (2.135 inch). On the same side, the gap between the mating hub halves was 0.25 mm (0.010 inch), measured by feeler gage. One of the two clamping bolts had an additional gap of 0.30 mm (0.012 inch), measured by feeler gage between a nut and a washer. On the opposite end, with the retained blade root, the gap between the mating hub halves was 0.64 mm (0.025 inch), measured by feeler gage. Tightening torque for the two blade retention bolts that held the retained blade root was approximately 11.3 N-m ( $\sim 100$  lbs-in) and 13.6 N-m ( $\sim 120$  lbs-in) for the leading and lagging bolts, respectively, as measured by a torque gage. The hub was then disassembled, revealing the retained collar from the separated blade and the retained blade root in its entirety (figure 10a, b).

The retained blade root appeared to have shifted spanwise outward (figures 10 and 11). There was a dirt/dust mark on the hub clamping surface approximately 4.4 mm (0.17 inch) inboard of the root end of the blade. The collar, still within the groove had slid toward the base of the blade root. Whereas on the exemplar blade, the distance from the base of the blade to the near edge of the

**Figure 10.** Upper image: Overview of hub with aft half removed. Lower image: Closer image of retained blade root. Arrows indicate the location of a mark on the hub and the position of the blade root.

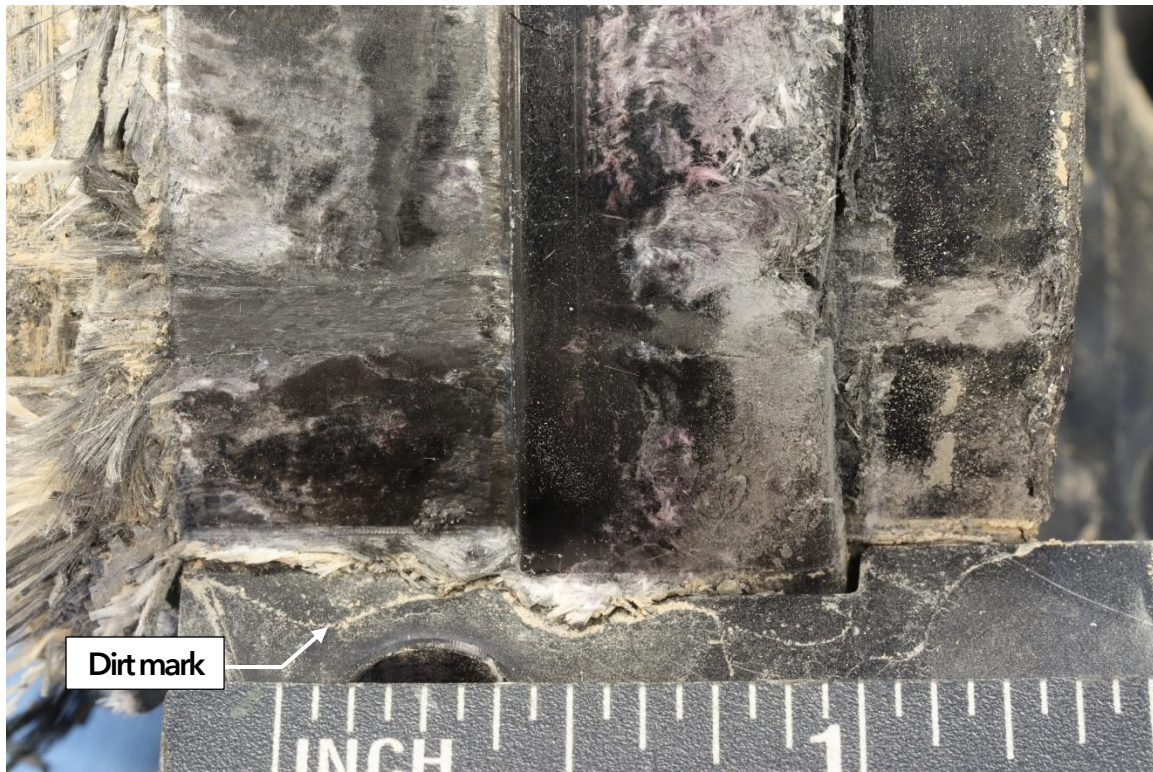
collar was approximately 13.17 mm (0.518 inch), the same feature on the remnant blade root was approximately 7.91 mm (0.312 inch). Resin and fiber material was observed extruding into the gap between the hub halves (figure 11). Dirt/dusk marks appeared to follow the edges of some of the remaining extruded material.

**Figure 11.** Image showing extrusion of blade root material into the gap between mating hub halves.
