# National Transportation Safety Board

WPR24FA053

## **MATERIALS LABORATORY**

Location: Eloy, Arizona  
Date: December 8, 2023  
Vehicle: Series 5 Kitfox, N66180  
Investigator: Elliott Simpson, AS-WPR

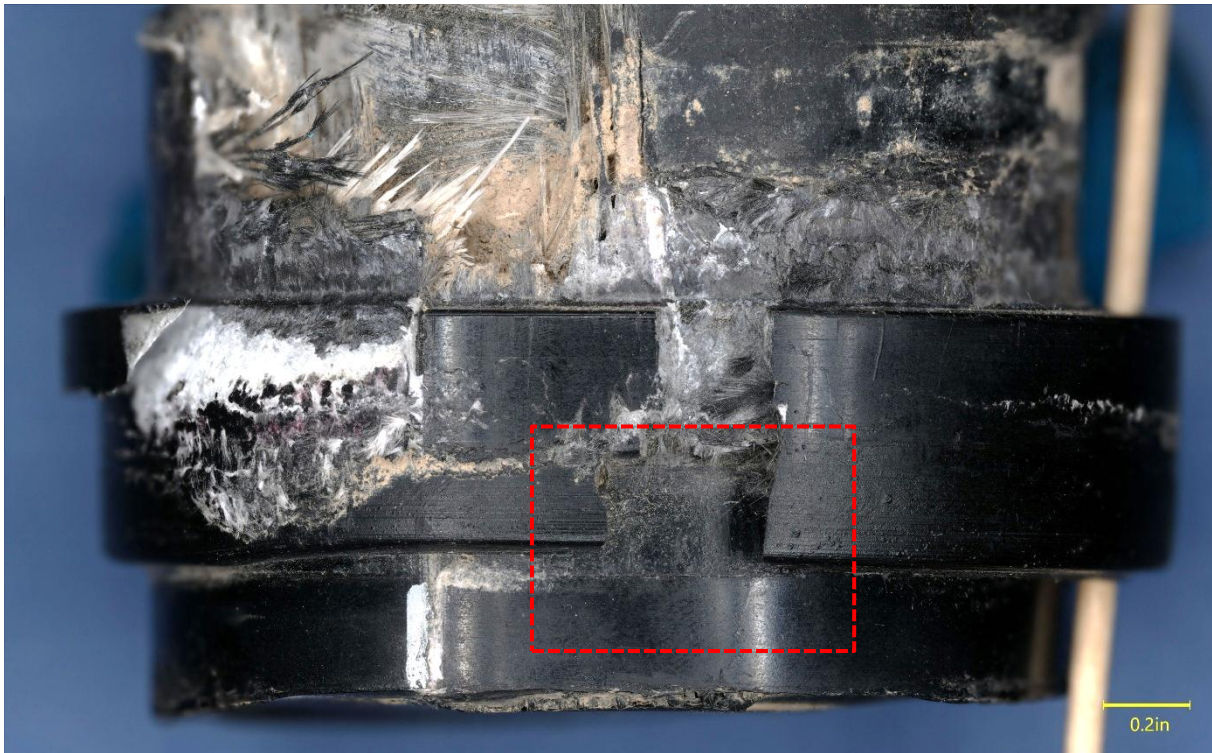
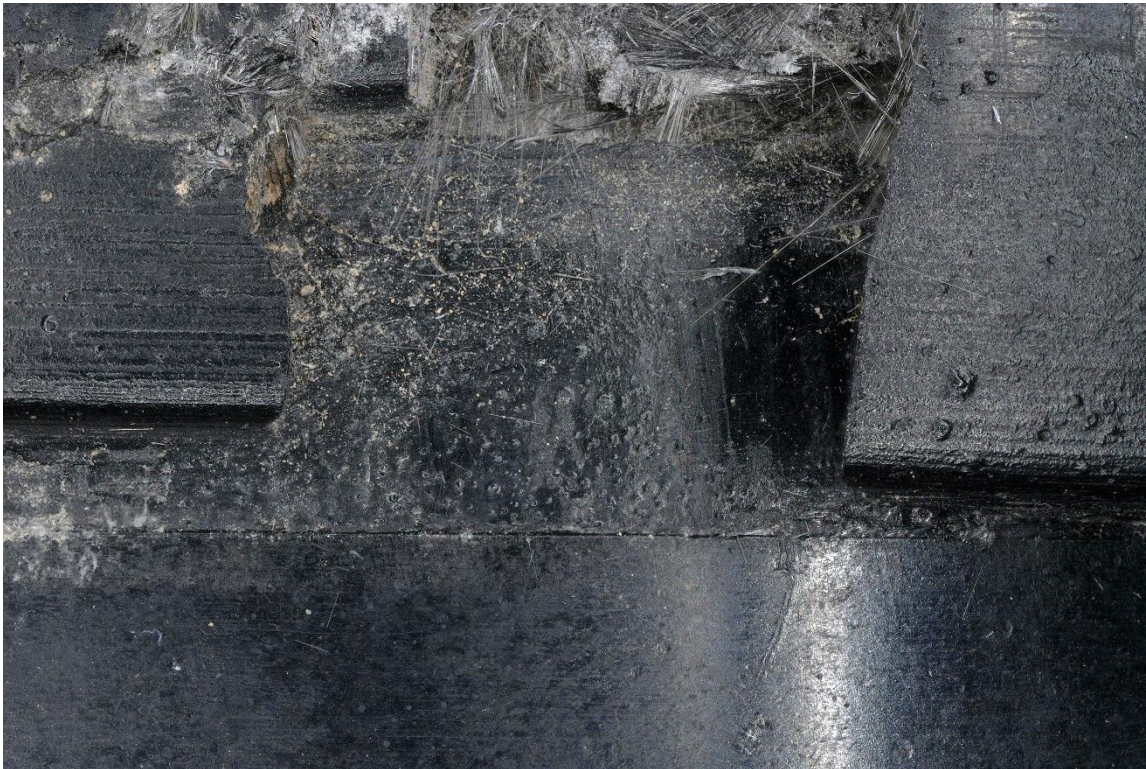
The inboard grip region on the blade root had two regions that exhibited different surface textures (figure 12). The inboard (lower) portion, extending approximately up to the lower edge of the displaced collar feature, had a flat and comparatively smooth appearance. The outer (upper) portion, extending up to the original edge of the collar, had a comparatively textured, raised, and dimpled appearance. Several comparatively faint spanwise scuff marks were observed in the upper portion. There was an axial rub mark on the hub and blade root at the trailing edge location (figure 13) and features consistent with rubbing on the hub and damage to the blade root near the leading edge location (not shown).

**Figure 12.** Top image: Overview image of blade root. Lower image: Higher magnification image showing the flat and smooth region below the comparatively textured region.

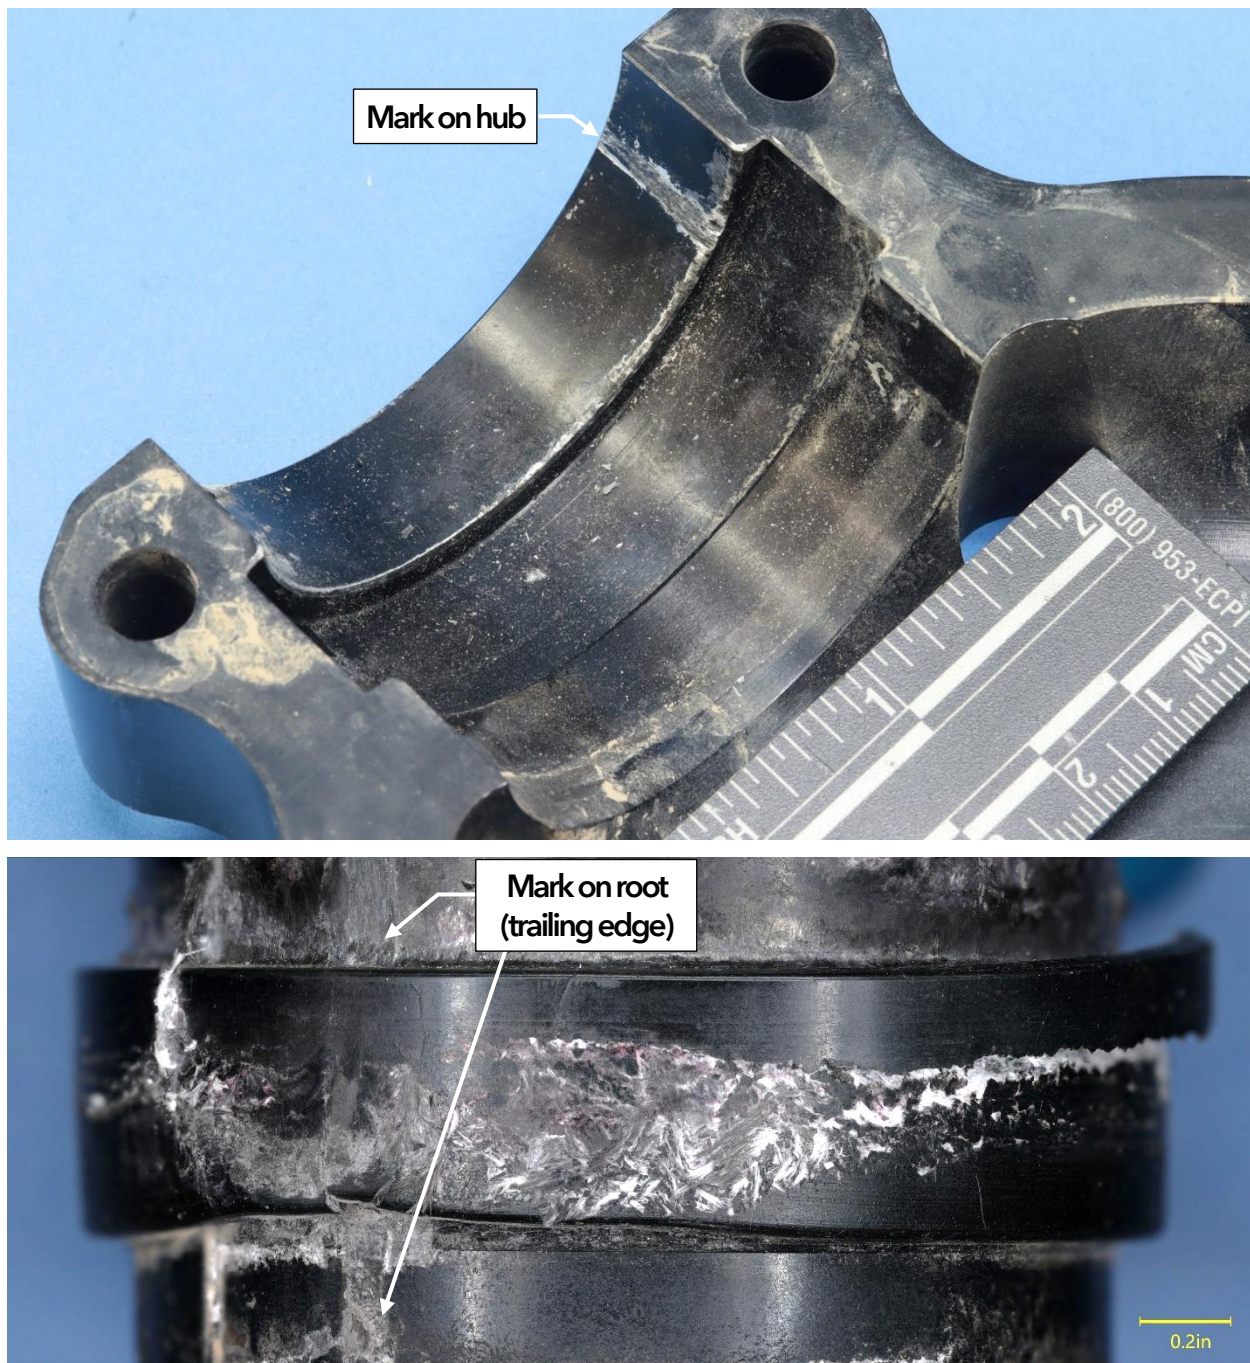
**Figure 13.** Marks on the hub and blade root near the trailing edge position.

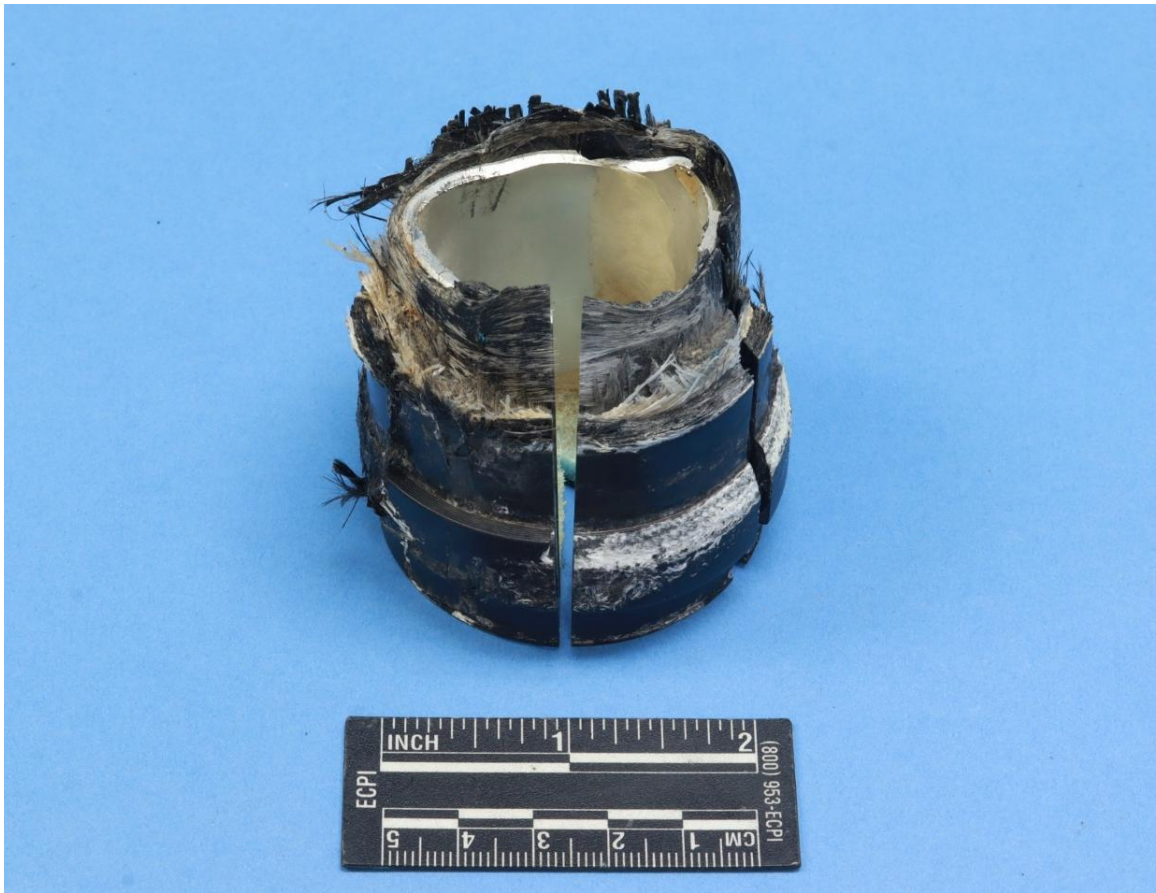
**Figure 14.** Location of longitudinal section removed from the blade root.

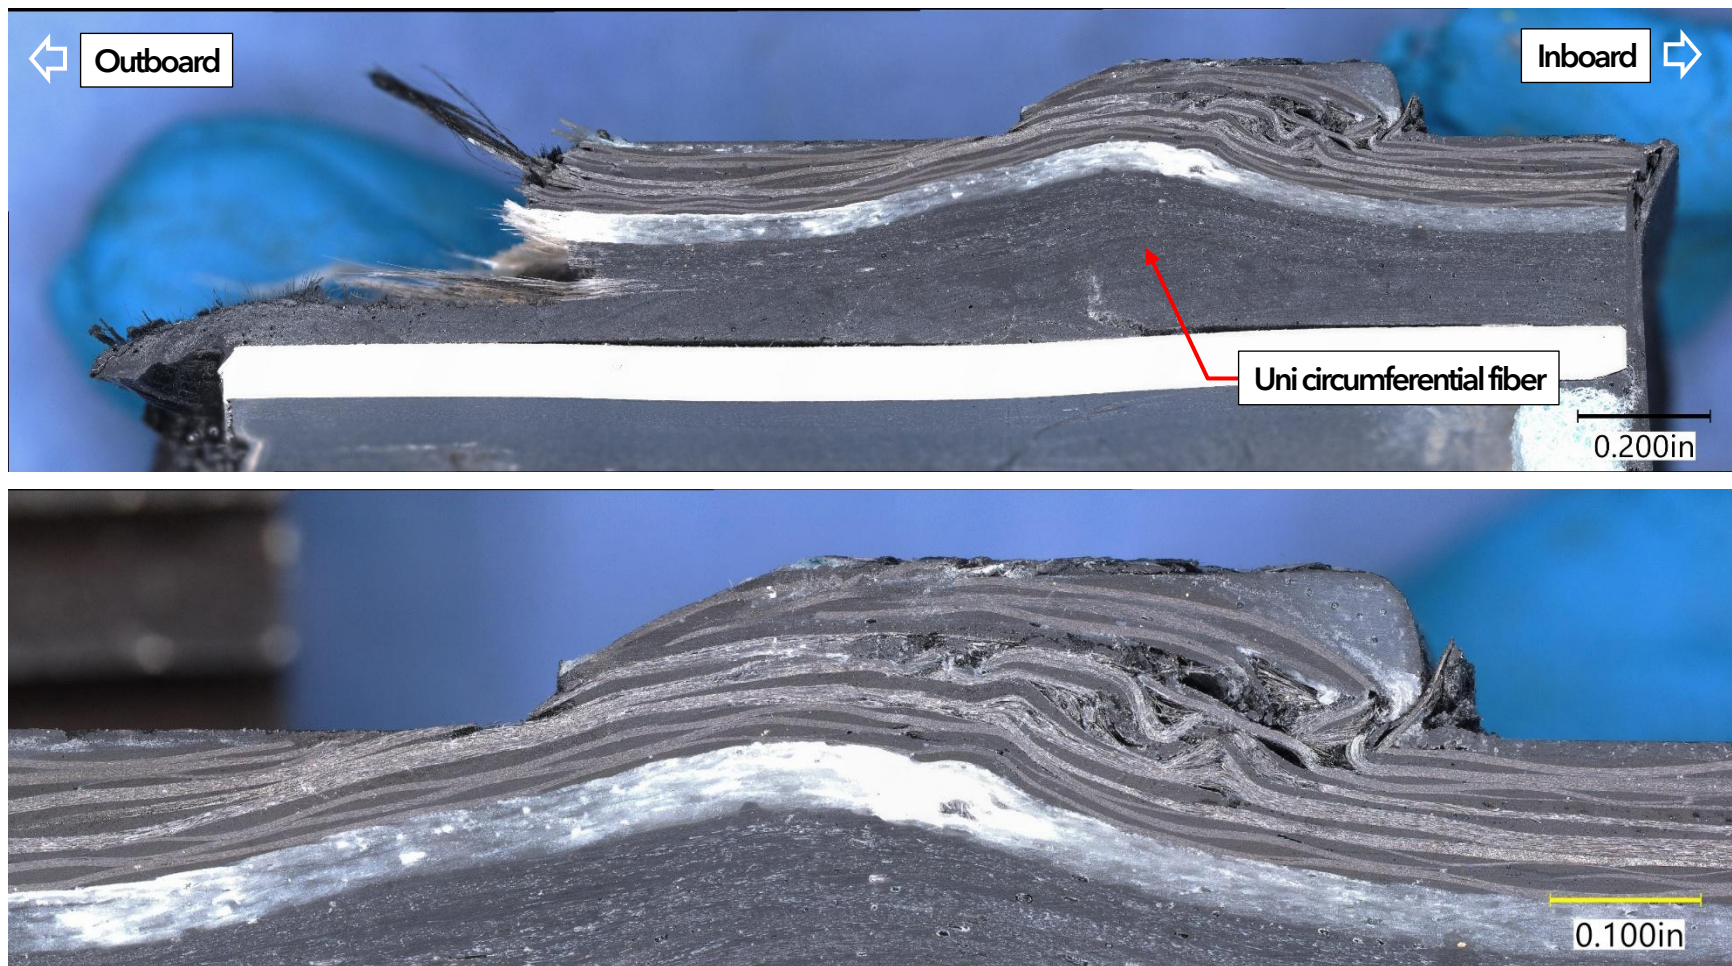
Within the collar feature, the fiber layers bowed radially outward, partially filling and forming the collar. The rest of the collar consisted of resin-rich wedge-shaped regions of epoxy along the upper and lower edges. In some regions, the excess volume between the bowed layers was filled by resin pockets or voids (figure 3a). In some regions, the excess volume was filled unidirectional circumferential glass fiber (for example, see figure 15 below).

**Figure 15.** Top Image: Overview image of axial cross section. Lower image: Higher magnification image of axial displacement of collar feature.

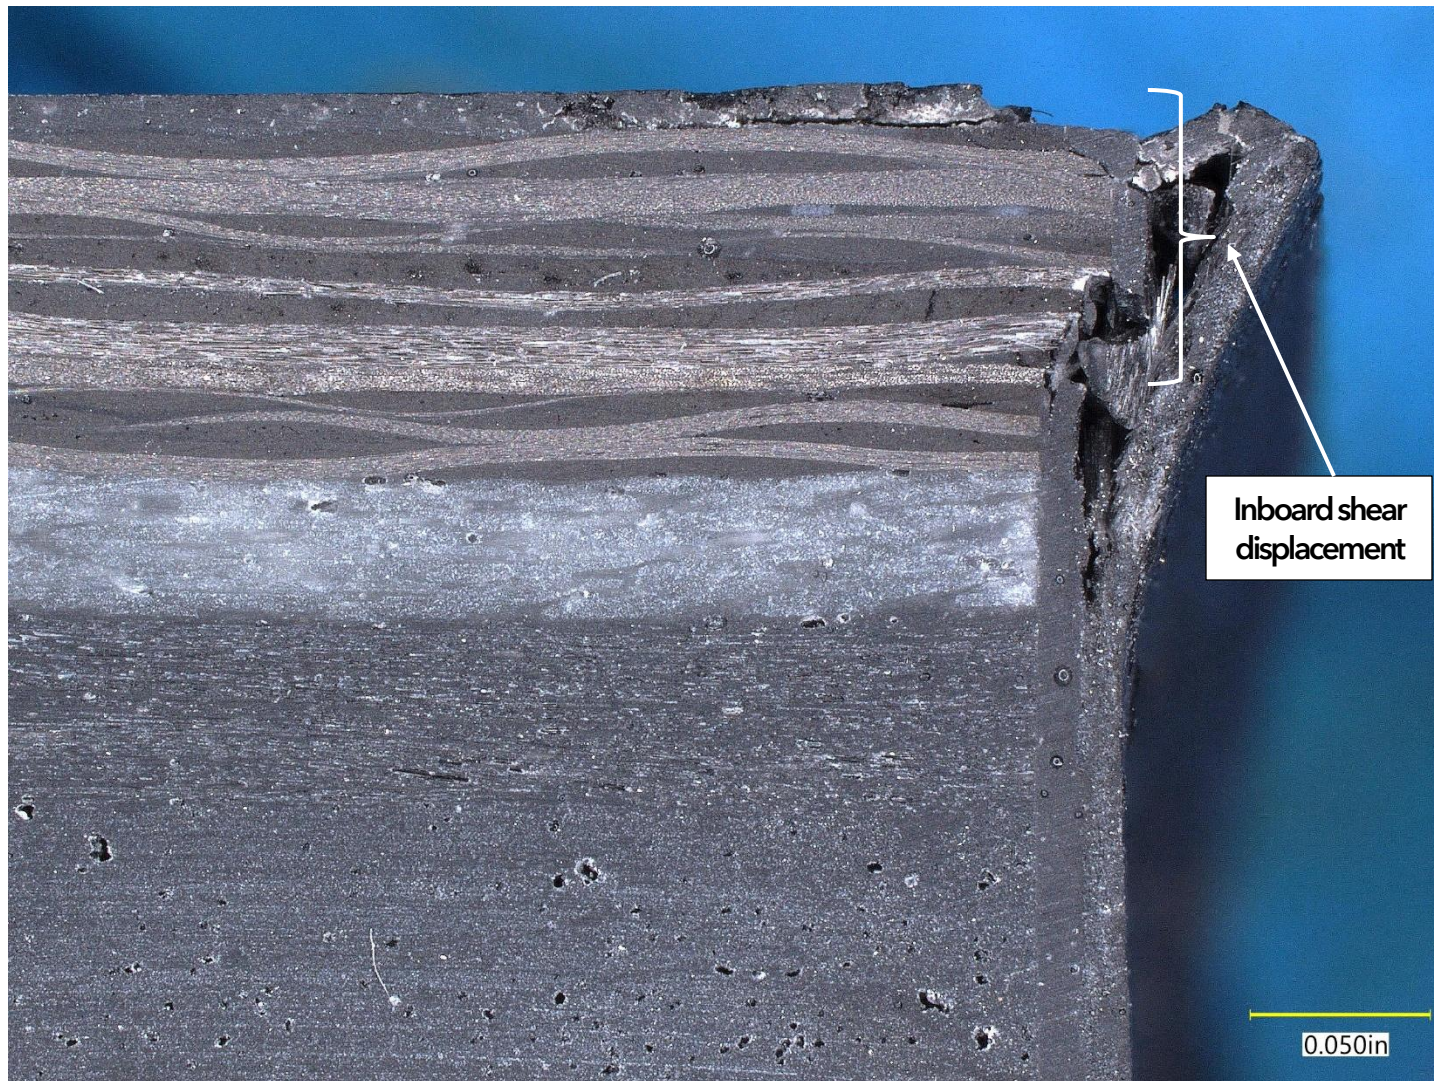
**Figure 16.** Image showing shear displacement of blade plies.

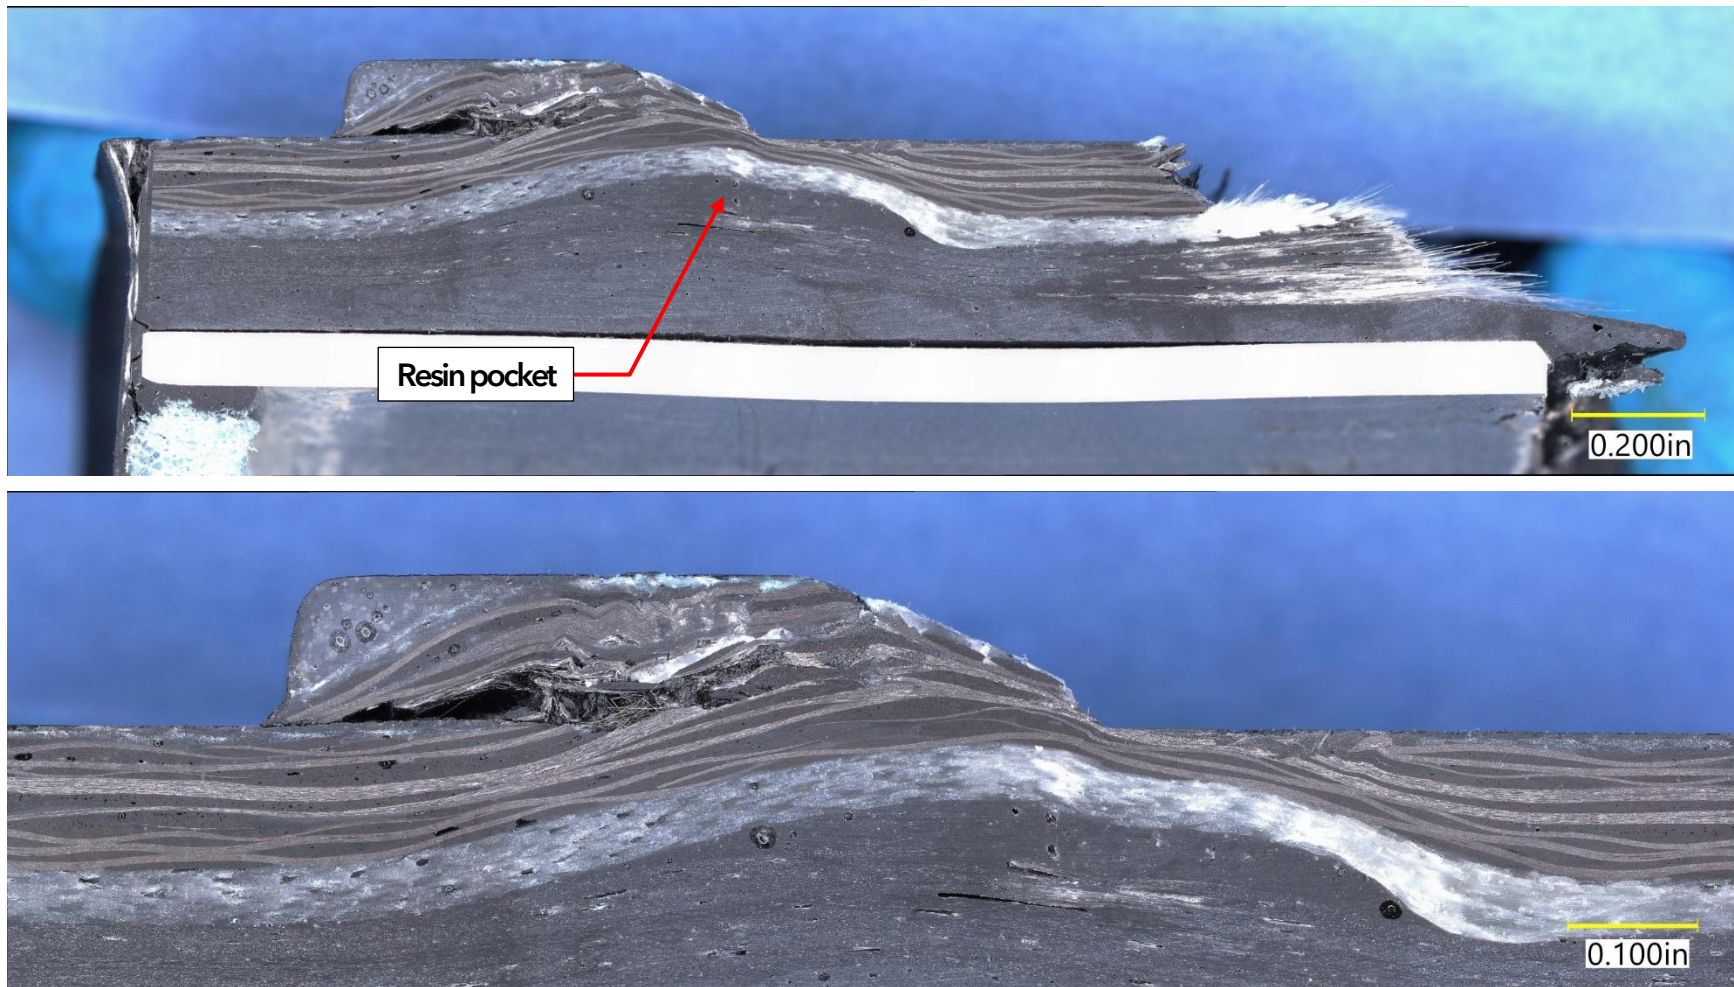
**Figure 17.** Top Image: Overview image of axial cross section. Lower image: Higher magnification image of axial displacement of collar feature.

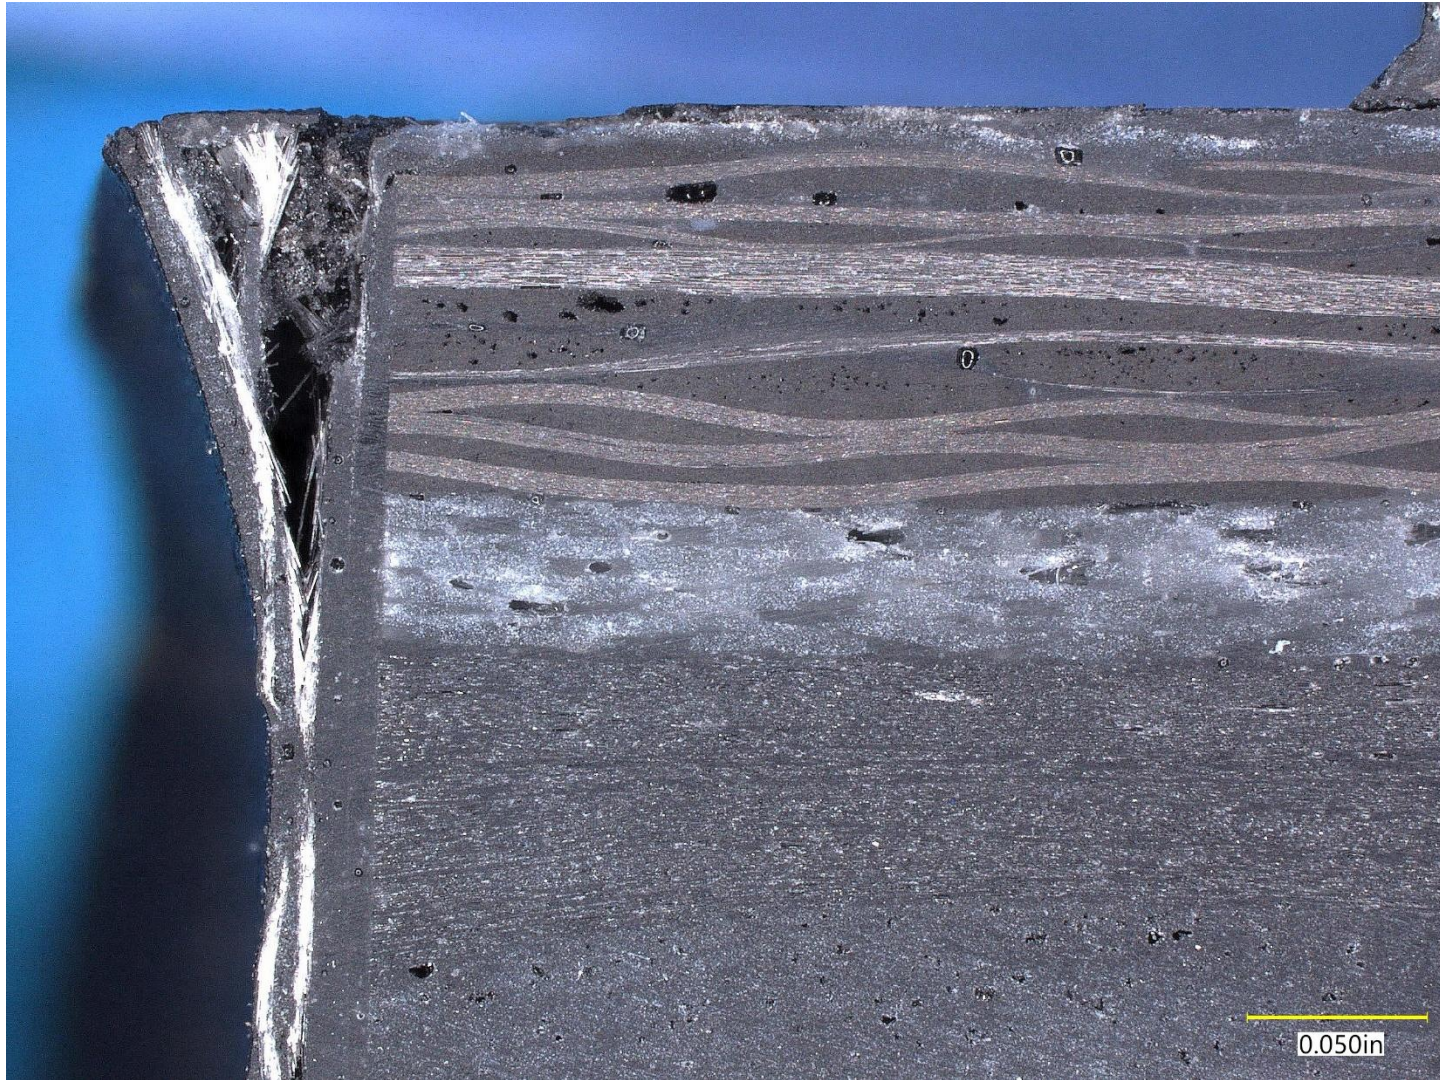
The blade root was sectioned in the spanwise direction at two locations located on the aft-facing side of the blade (high-pressure side) (figure 14). The cut faces were ground on silicon carbide paper through 600 grit to examine the composite structure and the displacement of the collar feature (figures 15 - 18). Along the spanwise outboard end of the collar, the resin-rich wedge had separated from the fiber plies. The outermost three or four plies had fractured near the spanwise outboard edge of the collar and had displaced spanwise inboard toward the root of the blade. On one cross section, the plies near the spanwise inboard edge exhibited buckling and peel separation (figure 15) and the outer four or five plies within the inboard grip area had sheared inboard relative to the underlying plies (figure 16). On the other cross section, there was comparatively little buckling of the plies and no apparent shear displacement of the outer plies (figures 17 and 18).

**Figure 18.** Image showing no apparent axial shear displacement of outer plies.

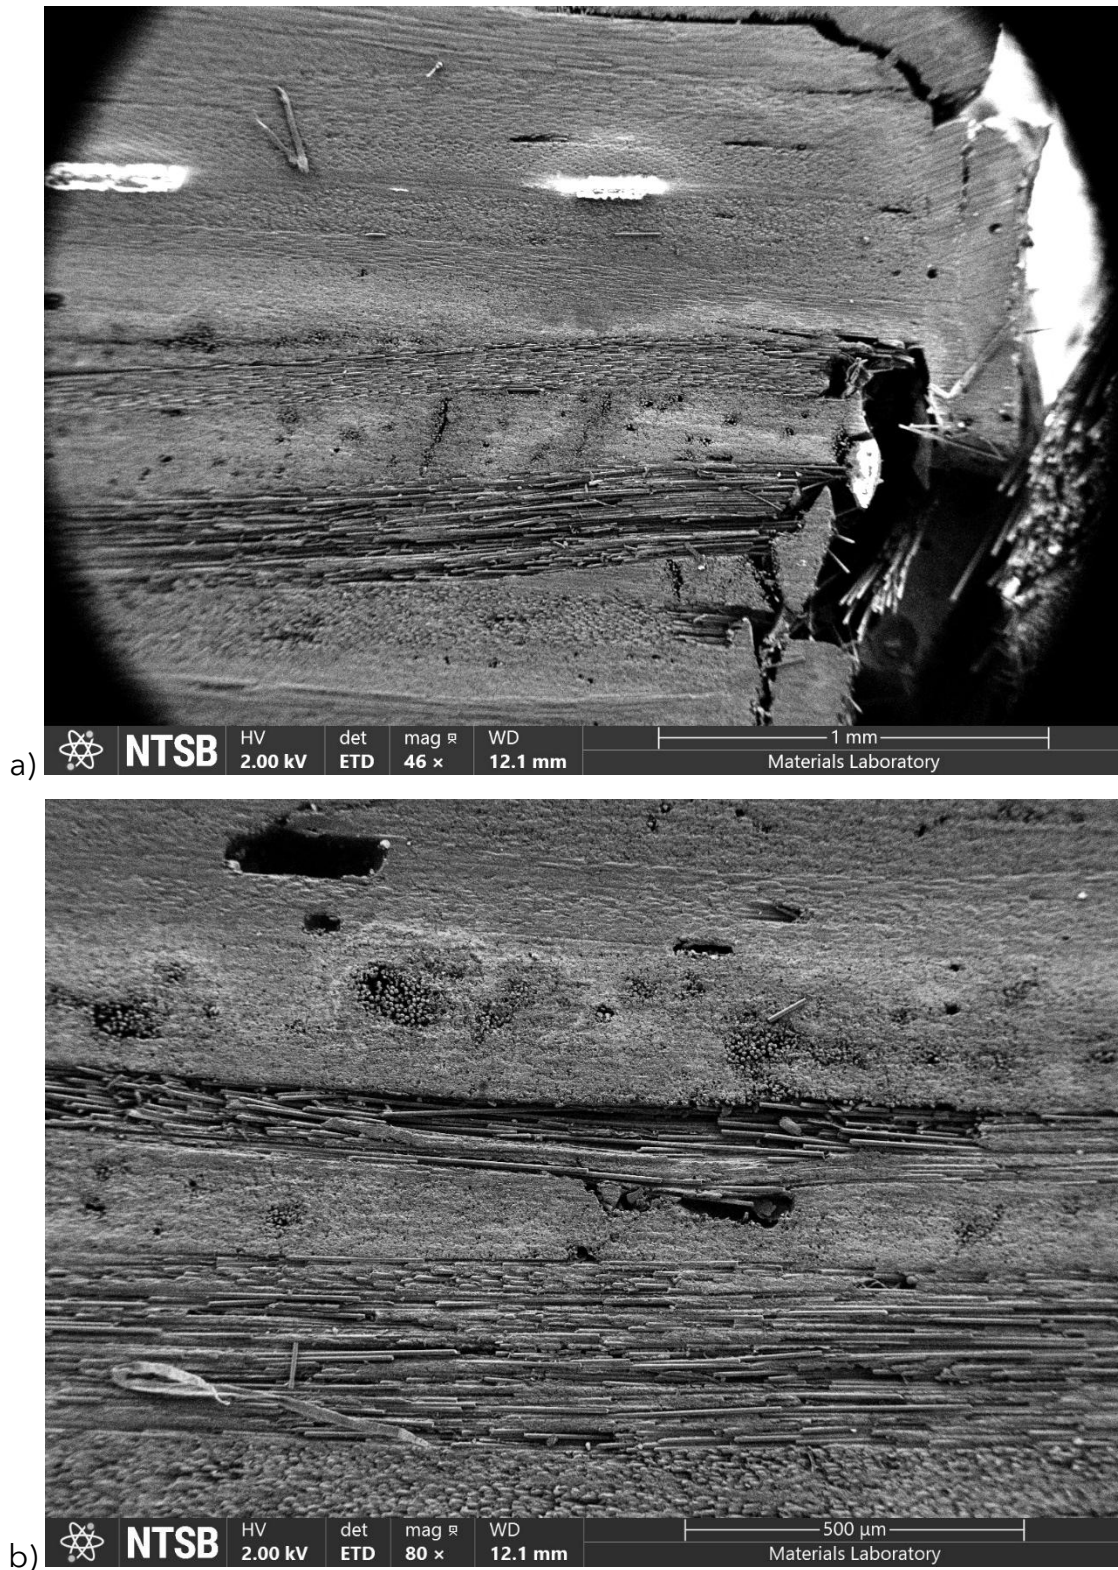
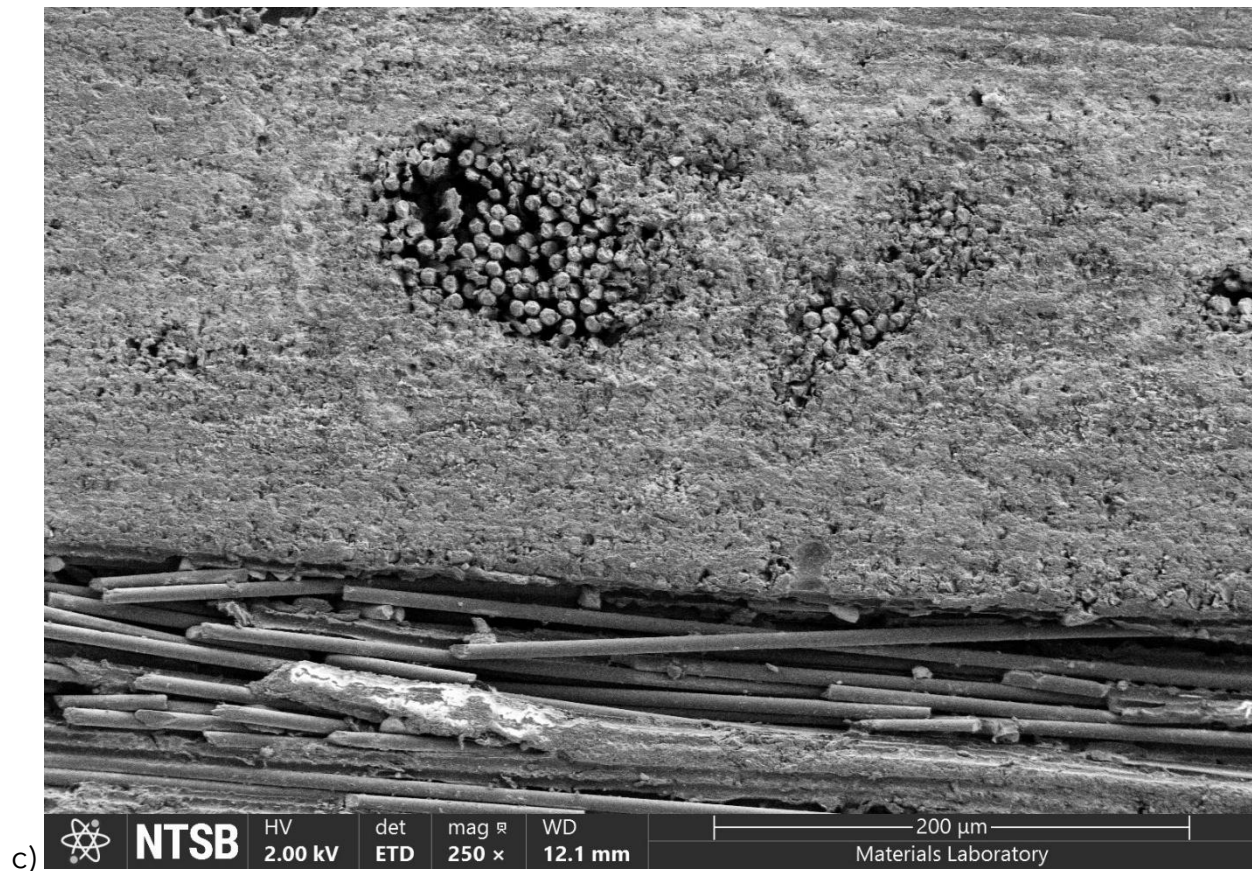
One of the cross sections was examined by scanning electron microscope and dry fiber features were observed (figures 19a - c). On circumferentially oriented tows, there were regions filled with fibers but with gaps between the fibers. On spanwise axially oriented tows, the fibers had pulled out, leaving a recess below the grinding plane.

**Figure 19.** Scanning electron microscope images of blade root cross section: a) overview image; b) higher magnification image showing axial fiber pullout; and

**Figure 19 (cont.).** c) higher magnification image showing dry fiber regions.
